HISTORIC BUILDING RECORDING: ROWLEY FARM LOWFIELD HEATH CRAWLEY SURREY

on behalf of English Partnerships

September 2006

ASC: 843/CRF/1

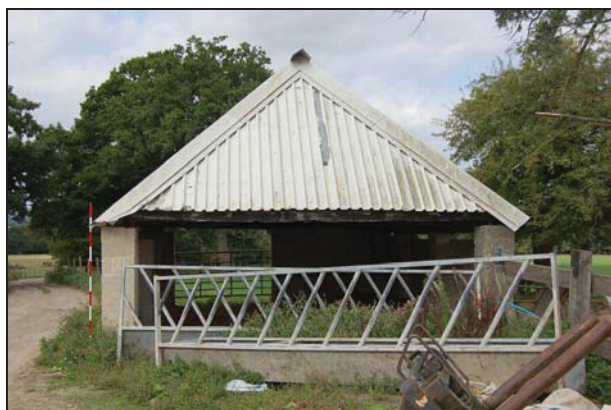
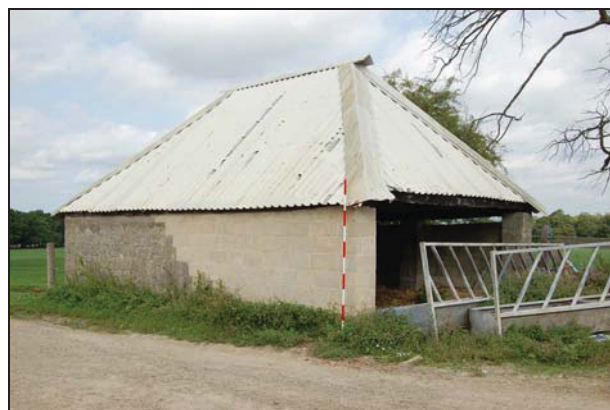
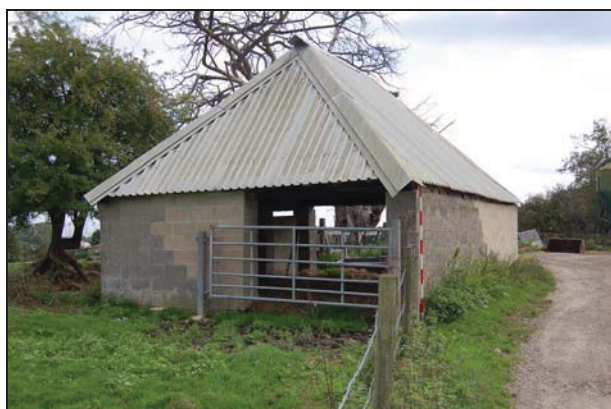
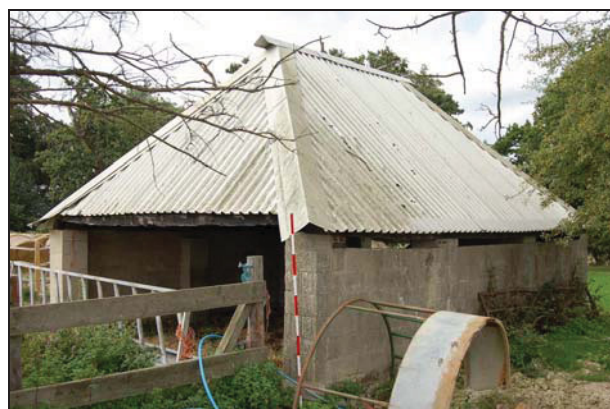
The roof is a clasped purlin type, with one purlin on either side made of single timbers laid with the larger section to the south. The principal rafters appear to have been replaced but the common rafters seem to be largely original, waney-edged timbers at 45cm centres that have been pegged at the apex. The rafters in the northern hipped roof are also waney-edged, with some bark still *in situ* on the eastern two timbers. The rafters on the southern hipped roof are all modern. The two trusses have bowed tiebeams, which are likely to have come from the same tree, probably a hedge oak.

Plate 1: South elevation

Plate 2: West elevation

Plate 3: North elevation

Plate 4: East elevation

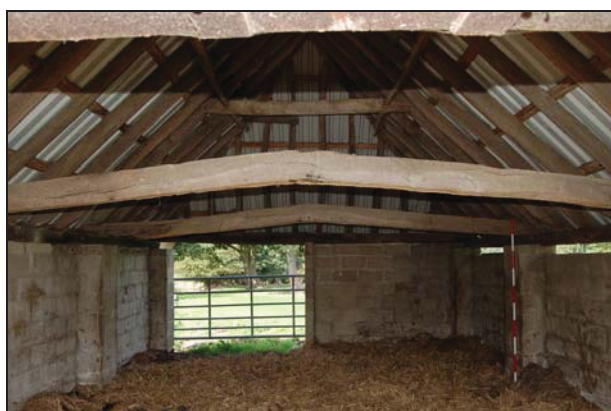
This has three mortices on the underside of the tiebeam, all with a single peg hole above and an iron nail on the northern side of the central mortice, which is scorched to the east and west. There is an iron tie at either end of the tiebeam on the northern side, the western one of which is no longer attached to the wall.

Plate 5: Interior looking north

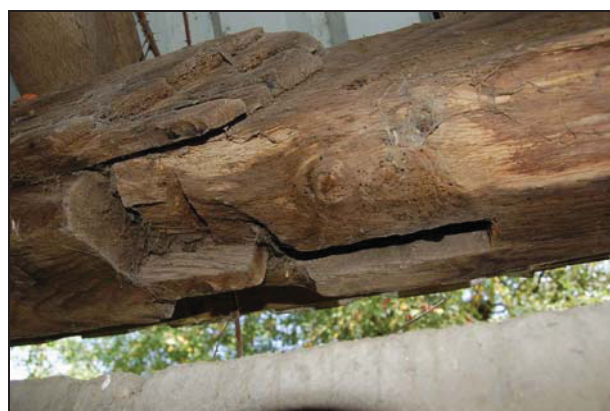
This also has three mortices on the underside of the tiebeam. The eastern mortice has two wooden pegs and the central one a single peg. The western end of the tiebeam has additional timbers to the north and south obscuring what appears to be an edge-halved scarf joint with bridled abutments immediately adjacent to the mortice. There is an iron tie on the northern side of the east end of the tiebeam and the southern side of the western end.

Plate 6: Scarf joint & mortice detail, northern tiebeam

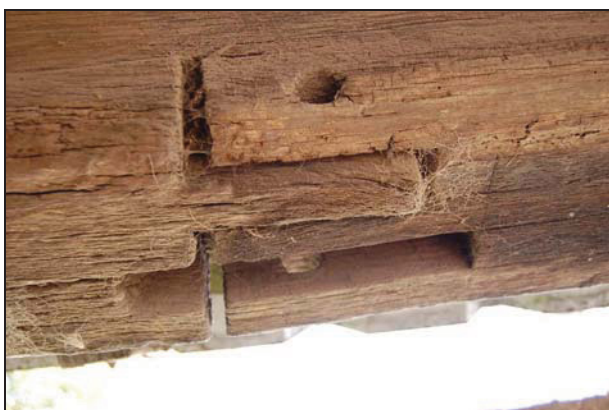
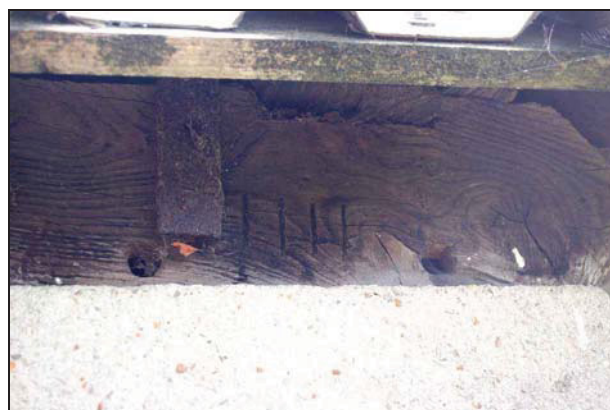
This has the most visible structural details along its length, including two edge-halved scarf joints with bridled abutments, several stud holes and three mortices with two peg holes above for larger timbers. The southernmost scarf joint is an interesting example of the amalgamation of an edge-halved scarf joint with a mortice on the eastern side.

Carpenter's assembly marks can be seen running consecutively from south to north, and additional assembly marks have been carved into the top and bottom of each of the scarf joints (I and II respectively). The ends of the wallplate, which is 14cm square, are well finished and protrude at either end of the elevation.

Plate 7: Scarf joint & mortice detail, east wallplate

Plate 8: Carpenters assembly mark, east wallplate

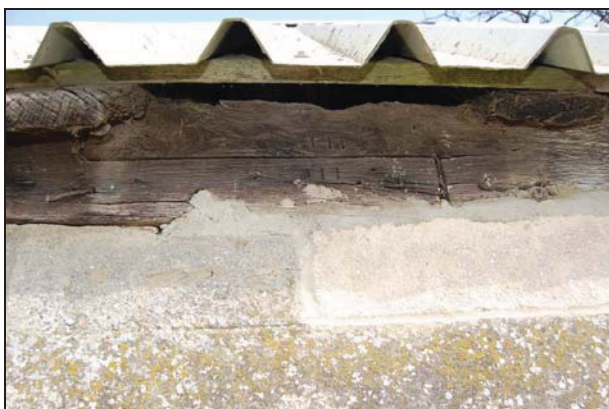
This is 14cm high and made up of two timbers joined by an edge-halved scarf joint. The timber to the south of the scarf joint is waney-edged, but that to the north is machine cut. The joint is marked with the number III.

Plate 9: Scarf joint & carpenters assembly marks,
west wallplate

The southern end of the western wallplate is likely to have come from the same building, although there is no evidence to confirm this at present. The northern end of the wallplate was clearly replaced in the modern era.

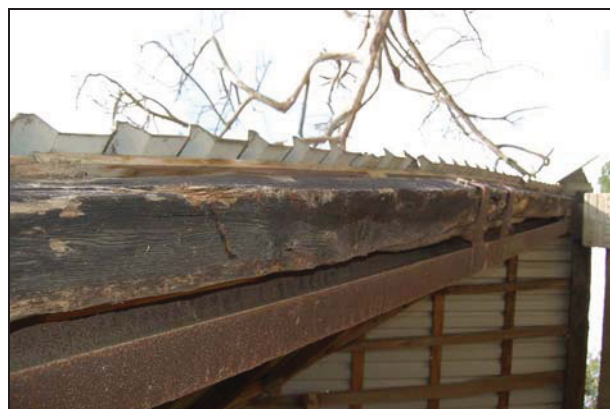
This is 17cm wide, 14cm high and is supported by a modern RSJ. There are three mortices on the underside with two pegs above each.

Plate 10: Beam over south opening

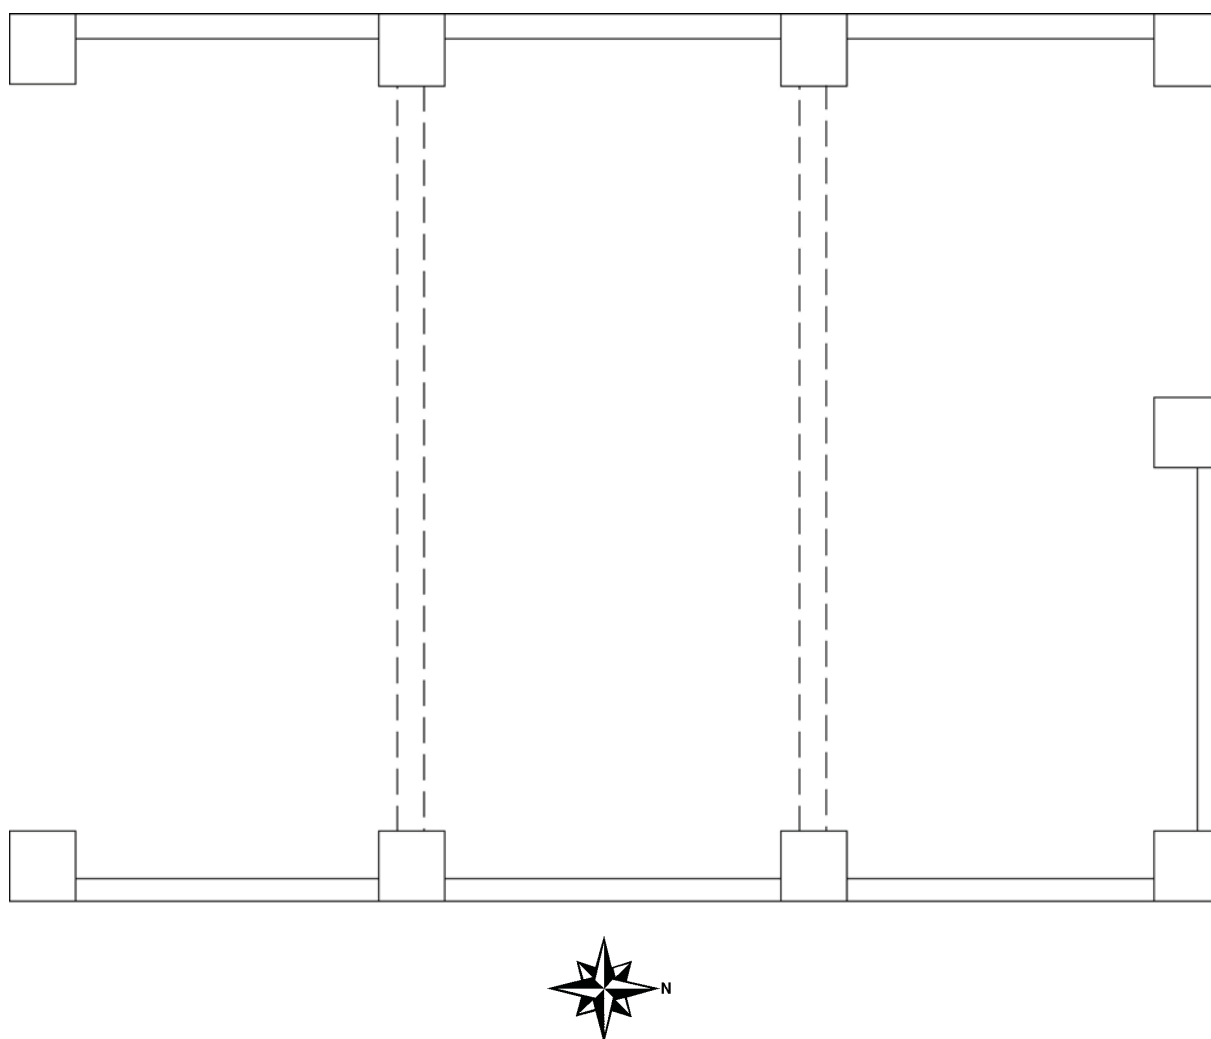
The building is a modern blockwork, single storey structure under a metal roof that is hipped at both ends (Fig. 3). It is open to the south and north giving access to the yard and a field respectively.

Figure 3: Schematic groundplan (*not to scale*)

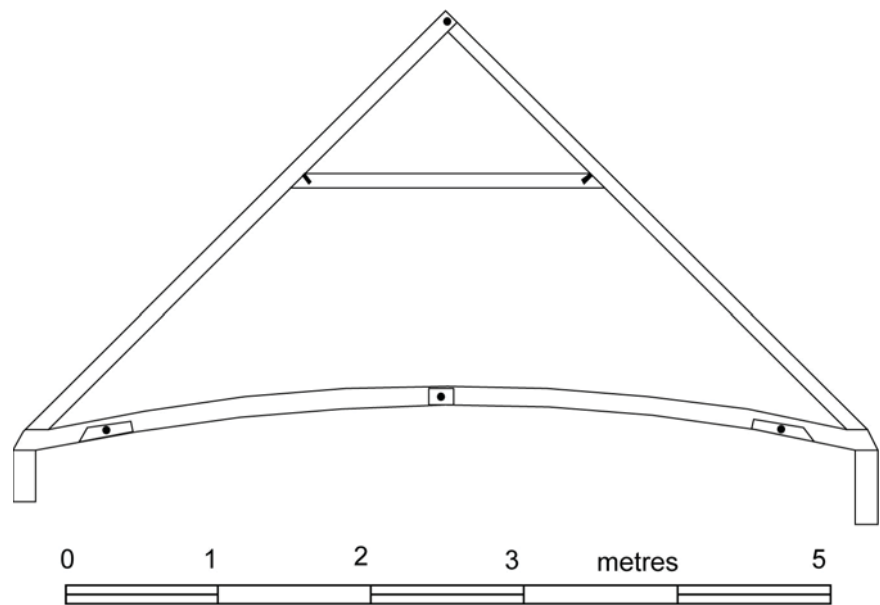
Figure 4: Southern roof truss (*scale 1:50*)

The edge-halved scarf joint in the southern roof truss would suggest that both of these are also from a medieval building, although the use of such poor quality wood tends to be associated with the late 17th and 18th centuries. Neither of the tiebeams have mortices on the top, which would suggest that they were intermediate trusses. The question of whether they were part of the same structure as the wallplates is debatable. Certainly the timbers themselves are of a rather poorer quality than one would expect in a domestic building with a screens passage, yet the scarf joint/mortice arrangement in the northern tiebeam is not too dissimilar to the scarf joint/mortice conjunction in the eastern wallplate, and may well indicate the work of a single carpenter. This gives rise to two possibilities; being narrower than the wallplate, the roof trusses either came from the cross wing of the same building or from a contemporary structure within the same complex. If the latter is the case, the presence of the mortices are likely to indicate that they came from a smaller farm building with internal subdivisions, such as stables rather than a barn.

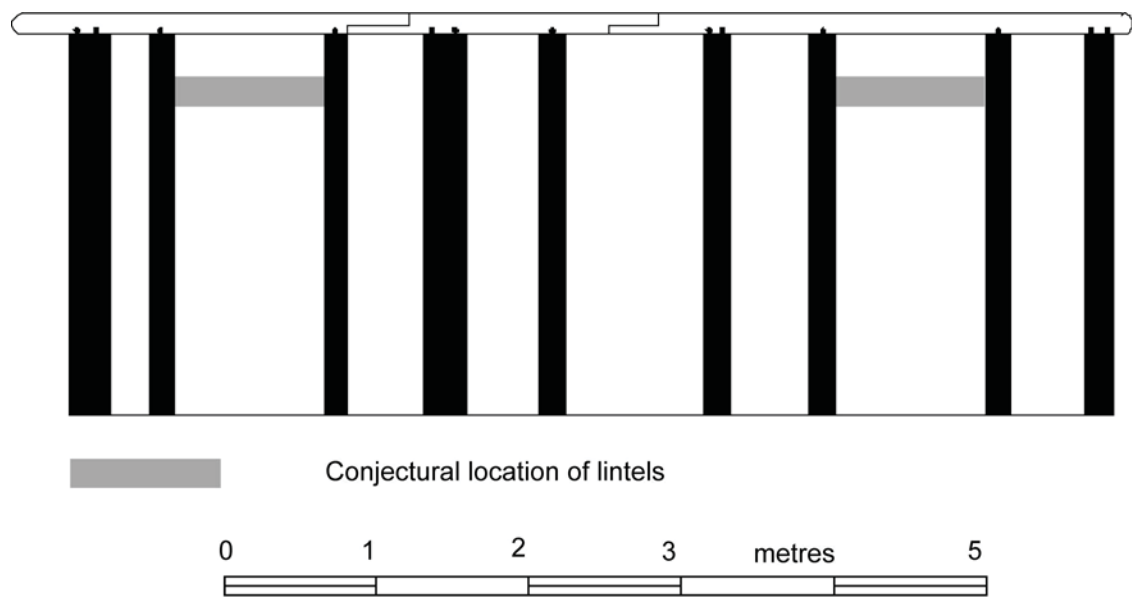
Figure 5: Reconstruction of the wall based on the mortices (*scale 1:50*)

The numerous mortices and stud holes indicate that the wallplates and tiebeams at either end of the structure are from a medieval timber framed building. The edge-halved scarf joint with bridled abutments present in the western wallplate had gone out of common usage by the end of the 15th century, which would suggest that the original building was no later than this time. The arrangement of the two neighbouring stud holes at both the northern and southern end of the beam suggest that there were doors located here, which gives rise to the possibility that this was once the beam over a screen.
