**WATCHING BRIEF:  
80 OXFORD ROAD  
STONE  
BUCKINGHAMSHIRE**

*on behalf of Crowndale Developments*

**October 2005**

**ASC: 594/SOR/2**

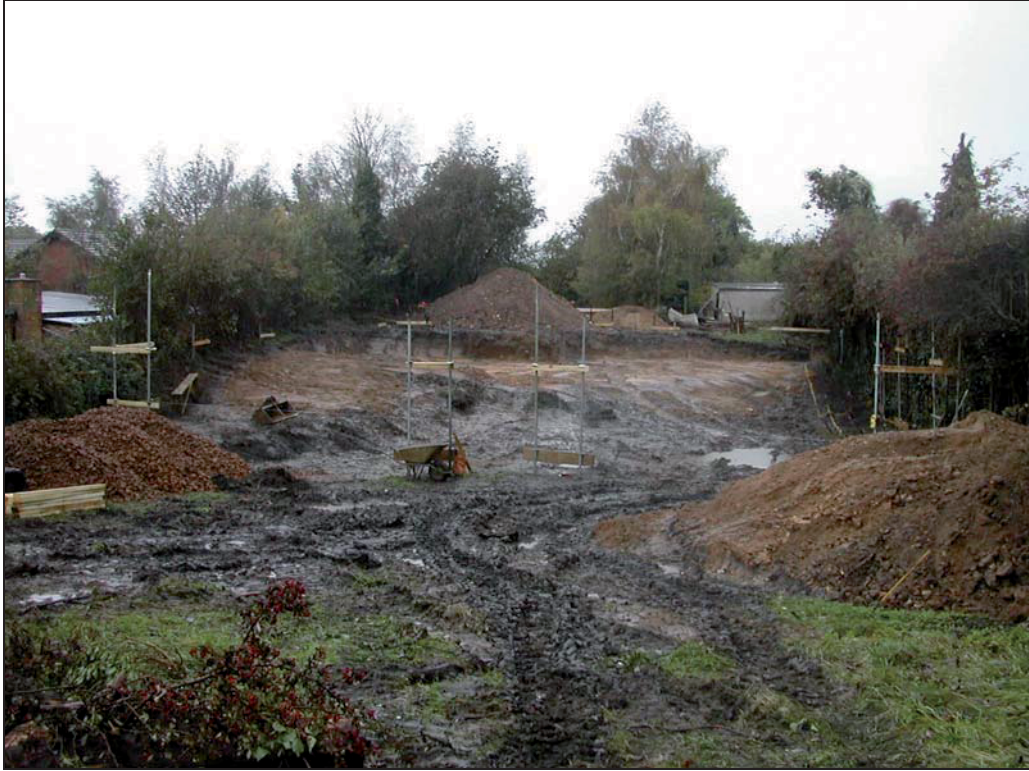
**Plate 1:** General shot looking west

Three areas of ground reduction were monitored; the access road, Plot 2 and Plot 3. The access road was reduced by c.1m revealing sandy subsoil with clay patches below the dark, sandy almost stoneless overburden. Some darker patches were observed, which appeared to be man-made but of recent date.

The area reduced for Plot 2 was approximately 10 x 15 x 1.4m (max). The south side had clearly been disturbed.

The ground for Plot 3, which lay beneath the footprint of the original building, was reduced by 1.9–2.0m. A pale cream sandy layer with occasional patches of yellow sand and occasional ironstone fragments, which lay below 0.4-0.5m of topsoil was revealed in the eastern section. No archaeological features or finds were observed.

- 5.1 Despite the discovery of Roman and Anglo-Saxon burials to the north and south of the site, no archaeological features or finds pre-dating the modern period were observed during the watching brief. The variable and, in some areas, disturbed stratigraphy suggests that small-scale sand extraction occurred on the site in recent times. It is possible that the quarrying destroyed earlier archaeological remains. It is however, equally probable that the site was never used for burials or any other human activity that would leave a more enduring entry in the archaeological record.
- 5.2 The conditions during the watching brief were generally favourable for the identification of archaeological remains and would result in a high confidence rating.

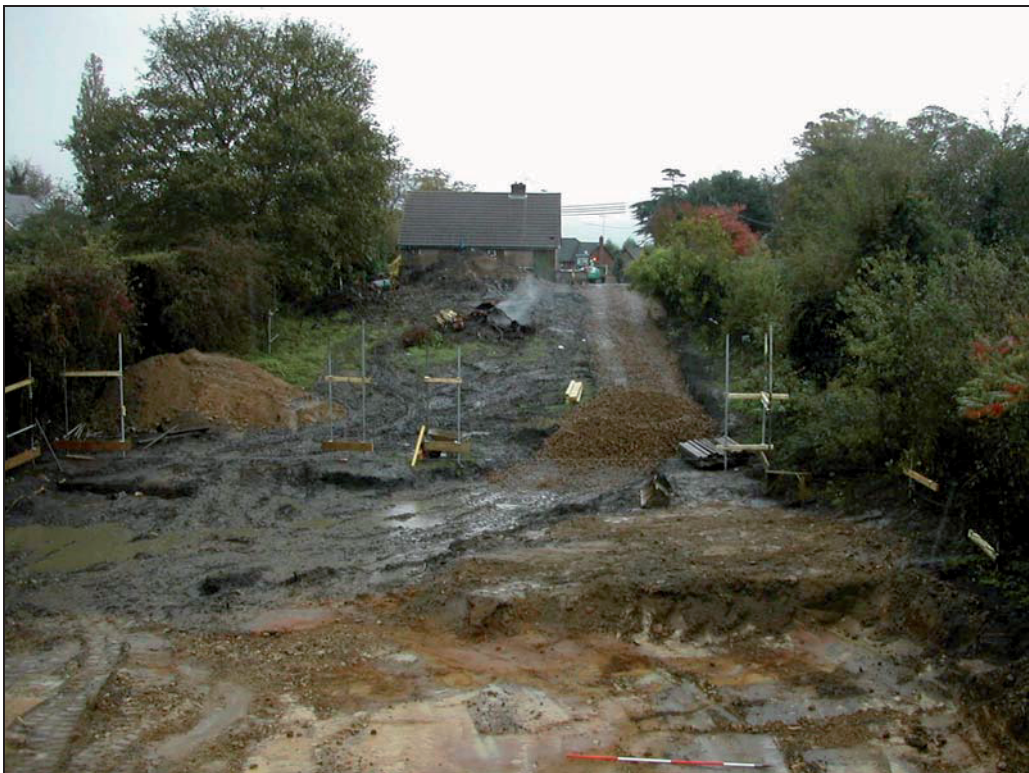
**Plate 2:** General shot looking east

The footing trenches for Plot 1, which were 0.65 m wide and between 1.90 and 2.25m deep were monitored throughout and found to have variable stratigraphy. Dark organic sandy deposits with occasional charcoal flecks overlay pale brown sand at the eastern end of the site. The majority of the ground on the northern end of the site was made up of two distinct bands of deposits. The upper level consisted of yellowish brown and pale sandy clay. These overlay clean white sand. A one-metre deep deposit of brown sandy soil overlay brown 'banded' clay in southern trench. No archaeological features or finds were observed, other than possible extraction pits for sand.
