**ARCHAEOLOGICAL EVALUATION:
42-52 DIGLIS ROAD
WORCESTER**

on behalf of Urban Aspects, for Greenvilla Developments

February 2007

ASC: 858/WDR/4

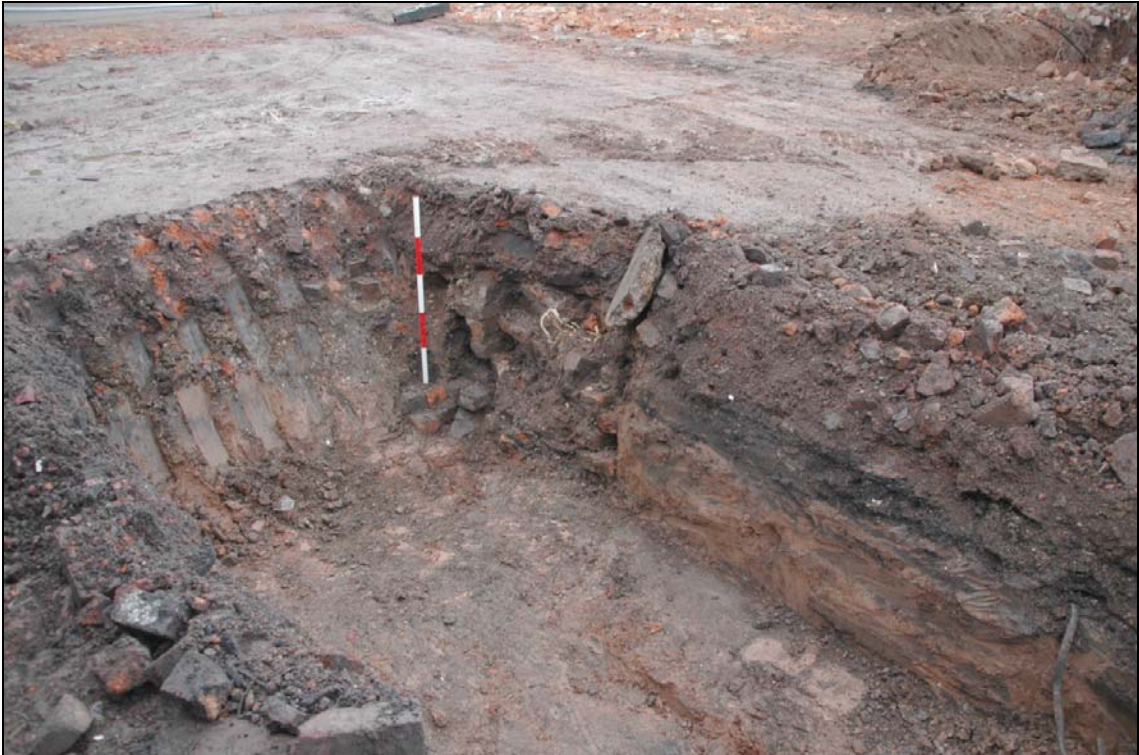
Plate 1: Trench 1, privy walls 105 & 106 and section in SE corner of trench

Description: This trench was orientated SE – NW and was c.1.1m deep at the SE end stepping up to 0.6m at the NW end. The canal up-cast was observed at 0.6m below the existing ground surface. Two features of note were observed. At the SE end of the trench sealed by a layer of brick rubble the corner of a brick built privy was observed (walls 105 & 106). At least eight courses of red machine-made bricks survived. A disconnected soil pipe was also seen associated with this structure. The only other feature of any significance was the SE corner of one of the buildings demolished prior to the start of the evaluation (walls 107 & 108). The bricks were stamped LBC (London Brick Company). A substantial footing trench c.1.0m had been excavated for the insertion of this wall.

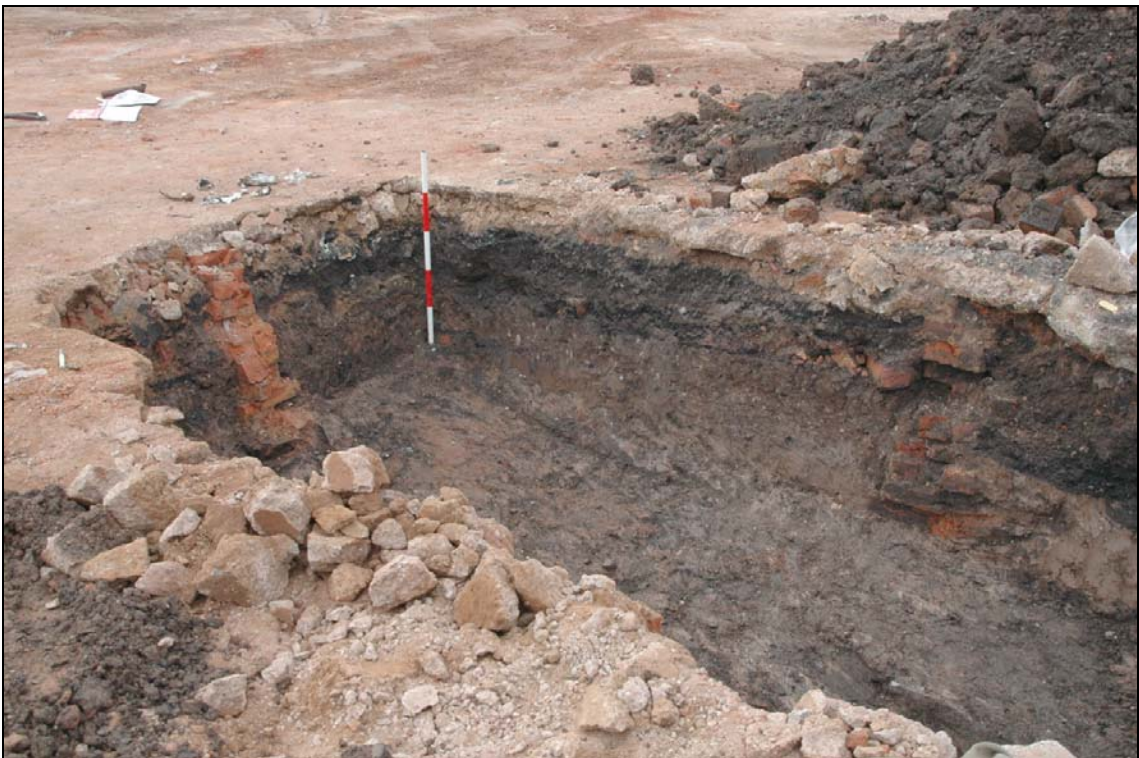
Plate 2: Trench 2, Walls 206 & 207 in section sealed by the concrete slab

Description: This trench was orientated NE – SW and was c0.8 – 1.0m deep. A modern concrete surface (201) covered the entire length of the trench. This concrete sealed a brick wall [206] at the SW end of the trench. Wall 206 emerged from the SW end of the trench and continued NE for 5.6m at which point it formed a bonded “T” junction with an NW –SE wall [207]. No other significant features were observed in this trench.

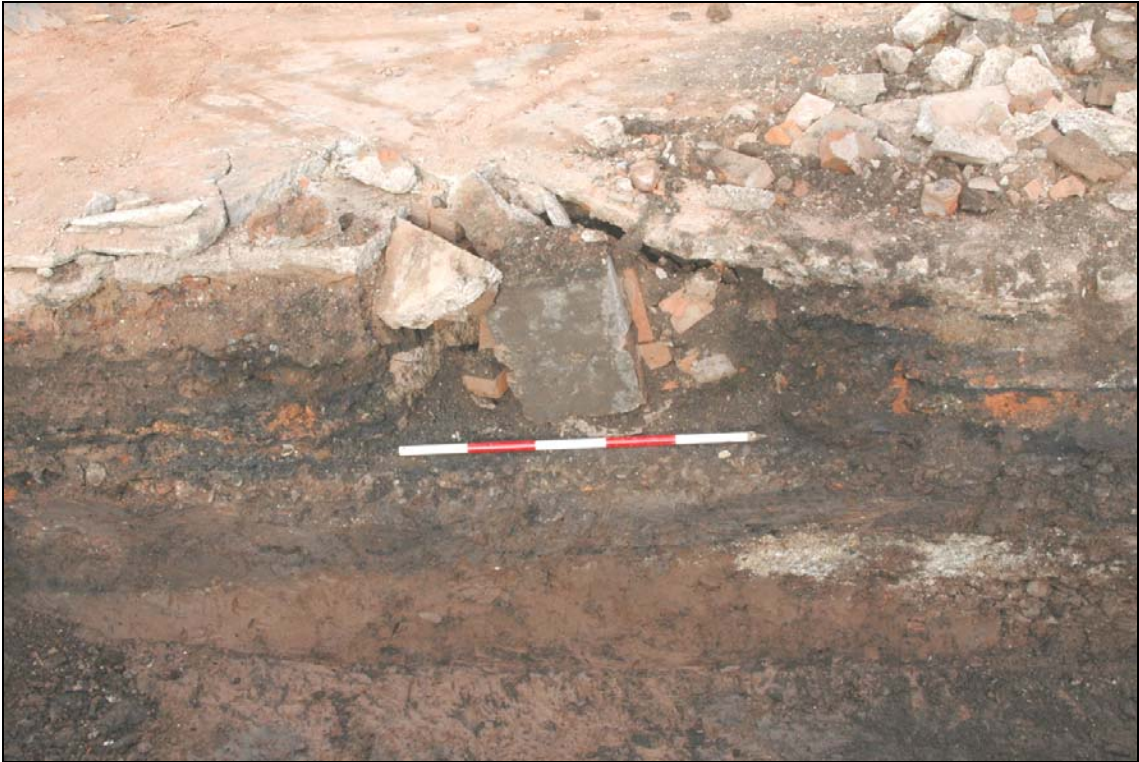
Plate 3: Trench 3, Wall 310 sitting on stone surface 305

Description: This trench was orientated NW – SE and was c.1.2m deep. Three features of note were observed in this trench. A concrete surface (301) sealed a brick wall [310] running diagonally across the trench from SE – NW continuing the alignment of the Millwrights warehouse wall to the SE. A second concrete surface (303) below the upper concrete surface abutted the SW face of the wall. This wall was constructed upon a stone surface (305) (stone size <50mm) which was seen throughout the trench. This stone surface sat upon the grey disturbed up-cast (306) from the excavation of the canal basin. A small sunken area filled with lime mortar (307) was noted below the grey up-cast and has been interpreted as a mortar mixing area associated with the original construction work of the site.

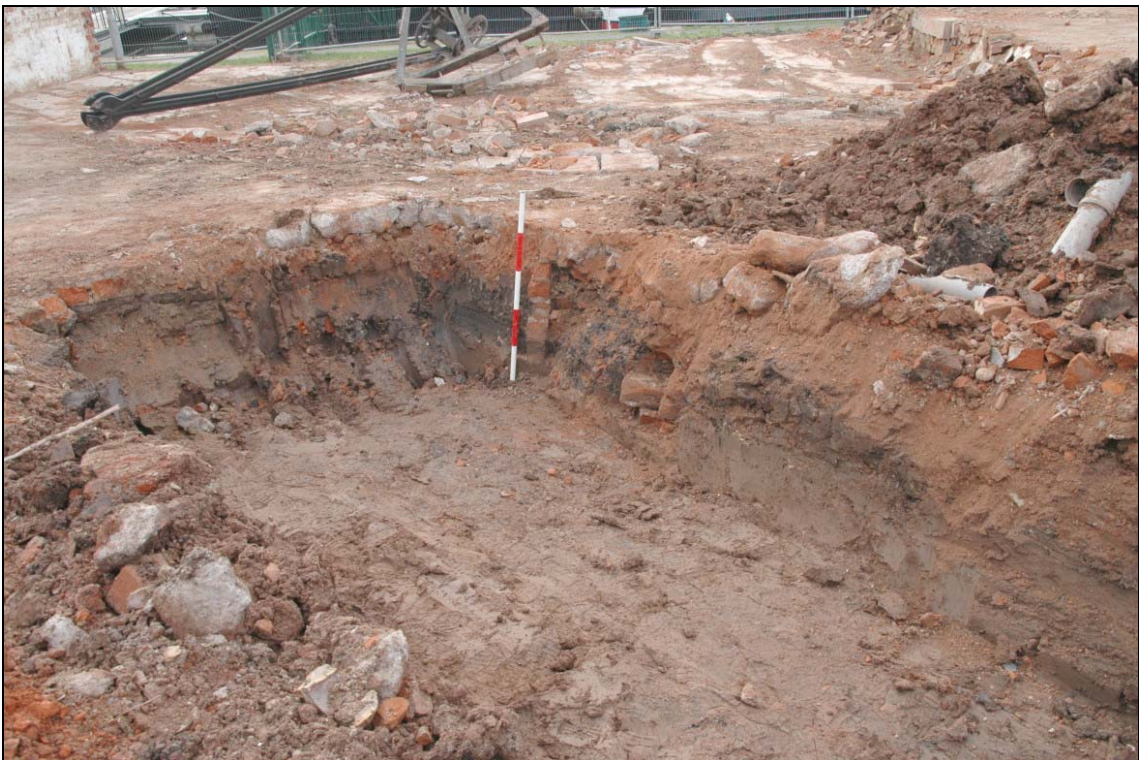
Plate 4: Trench 4, privy walls 408 & 409 and section in SW corner of trench

Description: This trench was orientated SW – NE and was c.0.7m deep. It run parallel to the backs of no 48 – 52 Diglis Road and was divided into two roughly equal sections due to a gas main running across it. Both sections were highly disturbed by service trenches. In the SW corner of the trench the footings for a privy were observed (walls 408 & 409). A soil pipe was observed leading away from this structure in a NE direction. At the NE end of the trench the SE facing face of another brick wall [413] was observed. This wall was exposed for 2.8m, and continued under the trenches NE baulk.

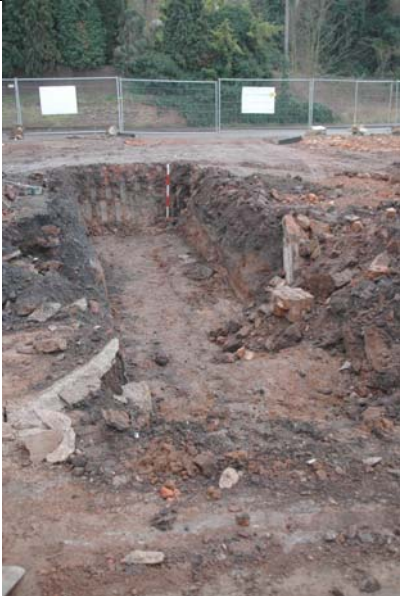
Trench 1

Max Dimensions (m)					
	Length	9.7	Width	2.0	Depth	1.2
	Levels					
	Trench base SE			16.88m OD		
	Trench top SE			17.9m OD 8		
	Trench base NW			17.00m OD		
	Trench top NW			17.47m OD		
	NGR Co-ordinates					
	SO	85071 53984		SO	85062 53988	
	Orientation			SE-NW		
Reason for Trench			General trenching pattern			
Context	Type	Description and Interpretation	Max Width (mm)	Max Thckn (mm)	Depth BGL (mm)	
101	Layer	Brick rubble	2000	450	0-450	
102	Layer	Broken tarmac and clinker (makeup)	2000	250	450-700	
103	Spread	Red clay (up-cast from excavation of the canal basin)	2000	>400	700-1100	
104	Layer	Very mixed fill around soil pipe	500	800	300-1100	
105	Structure	Brick wall of privy	200	800	300-1100	
106	Structure	Brick wall of privy	200	800	300-1100	
107	Structure	Brick wall NE-SW recently demolished	2000	1100	0-1100	
108	Structure	Brick wall NW-SE recently demolished	-	400	0-400

- 16.63m OD Top of auger hole
Red clay continuation of layer 103
- 15.98m OD Natural red clay more stony and firmer than above
- 15.93m OD Moisture content increasing
- 15.68m OD Very pale green silty clay lens, very moist
- 15.63m OD Red clay moist
- 15.53m OD Red clay slight sand content
- 15.43m OD Red clay, very dry and crumbly, few small stones
- 15.18m OD continues as above

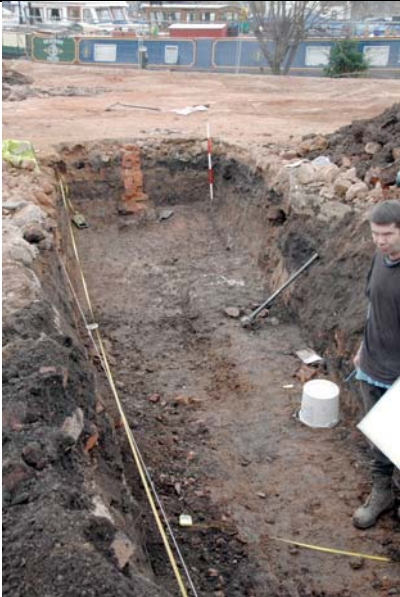
Trench 2

Max Dimensions (m)					
	Length	10.0	Width	2.2	Depth	0.9
	Levels					
	Trench base NE			17.48m OD		
	Trench top NE			16.21m OD		
	Trench base SW			16.42m OD		
	Trench top SW			17.45m OD		
	NGR Co-ordinates					
	SO	85057 53991		SO	85053 53983	
	Orientation			NE-SW		
Reason for Trench			General trenching pattern			
Context	Type	Description and Interpretation	Max Width (mm)	Max Thckn (mm)	Depth BGL (mm)	
201	Spread	Concrete surface	2000	150	0-150	
202	Layer	Brick, clinker and clay (makeup)	1000	450	150-600	
203	Layer	Brick, Clinker and clay (makeup)	1000	350	150-500	
204	Spread	Red clay (up-cast from excavation of the canal basin)	2000	>400	500-900	
205	Layer	Mixed layer of sand, clinker, coal and clay (makeup)	1000	500	500-1000	
206	Structure	Brick wall SW-NE bonded to wall 207 forming a "T" junction	300	850	150-1000	
207	Structure	Brick wall SE-NW bonded to wall 206 forming a "T" junction	300	750	150-900

208	Layer	Same as 202	1000	450	150-600	
209	Spread	Tarmac (surface)	1000	100	400-500	
210	Layer	Brick and clay (makeup layer)	1000	350	500-850

- 16.76m OD Top of auger hole
Red clay continuation of layer 204
- 16.06m OD Natural red clay more stony and firmer than above
- 15.76m OD 10% small stones
- 15.67m OD 20% small stones
- 15.60m OD continues as above

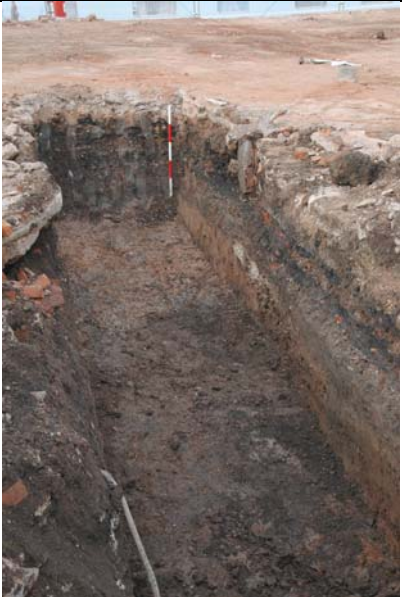
Trench 3

Max Dimensions (m)					
	Length	11.0	Width	2.0	Depth	1.3
	Levels					
	Trench base SE			16.14m OD		
	Trench top SE			17.49m OD		
	Trench base NW			16.31m OD		
	Trench top NW			17.49m OD		
	NGR Co-ordinates					
	SO	85060 53972		SO	85050 3977	
	Orientation			SE-NW		
Reason for Trench			General trenching pattern			
Context	Type	Description and Interpretation	Max Width (mm)	Max Thckn (mm)	Depth BGL (mm)	
301	Spread	Concrete surface	2000	100	0-100	
302	Spread	Concrete surface	2000	100	100-200	
303	Layer	Brick clinker & sand (makeup layer)	2000	450	200-650	
304	Layer	Brick clinker & sand(makeup layer)	2000	550	100-650	
305	Spread	Stone surface stones 40-60mm (yard/ track)	2000	100	650-750	
306	Layer	Mid grey brown clay (trample)	2000	150	750-900	
307	Layer	Lime mortar mixing hollow	1000	100	900-1000	
308	Layer	Layer of medium pebbles filling a hollow.	2200	150	900-1050	
309	Spread	Red clay (up-cast from the excavation of the canal basin)	2000	>400	900-1300

310	Structure	Brick wall (mid 20 th century building)	1200	550	100-650

16.19m OD Top of auger hole
 Red clay continuation of layer 309
 16.09m OD Natural red clay more stony and firmer than above
 15.55m OD continues as above

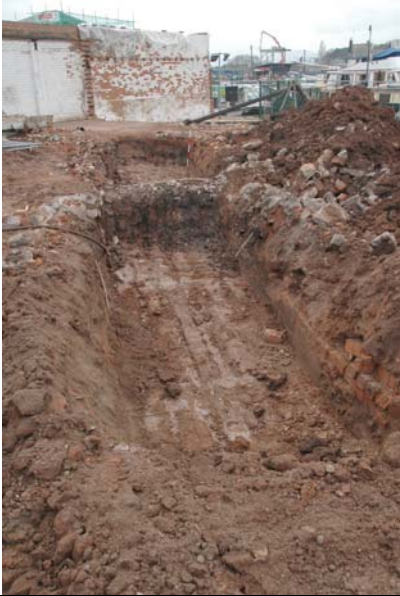
Trench 4

Max Dimensions (m)					
	Length	14.3	Width	2.0	Depth	1.0
	Levels					
	Trench base			16.91m OD		
	Trench top			17.72m OD		
	Trench base			16.87m OD		
	Trench top			17.66m OD		
	NGR Co-ordinates					
	SO	85066 53978		SO	85060 53965	
	Orientation			NE-SW		
Reason for Trench			General trenching pattern			
Context	Type	Description and Interpretation	Max Width (mm)	Max Thckn (mm)	Depth BGL (mm)	
401	Layer	2007 demolition rubble	2000	150	0-150	
402	Layer	Brick rubble (makeup)	2000	250	150-400	
403	Cut	Cut for foul pipe	-	150	250-400	
404	Spread	Red up-cast from the canal basin excavation	2000	500	400-900	
405	Spread	Orange/ red up-cast from the canal basin excavation	2000	350	650-1000	
406	Cut	Foundation cut for wall 413	2900	400	150-550	
407	Layer	Infill of privy	800	650	150-800	
408	Structure	Brick wall of privy	200	750	150-900	
409	Structure	Brick wall of privy	200	750	150-900	
410	Cut	Service trench	1400	500	100-600

411	Cut	Service trench	350	400	100-500	
412	Layer	Brick rubble	2000	350	150-400	
413	Structure	Brick wall	-	300	250-550
