**HISTORIC BUILDING RECORDING:  
42-52 DIGLIS ROAD  
WORCESTER**

*on behalf of Urban Aspects, for Greenvilla Developments*

**December 2006**

**ASC: 858/WDR/2**

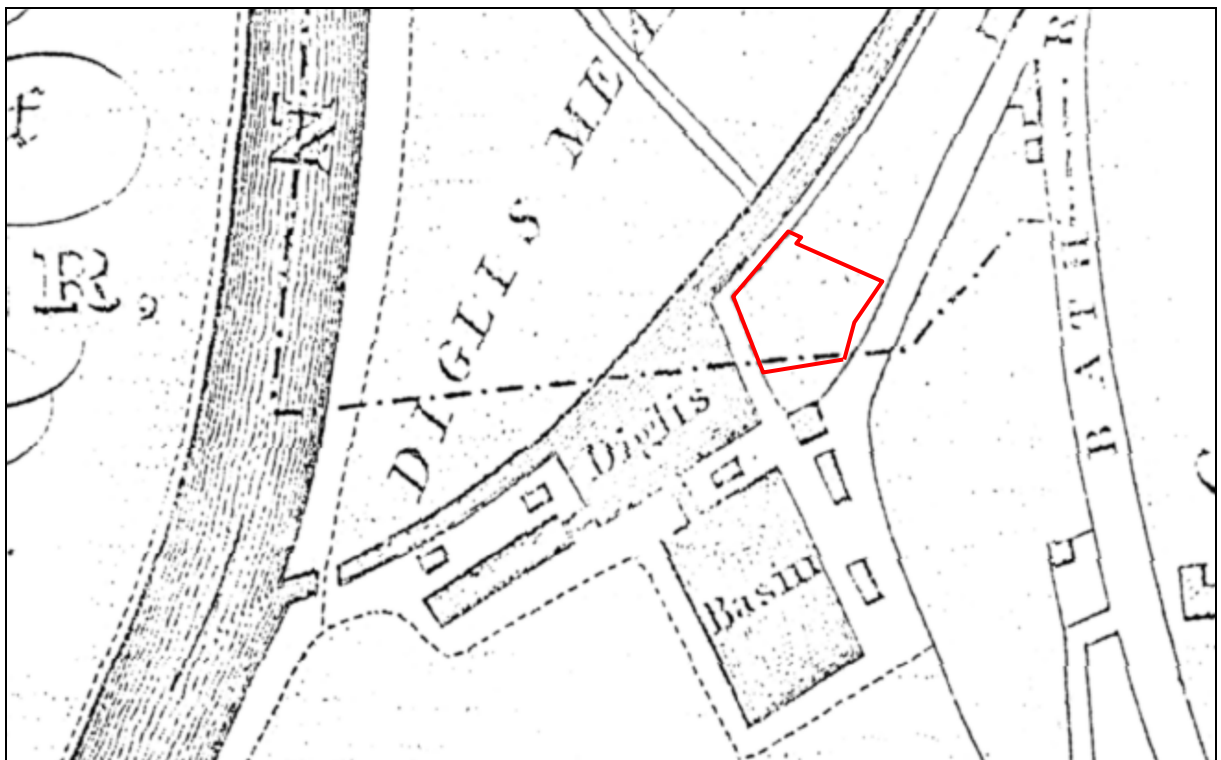
**Figure 3:** Extract from Eaton's Plan of Worcester, 1829 (*not to scale*)

The earliest map to show the site in any detail is Eaton's Plan of Worcester, dated 1829 (Fig. 3). This shows Diglis Road, the canal, and the two canal basins adjoining the site. The site, however, is shown as open ground at this time. The Dewhurst and Nichols map of 1838 (Meadows *et al* 2005, fig. 5) presents a similar picture, but by this time the millwright's warehouse is shown, and the site has been subdivided into three plots. The Tithe Map of 1841 (Fig. 4) shows a similar arrangement. The southern plot contains the millwright's warehouse, but the other plots are unoccupied.

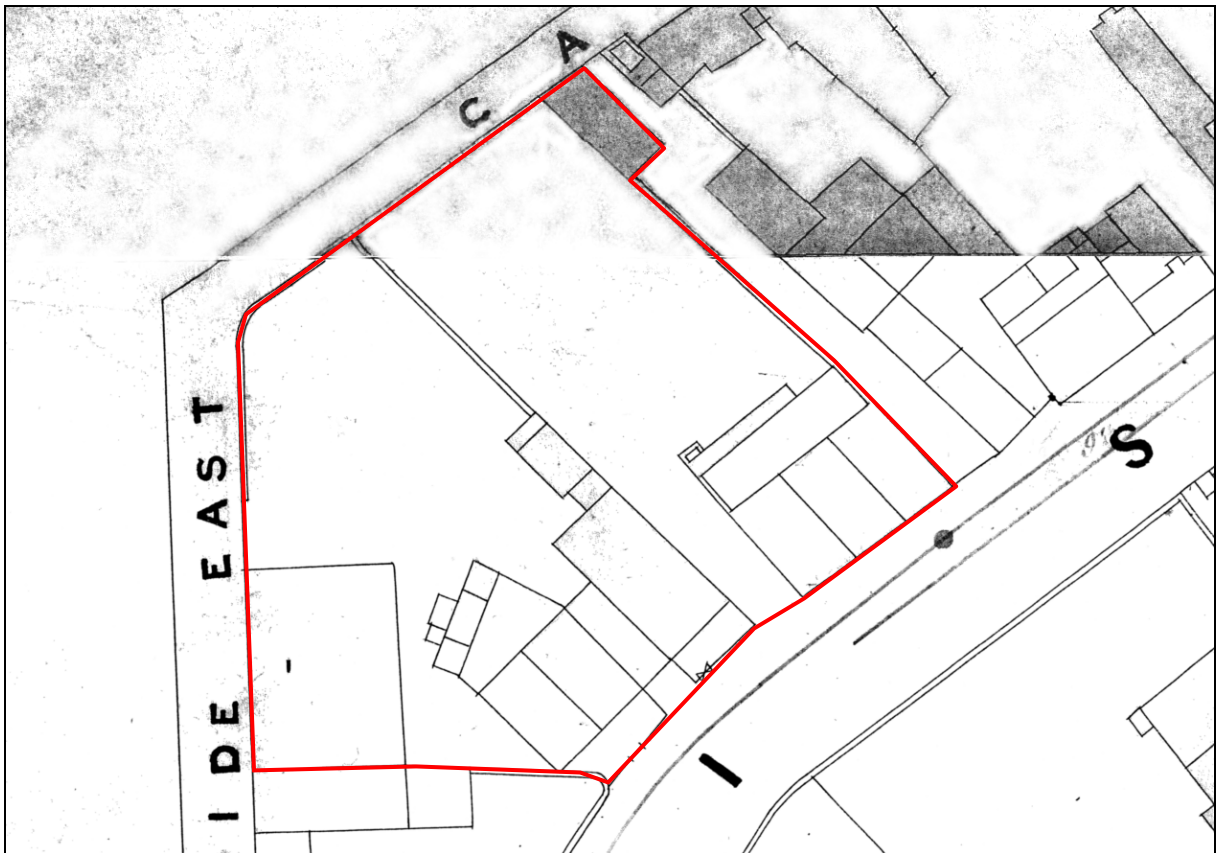
**Figure 5:** Extract from Worcester Board of Health plan, 1869 (*scale 1:500*)

By the publication of the large-scale Worcester Board of Health plan in 1869 (Fig. 5), the site comprised two plots, both of which had undergone some development. On the northern plot, the row of cottages (42-46) had been constructed, fronting directly onto the road, with a walled yard to the rear and a range of privies. The rear of the site was undeveloped, and was accessed from Diglis Road by an alley on the line of the present vehicular entrance gate. On the south plot the cottages (48-52) appear, apparently in their final form, with small gardens fronting the road and the *ginnel* (through-passage) providing access to the rear of the plot. To the rear of the smaller cottages is shown a common walled yard, with privies to the rear. The millwright's warehouse appears as before. The canalside boundary is walled.

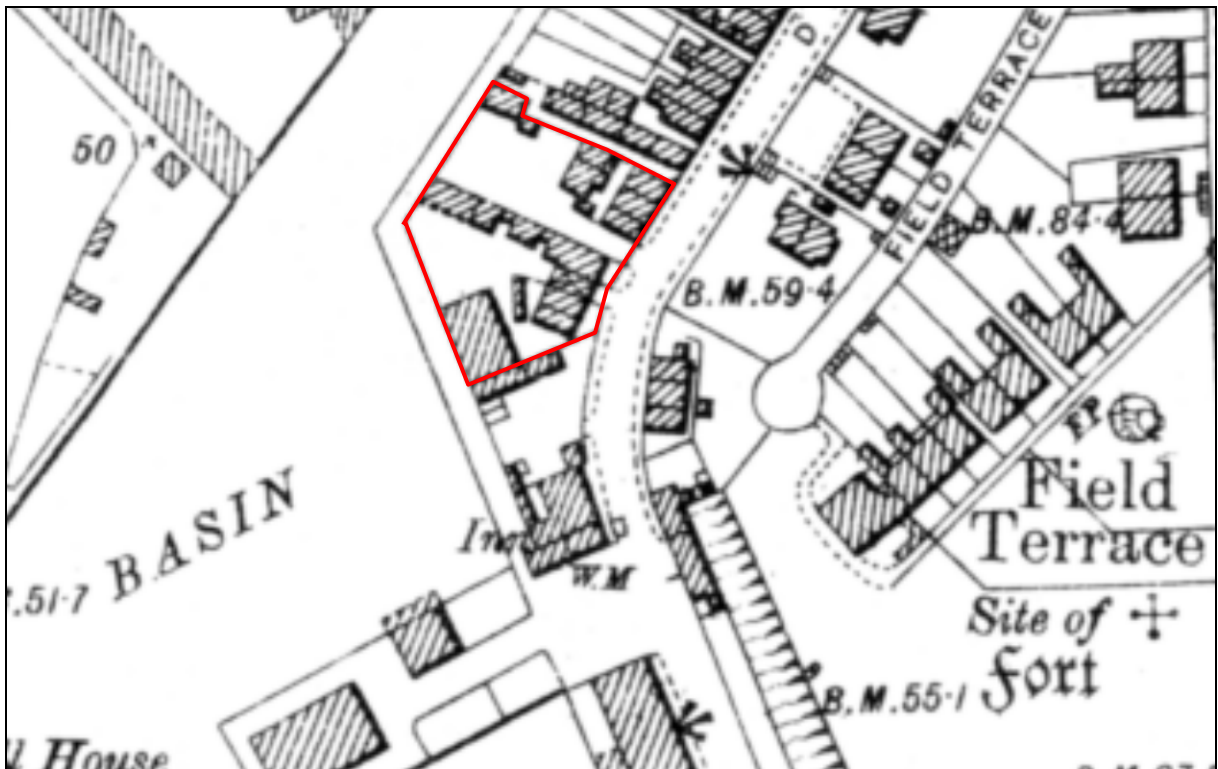
Figure 6: Extract from the First Edition Ordnance Survey 25" sheet, 1884 (not to scale)

By the publication of the First Edition Ordnance Survey sheet of 1884 (Fig. 6), the site had undergone further development. On the north plot, a sizeable structure had appeared to the rear of the yard behind the cottages, and at least two buildings are now shown at the north end of the plot. On the south plot, a range of buildings is now shown along the full length of the north boundary. Subsequent Ordnance Survey editions of 1928 and 1947 (Figs 7 & 8) show little change to the site. The wharf-side

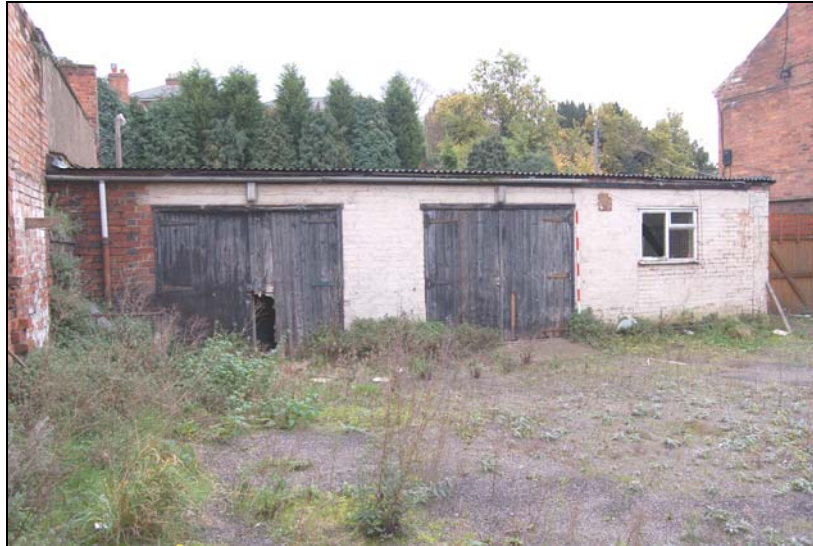
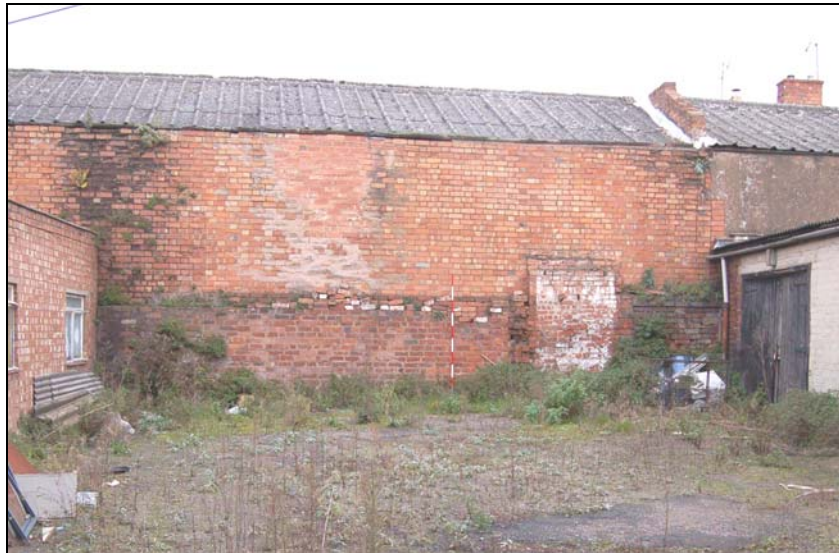
**Plate 1:** 42-46: west elevation

### 4.2 *42-46 Diglis Road* (Plates 1, 2)

This was originally a terrace of three brick-built cottages, each *c.*7.3 × 3.8m overall. The terrace has latterly been reduced in height to a single storey, given a pent roof of corrugated asbestos, and converted into three garages, with doors facing into the yard behind. This and subsequent alterations have removed most original features from the exterior of the terrace. The one remaining feature of interest is the boundary wall to the rear of the terrace, which retains evidence of the narrow rear yard and one of the privies, shown on early Ordnance Survey maps. This is constructed of red bricks 230 × 75 × 110mm, laid in lime mortar in no defined bond, and crudely repointed. It survives to a height of *c.*1.6m, rising to over 2m where the row of privies was located. This section is limewashed. The lower section of wall adjacent to the former cottages has retained its capping courses.

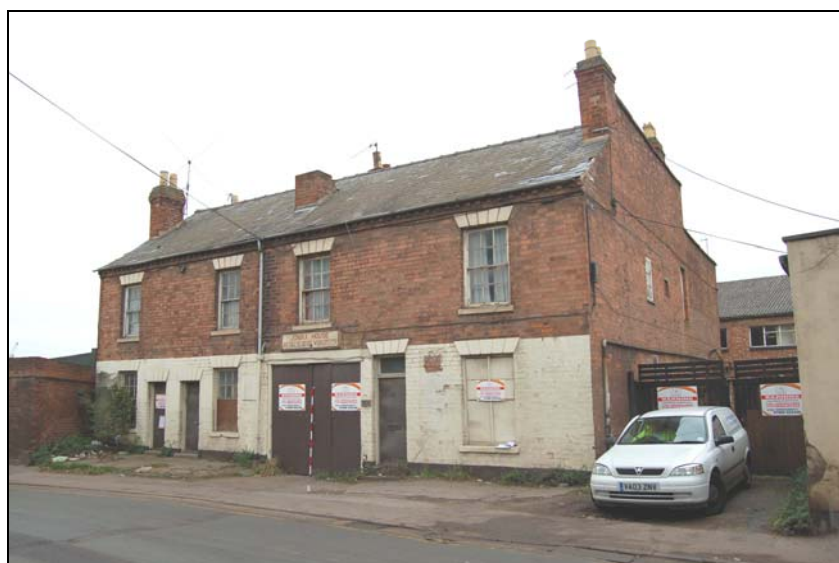
**Plate 3:** 48-52: east elevation, looking south-west

#### 4.3.2 *East Elevation* (Plate 3)

This is the main elevation fronting Diglis Road. It comprises a centrally located, plain door with a 6/6-light sash window to the north of it and double doors opening into a covered passage (ginnel) to the south. The two first-floor windows are similar to that on the ground floor and all the openings other than the double doors have flat relieving arches with pronounced voussoirs. The wall is painted at ground-floor level and the brickwork above it shows that the building is constructed in Flemish Bond using lime mortar with dentillated eaves. There is a sign over the double doors stating that no. 48 is 'Jomax House'.

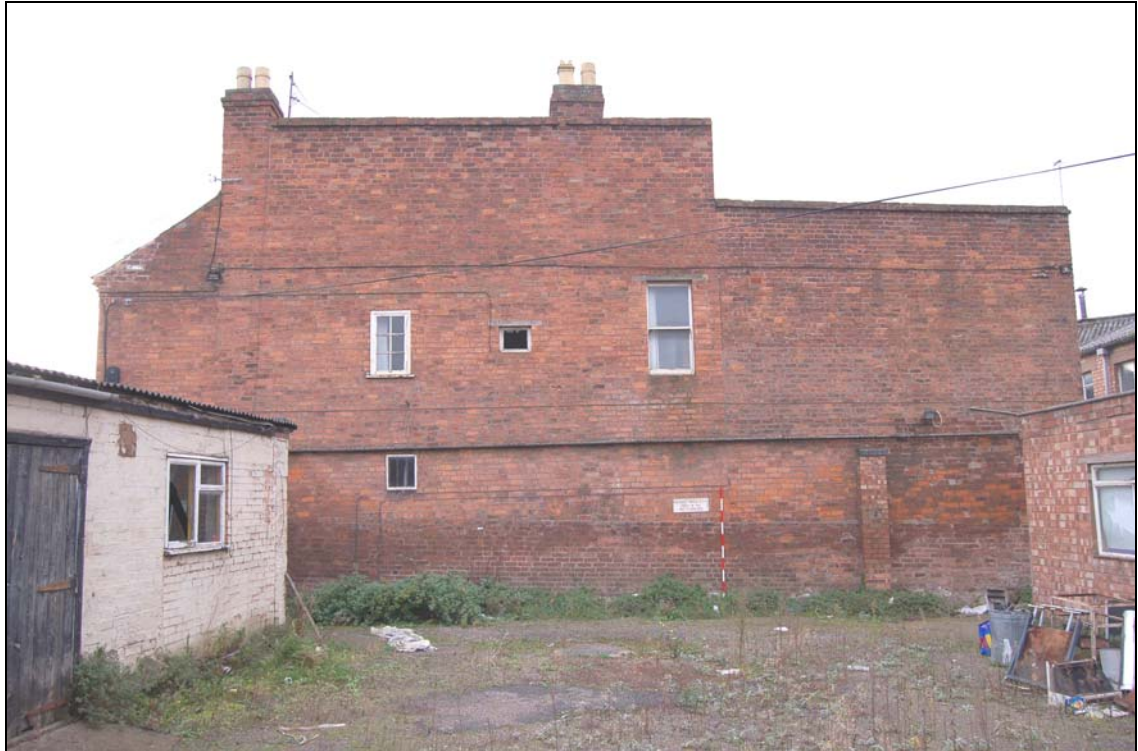
**Plate 4:** 48: north elevation

#### 4.3.3 *North Elevation* (Plate 4)

The north elevation is the most unusual as it incorporates an earlier boundary wall, which is built of machine-made red bricks measuring 230 × 110 × 75mm (9 × 4.5 × 3 inches). This part of the wall slopes from east to west, being 1.65m high at the eastern end and 1.48m at the western end. Like the boundary wall opposite, it has no defined bond, but is generally made up of stretchers and has been largely repointed.

The brickwork above the original boundary wall has been constructed using a stretcher bond. The bricks are similar to those used in the earlier boundary wall. A 450mm-wide buttress, built largely of Fletton bricks and topped with black coping bricks, has been added 3.98m from the west end.

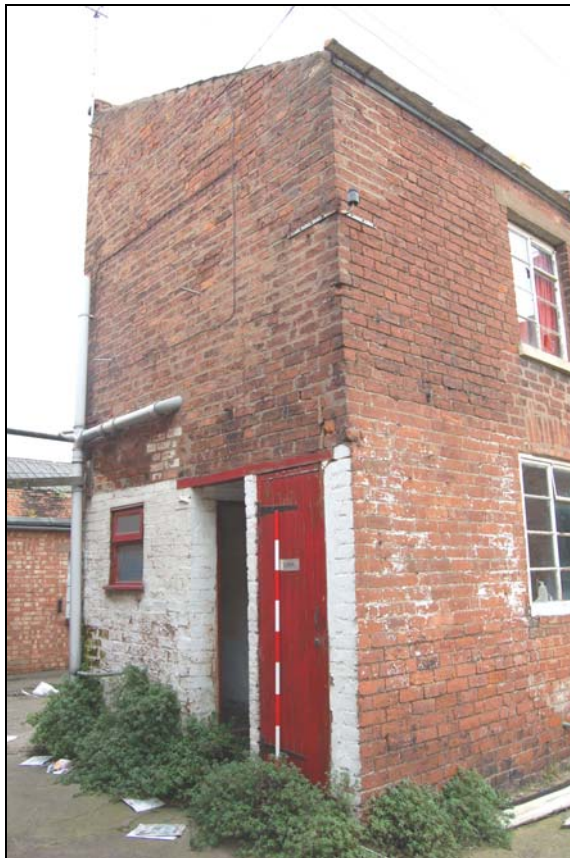
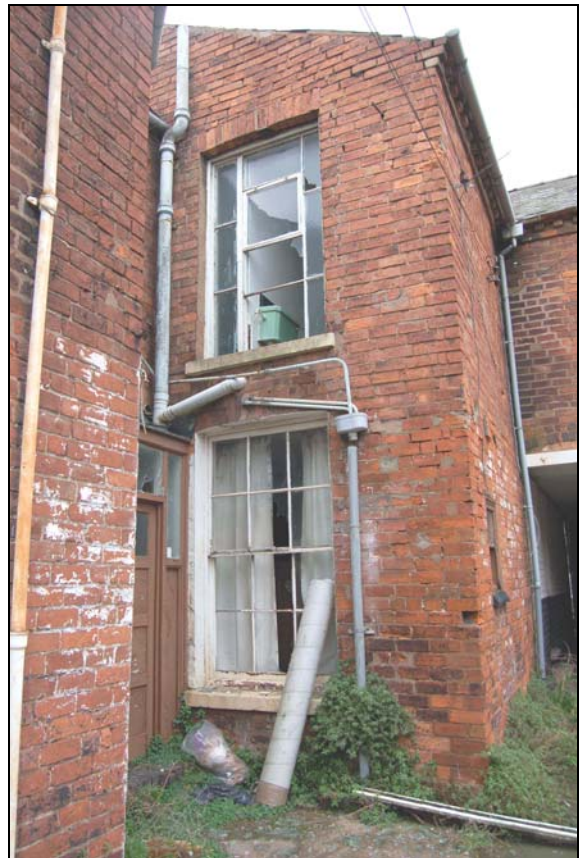
#### 4.3.4 *West Elevation* (Plates 5 & 6)

There are two plank & batten doors in the west elevation of the rear extension, opening onto an enclosed staircase and the kitchen (G2), both of which are located in the extension. To the north of the kitchen door is a 2-light window lighting the WC (G1). The ground floor level of the wall is painted white.

The west elevation of the main part of the building has a 6/6-light sash window with a stone sill but no relieving arch. Above this is a replacement window containing 10 lights under a segmental arch and with a stone sill.

The brickwork is similar to that elsewhere, but has the odd Fletton brick replacement. This elevation also has dentillated brickwork below the eaves.

The arch over the covered passageway has what appears to be a wider span to the south and a narrower one to the north. This may be an illusion due to structural problems.

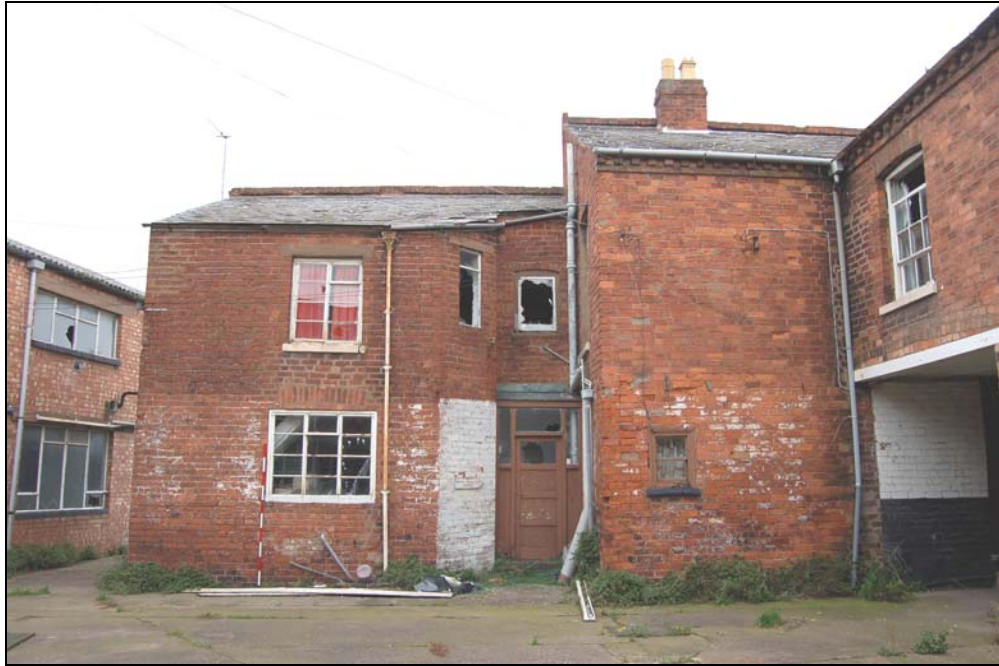
**Plate 7:** 48: south elevation, looking north

#### 4.3.5 *South Elevation* (Plate 7)

There is a panelled door with a rectangular fanlight within the angled recess at the eastern end of the extension. Two steps lead up to the door, which is signed as 'Maxwell Nicholls Ltd, Office'. The brickwork in the extension is in a Flemish garden wall bond with lime mortar, and that in the covered passageway is painted black to 1.18m above ground level and white above that.

There is an iron framed 4/4/4 Crittall-type replacement casement window to the west of the door beneath a brick arch lintel that indicates that the original window was the same width as that on the first floor. There is a 2-light flush window to the east of the door. There is a casement opening with a single course, segmental arch in the first floor above the door, which is smaller than the original window. To the west of this is an 8-light casement window under a stone lintel and to the east of it is a 2-light frosted glass window under a stone lintel but with no sill.

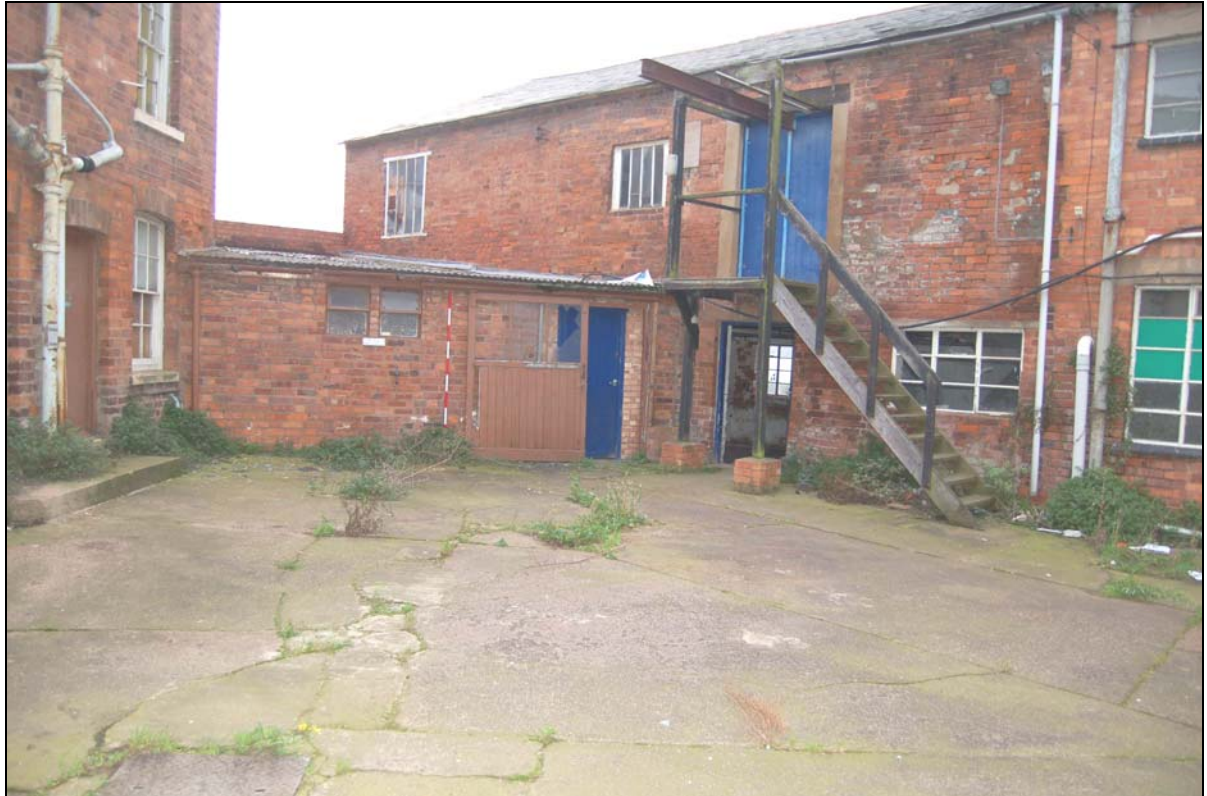
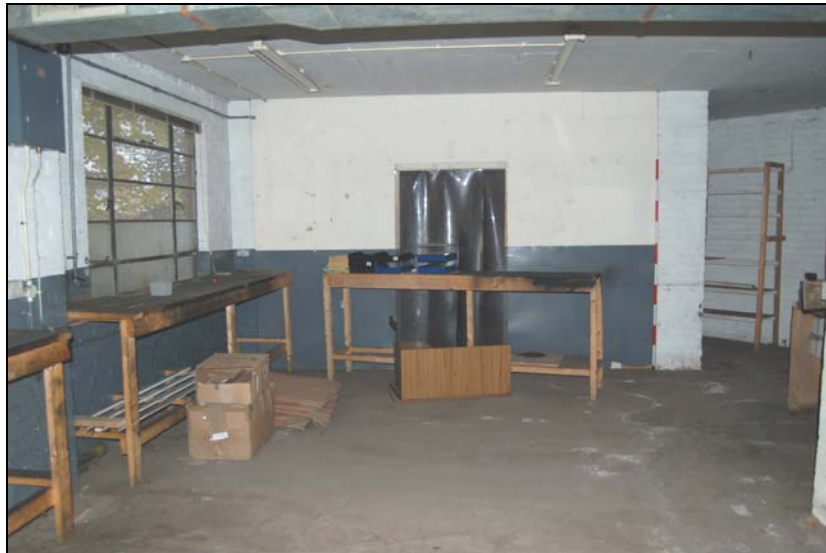
##### **4.6.2 *Link Building* (Plates 27, 38)**

Roughly triangular structure, constructed to link no. 52 with the millwright's warehouse over a former yard area. Single storey, walls of Fletton bricks, laid in cement mortar in stretcher bond, beneath a corrugated asbestos roof. The southern boundary wall of the site forms the south wall of this structure. Two wood-framed top-opening casement windows and a part-glazed sliding door in the north elevation. Internally it has a concrete floor, with doors to no 52 (Room G4) and to the millwright's warehouse.

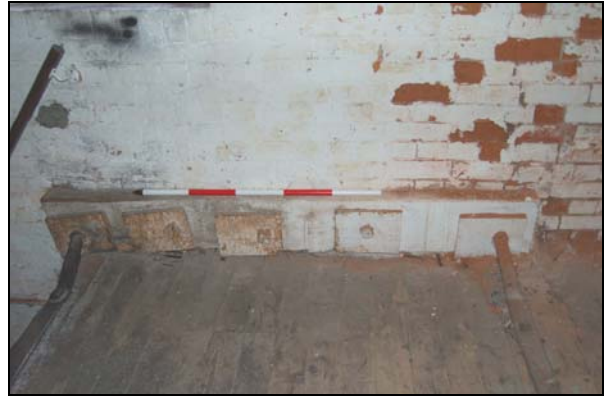
**Plate 33:** Warehouse: first floor, detail of crane mountings

Other features on this floor include a small office area on the west side, and a doorway to the modern extension to the north. The chimney breast noted on the ground floor rises up the north wall. Also near the north-west corner, the crane on the wharf outside is bolted through the wall to a substantial timber, placed against the wall at floor level, and two long iron straps, bolted to the floor. One of these is awkwardly located at the top of the stairs, adding weight to the suggestion that the crane was a later addition to the building.

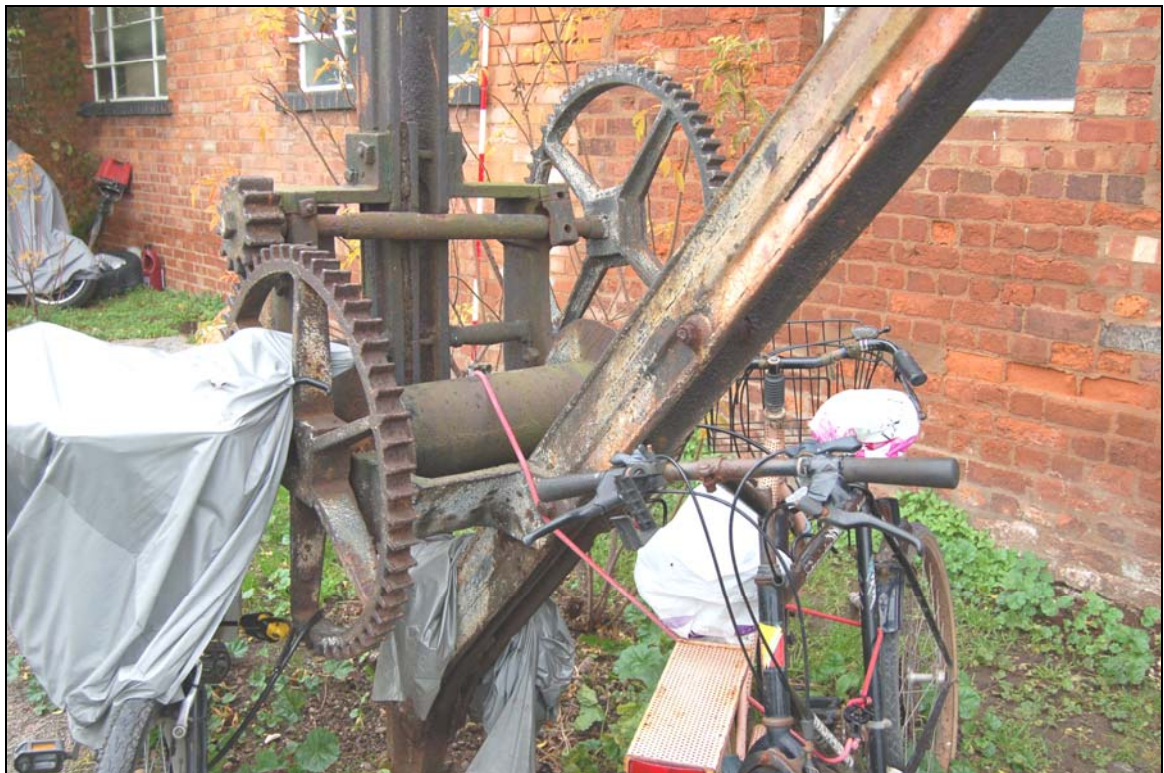
**Plate 34:** Canalside crane: detail of gears

On the wharf to the south of the millwright's warehouse is a hand-operated crane, of a type common to many contemporary canal wharves. Its jib is of composite iron and timber construction (the timber parts have been removed), in a fixed pivot, braced to the west wall of the building. There is a maker's name on one of the castings carrying the winding gear, partly obscured by rust,

which could be only partly read as 'RUSSELL'. The reach of the crane must have limited it to serving the loading doors on both floors of the building, as well as the adjacent canalside. The crane must have carried considerable loads, judging by the damage caused by it to the fabric of the building.
