**WATCHING BRIEF:
THE OLD COACH HOUSE
PITCHER LANE
LOUGHTON
MILTON KEYNES**

Stern Thom Fehler Architects Ltd for L & M Featherstone

January 2006

ASC: 864/LPL/01

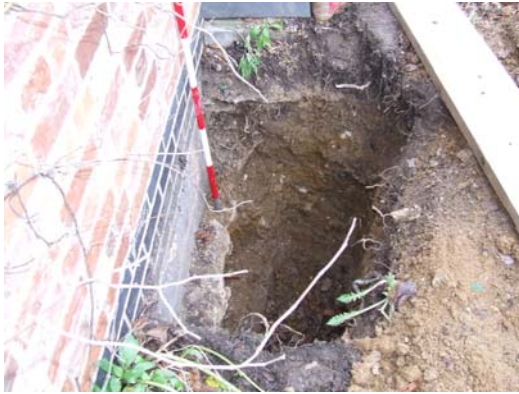
Plate 1: Test Pit 1, facing NNE

- Test pit 1 (Plate 1) was adjacent to the eastern elevation of the house and illustrated that the organic soil of a flowerbed directly overlay the underlying mid brown natural sandy clay which contained small nodules of chalk.

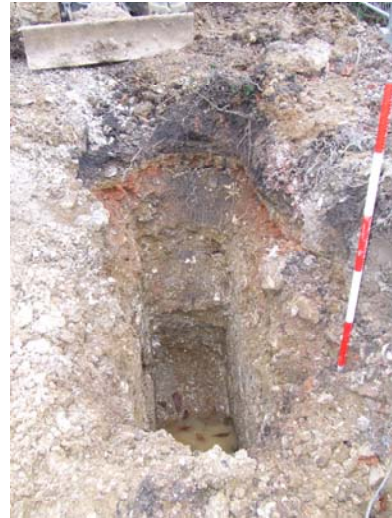
Plate 2: Test Pit 2, facing NNE

- Test pit 2 (Plate 2) was located at the northeast corner of the footprint of the extension. A *c.*0.4m deep layer of organic ashy soil containing frequent charcoal overlay a *c.*0.07m deep layer of brick rubble. The brick rubble sealed the underlying mid brown natural sandy clay which contained small nodules of chalk.

- 5.1 The stratigraphy observed during the watching brief suggested that the natural soils in the area of the driveway were removed during or after the late 19th century construction of the house. The top and subsoil were likely stripped to provide a firmer surface on which to lay metalling of some description. The layer of brick rubble exposed in test pit 2 could be the remnants of this surface or hardcore for it.

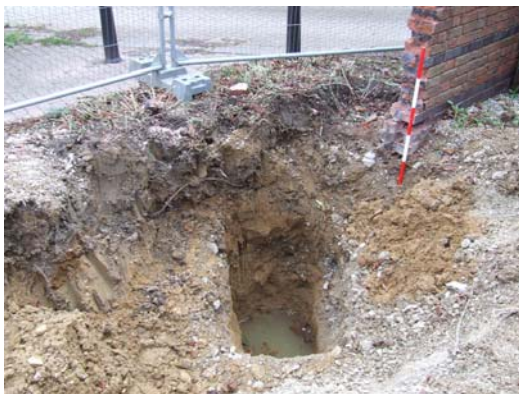
Plate 3: Test Pit 3, facing SE

- Test pit 3 (Plate 3) was located at the southeast corner of the footprint of the extension at the entrance to the driveway of the Old Coach House. A *c.*0.3m deep deposit of mid greyish brown organic sandy silt overlay an undetermined depth of natural mid reddish orange clayey sand.

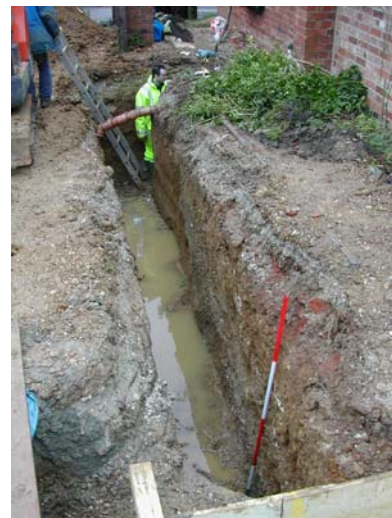
Plate 4: Central foundation trench, facing SW

- 4.3 The foundation trenches were *c.*0.6m wide and machine excavated to a depth of *c.*2.0m (Plate 4). The southern ends of the NNE-SSW aligned sections of the foundation trenches exposed a natural deposit of mid reddish orange sandy clay (Plate 5) and revealed that the surface of this deposit sloped down with a south-north strike. The northern two thirds of the foundation trenches illustrated that the reddish orange sandy clay was overlain by interleaved grey clayey and red sandy deposits (Plate 6) that dipped downwards with a similar south-north strike.

- 5.2 The foundation trenches of the extension revealed a number of relatively modern services which attest that this area was frequently disturbed by intrusive groundworks during the 20th century.

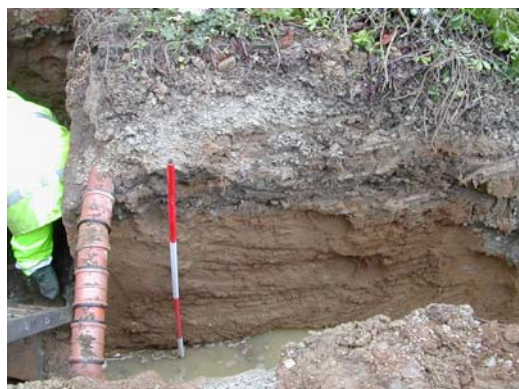
Plate 5: Natural at south of foundation trench, facing WNW

- 5.3 The reddish orange sandy clay at the south of the foundation trenches is an undisturbed natural deposit.
- 5.4 The origins of the interleaved clays and sands in the northern two thirds of the foundation trenches remain unclear. Organic deposits and archaeological finds suggesting deliberate infilling of a landscape feature were not observed within them and a natural origin is tentatively suggested. The dipping south-north strike of the clays and sands and the inclusion of small chalk nodules suggests that reworked minerogenic deposits may have gradually accumulated in a natural hollow.
