**BUTLERS MANOR COTTAGE
NORTHALL
BUCKINGHAMSHIRE**

on behalf of Tony Witchell

by Jonathan R. Hunn BA PhD MIFA

February 2007

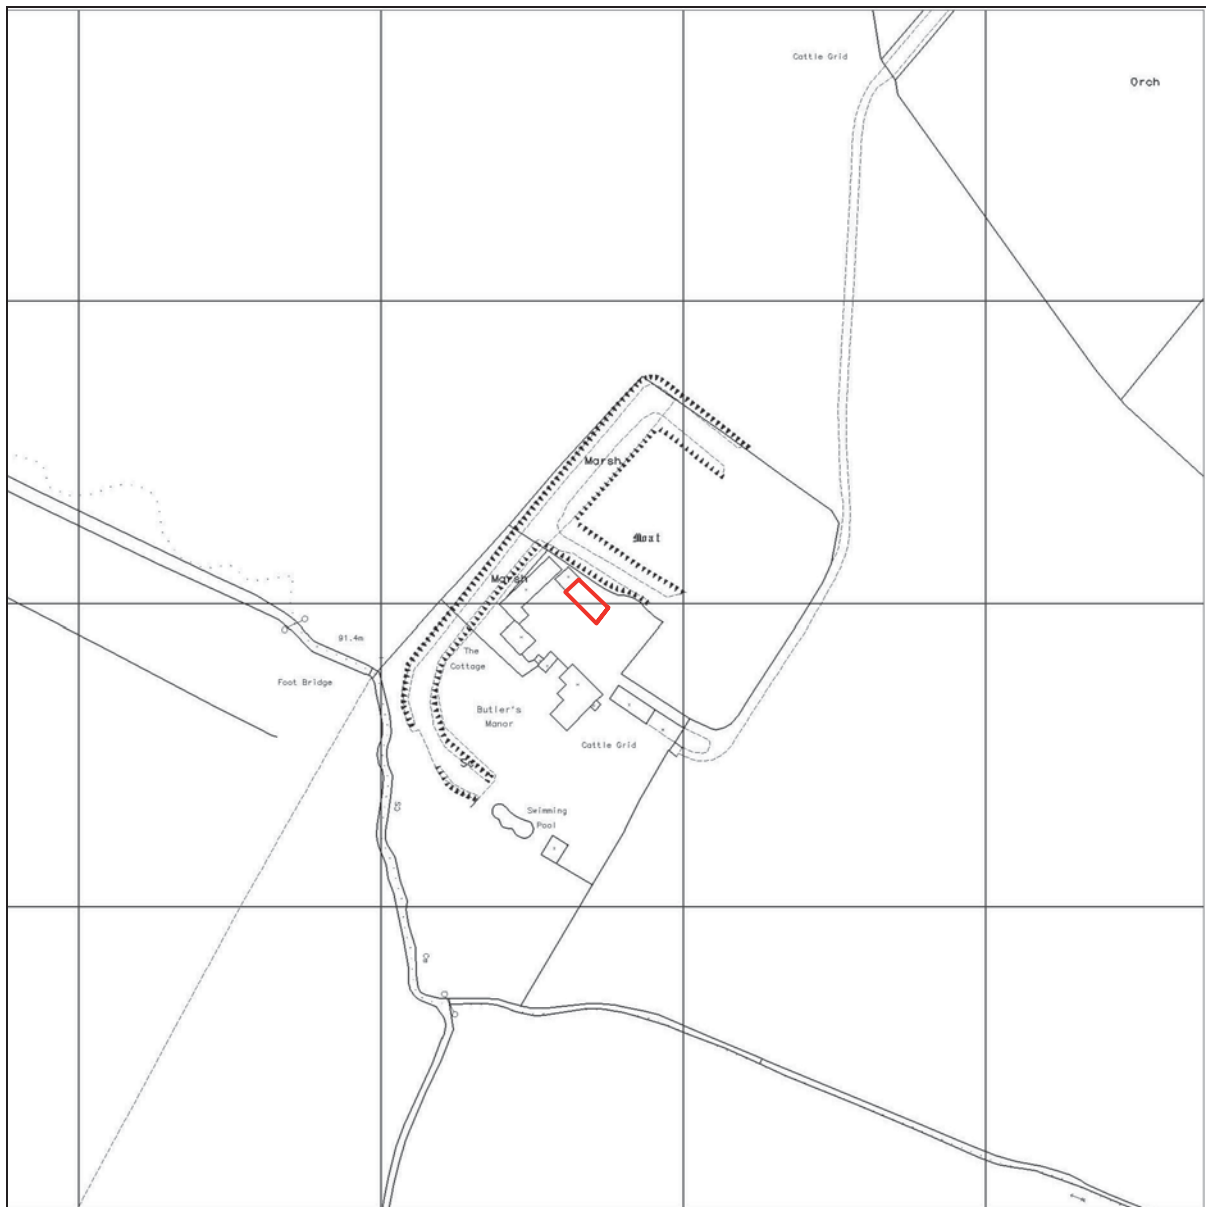
Figure 2: Site plan showing area of proposed development (scale 1:2500)

- 3.2 The site comprises a rectangular moated enclosure containing two square-shaped islands, separated by a ditch (Fig. 2). A more detailed description of the site is contained in the Schedule of Monuments (File AA 64068/1). The L-shaped manor house is believed to date from the early 17th century, with extensions in the early 18th and 19th centuries (RCHM 1913: 109). The house, along with an 18th century stable block and more recent outbuildings, is located on the southern island. A more modern house is on the northern corner of the same island, and areas of its grounds, such as tennis courts, cover the earlier 19th century buildings. The northern island has no standing buildings, but both islands show evidence of possible buried structural remains. In the case of the southern island, this may represent building platforms related to the original medieval occupation of the site.

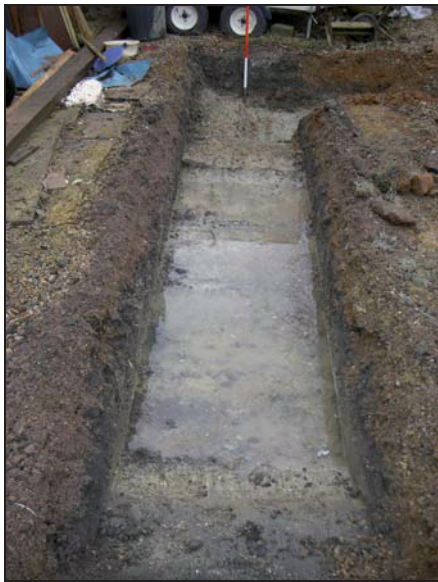
Plate 3: Detail of Trench 1

Trench 1 (Fig. 3: Plate 3)

Location: 2m from the southeastern end of the present building and within the footprint of the proposed extension.

Dimensions: 1m × 5m (with a 1.2m extension NE of the northern end of the trench).

Description: There was c. 0.4m of overburden lying above the natural chalky drift. The overburden comprised a 0.05m thick layer of gravel [1] lying on a compacted topsoil [2] (Plate 4). There were no cut features observed in the natural ground, nor any artefacts observed.

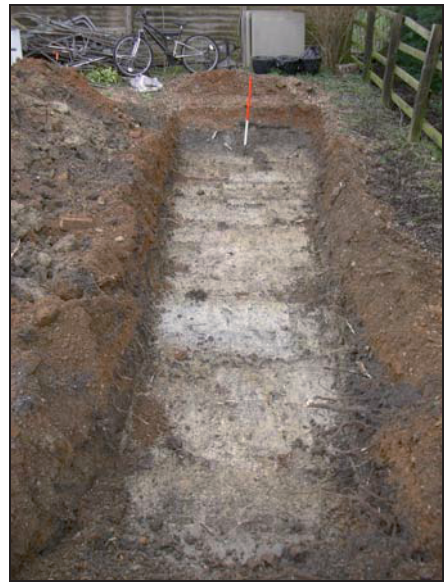
Plate 4: Detail of Trench 2

Trench 2 (Fig. 3: Plate 4)

Location: This lay 1m from the north easterly boundary of the property and 3.7m from the northern wooden fence.

Dimensions: It was 6.3m x 1.5m at its northern end and 1.2m wide at its southern end

Description: The nature of this trench was identical to T1 (above) except there were more roots present from the adjacent hedge and trees. No features or artefacts were noted.

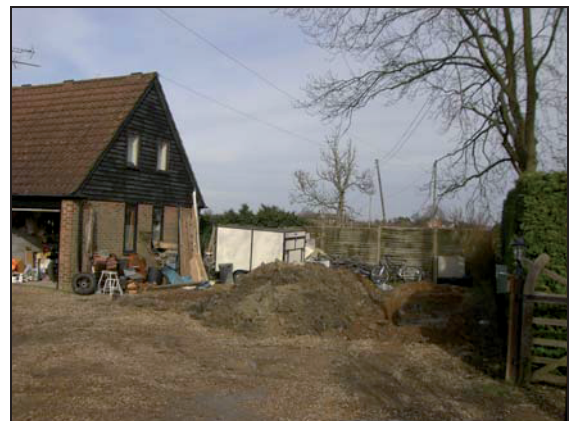
Plate 6: The site after completion of trial trenches

- 5.1 A total of 14.7 sq. metres of the proposed new building was trial trenched. This amounted to approximately 25% of the proposed extension area. No features or artefacts were noted within the trenches.

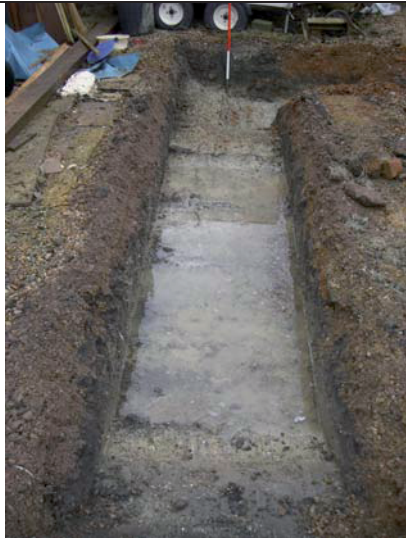
Trench 1

Max Dimensions (m)					
	Length	5m	Width	1m	Depth	0.4
	Levels					
	Trench base north east		91.06m OD			
	Trench top north east		91.46m OD			
	Trench base south west		91.18m OD			
	Trench top south west		91.58m OD			
	NGR Co-ordinates					
	SP	95466-21105	SP	95463-21102		
	Orientation		SW-NE			
Reason for Trench		evaluation				
Context	Type	Description and Interpretation	Max Width (mm)	Max Thckn (mm)	Depth BGL (mm)	
1	layer	gravel	all	50m	0mm	
2	layer	A horizon - topsoil	all	350	50mm

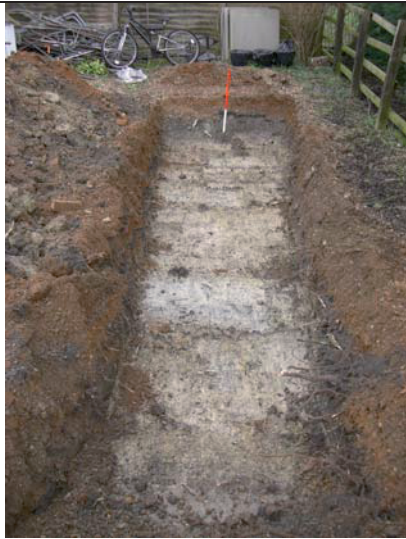
Trench 2

Max Dimensions (m)					
	Length	6.3m	Width	1.35m	Depth	0.35m
	Levels					
	Trench base north east		91.20m OD			
	Trench top north east		91.55m OD			
	Trench base south west		91.15m OD			
	Trench top south west		91.50m OD			
	NGR Co-ordinates					
	SP	95467-21097	SP	95470-21100		
	Orientation		SW-NE			
Reason for Trench		evaluation				
Context	Type	Description and Interpretation	Max Width (mm)	Max Thckn (mm)	Depth BGL (mm)	
1	layer	gravel	all	50m	0mm	
2	layer	A horizon - topsoil	all	350	50mm
