WATCHING BRIEF: KISLINGBURY FLOOD ALLEVIATION SCHEME, NORTHAMPTONSHIRE

on behalf of Edmund Nuttall Ltd

September 2003

ASC: KFA03/2

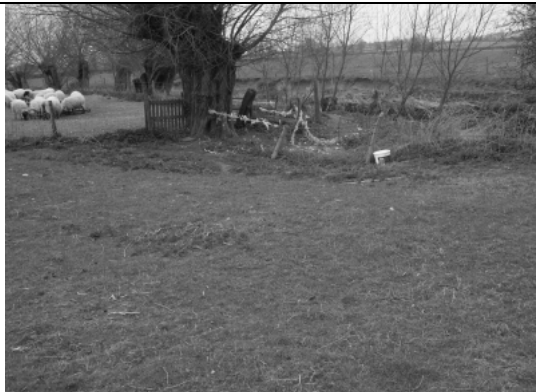
Earthwork 1, facing southwest

Earthwork 1				
Shape in plan:		Sub circular		
Dimensions:				
Length	Width	Diameter	Height	Depth
-	-	8.00m	-	0.70m
NGR Co-ordinates:		SP 69547 59590		
Interpretation:				
The river Nene is located immediately west of this earthwork, which represents the easiest point of access to the river within Area A. The large quantity of sheep hoof prints which mark this area suggest that this is a watering point, the continuous use of this area may have caused the formation of a depression at this point.

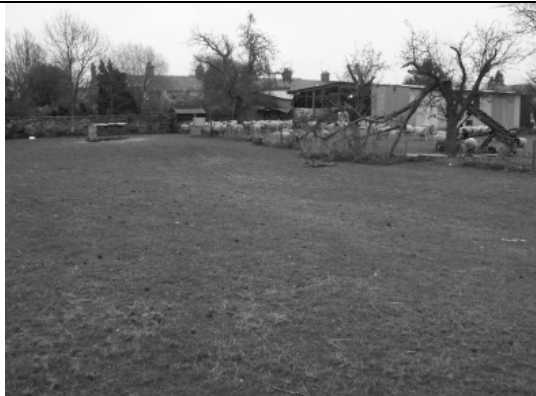
Earthwork 2, facing southeast

Earthwork 2				
Shape in plan:		L-shaped slope/ridge aligned northwest to southeast.		
Dimensions:				
Length	Width	Diameter	Height	Depth
24.00m	7.00m	-	-	1.30m
NGR Co-ordinates:		SP 69567 59586		
Interpretation:				
Located immediately northwest and downslope of the farm gate towards the river. The floodplain to the south of 2) is at the same level as the base of 2). This suggests that the ridge of 2) is possibly banked material used to raise the ground level slightly above the average flood level.

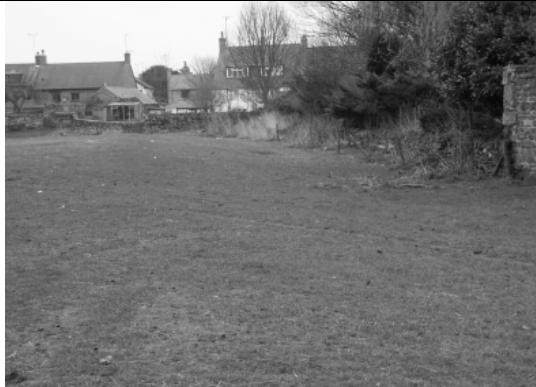
Earthwork 3, facing east

Earthwork 3				
Shape in plan:		Linear bank aligned east-north-east to west-south-west slopes gradually to the south.		
Dimensions:				
Length	Width	Diameter	Height	Depth
c.70.00m	9.00m	-	-	1.00m
NGR Co-ordinates:		SP 69616 59575		
Interpretation:				
Linear bank which starts close to the farm gate and runs parallel to the adjacent property boundaries. Most likely a flood defence related to surrounding properties. The gardens in these properties are raised to the same level as the bank this would cause the lower part of 3) to hold water e.g. like a drainage ditch during wet periods.

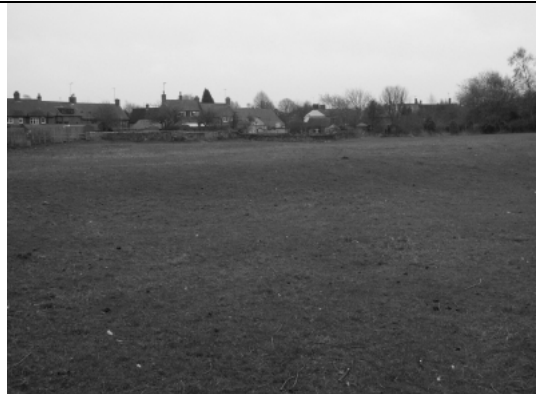
Earthwork 4, facing southeast

Earthwork 4				
Shape in plan:		Curvilinear channel		
Dimensions:				
Length	Width	Diameter	Height	Depth
c.100.00m	11.00m	-	-	1.00m
NGR Co-ordinates:		SP 69581 59632		
Interpretation:				
Initially this has the appearance of an old river course or channel. However, it is also possible that this has been excavated in order to channel water away from the higher ground towards the river in order to drain the field.

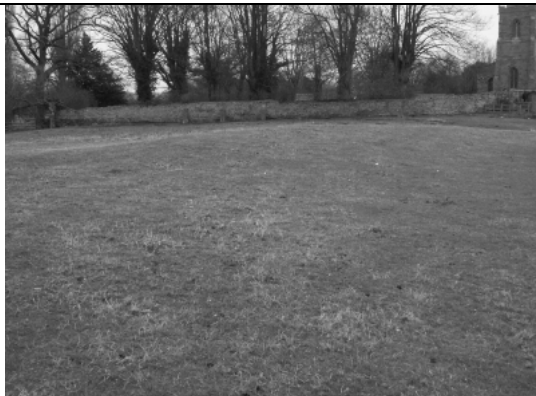
Earthwork 6, facing northeast

Earthwork 6				
Shape in plan:		Semi-circular		
Dimensions:				
Length	Width	Diameter	Height	Depth
c.51.00m	45.00m	-	-	1.00m
NGR Co-ordinates:		SP 69650 59600		
Interpretation:				
It is very apparent that gardens in adjacent properties have been raised. Is this a borrow pit? It would have been the most convenient location to get material from.

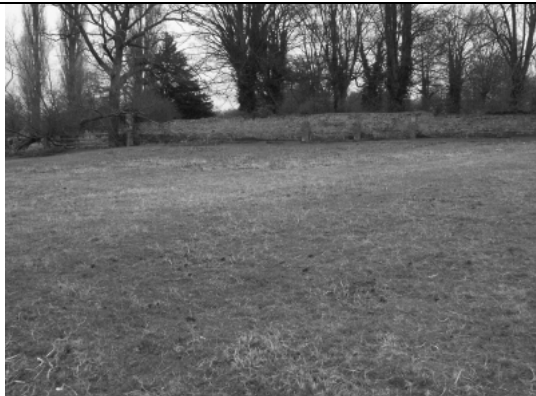
Earthwork 8, facing north

Earthwork 8				
Shape in plan:		Circular		
Dimensions:				
Length	Width	Diameter	Height	Depth
16.00m	-	-	-	0.60m
NGR Co-ordinates:		SP 69640 59647		
Interpretation:				
<p>This may have been a pond or a smaller version of the quarry pit 6, used to raise the level of the adjacent churchyard to the northeast. The churchyard is noticeably higher than the land within the survey area.</p>

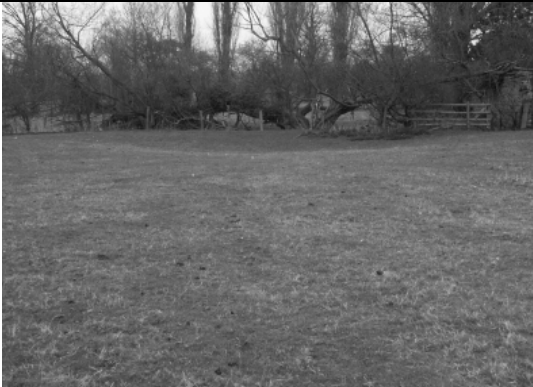
Earthwork 9, facing north

Earthwork 9				
Shape in plan:		Circular		
Dimensions:				
Length	Width	Diameter	Height	Depth
-	-	15.00m	-	0.80m
NGR Co-ordinates:		SP 69630 59661		
Interpretation:				
Possible pond or borrow pit used to raise the ground level in the church northeast to the same level as earthworks 8 and 6.

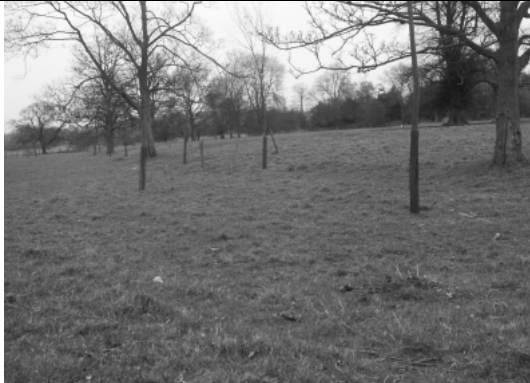
Earthwork 10, facing northeast

Earthwork 10				
Shape in plan:		Sub-triangular		
Dimensions:				
Length	Width	Diameter	Height	Depth
c.120.00m	95.00m	-	-	1.00m
NGR Co-ordinates:		SP 69793 59775		
Interpretation:				
<p>Possibly the most significant of all the earthworks, this is a broadly flat platform, possibly for a Medieval Manor house (19th century antiquarian Baker – suggests the manor house existed northwest of the church. This platform and the associated pond 13 are northwest of the church, and are the most likely earthworks to be associated with a medieval manor house.</p> <p>The river would have been an important trade and communication route, especially for giving access to nearby Northampton. Making this an ideal location.</p> <p>The pond may have been used for fish storage. The curve of 10 and platform 16 follow the curve of the river at this point.</p>

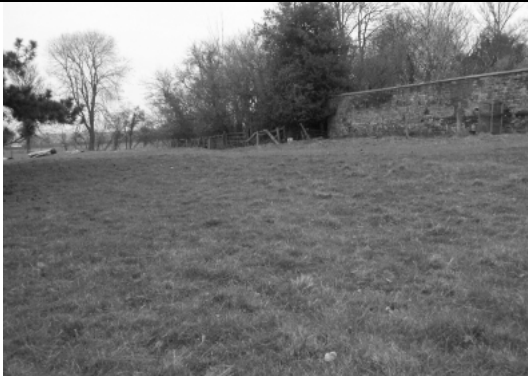
Earthwork 12, facing north.

Earthwork 12				
Shape in plan:		Irregular depression		
Dimensions:				
Length	Width	Diameter	Height	Depth
65.00m	35.00m	-	-	0.50m
NGR Co-ordinates:		SP 69753 59737		
Interpretation:				
<p>This may be a borrow pit used to raise the level of the surrounding gardens and thus protect them from floodwaters.</p> <p>Possibly also had a similar function to 6, 8 and 9 in the other field.</p>

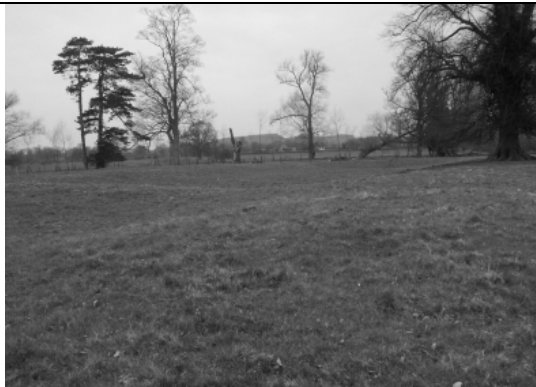
Earthwork 13, facing north

Earthwork 13				
Shape in plan:		Rectangular pond		
Dimensions:				
Length	Width	Diameter	Height	Depth
33.00m	14.00m	-	-	1.00m
NGR Co-ordinates:		SP 69652 59781		
Interpretation:				
<p>The base of this earthwork is rectangular and Ordnance Datum Levels taken in each corner show that it is perfectly flat. This earthwork is striking amongst those recorded in Area A as it has such squared corners.</p> <p>This is likely to have been a pond possibly for the storage of fish.</p> <p>Base dimensions were 10.00m long x 29.00m wide x 1.00m deep.</p>

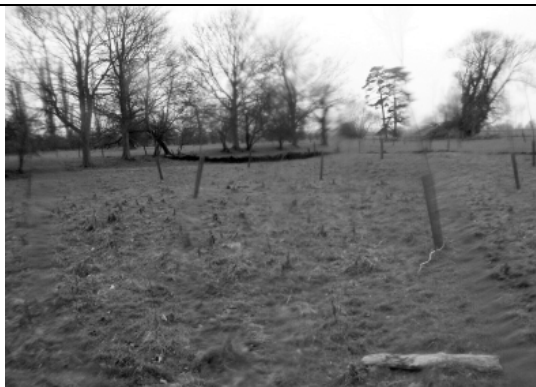
Earthwork 14, facing west

Earthwork 14				
Shape in plan:		Curvilinear channel		
Dimensions:				
Length	Width	Diameter	Height	Depth
60.00m	12.50m	-	-	0.60m
NGR Co-ordinates:		SP 69645 59746		
Interpretation:				
Curvilinear channel similar to 4 c.30m to the south could be the course of an old river channel/paleochannel.

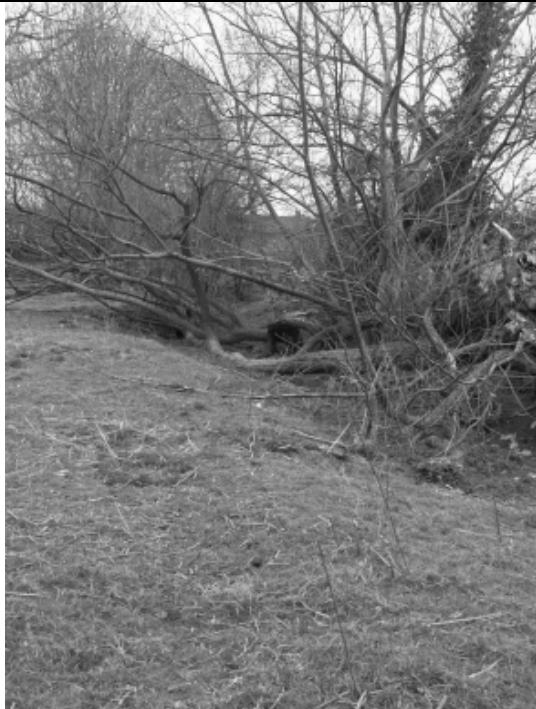
Earthwork 15, facing southwest

Earthwork 15				
Shape in plan:		Ditch aligned northeast to southwest		
Dimensions:				
Length	Width	Diameter	Height	Depth
60.00m	7.50m	-	-	1.00m
NGR Co-ordinates:		SP 69636 59680		
Interpretation:				
<p>Ditch aligned at right angle to the river, trees planted along it suggest that it is a property boundary and drainage ditch. Would be at least 200 years old judging by size/quantity and variety of trees.</p>

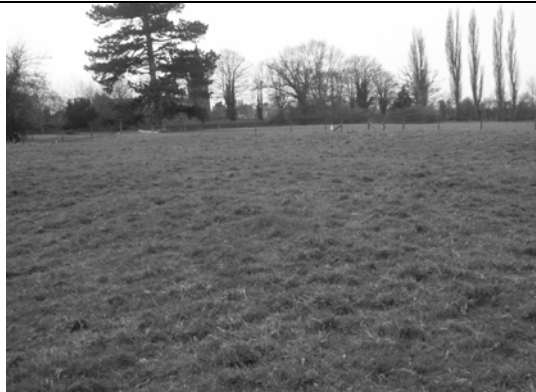
Earthwork 16, facing south

Earthwork 16				
Shape in plan:	Irregular curved platform			
Dimensions:				
Length	Width	Diameter	Height	Depth
70.00m	46.00m	-	-	0.50m
NGR Co-ordinates:	SP 69769 59869			
Interpretation:				
<p>This appears to have been a second outer platform and ridge. It is located north of platform 10 and is slightly lower. It lies c.0.70m lower than platform 10.</p> <p>Feature 17 to the north of 16 shares its broadly east west curve is 17 an outer defence to 16. The shared curves may also suggest that both earthworks are contemporary.</p>

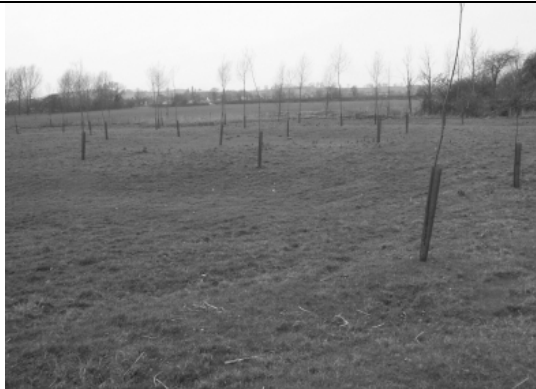
Earthwork 17, facing northwest

Earthwork 17				
Shape in plan:		Curvilinear ditch with rectangular pond on eastern end		
Dimensions:				
Length	Width	Diameter	Height	Depth
65.00m	8.00m	-	-	0.50m
NGR Co-ordinates:		SP 69751 59904		
Interpretation:				
<p>This is a possible outer flood defence for platforms 10 and 16.</p> <p>The east-west alignment of 17 and the curve of the northern ridge of 10 and 16 suggest that all three may be contemporary.</p>

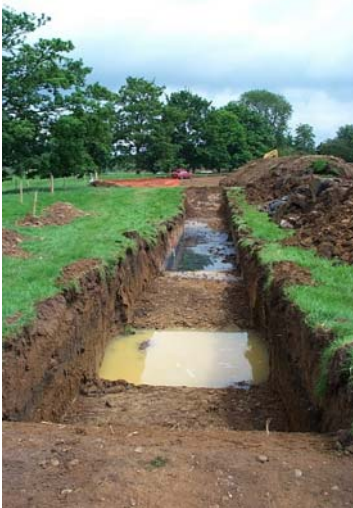
Max Dimensions			
	Width	2.50m	Depth	30.00m
	NGR Co-ordinates			
	Northeast end of trench SP 69644 59800		Southwest end of trench SP69628 59782	
	Orientation			
Reason for Trench		Northeast - Southwest		
Notes – Trench 1 contained Pond [19], buried layers. Full technical details of these deposits and cuts can be found in Appendix 3.		To gain information about <i>earthwork 13</i>

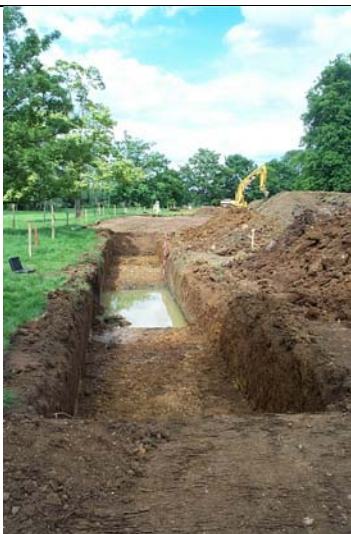
Max Dimensions			
	Width	2.50m	Depth	22.00m
	NGR Co-ordinates			
	Northeast end of trench SP 69618 59761		Southwest end of trench SP 69609 59741	
Orientation		Northeast - Southwest		
Reason for Trench		To gain information about <i>earthwork 14</i>		
Notes – Trench 2 contained Paleochannel [26]. Two deposits buried layers. Full technical details of these deposits and cuts can be found in Appendix 3.
