**WATCHING BRIEF
A47 HARDWICK ROUNDABOUT IMPROVEMENTS
KINGS LYNN
NORFOLK**

on behalf of Birse Construction

March 2003

ASC: KLH02/2

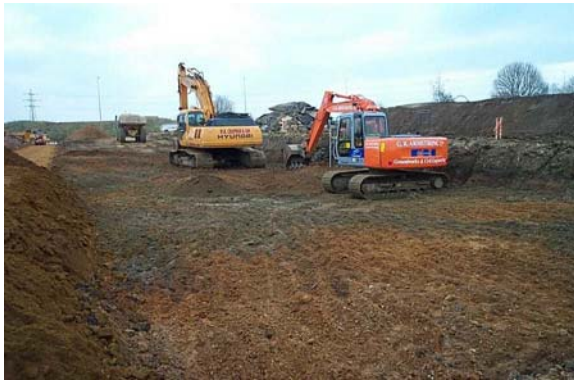
Plate 1: Stripping on the main roundabout, piers 1 – 4.

Prior to the construction of Piers 1 – 4 an overburden strip was required across the roundabout. This involved the removal of topsoil and all other overburden in a northwest to southeast strip measuring c.110m L x c.17.00m W x 0.50m – 1.90m D. The natural subsoil was removed to a depth of 0.90m in the centre of this strip (Fig. 5, Plate 3).

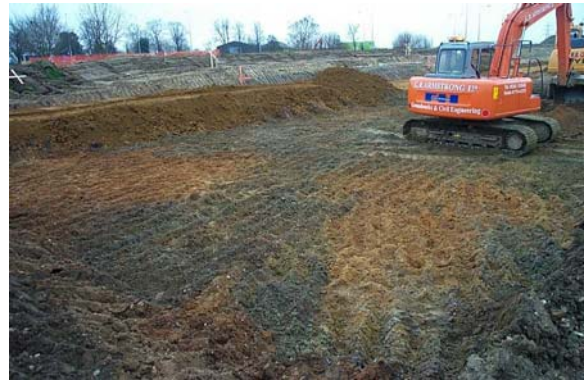
Plate 2: Stripping on the main roundabout, piers 1 – 4.

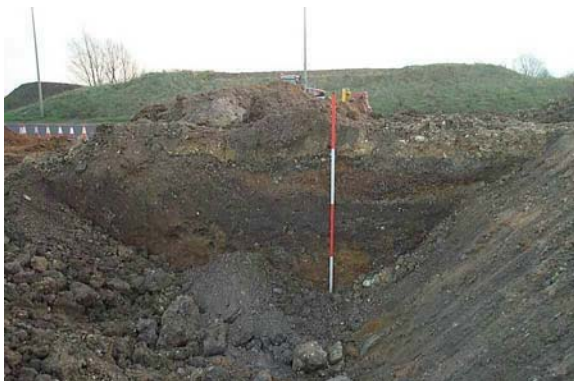
Plate 3: Test pit on main roundabout, facing east.

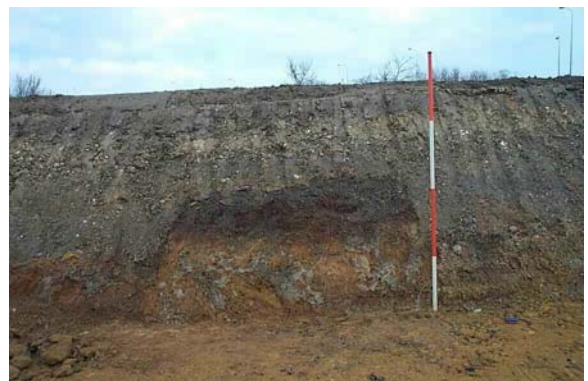
Plate 4: Natural subsoil visible in section of pier strip on main roundabout, facing north.

The west facing section of a test pit c.20m south of the above stripping (Fig. 5, Plate 4) was also observed during the same monitoring visit. An almost identical stratigraphic sequence of modern make-up layers overlying natural subsoil was observed.

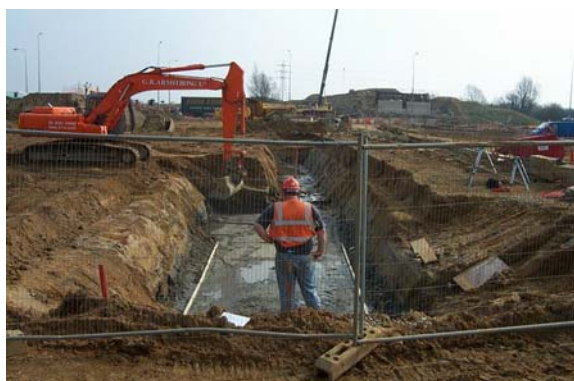
Plate 5: Culvert during excavation, facing east.

A drainage culvert measuring c.96.00m L x c.8.00m wide x c.2.00m D was excavated 12m north of Piers 1 - 4. This was aligned northwest to southeast, parallel to the piers. The groundworks for this involved the removal of layers 1 – 5 (above) and the excavation of a trench which cut the natural subsoil to a depth of 2.00m.

No archaeology was observed at the interface between layer 5 and the natural subsoil, where the potential was highest, or within the natural subsoil. Three 20th century drainage pipes were observed in the sections of the culvert. These were aligned broadly north – south, and are very likely to have been associated with the A10 road, which formerly ran across the land now occupied by the roundabout.

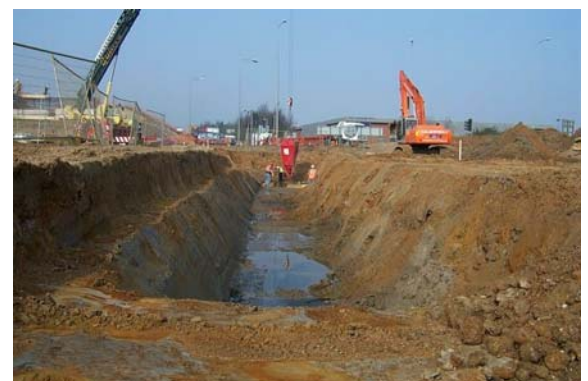
Plate 6: Natural subsoil visible in culvert sections, facing west.
