**WATCHING BRIEF
FLOOD ALLEVIATION SCHEME
UPSTREAM FROM DODFORD MILL
WEEDON, NORTHAMPTONSHIRE**

July 2002

ASC:FDW01/2

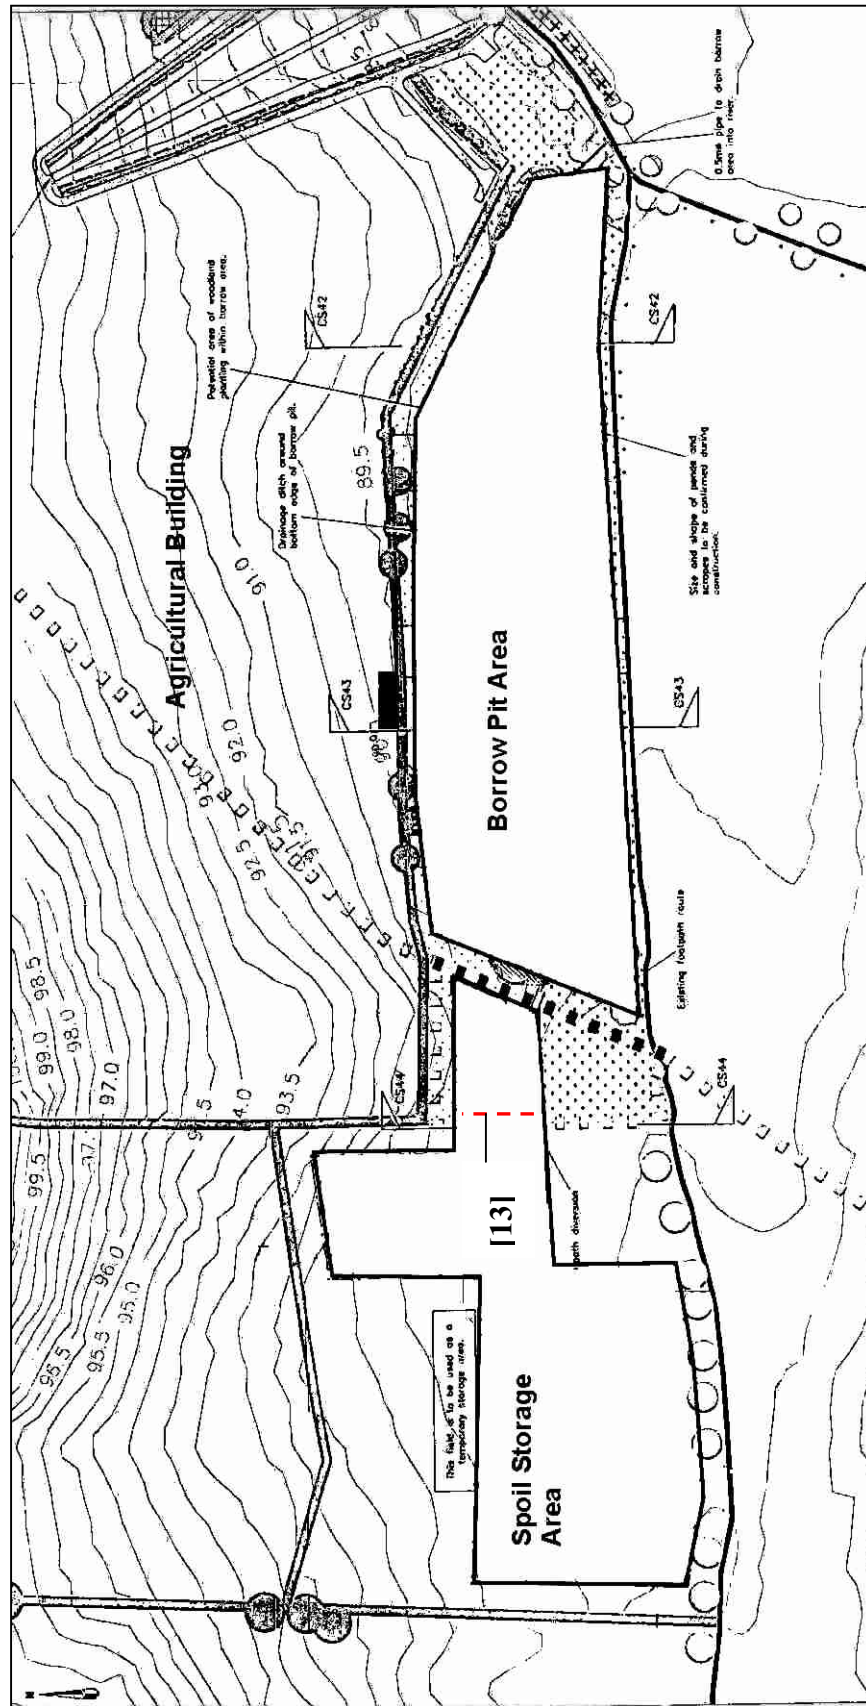
Figure 3: Borrow Pit and Spoil storage Areas (based on scale 1:1250)

The borrow pit area was 300m in length and 80m wide, narrowing to 30m wide at the eastern end. Three phases of excavation work were monitored on this area, this included the excavation of eight test pits, the topsoil stripping of the entire field and the excavation of an alluvium layer in the western end of the field. One post medieval land drain was recorded, this was aligned east west, hand excavation recorded the existence of a ceramic pipe in the base of this linear feature.

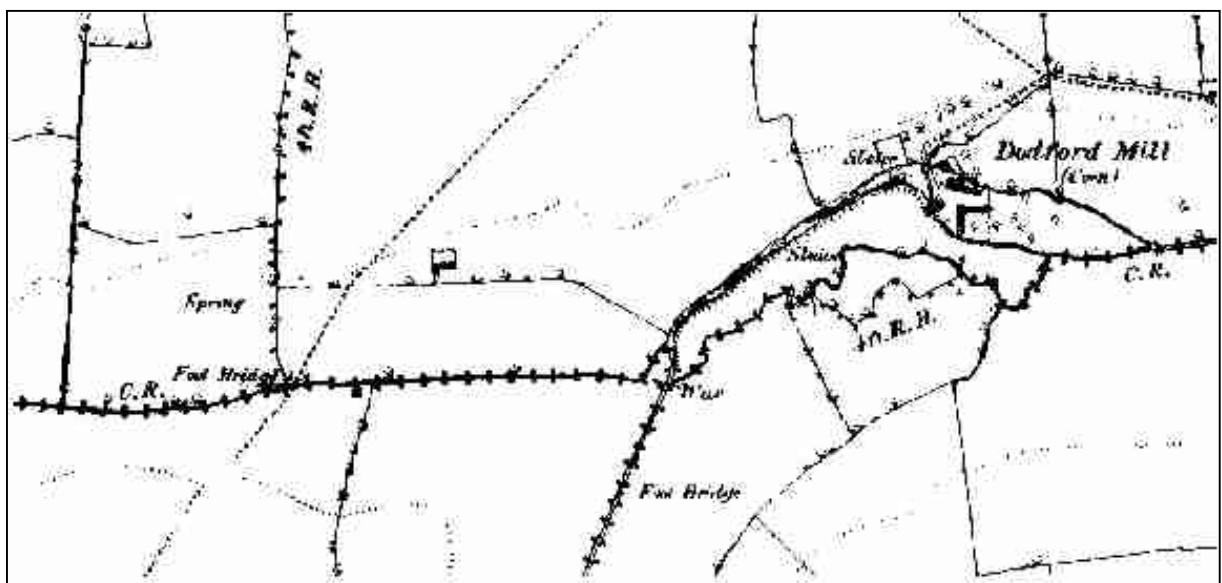
Figure 4: Extract from 1st Edition 6" map, 1890.

One ditch [11] was recorded during the stripping of the southern field. Excavation produced no artefactual material, however several pieces of waterlogged wood were recorded. These were all un-worked and appeared to have been relatively recently deposited. This type of soil and the location of this ditch *c*100m upslope of the river would not have provided suitable conditions for the preservation of wood for any length of time. It is suggested that this ditch is a post medieval field boundary. Particularly as it is aligned broadly northeast-southwest *c*1m north of a present day field boundary on the same alignment. These ditches were also of similar proportions both being *c*1m wide and 0.5m deep. A ditch on this alignment is recorded on cartographic sources from the late 19th century (Fig. 4).

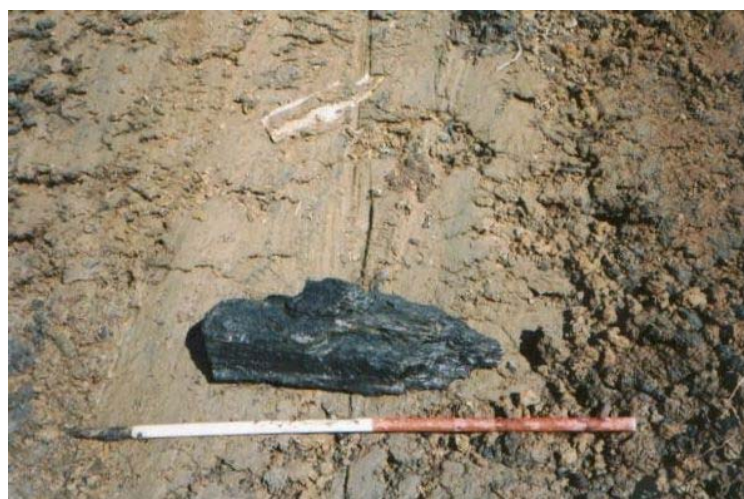
Plate 1: Piece of waterlogged timber recovered from layer 8, culvert trench.

A working area 70mL x 26.5mW x 5mD was excavated. The distinctions between the various stratigraphic layers in the north facing section of this area were particularly clear (Appendix 2, sketch 7). Four layers of alluvium (2, 3, 4 and 5) were recorded, below these were 2 layers of natural clay subsoil (6 and 7). Perhaps the most significant of the layers observed in this series was layer 8 at the base of this section. This layer was black in colour and silty clay in character, it contained moderate amounts of waterlogged timber (Plate 1) of which two samples were taken. Neither of these samples or any of the other timbers examined during the project showed any signs of having been worked. This layer and all of its contents appear to have been naturally derived.

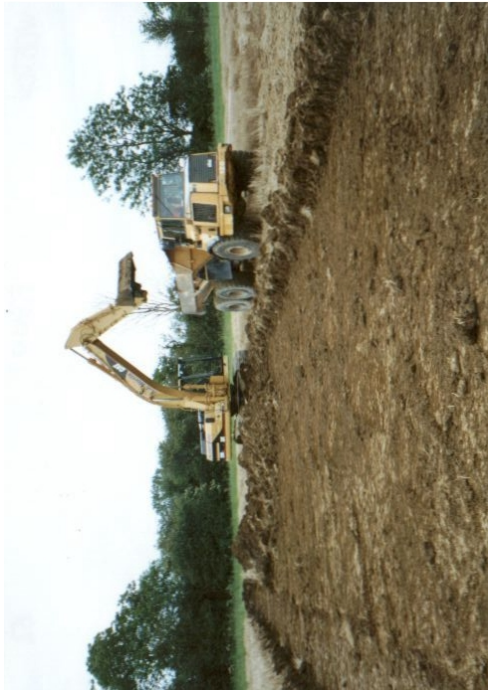
Plate 2: Topsoil stripping on river diversion

A river diversion channel was required ahead of the construction work. Topsoil stripping and the subsequent excavation of a channel to a depth of 2.8m recorded no archaeological features. This measured c90mL x 8.5mW x 2.8mD.

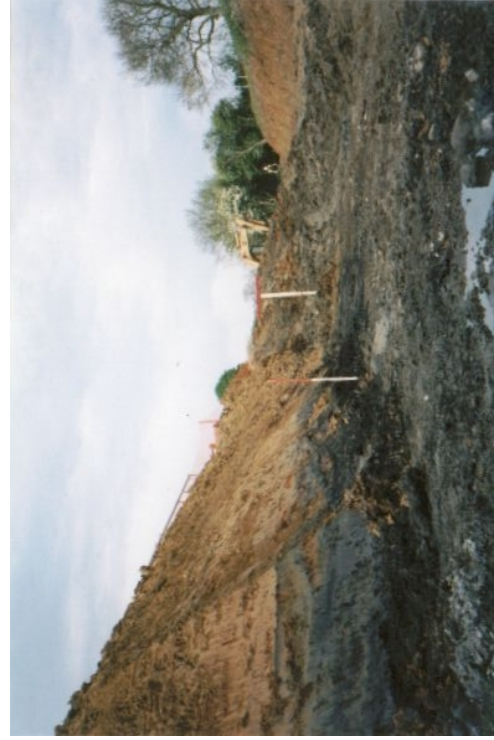
Plate 5: Culvert trench during excavation

During the excavation of the Culvert Construction Trench, topsoil and alluvium were removed. The first phase these works involved the clearance of undergrowth from the banks and removal of river silts from the base of a c90m section of the River Nene. No archaeological features or stray artefacts were identified in either the base or the banks, and no finds were retrieved from the associated spoil heaps.

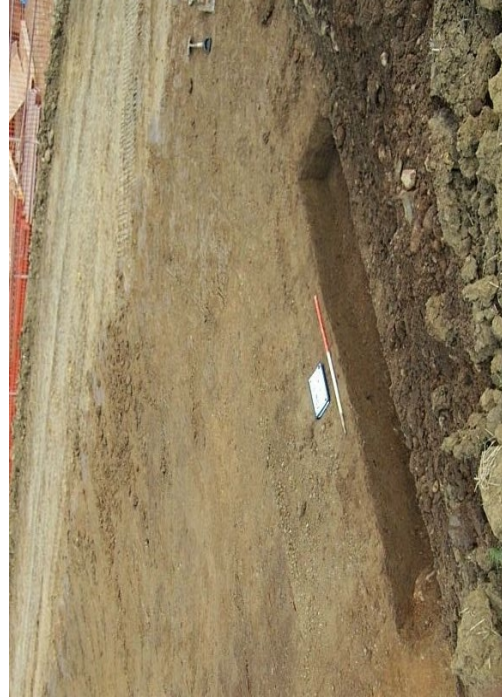
Plate 9: Segment excavated through layer 14

No archaeological features were recorded during the stripping of the northern field. Although an exploratory 4m x 0.5m segment (Plate 9) was hand excavated through a distinctive deposit in the southern part of this area (Appendix 2, Sketches 12 and 13). Layer 14 was recorded as a result, it is considered highly likely that this is part of an alluvial layer associated with regular flooding episodes in the low lying central part of the dam area.

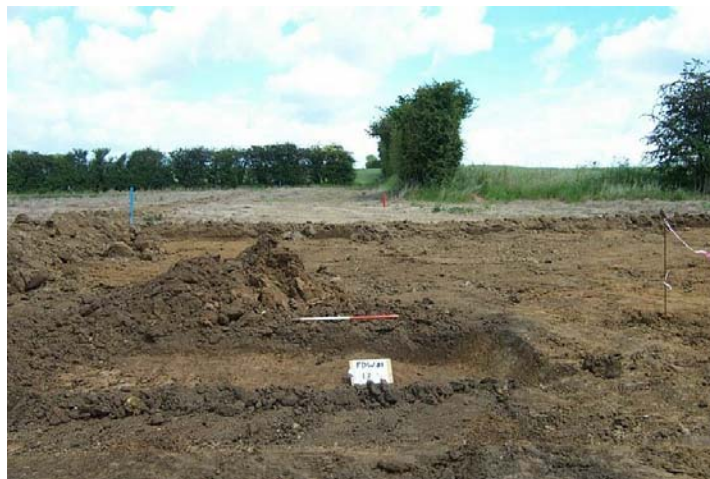
Plate 12: Ditch [13] south facing section

A piece of land 180m x 150m was used for spoil storage during the groundworks for the Dam and Borrow pit. During the preparation of this area topsoil was stripped from this field. One ditch [13] was excavated in this area. This was aligned north – south and contained one deposit 12, from which pieces of modern building material and glass were recovered. It is considered likely that this ditch was a post medieval field boundary similar to ditch [11] recorded in the dam area. Several sources back up this interpretation. Firstly, ditch [13] is aligned north-south in line with a hedgerow, and present day field boundary, c30m north of the excavated segment (Plate 12). Also, cartographic sources (Fig. 4) clearly show that this field boundary and very likely the ditch and hedgerow associated with it used to extend south to the river Nene directly through the development area.

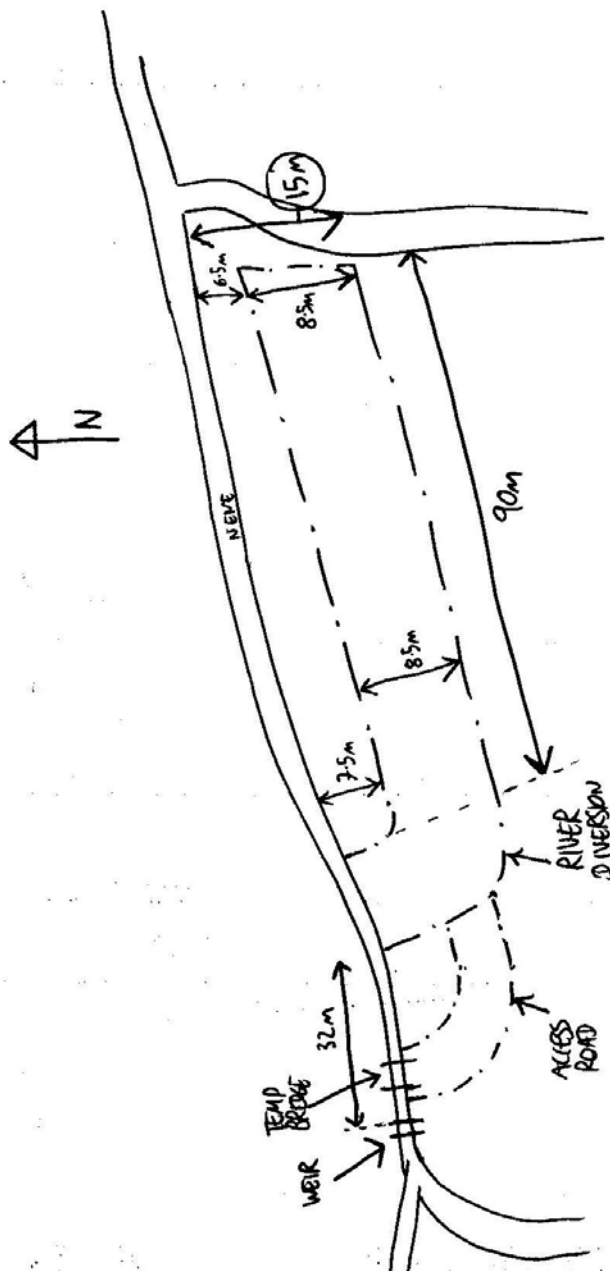
Sketch 1

SKETCH 1: RIVER DIVERSION (TOPSOIL STRIP)

THE RIVER DIVERSION WILL BE RE-EXC ON 8/5/02, TO A DEPTH OF 2.5m.

NOTE - TOOTHBUCKS BUCKET USED ON RIVER DIVERSION;

- TOOTH BUCKET WAS USED ON ACCESS ROAD - REST OF MACHINING WILL BE DONE WITH FLAT BLADED DITCHING BUCKET.

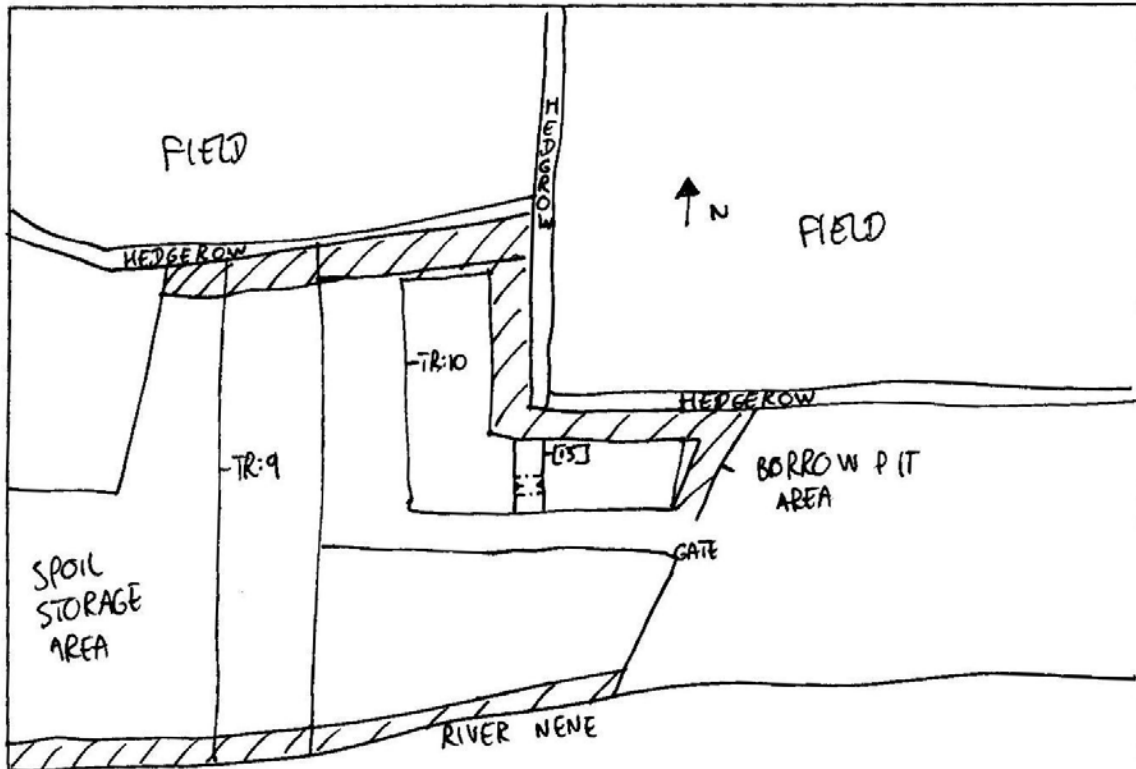
Sketch 11

DITCH [13] WAS PERFECTLY ALIGNED WITH HEDGEROW & FIELD BOUNDARY RUNNING N-S IMMEDIATELY NORTH OF TR:10. IT IS HIGHLY LIKELY THIS FIELD BOUNDARY USED TO EXTEND SOUTH.

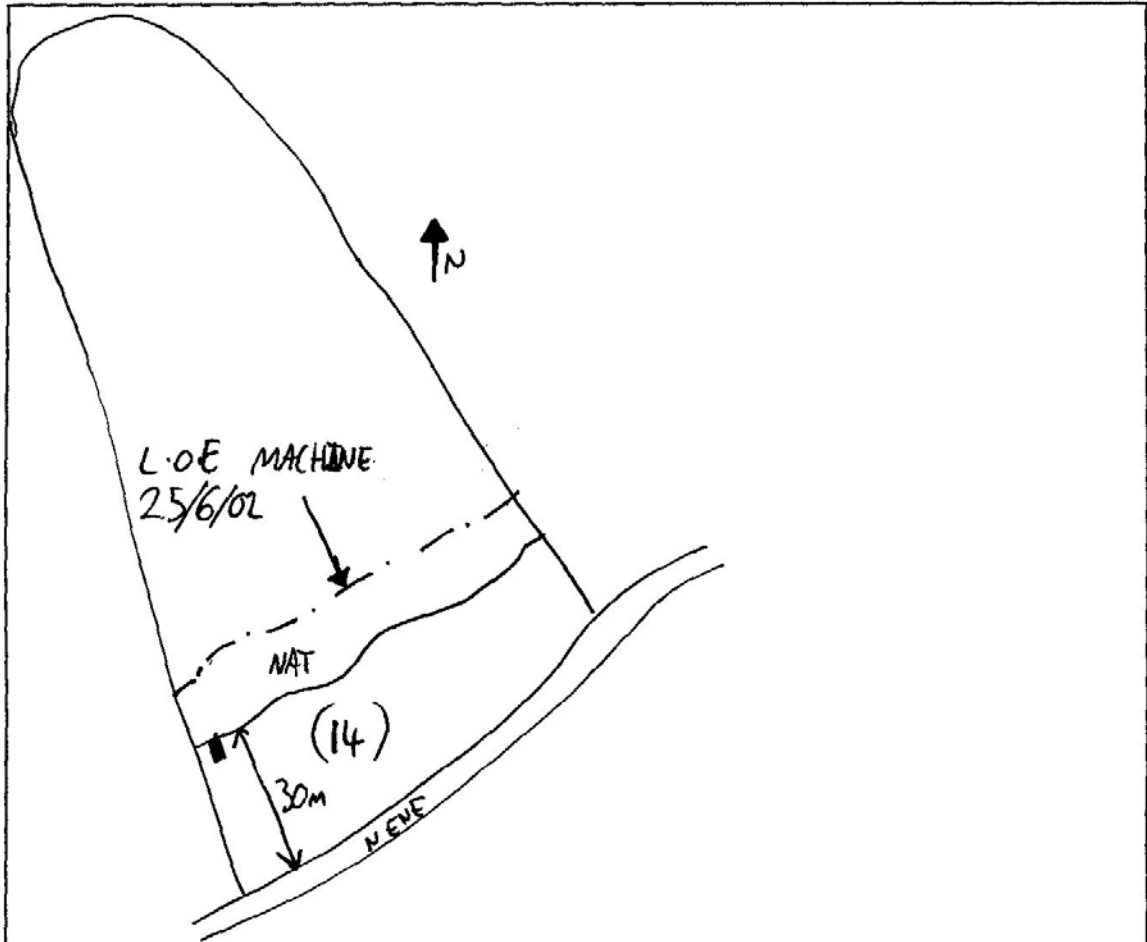
Sketch 12

SKETCH DURING MACHINE STRIP
 OF NORTH FIELD DAM AREA.
 4M X 0.5M SLOT EXC THRU
 LAYER (14). LIKELY TO BE
 LAYER ASS WITH RIVER.

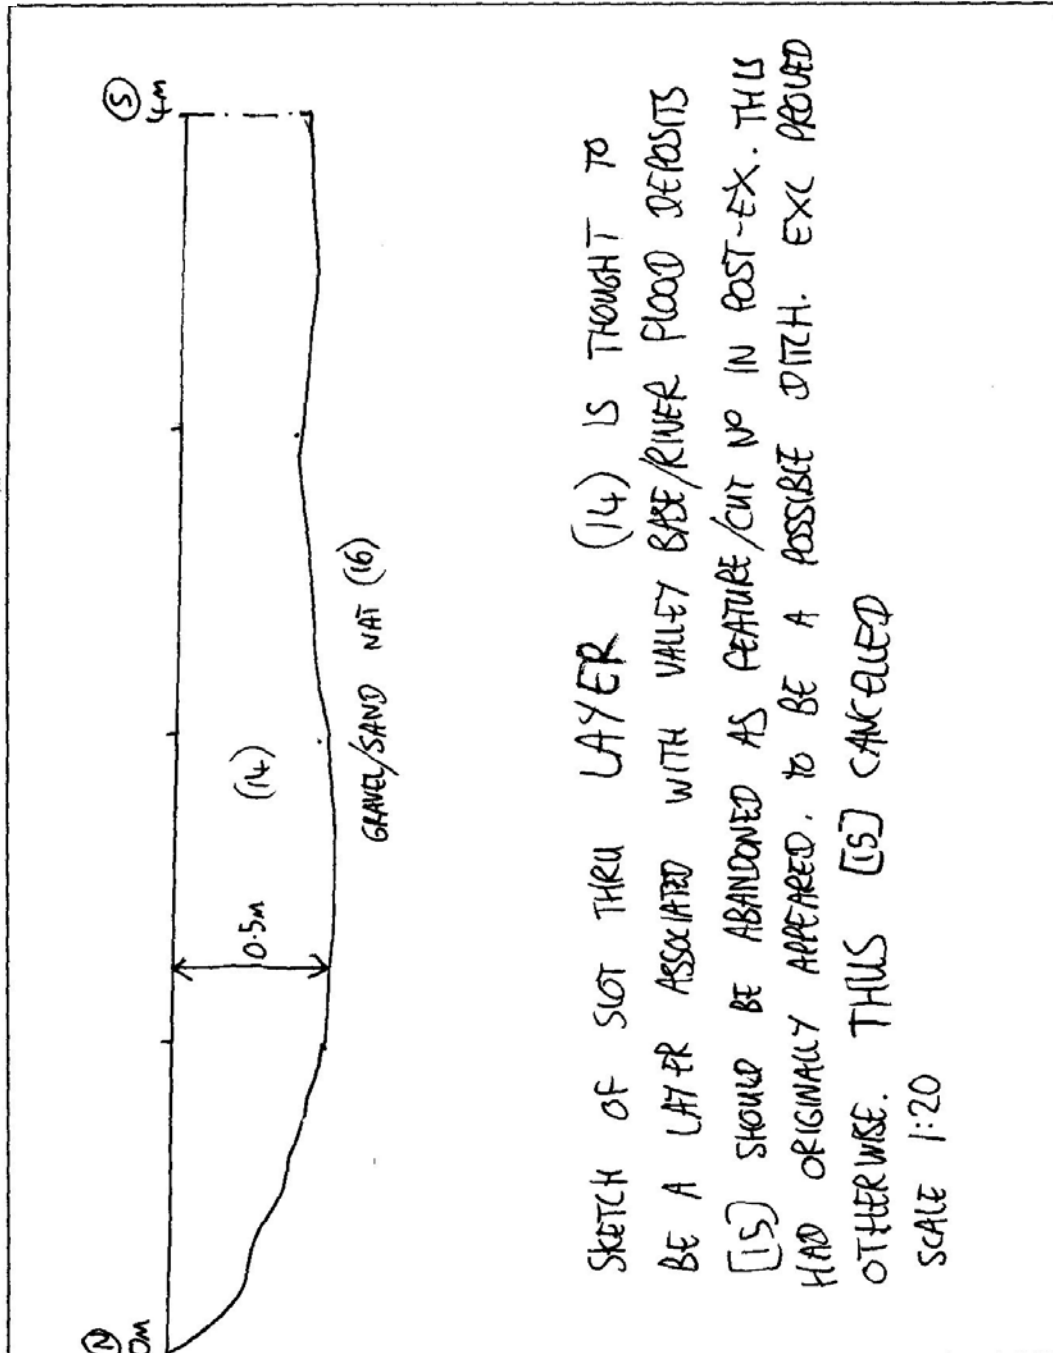
Sketch 13

SKETCH OF SLOT THRU LAYER (14) IS THOUGHT TO BE A LAYER ASSOCIATED WITH VALLEY BASE/RIVER FLOOD DEPOSITS [15] SHOULD BE ABANDONED AS FEATURE/CUT NO IN POST-EX. THIS HAD ORIGINALLY APPEARED, TO BE A POSSIBLE DITCH. EXC PROVED OTHERWISE. THIS [15] CANCELLED
SCALE 1:20
