**ARCHAEOLOGICAL INVESTIGATION AT  
BURY FARM, CHURCH END,  
KENSWORTH, BEDFORDSHIRE**

*On behalf of  
Vernon Moore Esq.*

**12<sup>th</sup> February 2001**

**ASC/M/KBF01/2**

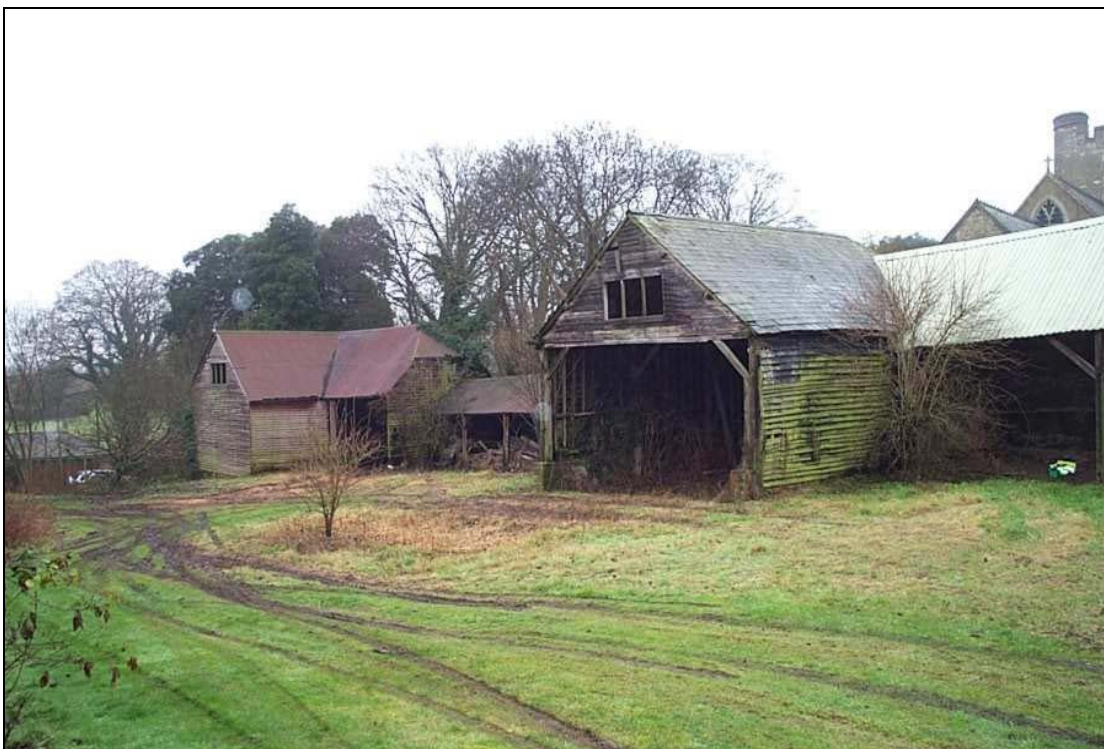
**Plate 1:** View of the Site looking South

2.3.2 The proposed development comprises the residential conversion of the range of farm buildings on the west side of the site (Fig. 2). The five buildings concerned (Plate 1: Fig 3) are all timber-framed on brick footings, with roofs

1. Barn, L-shaped, max. dimensions 12.5 x 10m.
2. Shelter shed, 16m x 4.5m
3. Barn, 7.5m x 10.5m
4. Shelter shed, 16m x 6.0m (concrete floor & feed trough)
5. Barn, 17.8m x 6.0m.

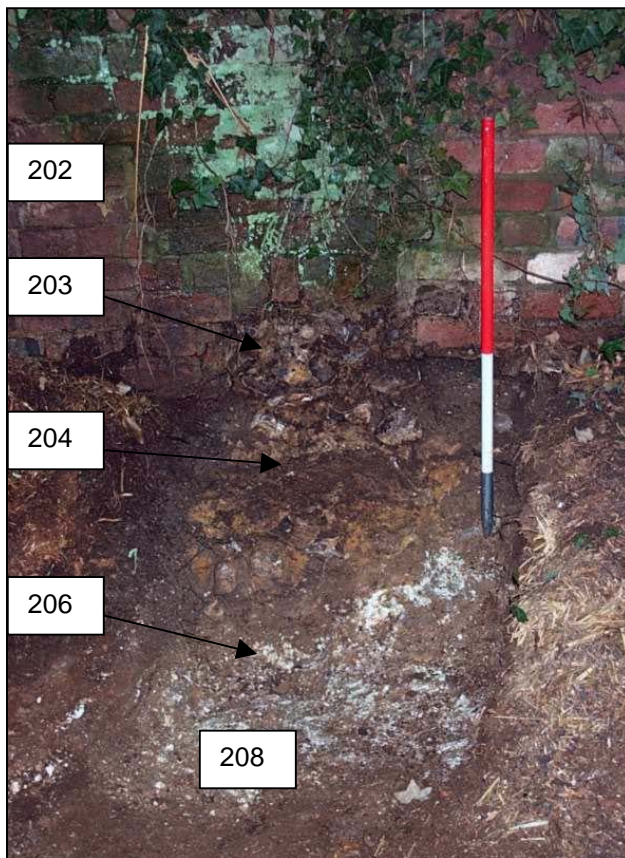
e = 1m)

The footings of the barn wall at this point consisted of red brick courses, laid in stretcher bond (202). The brick wall overlaid the base of a wall (203) comprised of flints set on a cream mortar, 0.43m wide and standing to a height of 0.2m, running at right-angles to Wall 202. This flint wall evidently either represented an earlier structural phase of Barn 1, or predated it. Wall 203 was set centrally on a wider footing (204) of coarser flints with an orange brown clay (?) bonding, 0.25m deep

A rectangular feature 0.33m x 0.40m (206) was noted at the eastern end of Wall 203. It was filled with a deposit of orange brown clay, but contained no finds, and was interpreted as a posthole.

- 6.5** Of particular interest is the truncated east-west flint wall (203) located in Building 1. This appears to predate the surviving elements of the west wall of that structure, and probably belongs either to an earlier phase of Building 1, or to an earlier building on the same site.

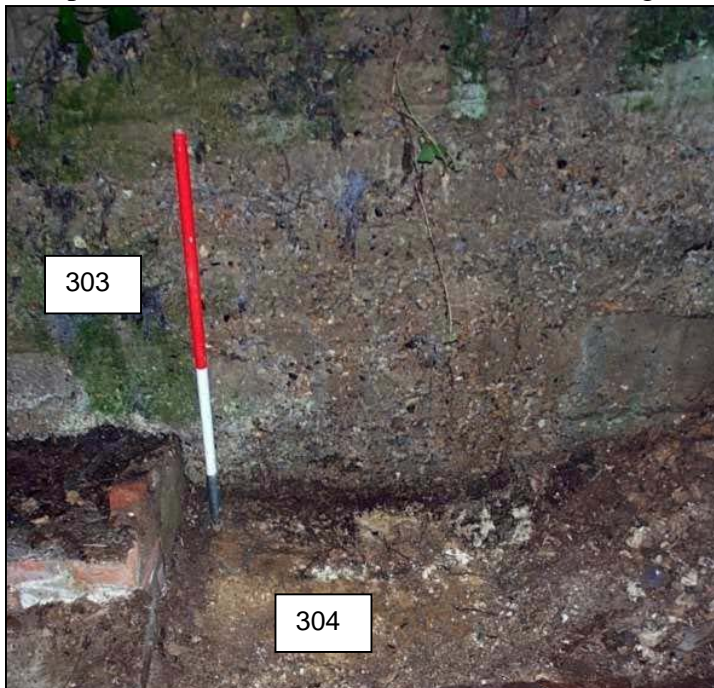
Plate 4: Trench 3 (Scale = 1m)

In this building, the inner face of the west wall has been reinforced with a layer of concrete (303), poured within timber shuttering and having a projecting 'foot' at its base. Consequently, no details of the structure of the wall were visible. The 'foot' was removed with the breaker, revealing that the base of the wall 0.25m below the modern ground surface, was set directly onto natural chalk (304), which sloped down slightly towards the wall.

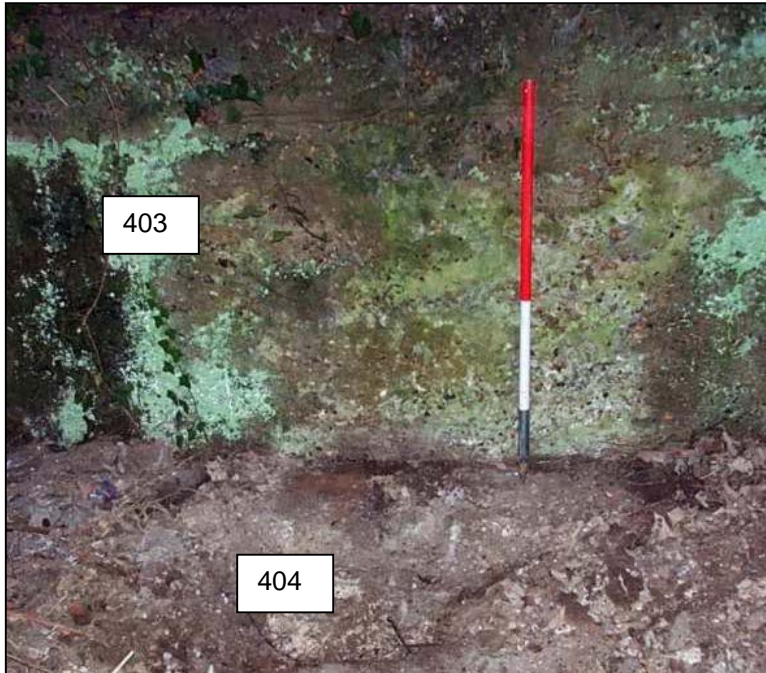
**Plate 5:** Trench 4 (Scale = 1m)

The wall in this location was much the same as described for Test Pit 3. In this instance the ‘foot’, which projected 0.25m from the base of the wall, was more substantial and could not be removed with the breaker. Consequently, the base of the wall could not be examined. Natural chalk (404) was encountered 0.3m below the modern ground surface.

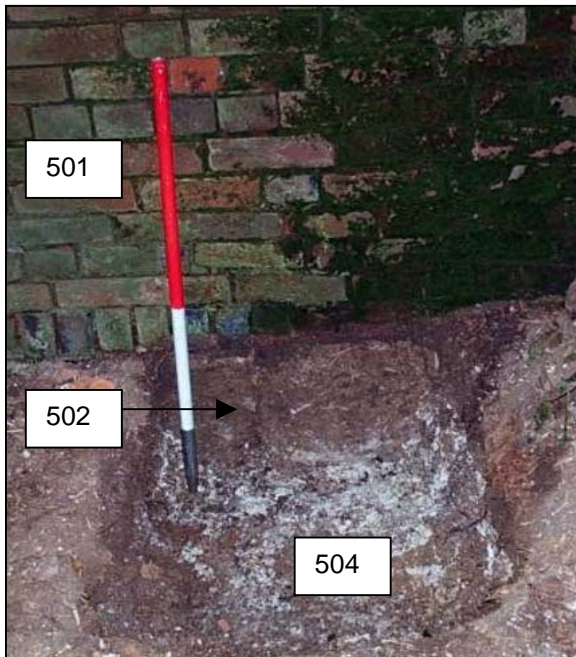
**Plate 6:** Trench 5 (Scale = 1m)

In this building, the west wall (501) was constructed in red brick, laid in Flemish bond. It was set on a footing of large roughly squared blocks of Totternhoe Clunch stone, 0.3m tall (502). These blocks were bonded with orange-brown clay containing chalk flecks (503) and were set directly onto the natural chalk (504), 0.4m below the present ground surface. No foundation trench was present.
