**ARCHAEOLOGICAL EXCAVATION:  
25 HORN STREET  
WINSLOW  
BUCKINGHAMSHIRE**

*on behalf of Mr D. Wigley*

**January 2007**

**ASC: 786/WHS/2**

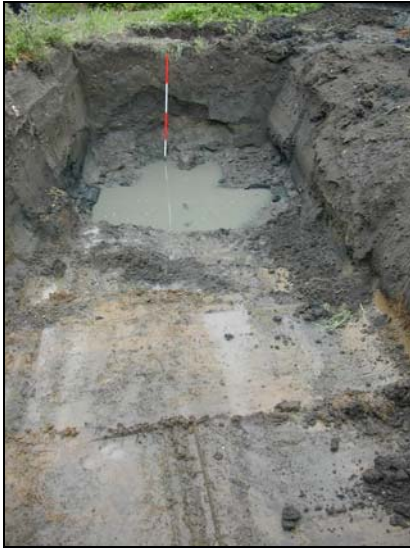
**Plate 1:** Trench 1, general view southeast

- 4.1.1 Trench 1 (9.9m x 4.1m) was opened within plot 3 of the proposed development, c.3m from the eastern boundary wall and c.13m from the southern boundary wall (Plate 1). Trench 2 was excavated 0.75m to the south of Trench 1 (Figs, 4 & 5, Plate 2) (2.2m x 2.6m).

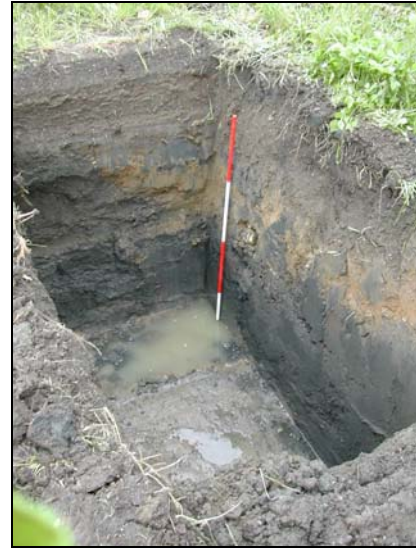
**Plate 2:** Trench 2, view east

- 4.1.3 Trench 2 measured 2.2m at its deepest point. The topsoil layer observed in Trench 1 was also present in this trench, to a depth of 0.63m. Below the topsoil was a 0.71m thick layer of dark greyish brown silt, which corresponded with (21) Trench 1. Below this was a 0.82m thick layer of black organic silt (26), which was similar to (24) Trench 1.

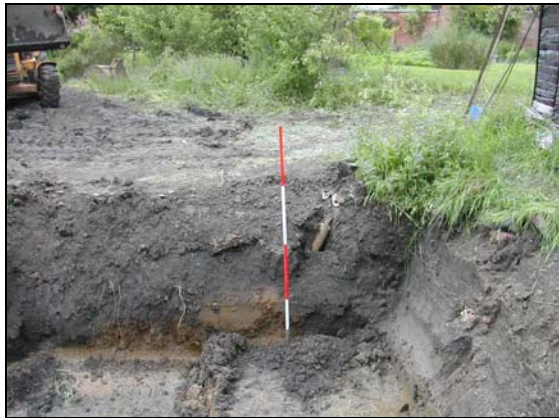
**Plate 3:** Detail trench 1, northern end, view west

- 4.1.2 The area of Trench 1 was covered with a layer of topsoil, (20), to a depth of 1.56m at the southern end of the trench and 0.9m at the northern end, where it was cut by a modern service trench (Plate 3). A shallow pond-like feature was noted in the centre of the trench. Its fill consisted of a dark greyish organic silt, (22), sealed by a layer of dark greyish brown silt, (21), (Plate 4). To the south of the pond-like feature was a linear feature, [27], running on a northeast-southwest alignment, located 1m from the southern end of the trench (Plate 5). This feature was at least 0.7m deep, but the bottom was not reached due to water levels within the trench (Plate 6). The fill of this feature consisted of a black organic silt, (24), from which animal bone, wood and one small fragment of brick were recovered.

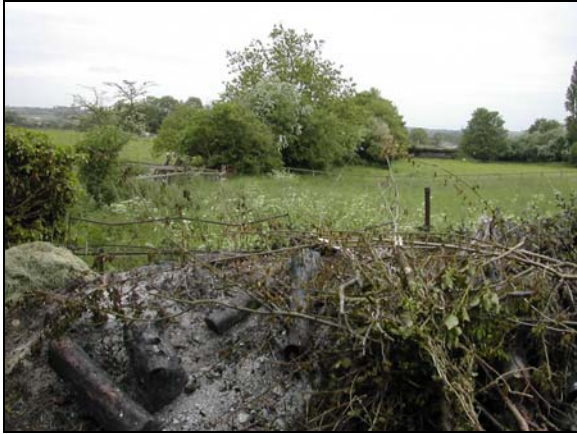
**Plate 7:** Hedgeline beyond southern boundary of site, view south

- 5.3 The linear feature, [27], observed in Trench 1 is at the bottom of this slope. Its fill consisted of a smooth, black organic silt, containing animal remains. If the area of Horn Street was used as a processing area for cattle, it is probable that [27] was a drainage ditch that was also used as a dumping area for any excess material produced by the tanning process. In addition to this, there is the suggestion of an alignment between the linear feature and the hedgerow that forms one of the field boundaries just beyond the southern boundary of the site (Plate 7), which further suggests that the purpose of the feature was drainage.

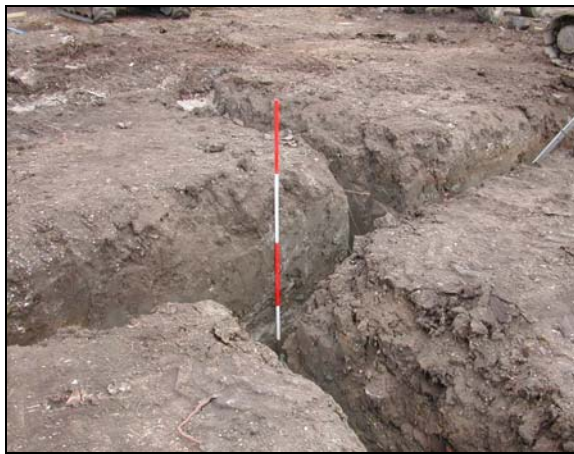
**Plate 9:** Plot 1 foundations looking north west

The footing trenches of Plot 1 (Fig. 3) were 0.6m wide by 1.75m deep, below a reduced level of 0.35m (Plate 9). The footing trenches were all cut into natural dark grey clay, with no features or artefacts being observed.

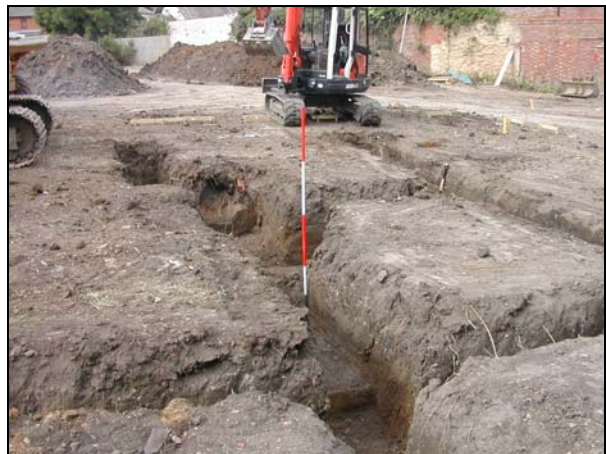
**Plate 10:** View north of foundations in the middle of plot 2

The footing trenches of Plot 2 were also 0.6m wide, with the depth varying from 1.2m to 1.7m (Plate 10). The natural soil again comprised dark grey clay, and no pre-modern finds or features were observed. Some 'pockets' or pits were observed within the footprint of the building, which were interpreted as 'bedding plots' for trees and shrubs from the garden.

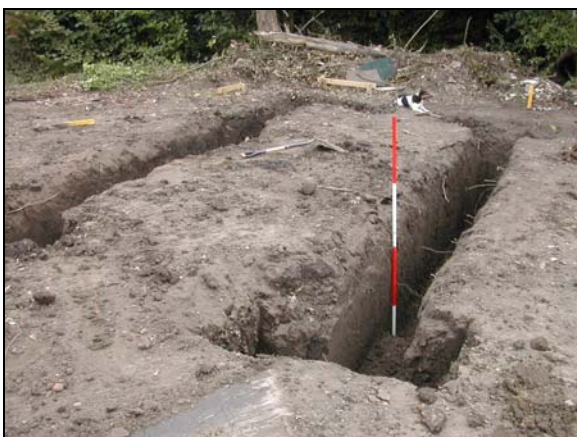
**Plate 11:** SE view of double garage between plot 2 and 3

The footings of the double garage located on the southeastern side of the site were observed, and varied in depth between 1.1m and 1.95m, and 0.6m wide (Plate 11). On the southeastern side the ground was composed of dark grey silty clay with few stone inclusions, with as much as 1.2m comprising made up ground. A possible pit filled with slightly darker grey silty clay was observed in the southeastern corner. The remains of a brick inspection pit probably belonging to a former drainage system was observed in the northwestern corner.

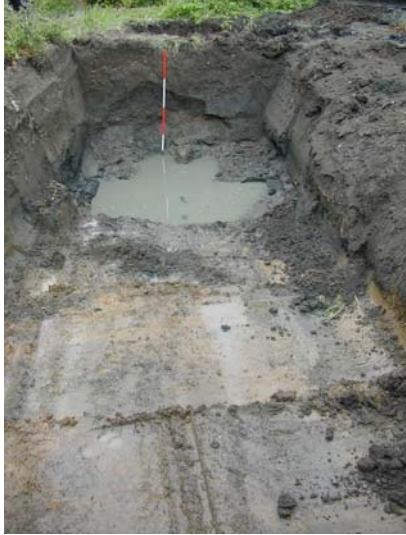
<b>Trench 1</b>

<b>Max Dimensions (m)</b>					
	<b>Length</b>	9.9	<b>Width</b>	4.1	<b>Depth</b>	Not reached
	<b>Levels</b>					
	<b>Trench base north</b>		m OD			
	<b>Trench top north</b>		m OD			
	<b>Trench base south</b>		m OD			
	<b>Trench top south</b>		m OD			
	<b>NGR Co-ordinates</b>					
	<b>N</b>	76798 27517	<b>S</b>	76805 27510		
	<b>Orientation</b>		North-south			
<b>Reason for Trench</b>						
<b>Context</b>	<b>Type</b>	<b>Description and Interpretation</b>	<b>Max Width (mm)</b>	<b>Max Thckn (mm)</b>	<b>Depth BGL (mm)</b>	
20	Layer	Very dark grey topsoil	-	1600	1600	
21	Layer	Dark greyish brown silt	-	600	2200	
22	Fill	Very dark grey organic silt	-	200	2400	
23	Fill	Very dark grey topsoil	-	-	900	
24	Fill	Black organic silt (fill of [27])	-	?	2100	
27	Cut	Linear feature	-	-	-

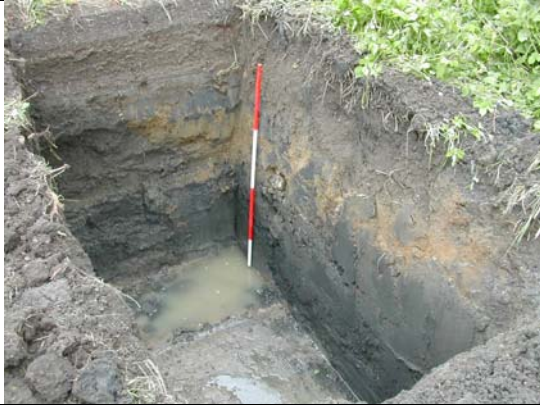
<b>Trench 2</b>

<b>Max Dimensions</b>				
	<b>Width</b>	2.2m	<b>Length</b>	2.6m	
	<b>Depth</b>	2.2m (at deepest point)	<b>Level (top)</b>	108.03m (south east corner)	
	<b>NGR Co-ordinates</b>				
	<b>N</b>	76805 27509	<b>S</b>	76807 27508	
<b>Orientation</b>		East-West			
<b>Reason for Trench</b>					
<b>Context</b>	<b>Type</b>	<b>Description and Interpretation</b>	<b>Max Width (mm)</b>	<b>Max Thckn (mm)</b>	<b>Depth BGL (mm)</b>
20	Layer	Very dark grey topsoil	-	700	700
21	Layer	Dark greyish brown silt	-	700	1400
26	Layer	Black organic silt	-	820	2200
