**HISTORIC BUILDING RECORDING & WATCHING BRIEF:  
50 HIGH STREET  
TRING  
HERTFORDSHIRE**

*on behalf of David Metcalfe*

**March 2007**

**ASC: 855/THS/02**

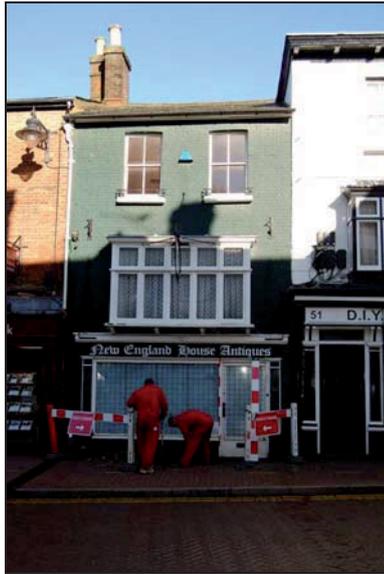
**Plate 1:** South elevation

This fronts the High Street and consists of a brick wall set in Flemish Bond and painted green. There are two sash windows on the second floor and an oriel window on the first floor. The second floor windows have flat relieving arches and stone sills with decorative ironwork.

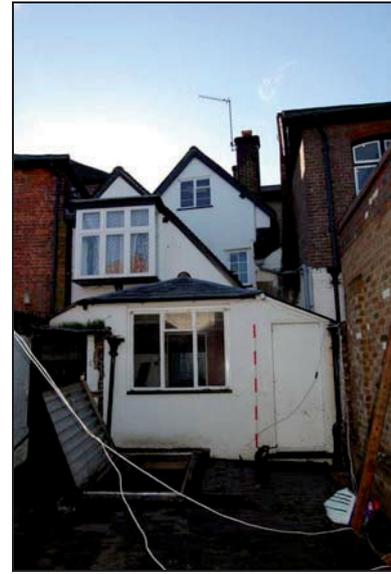
**Plate 2:** North elevation

This is the rear elevation, which consists of the north wall of each of the successive phases of extension to the north. All of the elevations are rendered and under slate roofs. There is access to the building by a door to the east that has four panels with glazing in the upper section and another to a store in the west. The latter has been blocked. Between the two doors is a modern casement window, in front of which is the hatch that allows external access to the cellars.

There is an oriel window on the first floor of the first extension to the rear and a 6-light casement to the first floor of the original building. A modern casement window lights the second floor of the original building.

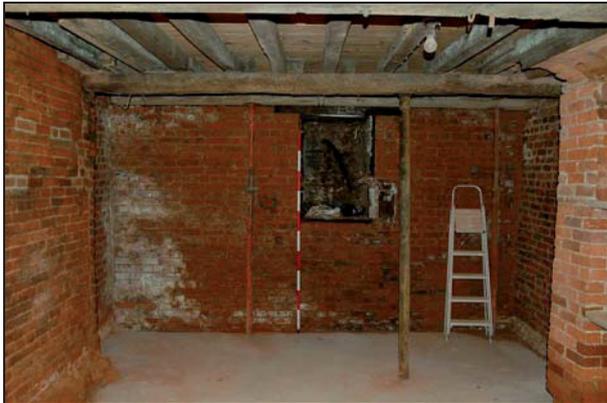
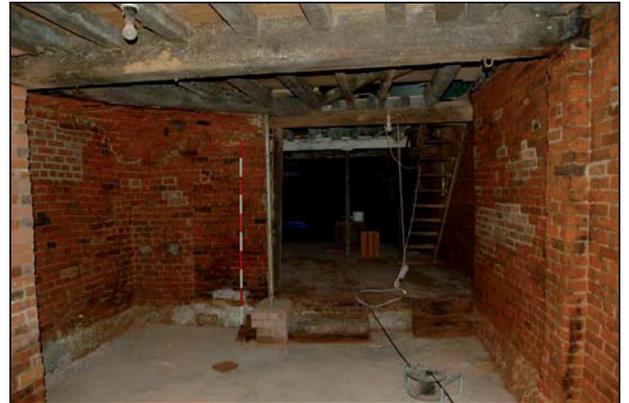
*Description:* The cellar is entirely brick built, but with so many alterations, repairs and replacements that a chronological narrative is impossible within the remits of this project. The bricks are predominantly hand made, set in an English Bond using lime mortar. Those in the east wall tend to be approximately 21 x 10 x 5.5cm (8 x 4 x 2 inches) and could be 17<sup>th</sup> century. In contrast, those in the south wall measure approximately 22 x 11 x 6.5cm (8½ x 4½ x 2½ inches) and are 19<sup>th</sup> century. The west wall also shows evidence for rebuilding to the north of the southernmost binding beam.

The central binding beam has a 4cm wide chamfer with a run out stop in the northwest corner. The joists are c.12 x 6 -12 x 10cm on 50cm centres.

The floor, which is concrete, has been lowered by 28cm revealing the clunch natural.

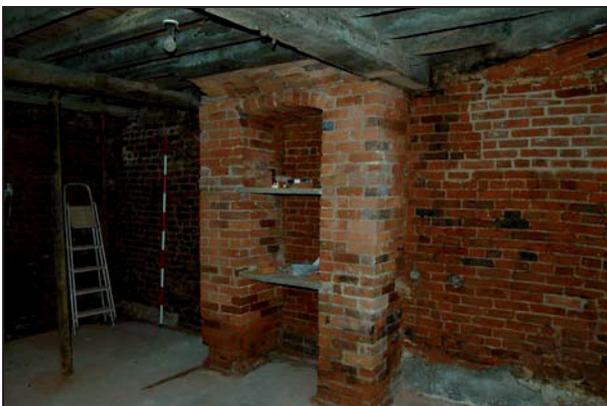
**Plate 5:** Cellar: C1, chimney support

There is a chimney support on the west wall, a coal chute in the south wall and two steps up to C2 to the north. The northwest corner of the room has an irregular shape with a diagonal joist giving additional support to the floor above.

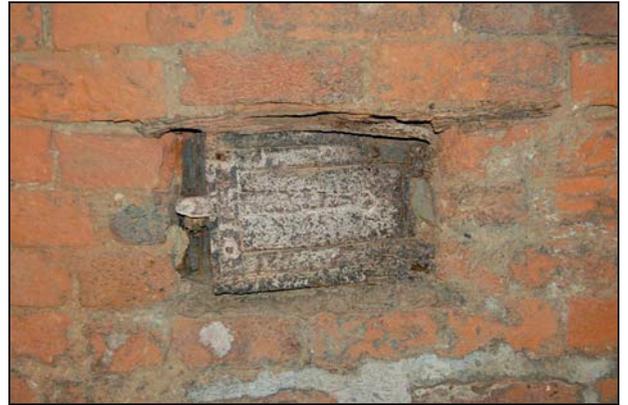
**Plate 8:** Cellar: C2, hatch detail

There is a small hatch of no obvious function in the northwest wall, a wooden staircase in the southeast corner to the ground floor and a staircase to the yard in the north wall.

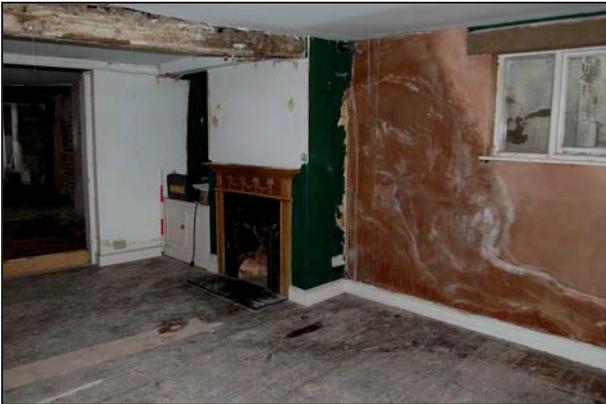
**Plate 15:** G1: fireplace in west wall

The west wall is more robustly constructed and has had a fireplace inserted approximately 1.95m from the street frontage. There is no supporting dwarf wall, although a small section of a sill beam is still extant to the north of the fireplace. A

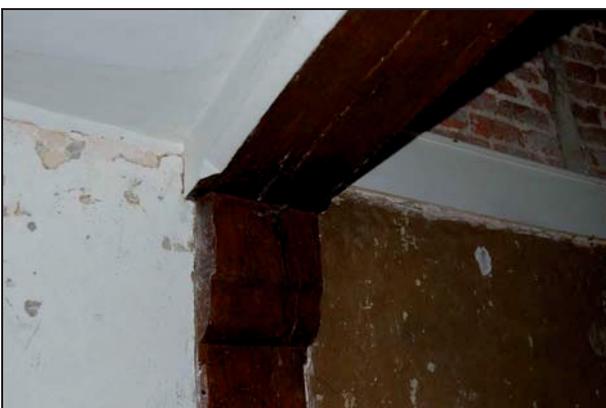
**Plate 17:** G1: ogee moulding in post

There is ogee moulding on the principal post adjacent to the staircase, which runs along the east wall, and ordinary Lambs Tongue Chamfer Stops (generally dated late 16<sup>th</sup> to early 17<sup>th</sup> century) on the beam associated with it. However, there are long Lambs Tongue Chamfer Stops on the penultimate beam to the south, which are indicative of a later 17<sup>th</sup> century date.

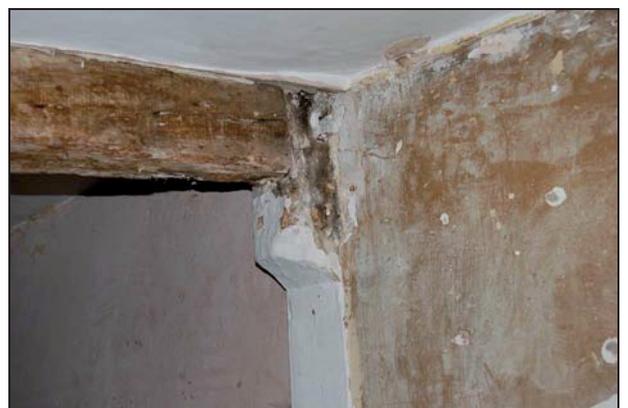
**Plate 18:** G1: gunstock jowlpost

The east and west walls in Room G1a are very different, and were clearly the external walls of the properties to either side of number 50. The east wall is built on a supporting dwarf wall that is approximately 16cm high. It has an arched brace in the southernmost bay, which was later infilled with brick and a bonding beam. The brick infill appears to be earlier here than along the rest of the wall, where it appears to date from the early 19<sup>th</sup> century. The principal posts are 11-24cm wide and the studs are 9-10cm wide. The gap between the uprights is 63-69 cm. The dimensions of the timbers as well as their spacing suggests that this wall is probably 17<sup>th</sup> century, which is further supported by the gunstock jowls at the northern end of G1a.

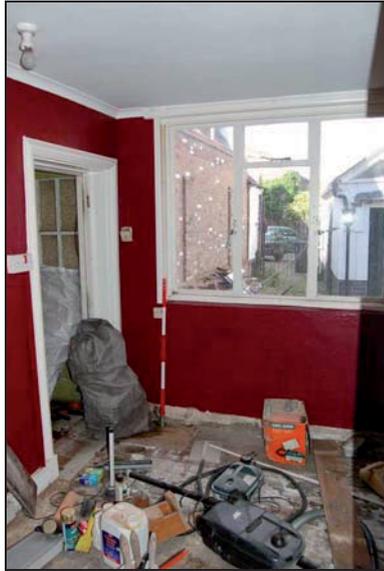
**Plate 19:** G2: looking northwest

*Description:* This lies within a single storey addition and consists of a plastered and painted room with a lath and plaster ceiling, oak flooring, a modern casement window in the north wall and the remains of a sliding door in the south wall. A door in the west wall opens into a store with a quarry tiled floor and a door at both the north and south ends.

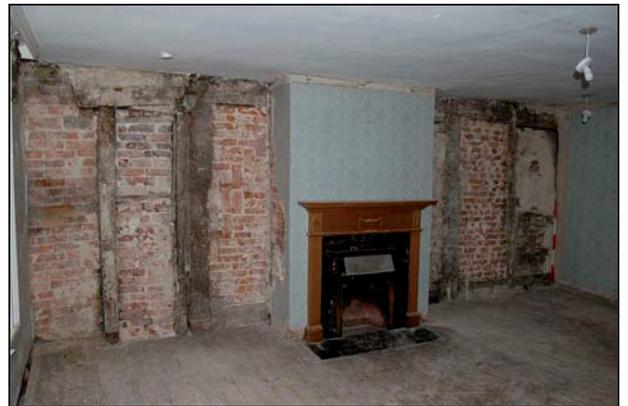
**Plate 22:** F1: west wall

The west wall has a mock Regency fireplace and a gunstock jowlpost to the south of it. This was clearly the earlier end wall of this building, which appears to have been extended in the 18<sup>th</sup> century as suggested by the additional wallpost and the bonding beams. It was extended again in the 19/20<sup>th</sup> century. The remaining wattle and daub in the northern part of the wall would suggest that this wall is possibly 16<sup>th</sup> century.

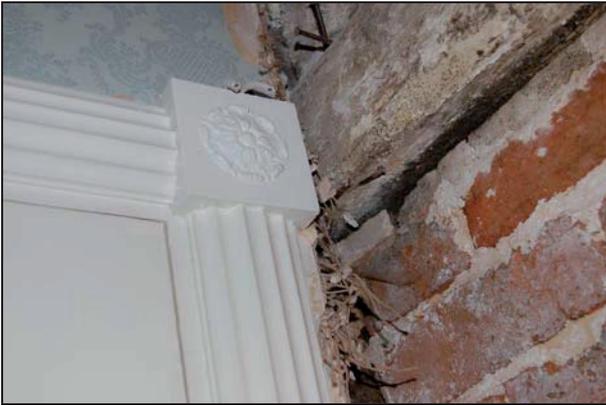
**Plate 25:** F1: door detail

There is a plain door with convex, reed-moulded architrave on a square base with a flower motif in square panels in the top corners.

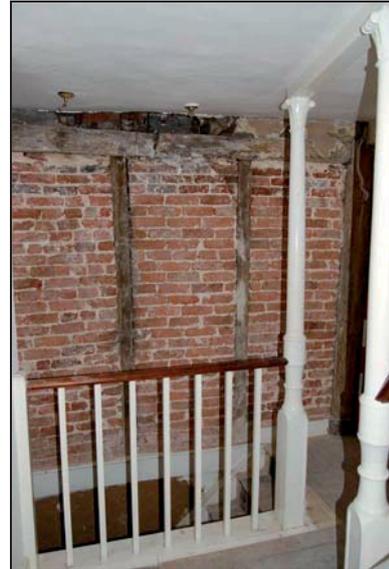
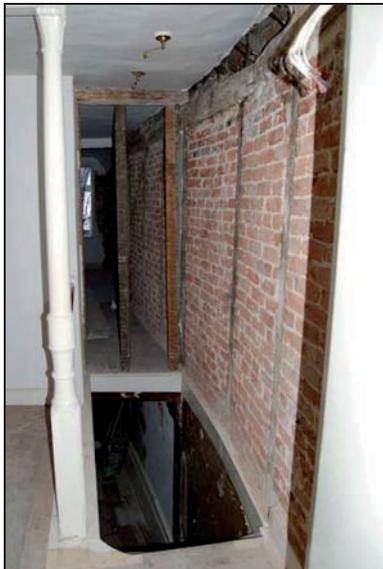
The east wall is timber framed with brick infill and far from straight. The other walls are plastered with moulded skirting. The ceiling is lath and plaster and the floor is of timber boards running both east to west and north to south.

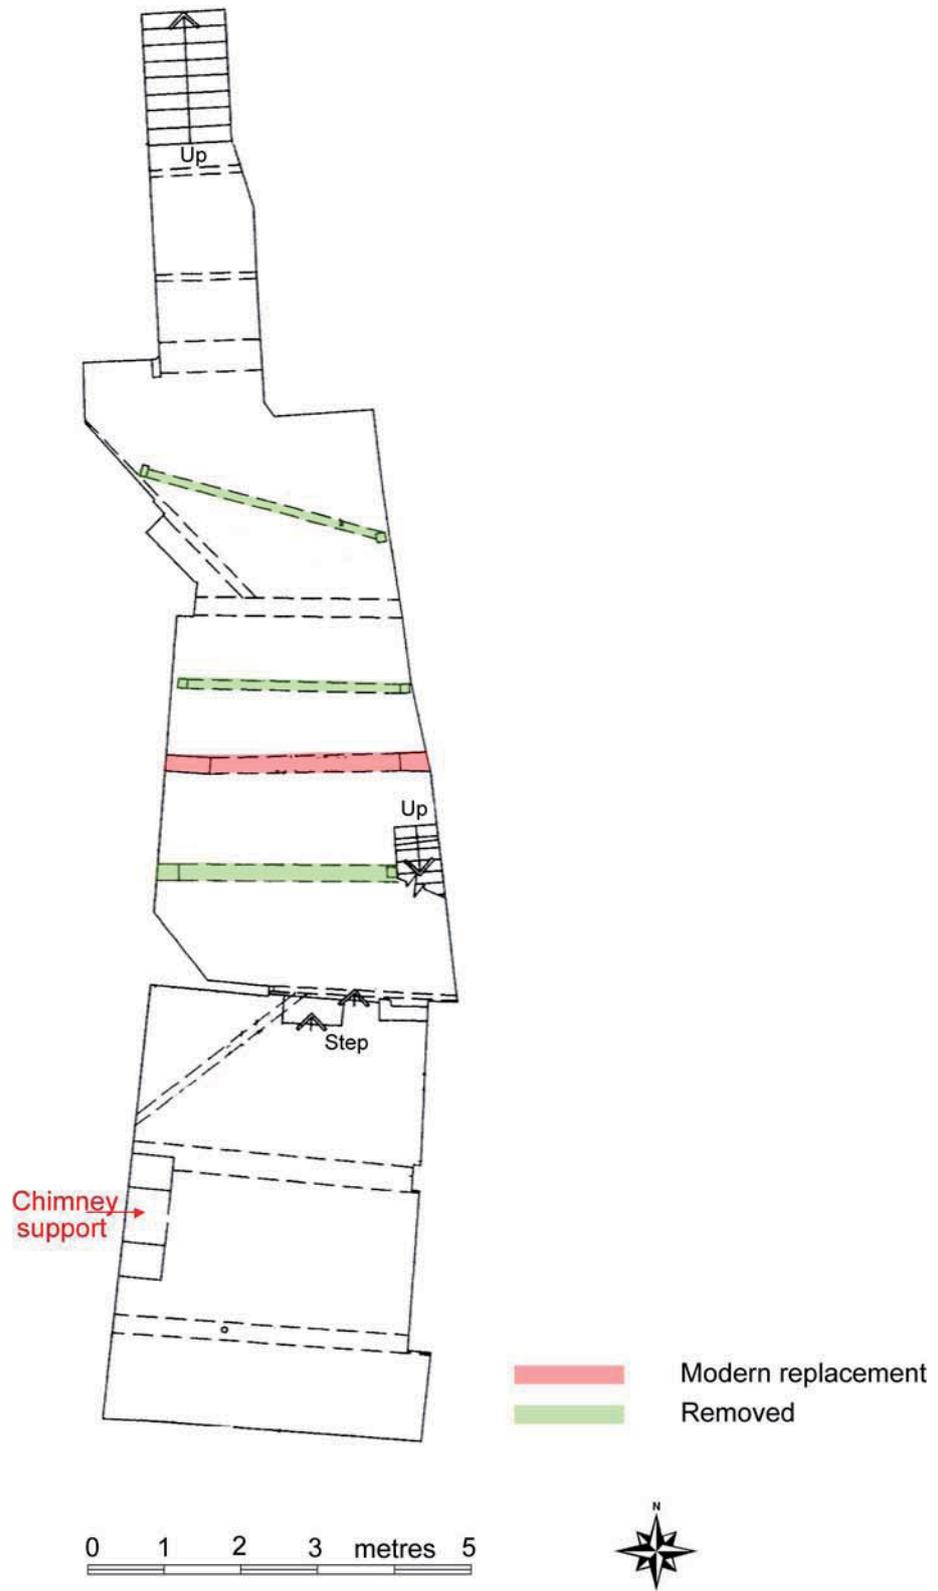
**Figure 9:** Basement floor plan (Scale 1:100)

*Description:* The brickwork is equally variable in this part of the cellar and includes 18/19<sup>th</sup> century brick set in a mixed bond in the west wall, some vitrified bricks in the northeast end of the room, a new skin along the stairs and yellow and red brickwork in the entrance passage to the north.

The floor is brick and concrete and the ceiling is made up of joists and the floorboards above. The joists are of varying dimensions and spacing.

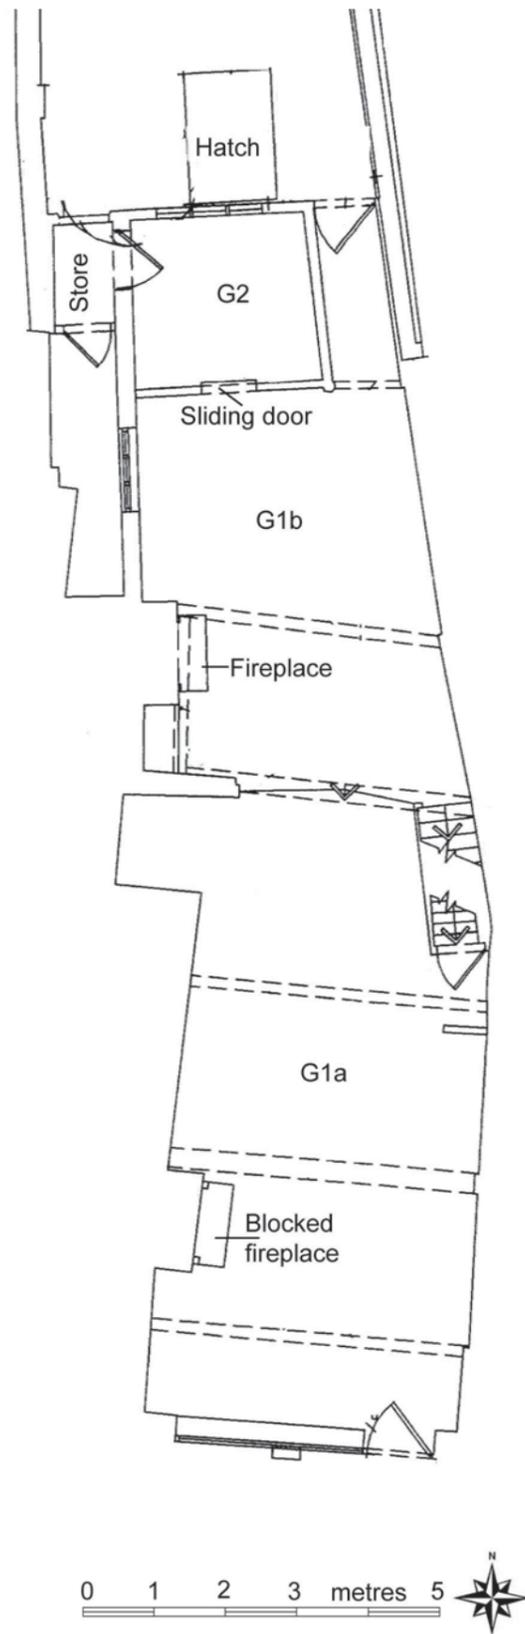
Figure 10: Ground floor plan (Scale 1:100)

*Description:* This is now one large room as the former internal walls have been removed. The southern half of the room (G1a) is timber framed with brick infill. The walls to the north of the staircase (G1b) are plastered.

number of bonding timbers have been exposed, which are likely to have been inserted when the brick infill was put in, in the 18<sup>th</sup> century. It was at this time that the building was extended c.1.18m further south, as the bonding timbers at the southern end of the wall suggest.

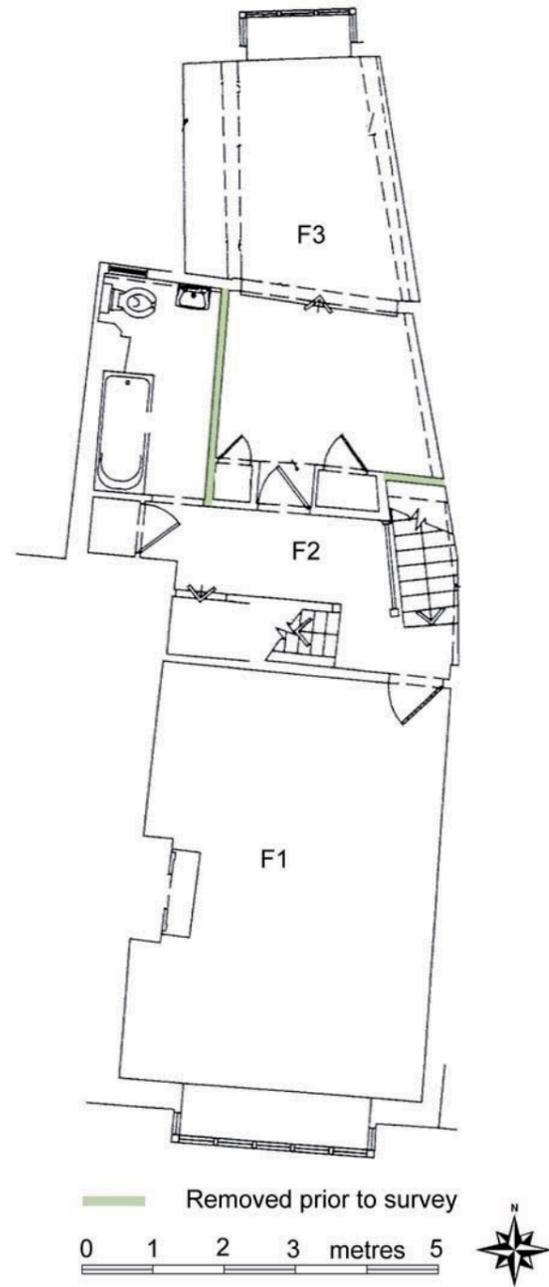
**Figure 12:** First floor plan (Scale 1:100)

*Description:* The east and west walls are timber framed with brick infill and the north and south walls are plastered and papered.

The ceiling is lath and plaster and the floor has wide oak boards running east to west. There is a modern fireplace in the west wall and an early 20<sup>th</sup> century oriel window of 14-lights with two casements in the south wall.

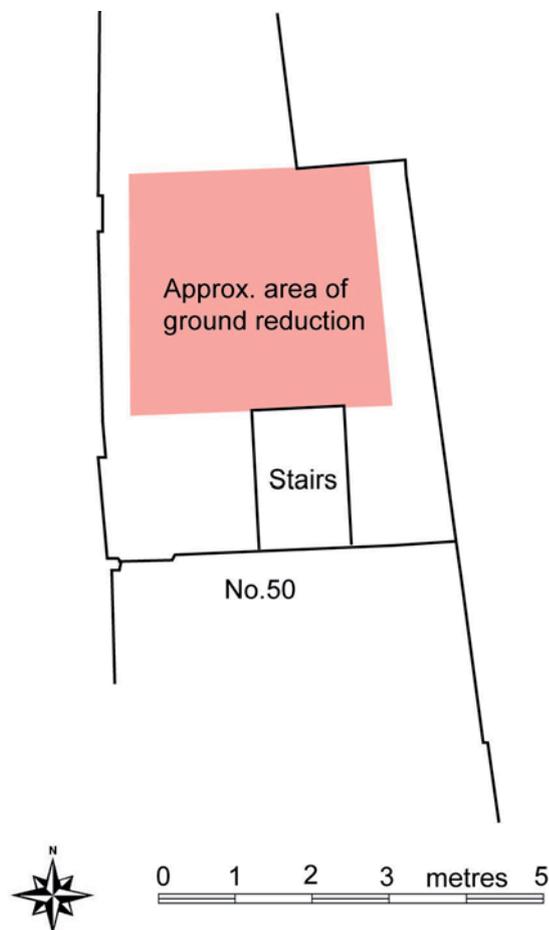
**Figure 19:** Approx. location of the ground reduction (*Scale 1:100*)

- 5.1** Two site visits were made to inspect ground works to the rear of the building. The initial ground reduction of up to 30cm deep revealed that this was made ground containing a number of services.
- 5.2.1** The excavation of two underpinning pits was monitored. The first, which lay in the northwest corner of the cellar at the junction with the stair, was irregularly shaped and approximately 1.25m N-S, 0.50m E-W and 0.72m deep. The second lay immediately below the fireplace in Room G1b was 1.20m N-S, 1m E-W and approximately 0.35m deep. There were no archaeological features or finds in either of the two pits as they consisted entirely of decomposed chalk.

- 6.6** The evidence from the groundworks suggests that the yard to the rear of the property has been severely disturbed by building works and the installation of services. The cellar floor is clearly at such a depth for the construction of the cellar to have destroyed any existing archaeological features.
