HISTORIC BUILDING RECORDING: EASTBURY FARMHOUSE WOODFIELD AVENUE NORTHWOOD HERTFORDSHIRE

on behalf of Alan C Ford Ltd

January 2007

ASC: 873/NEF/3

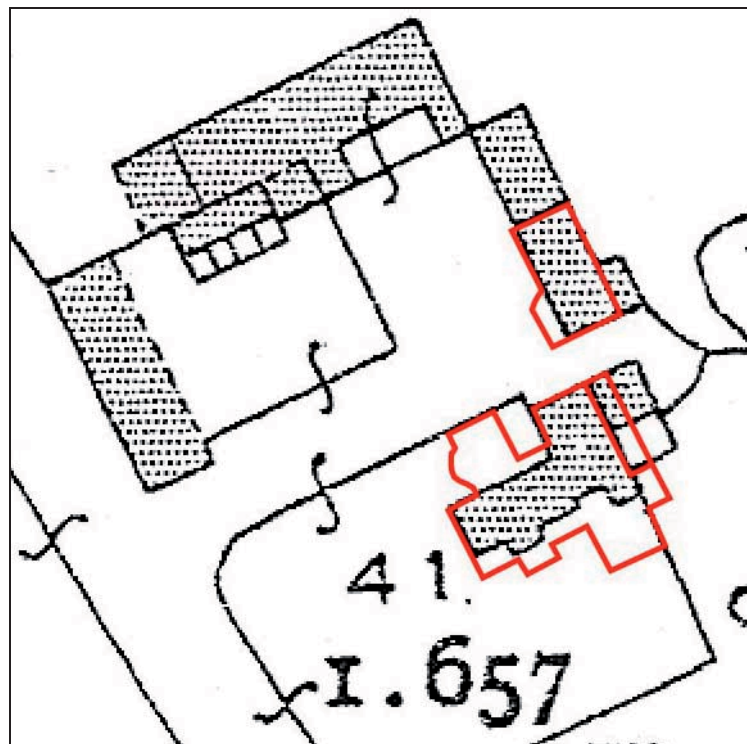
Figure 6: Extract from 1935 Ordnance Survey Map (*scale 12" to 1 mile*)

This inaccuracy in the south elevation of the farmhouse is repeated in the 1914 Ordnance Survey map (Fig. 5), which shows an addition to the eastern side of the building and a small addition to the north elevation. There is also an addition to the east elevation of the outhouse, which survived until at least 1935 (Fig. 6).

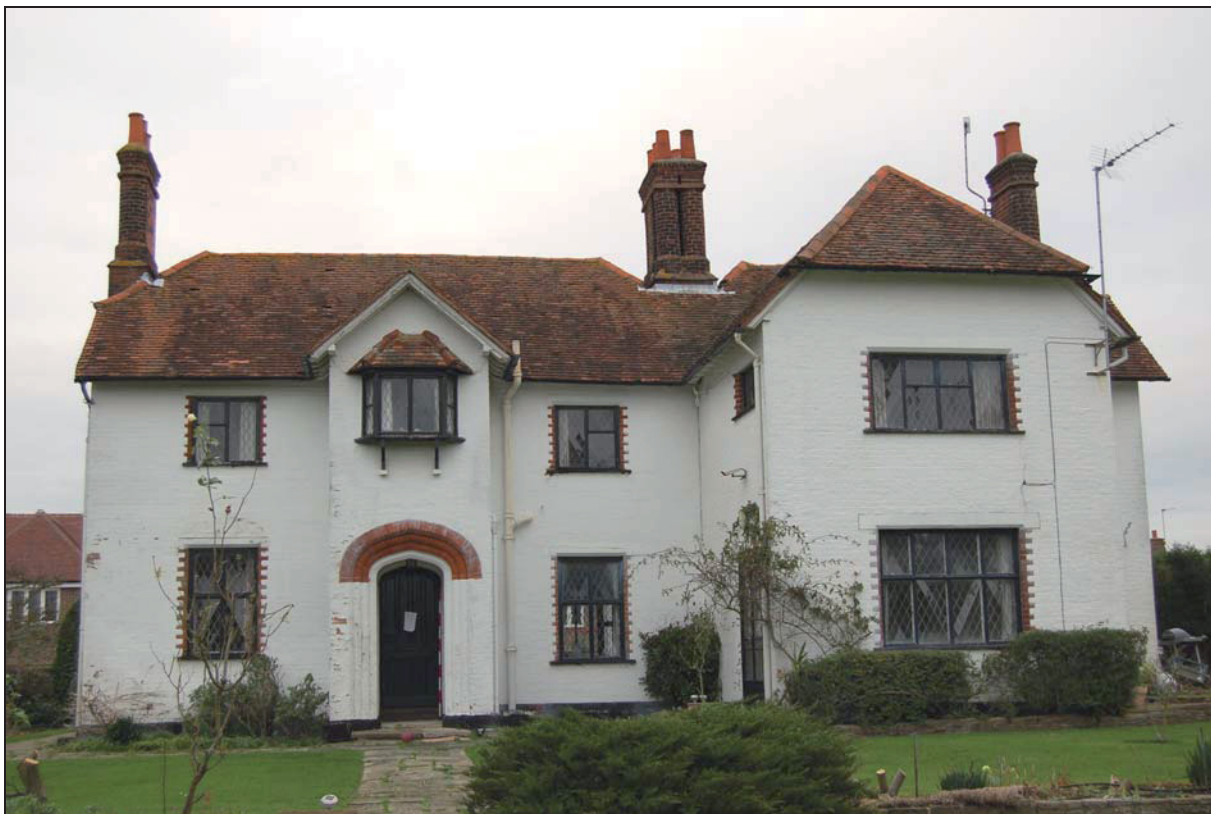
Plate 1: South elevation

4.2 *South Elevation* (Plate 1)

This is the main elevation of the house, with a neo-gothic front door within a 2-storey porch. The porch has a Tudor arch with 3 orders of brick on the ground floor and a 6-light bay window under a tiled pentice roof to the first floor. There are two 3-light windows in each floor of the main range of the building and one 6-light window in each floor of the east range.

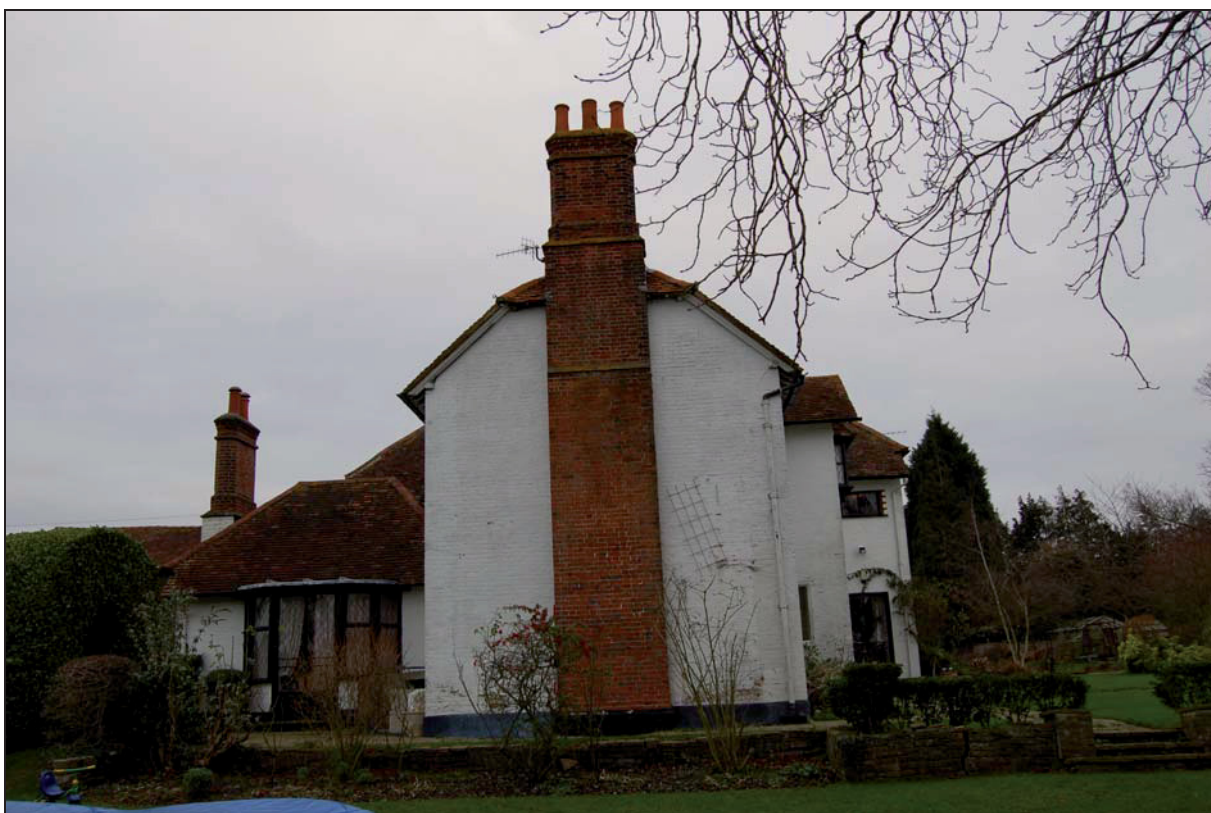
Plate 2: West elevation

4.3 *West Elevation* (Plate 2)

The west elevation has an external, brickbuilt chimney stack with 3 pots to the main range. The single storey extension to the north has a bay containing double doors and associated windows providing access from the dining room (G7) to the garden. There is a small opening in the west elevation of the porch and a set of double doors in the east range to Room G4. There are 2-light windows in the east range, lighting F7 and the cupboard in F9.

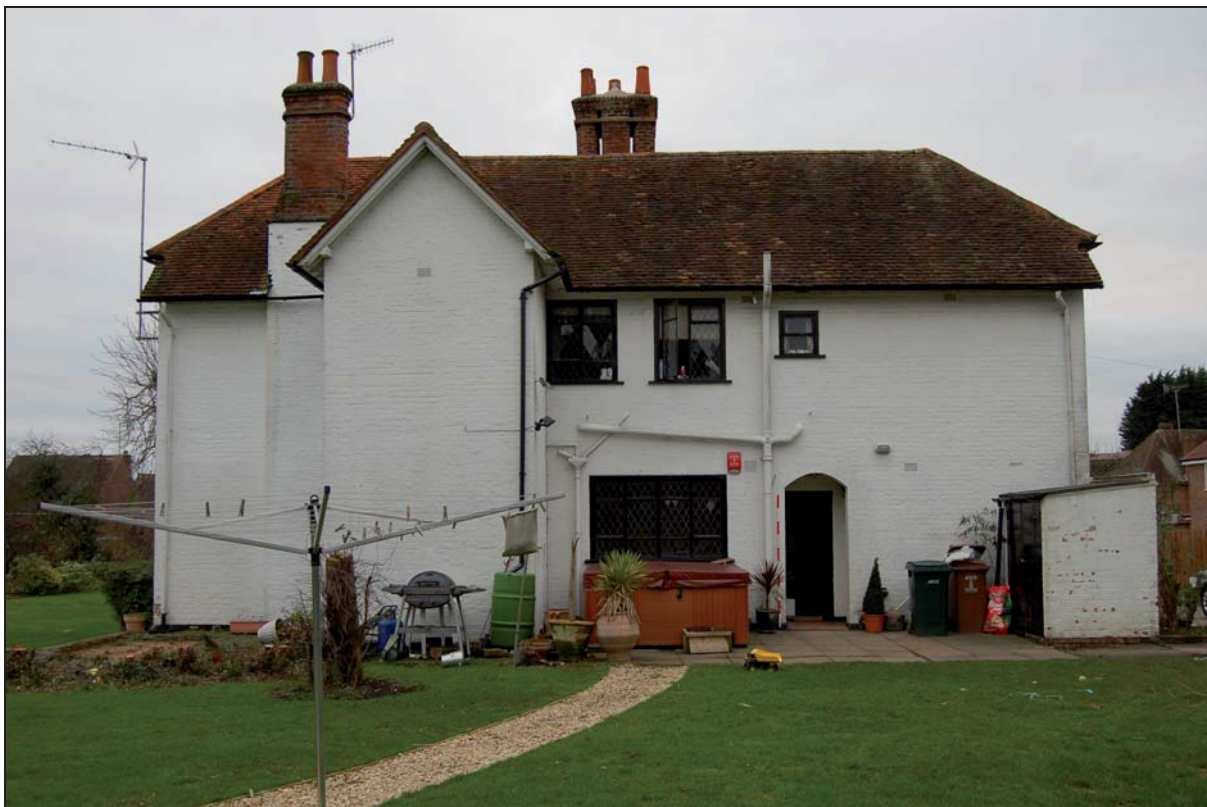
Plate 3: East elevation

4.4 *East Elevation* (Plate 3)

There is an external brick built chimney stack with 2 pots to the south of the 2-storey extension. All the openings are to the north of the extension, and consist of two 4-light and one 2-light window on the first floor and a 4-light window on the ground floor. The door, which opens into the lobby (G2), is set back behind an arch to the north of the ground floor window.

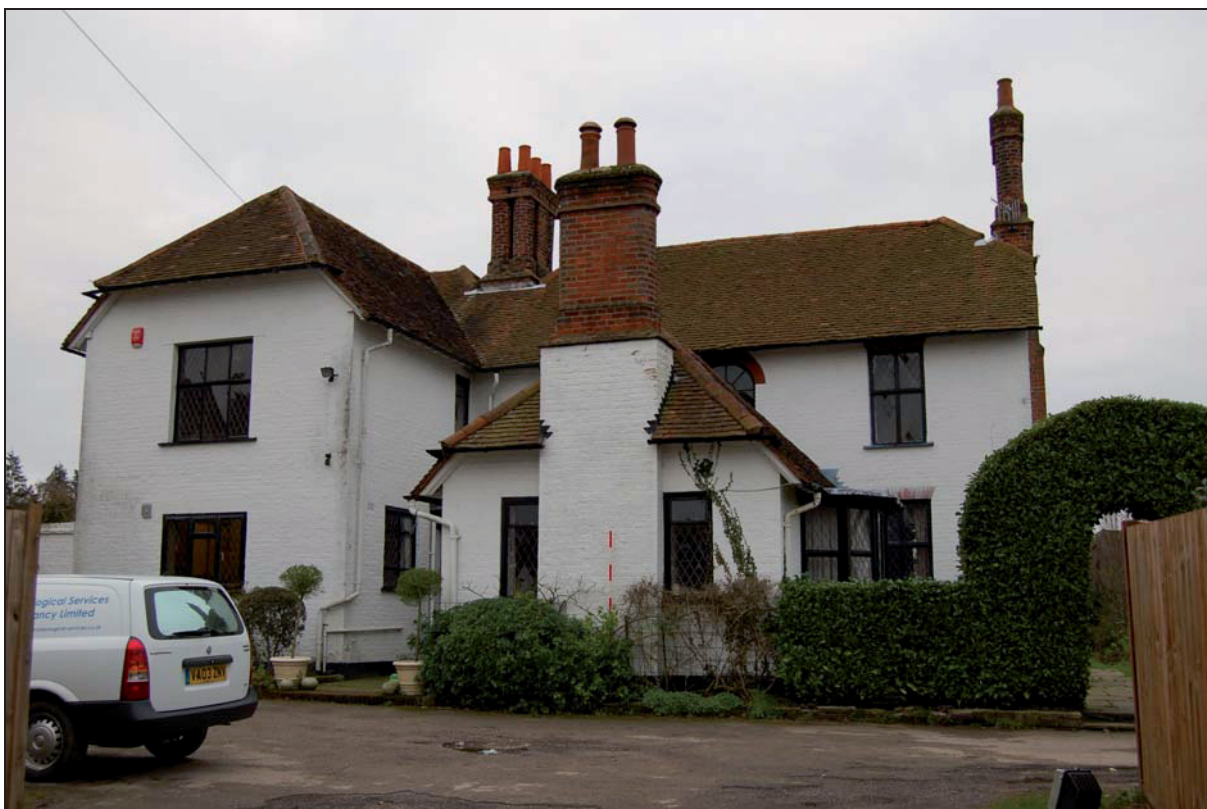
Plate 4: North elevation

4.5 *North Elevation* (Plate 4)

This is dominated by the two lateral extensions of the east range and the dining room (G7). The east range has a hipped roof and a 6-light window to each floor. The dining room extension also has a hipped roof and a 2-light window on either side of an external chimney stack. A double door with adjoining windows is situated between the two extensions and another 4-light window is located at the western end of the ground floor. An arched window is located above the dining room (G7) with a 4-light window to either side.

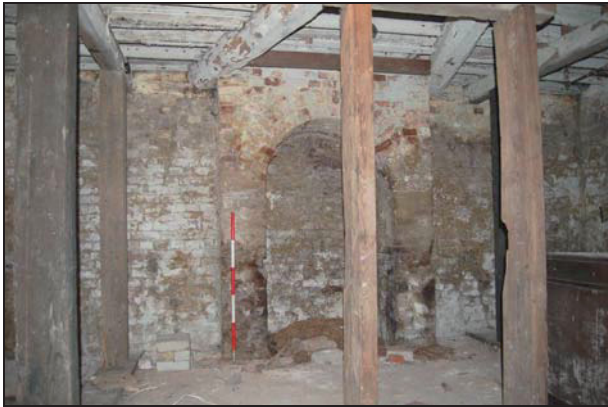
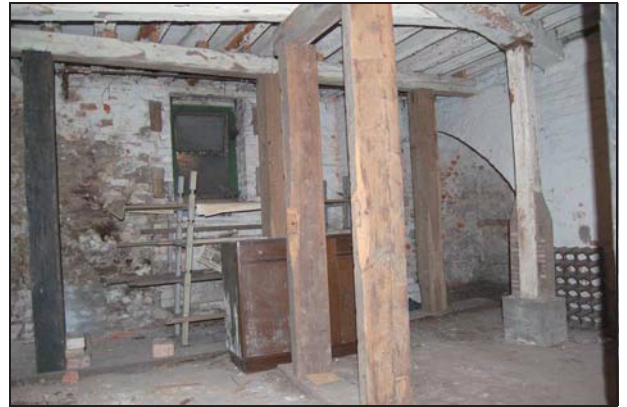
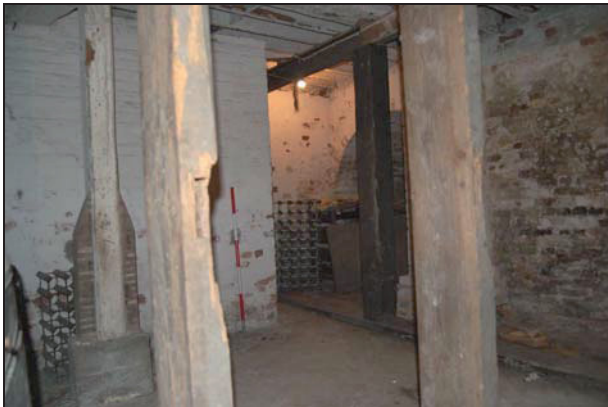
Description: The cellar is brick built with a concrete floor. The north and east walls are painted. The staircase, which runs along the east wall, has 12 brick treads with timber end pieces. There is a half-arched recess below the staircase and a complete arch to the south of the stairs opening into a recessed storage area.

A series of posts support four beams, which in turn support the floor joists, many of which are re-used timbers. The central two are Y-shaped and terminate on either side of the fireplace support against the west wall. The room is lit by a 2-light, tilting window in the north wall.

Plate 5: Cellar: east wall

Plate 6: Cellar: SE corner

Plate 7: Cellar: SW corner

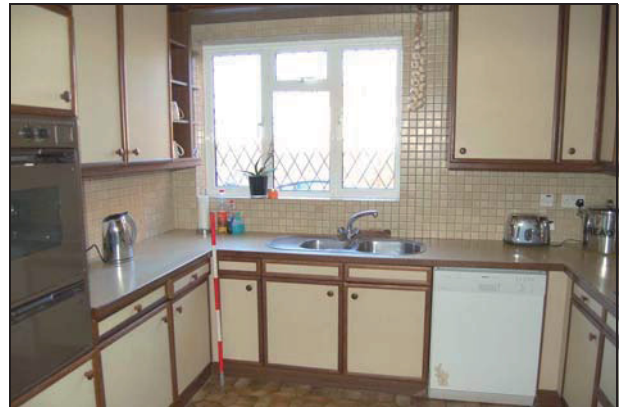
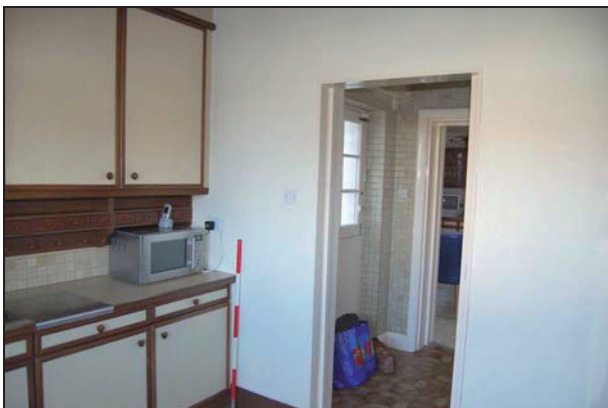
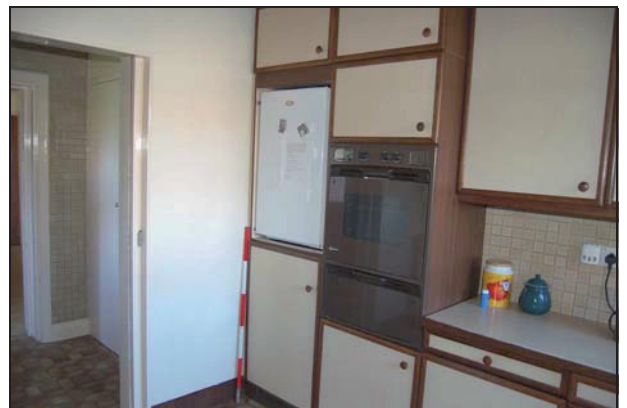
Description: This is a completely modernised kitchen with a 4-light UPVC window in the north wall, a sliding door in the south wall and a lino floor. All the walls, apart from the south wall, are tiled with fitted kitchen cupboards. The ceiling has tongue and groove panelling.

Plate 8: G1: north wall

Plate 9: G1: SE corner

Plate 10: G1: SW corner

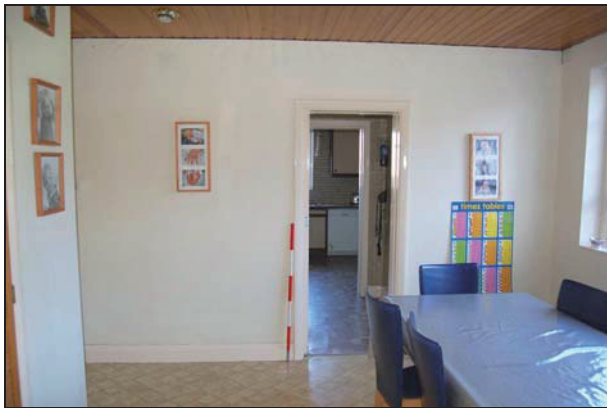
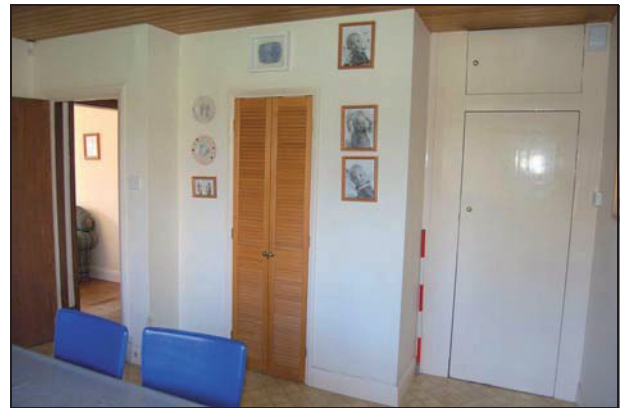
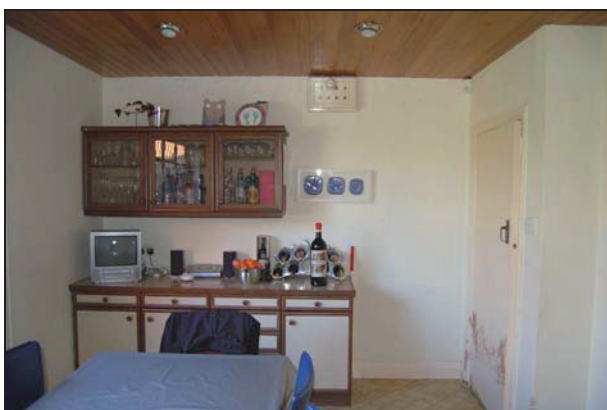
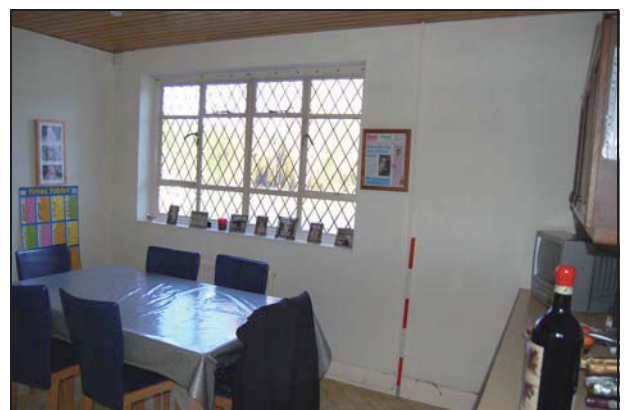
Description: This is a breakfast room with a boiler cupboard in the chimney breast in the west wall and cupboards to the north of it. There is a 12-light window in the east wall with casements on either side and two centrally-located casements in the upper lights. There is a sliding door in the north wall leading to Room G2 and a solid modern door in the west wall opening into the living room (G6). The walls are painted, have plain skirting boards. The ceiling has tongue and groove panelling and the floor is lino/

Plate 13: G3: north wall

Plate 14: G3: west wall

Plate 15: G3: south wall

Plate 16: G3: east wall

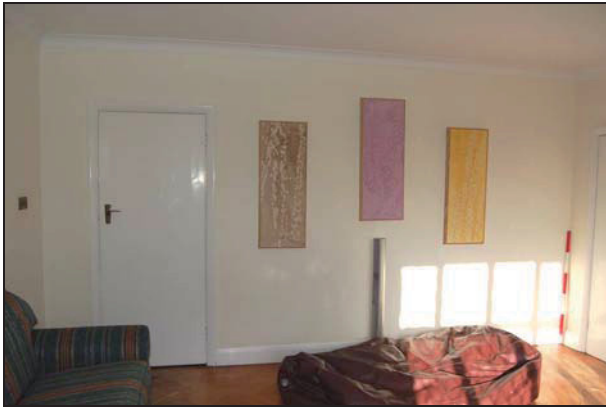
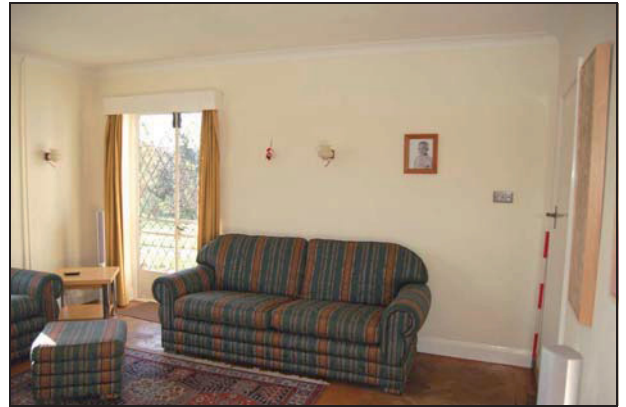
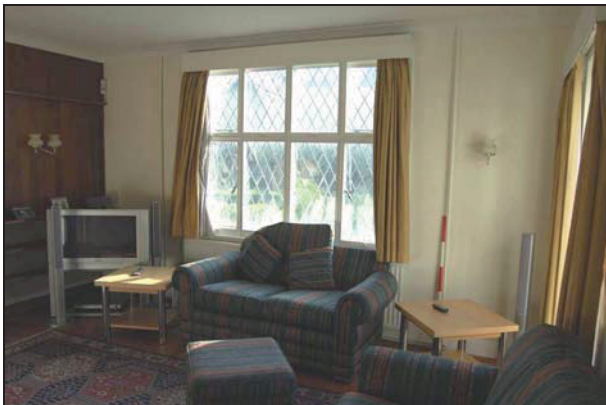
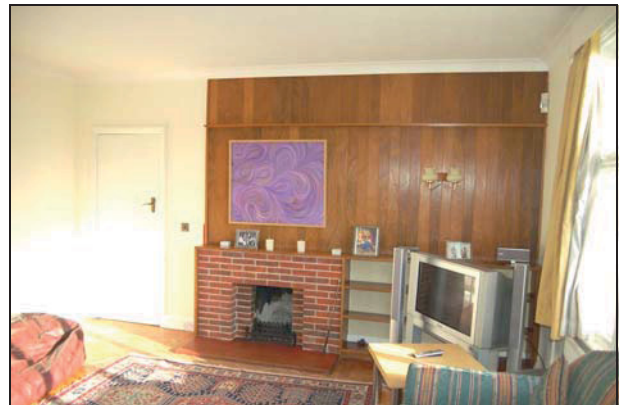
Description: This is the family room, which has a fully glazed, double Crittall-type door in the west wall opening into the garden, a plain door in the east wall opening into a small extension (Room G5) and a door in the north wall to a small through passage between rooms G3 and G6. The walls, which have coving and skirting boards

are painted, apart from the east wall, where there is tongue and groove panelling around the modern fireplace. There are built-in shelves to the south of the fireplace, which is of red brick with a quarry-tiled hearth. The window in the south wall has 8 diamond leaded lights, the central ones of which are fixed, and secondary glazing. There is a parquet floor.

Plate 17: G4: north wall

Plate 18: G4: west wall

Plate 19: G4: south wall

Plate 20: G4: east wall

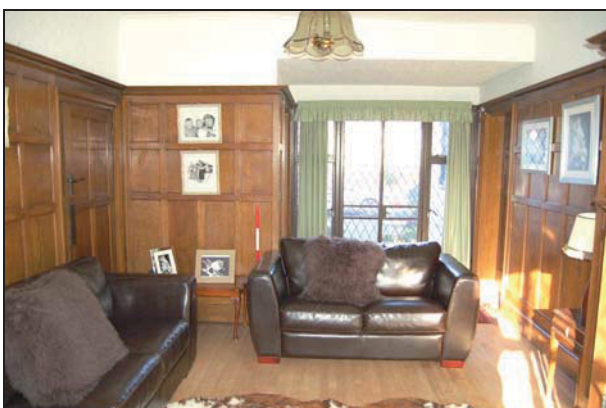
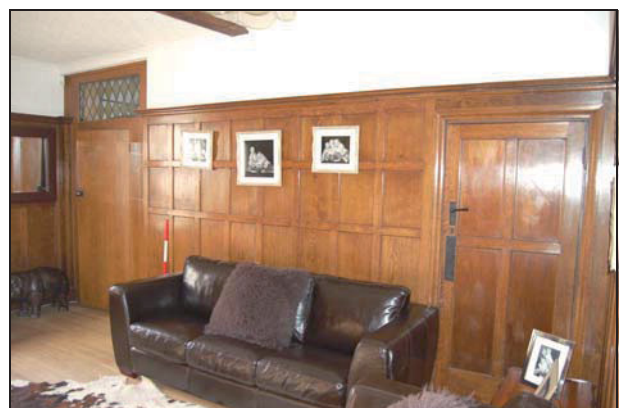
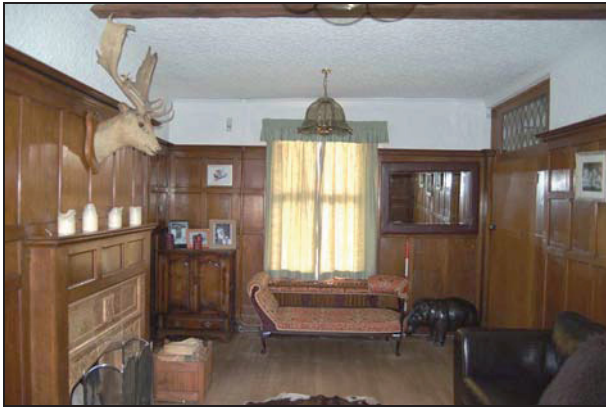
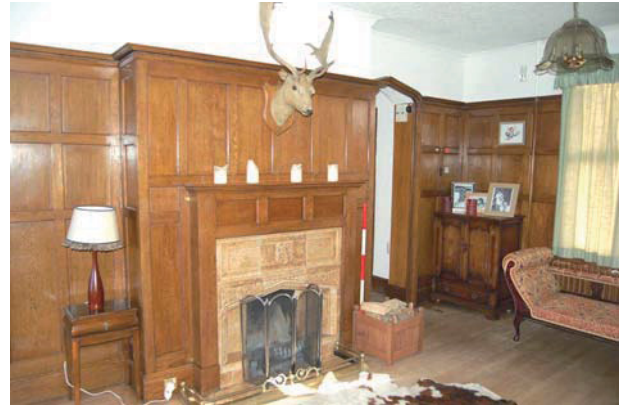
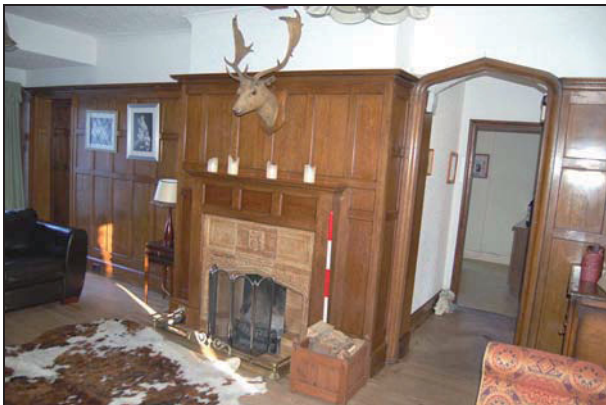
Description: This is a panelled living room with a reproduction tiled fireplace in the east wall that is decorated with a heraldic shield and Tudor roses above a 4-centred arch. A single, chamfered axial beam with no chamfer stops extends east-west over the fireplace. The room is lit by a 4-light window in the south wall and a fully glazed, double door in the north wall with 2-light casement windows on either side. There is a 6-panelled door leading to the dining room (G7) and a 4-panelled door to the rear subdivision of the hall that provides access to the cellar (C1) in the west wall. A plain door, also in the west wall, opens into the hall (G8). A 6-panelled door to the north of the fireplace in the east wall opens into a small lobby (G11). The door to the south of the fireplace has been removed. The ceiling is painted and papered, and is lower at the northern end of the room, which suggests that this was added when the dining room (G7) was built. The floor is modern wood.

Plate 21: G6: north wall

Plate 22: G6: west wall

Plate 23: G6: south wall

Plate 24: G6: SE corner

Plate 25: G6: east wall

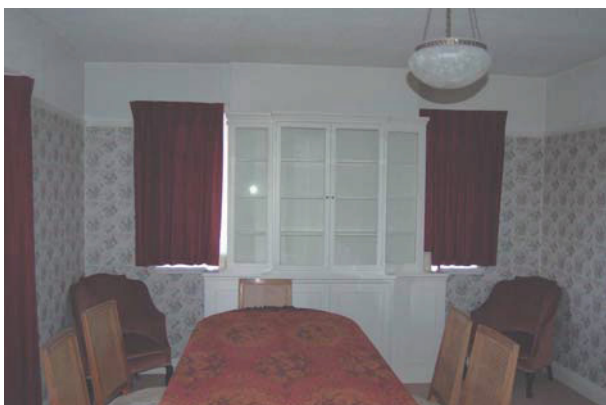
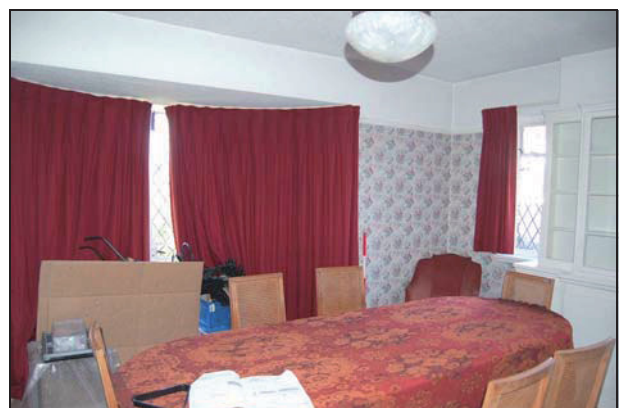
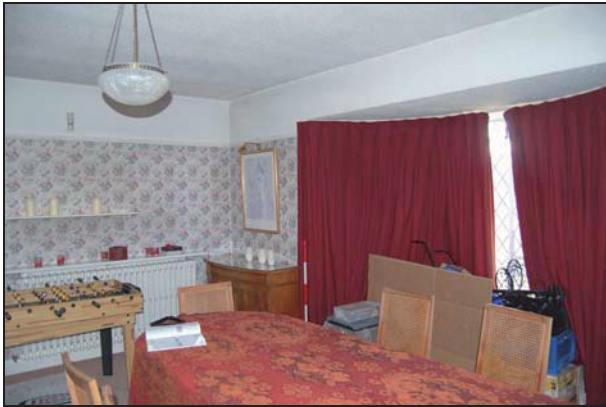
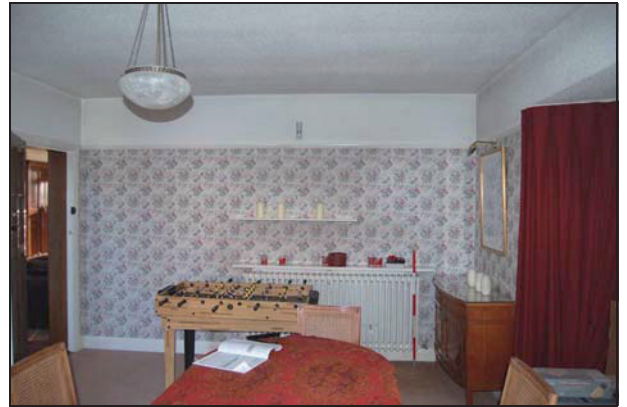
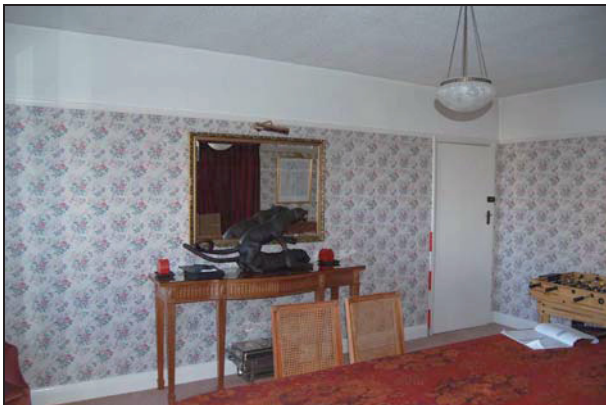
Description: This is the dining room, which is accessed by a plain door in the east wall that opens into the living room (G6). There is a bay in the west wall with fully glazed, double doors with side windows. There are two 2-light windows with opening upper casements in the north wall on either side of a built in cupboard, formerly the location of a fireplace. The walls are papered and have skirting boards and a picture rail. The ceiling is papered and painted and the floor carpeted.

Plate 27: G7: north wall

Plate 28: G7: SE corner

Plate 29: G7: NE corner

Plate 30: G7: south wall

Plate 31: G7: west wall

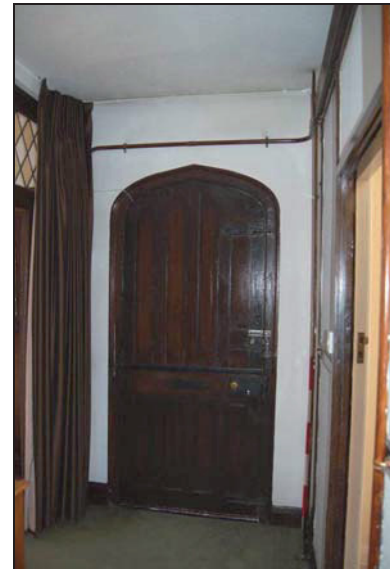
Plate 32: G8: front door

Description: This is the hall, which has a neo-gothic door under a 4-centred arch in the south wall. Studs have been added to the west wall to add to the medieval effect. Otherwise the walls (and ceiling) are papered and painted. There is a plain door in the north wall leading to a subdivision that extends behind the stairs and provides access to the cellar and Room G6. Another door in the east wall opens directly into Room G6 and has coloured, leaded glass above the door frame. A plain door in the west wall

opens into the study (G9). The topmost section of the west wall is recessed and houses lights. The staircase, which runs along the east wall, has 13 treads to a half landing and then another 4 to the first floor. It has a square newel post with moulded caps and rails and a solid infill.

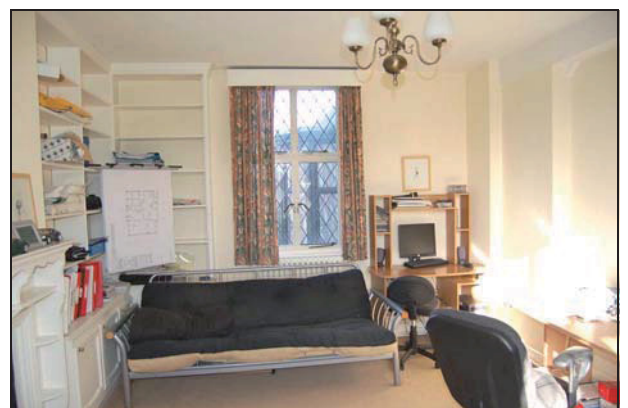
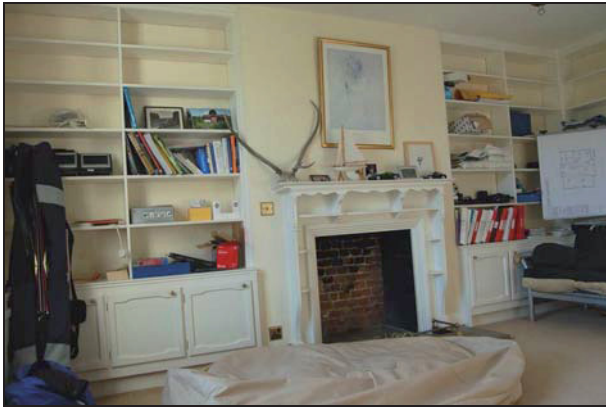
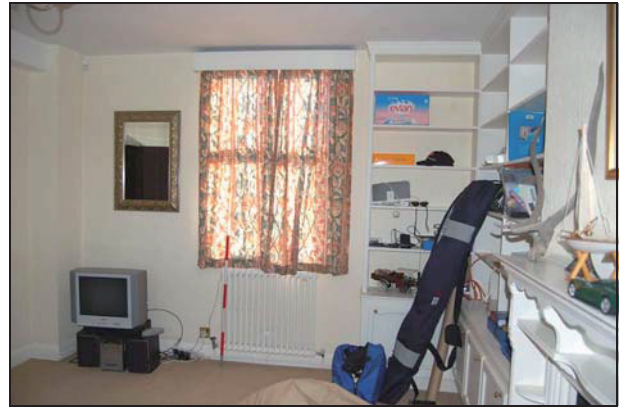
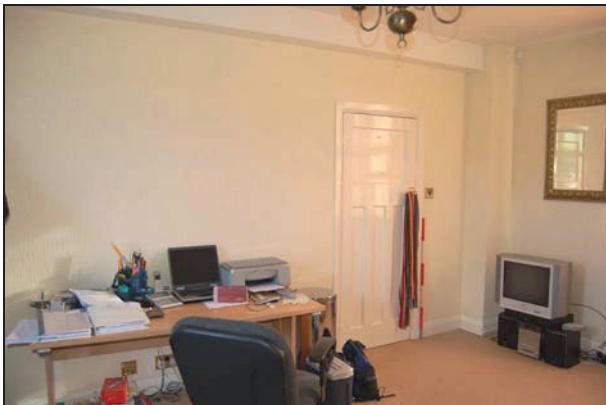
Description: This study has a 4-light window in both the north and the south walls and a plain door in the east wall leading to the hall (G8). The walls have skirting boards and are papered, and the ceiling is painted. There is a brick fireplace with a stone hearth and timber surround in the west wall and cupboards along the west, north and south walls. The east wall is stepped at the northern end and has the inverse of the recess at the top. The floor is carpeted.

Plate 34: G9: north wall

Plate 35: G9: west wall

Plate 36: G9: south wall

Plate 37: G9: SE corner

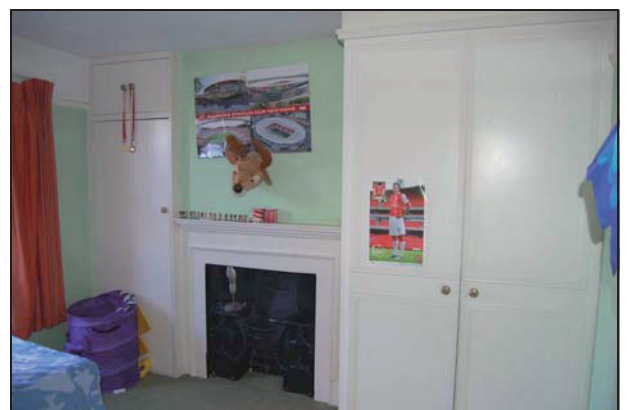
Plate 40: F2: east wall

Description: This bedroom is accessed by a door in the west wall and lit by a 4-light, casement window with no fixed lights in the north wall. The walls are papered and painted, and have plain skirting boards and picture rail. The ceiling is papered and painted, and the floor, which slopes to the east, is carpeted. There is a cast iron fireplace with a hob grate and a timber surround against the east wall. There is a built-

in cupboard to the north of it and modern built-in cupboards to the south of the fireplace and against the west wall.

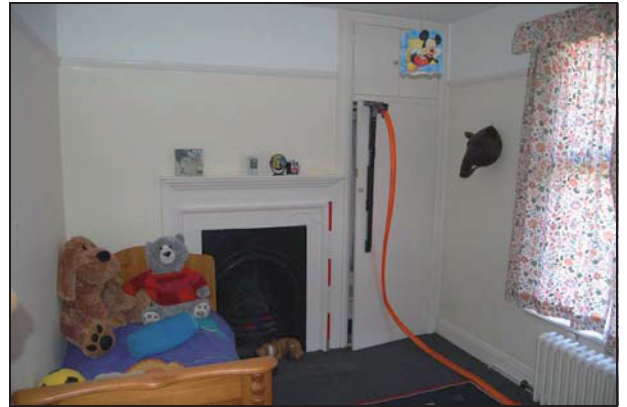
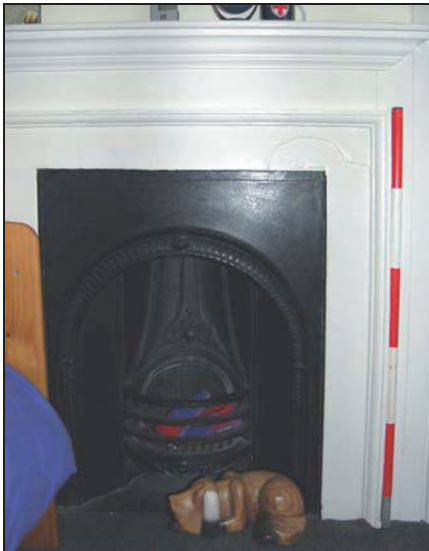
Description: This bedroom is accessed by a door in the east wall and lit by a 4-light, casement with no fixed lights in the north wall. There is a cast iron fireplace in the west wall with a timber surround and a built in cupboard to the north of it. The walls are papered and painted, and have plain skirting boards and picture rail. The ceiling is papered and painted, and the floor is carpeted.

Plate 42: F3: west wall

Plate 43: F3: fireplace detail

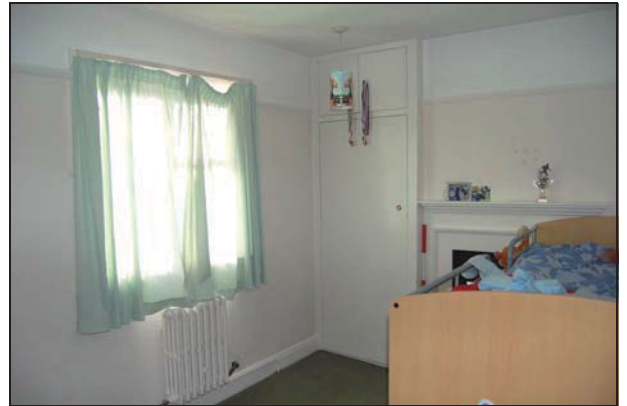
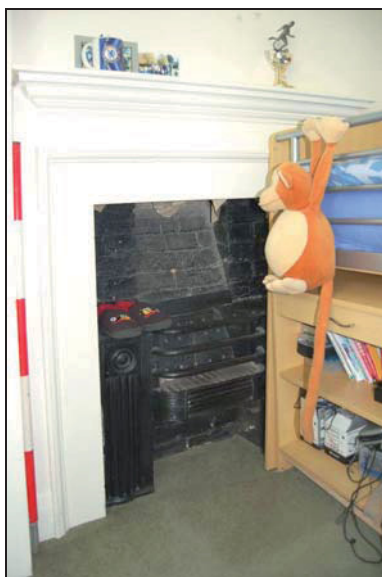
Description: This bedroom is accessed by a door in the east wall and lit by a 3-light window in the south wall with two opening casements. There is a cast iron fireplace with a brick back, hob grate and a timber surround against the west wall and a built-in cupboard to the south of it. The walls are papered and painted, and have plain skirting boards and picture rail. The ceiling is papered and painted, and the floor is carpeted.

Plate 44: F4: SW corner

Plate 45: F4: fireplace detail

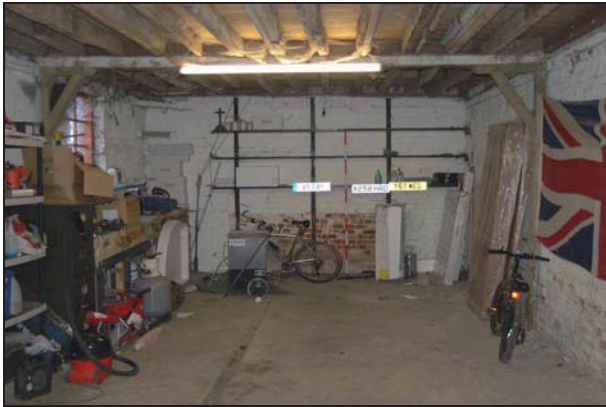
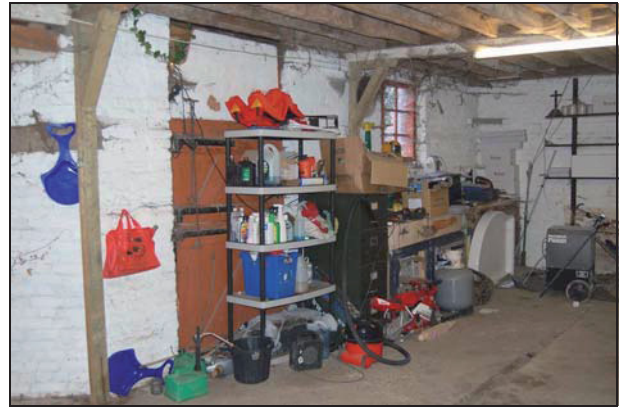
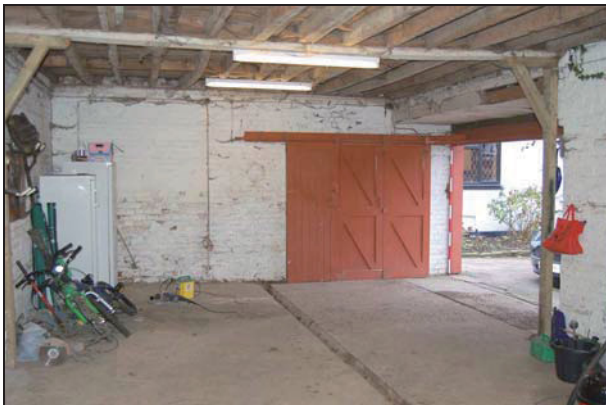
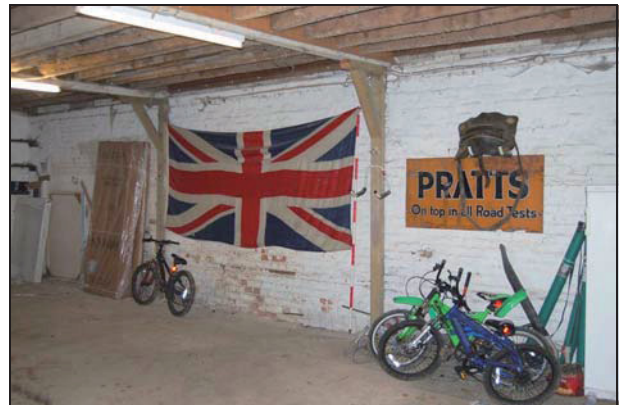
The interior of the outhouse contains two bonding timbers in the north wall and one bonding timber in the east wall, which would suggest that this is an early 19th century structure. There are a number of re-used joists that were formerly covered with lath and plaster. Two ties are visible in the northwest corner, the lower one of which has a plaque dedicated to St. Barnabas. A trap to the first floor, which was inaccessible on the day of the survey, is also in the northwest corner. The floor, which is concrete, has a central runnel.

Plate 58: Outhouse: north wall

Plate 59: Outhouse: west wall

Plate 60: Outhouse: south wall

Plate 61: Outhouse: east wall
