HISTORIC BUILDING ASSESSMENT: CLARENDON ARMS CHANDLERS CROSS HERTFORDSHIRE

on behalf of Wakelin Associates (agents)

MARCH 2007

ASC: 895/CCC/1

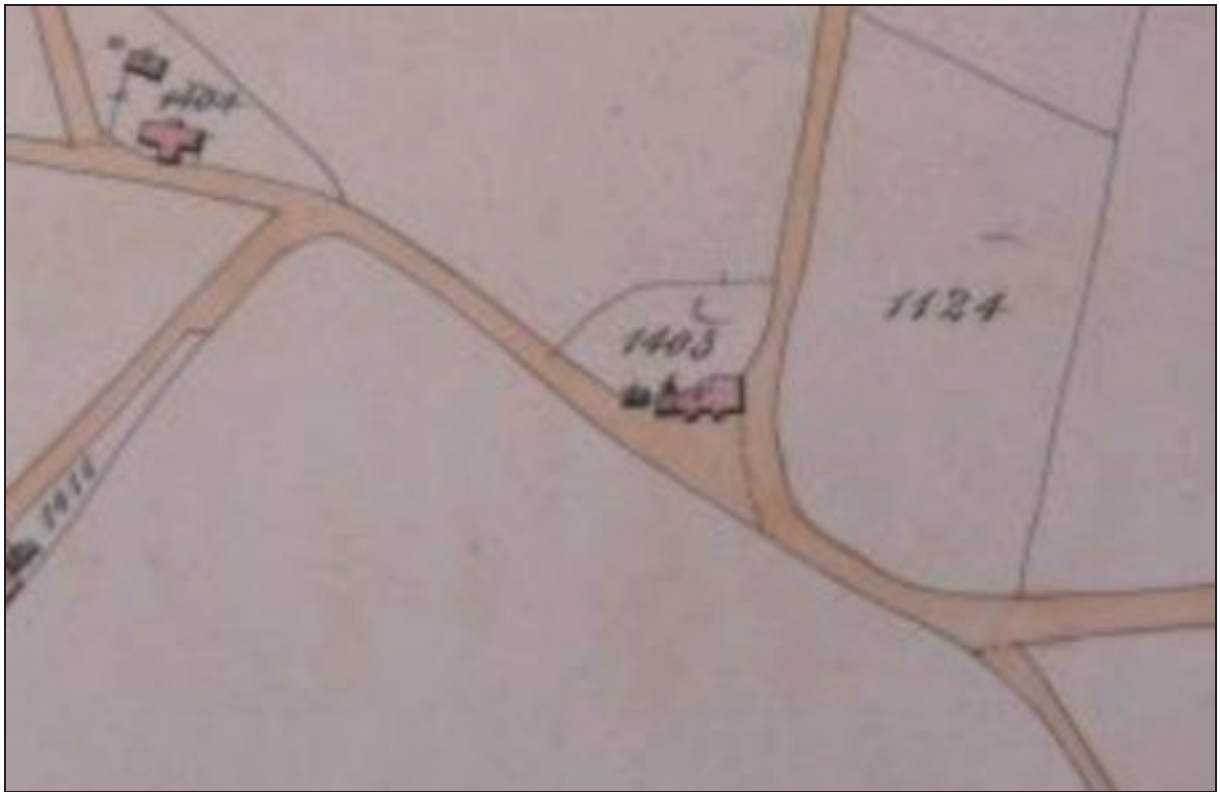
Figure 3: Extract from the Watford Tithe Map, 1842 (not to scale)

The earliest available map showing the *Clarendon Arms* is the Watford Tithe Map of 1842 (HALS DSA4/111/2: Fig. 3). This shows the building in its original form, comprising the eastern end of the present building, and the single-storey extension to the north. At its south-west end is a much smaller rectangular structure. This is too close to the pub to be the Coach House. Apart from the pub and outbuilding, there are no other structures in the immediate vicinity.

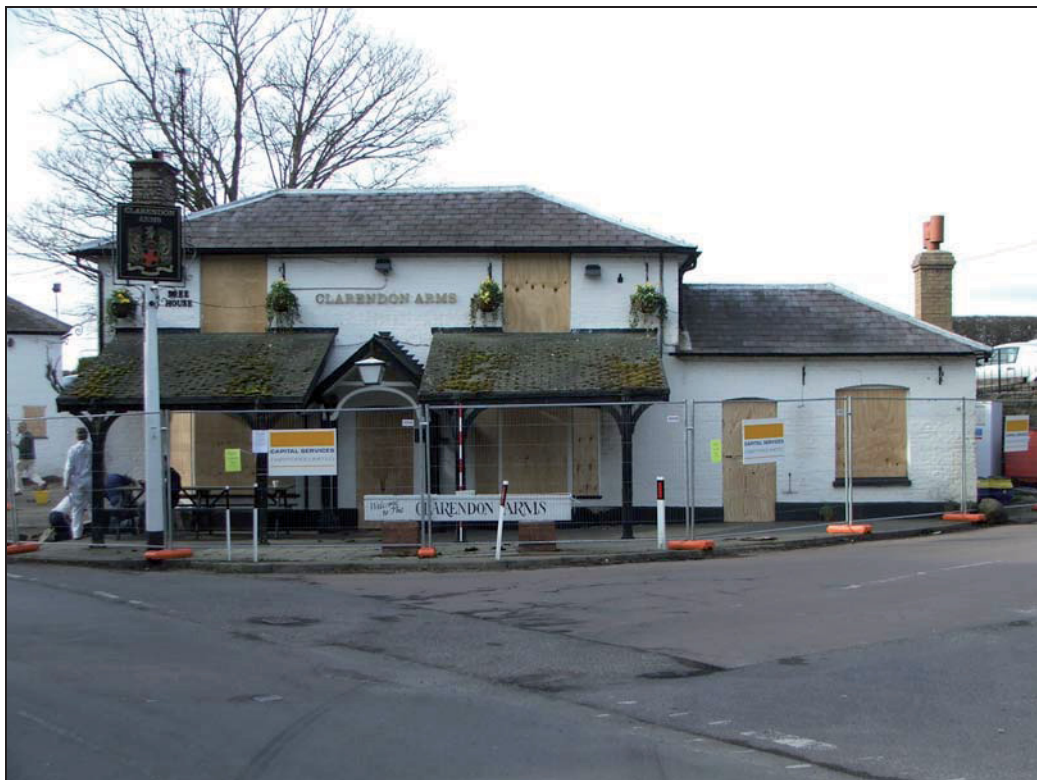
The frontage of the two-storey section is symmetrical, comprising a central entrance door under a timber-framed, slated porch, flanked by three-sided single-storey bay windows, fitted with wooden sash frames. Extending forwards above the bays are two large slate-clad timber-framed canopies, forming a covered seating area in front of the building. At first-floor level above each bay is an 8-over-8 sash window. Brickwork is all Flemish Bond.

The frontage of the single-storey north elevation contains an entrance door and a fixed 20-light window.

Plate 1: *Clarendon Arms*, east elevation

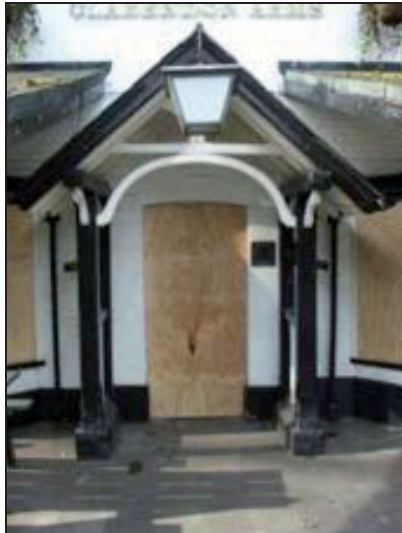
Plate 2: East elevation: porch over main entrance

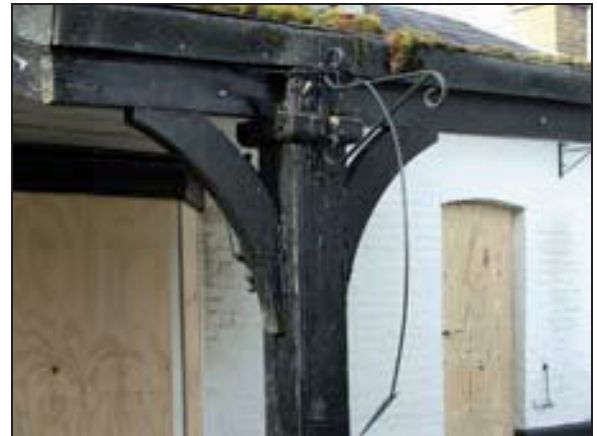
Plate 3: East elevation: detail of canopy support

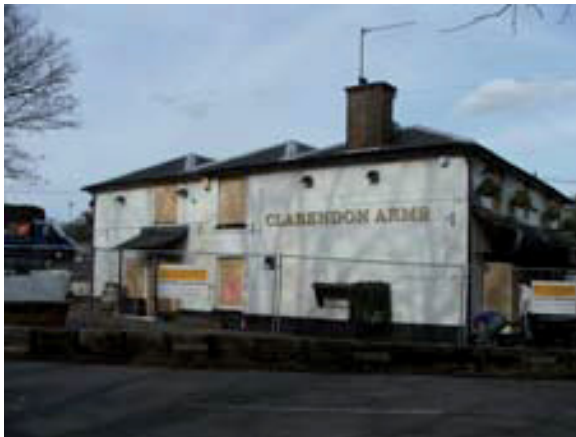
The lower part of the south elevation has been rendered, to varying heights. The west bay has an entrance door under a felted porch, with an 8-over-8 sash window to the west and a smaller 8-over-8 sash window above. The central bay has a fixed 16-light window on the ground floor, and a similar-sized 4-over-12 toplight casement above. There are traces of a blocked window on the ground floor, east of the existing window. The east bay has no evidence for openings, past or present. Brickwork of the east and central bays is in Flemish Bond, changing to Stretcher Bond on the west bay, below the valley between the adjoining roofs.

Plate 4: South elevation

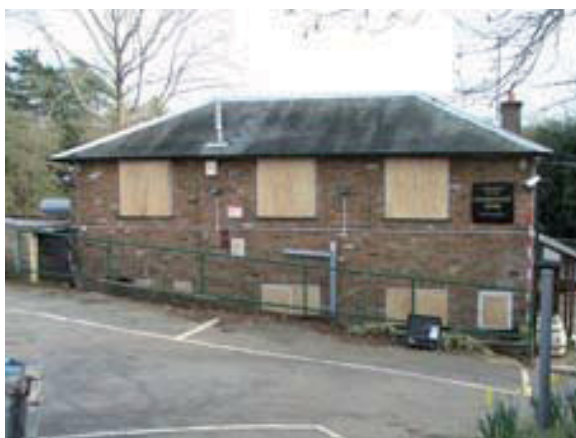
The lower part of this elevation is largely obscured by terracing. At first-floor level there are three 16-light casements. The five windows on the ground floor are all small modern casement or fixed windows, related to the toilets and kitchen. Brickwork on this elevation is unpainted, and consists of reclaimed bricks laid in Stretcher Bond.

Plate 6: West elevation

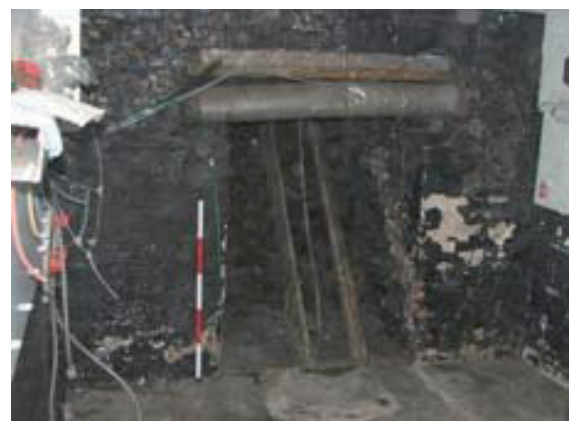
Size: 3.76 × 2.82m, height 2.15m

Location: North side, below G7.

Description: Lower cellar. Concrete floor, brick walls, painted black (lower), and white (upper). Ceiling is lower surface of concrete slabs supporting floor of G7 above. Barrel drop/chute to north, from trapdoor in Chandlers Lane. Steep concrete stairs to G3a and G7 in south-west corner: large square sump in south-east corner.

Plate 7: C1, looking north

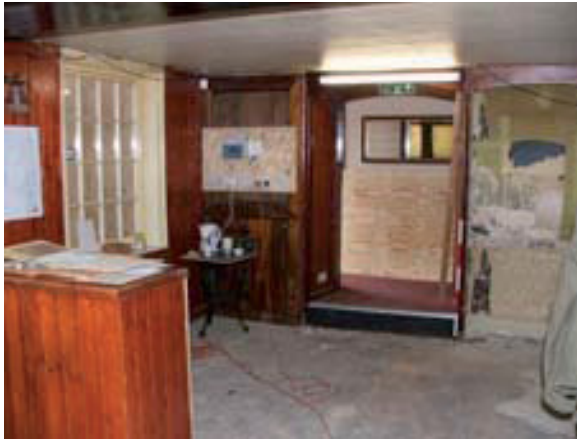
Size: 4.95 × 3.55m, height 2.33m

Location: South side, between G1b and G4

Description: Bar area. Concrete floor (covering removed). Walls matchboarded and varnished/stained to full height, with torus skirtings. Entrance from lobby G4 to west. Door to kitchen G3a to north. Original north wall removed, replaced by RSJ. East wall pierced by opening to G1b, and reduced to form counter, with RSJ support above. Window to south. Bar terminates in north-east corner.

Plate 8: G1a, looking south-west

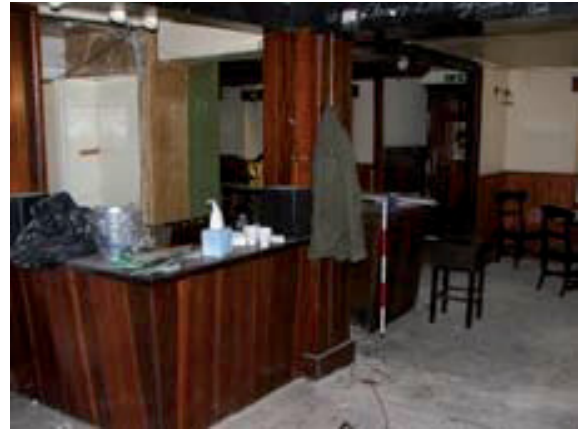
Size: 4.92 × 3.78m (exc. bay), height 2.36m

Location: South-east corner, between G1a and G1c.

Description: Bar area. Parquet floor. Lower part of walls matchboarded, with torus skirtings, upper part painted. Entrance from G1a to west, linked to G1c to north. Original north wall removed, replaced by RSJ. Modern stone-clad feature chimney breast to south, with small iron fire-basket. Bay window to east. Bar in north-west corner: hinged section provides access to serving area behind bar.

Plate 9: G1b, looking north-east

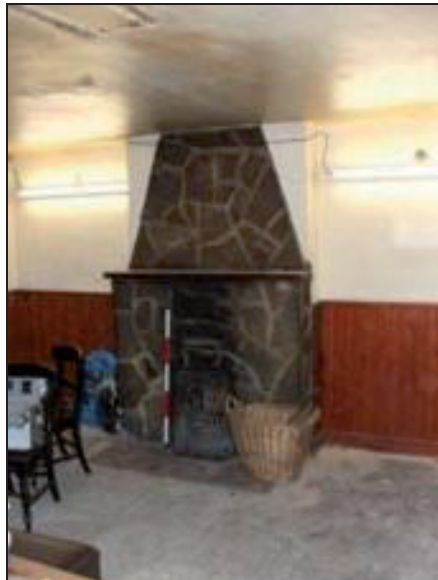
Plate 10: G1b, fireplace and chimney breast

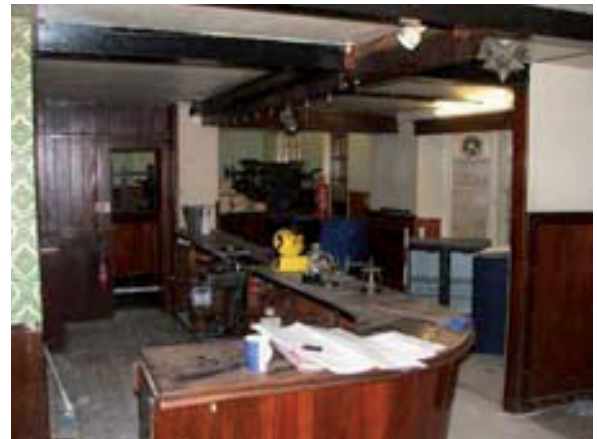
Size: 4.40 × 3.80m (exc. bay), height 2.36m

Location: East side, between G1b, G2 and G3a

Description: Bar area. Concrete floor (covering removed). Lower part of walls matchboarded, with torus skirtings, upper part painted. Linked to G1b to

south, G2 to north. South wall largely removed and replaced by RSJ. Blocked doors to G3a and stairwell to west. Bay window to east. Bar runs north-south across room.

Plate 11: G1c, looking north-east

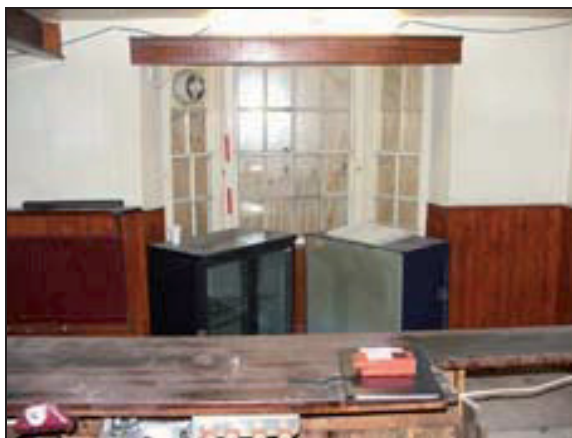
Plate 12: G1b, bay window, looking east

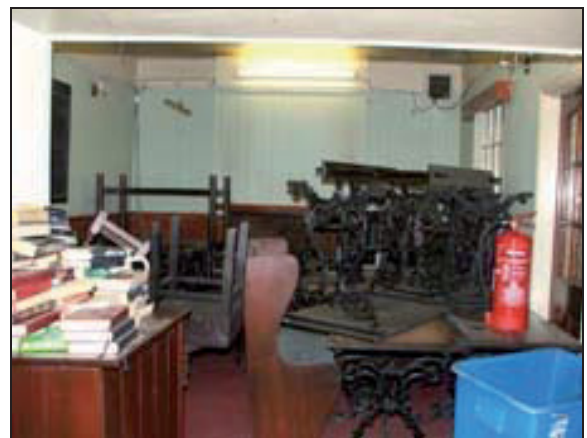
Size: 4.27 × 3.60m, height 2.77m

Location: North-east corner, between G1c and G7

Description: Bar area ('snug' or saloon). Solid floor, carpeted, 0.25m above G1. Walls matchboarded to full height. Varnished/stained lower, painted upper. Linked to G1c to south by separate accesses from either side of bar. Window and external door to east, feature fireplace with brick surround and wood mantel to north. Difficult to examine in detail, as room filled with bar furniture.

Plate 13: G2, looking north

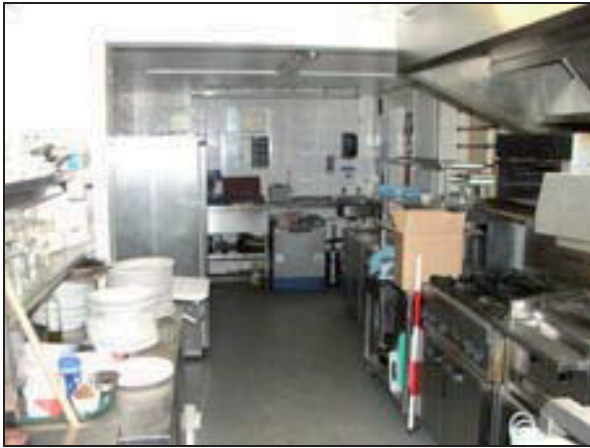
Description: Kitchen (cooking/serving area). Composition floor, walls tiled white throughout. Hardboard ceiling. Original west wall replaced by RSJ, linking G3a and G3b. Doors to north (C1, G7) and south (stairwell and G1a), blocked door to east (G1c). No windows. Cookers to north, preparation/serving area to south.

Description: Kitchen (preparation/scullery area). Composition floor, walls tiled white throughout. Plasterboard ceiling. Original east wall replaced by RSJ, linking G3a and G3b. Door to north (covered yard), pantry to south. Barred casement window to north, two small 1-over-1 casements to west. Sinks to north and west, preparation area to south.

Plate 14: G3a & G3b, looking west

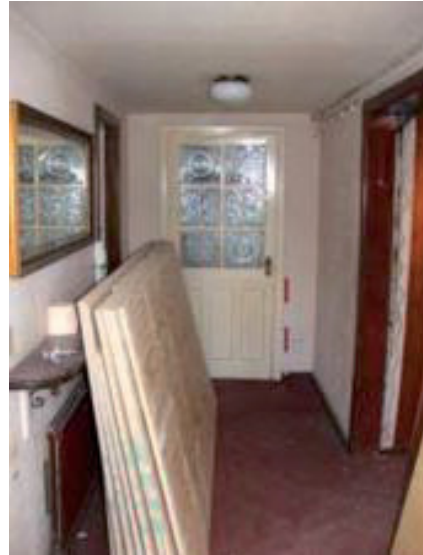
Size: 4.23 × 1.49m, height 2.14m

Location: South, between G1a and G5/G6

Description: Entrance lobby. Solid floor, carpeted. Walls papered, plain modern skirtings. Entrance to G1a to east, external door with flanking glazed panels to south, doors to G5 and G6 to west, door to former corridor (latterly a cupboard) to north.

Plate 15: G4, looking north

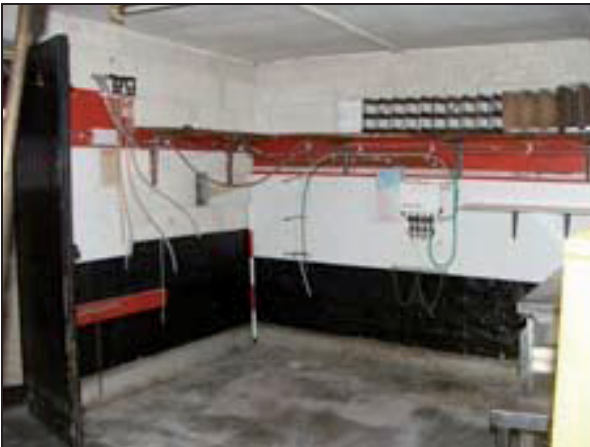
Size: 3.80 × 3.12m, height 2.14m

Location: North, between G2 and G3a. Above lower cellar

Description: Upper cellar. Concrete floor, about 1m higher than general ground floor level, approached by steep concrete stair from G3a to south. Brick walls, painted black (lower), and white (upper), partly lined with board. Double doors and ramp to covered yard to west.

Plate 16: G7, looking north-west

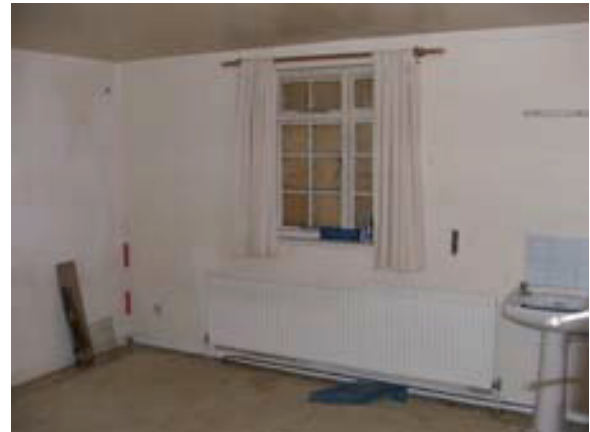
Size: 4.28 × 3.78m, height 2.33m

Location: South-west corner, between F2 and F4

Description: Bedroom. Chipboard floor, walls papered and painted, modern chamfered skirtings and architrave, with modern flush panelled door. Plasterboard ceiling. Door to north (F5), windows to west (16-light casement) and south (8-over-8 sash). Hand basin in north-west corner.

Plate 17: F1, looking south-west

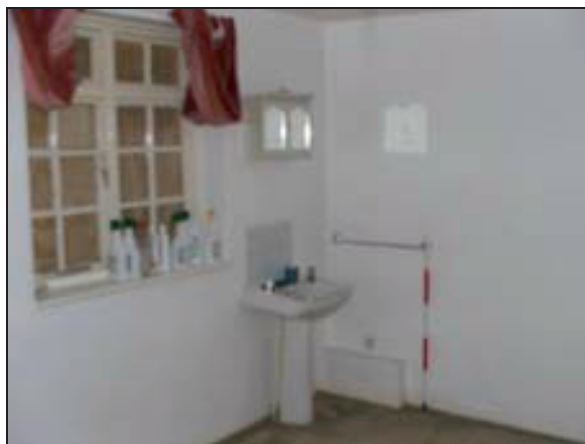
Size: 4.25 × 2.90m, height 2.33m

Location: North-west corner, between F2 and F6

Description: Bedroom. Chipboard floor, walls papered and painted, modern chamfered skirtings and architrave, with modern flush panelled door. Plasterboard ceiling. Door to south (F5), windows to west (16-light casement) and north (16-light casement). Hand basin in north-east corner.

Plate 18: F3, looking north-east

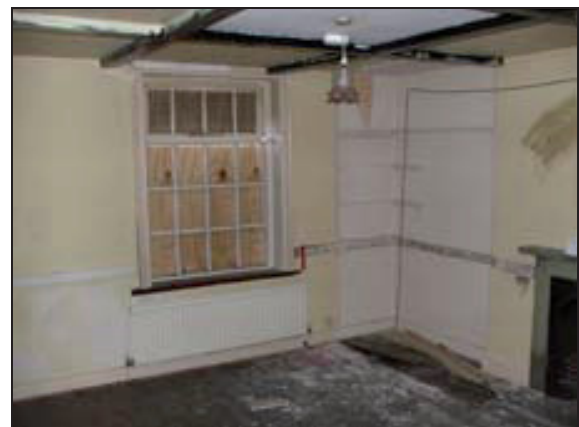
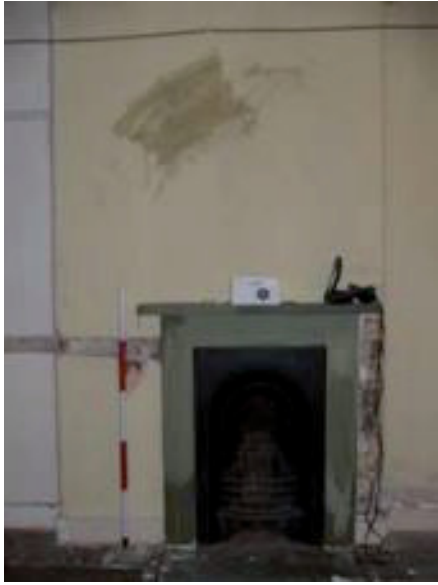
Size: 3.80 × 3.67m, height 2.25m

Location: South side, between F1, F5 and F7

Description: Bedroom. Floor boarded, north-south, c.200mm wide boards. Walls papered and painted, with plain skirtings and a plain dado rail. Doors and architrave as for F1. Two doors to north (F5), window to south (4-over-12 toplight casement). Chimney breast to west, with small arched cast-iron fireback in plain surround. Ceiling is lath & plaster, with added 3-by-3 lattice of planed timber beams, set into walls. Possibly intended to support sagging ceiling, rather than just a decorative feature.

Plate 19: F4, looking south-west

Plate 20: F4, fireplace, looking west

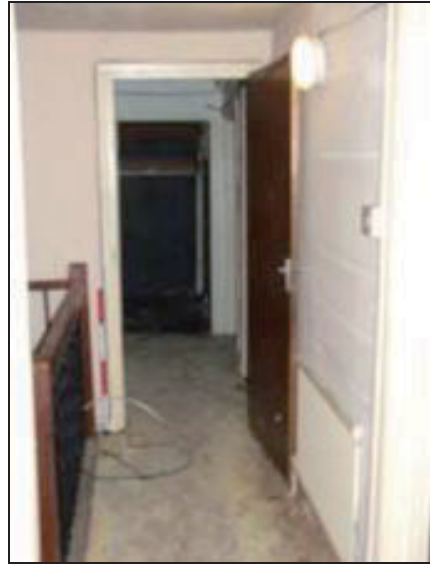
Size: 6.2 × 2.1m (max), height 2.19m

Location: Centre, between all other first floor rooms

Description: Stairwell and landing. Enclosed staircase c.0.8m wide, 11 steps, turns through 90° at top. Modern rails and banisters, with twisted wrought iron spindles. Landing boarded, as F4. Walls papered and painted, ceiling lath & plaster. Small ceiling hatch at west end (access to tanks). Cupboard at east end, with 3-plank door.

Plate 21: F5, looking east

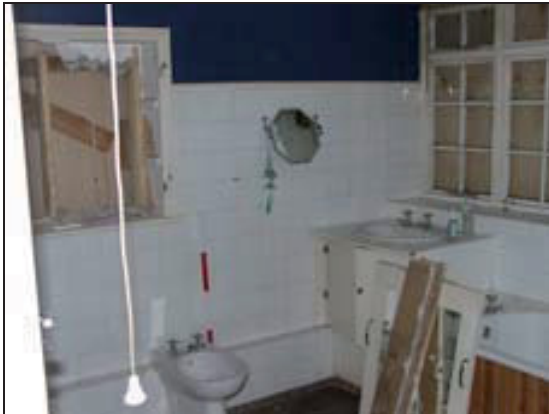
Size: 3.71 × 2.87m, height 2.25m

Location: North, between F3, F5 and F8

Description: Bathroom. Floor boarded, as F4. Walls tiled to differing heights: walls papered and painted above tiling. Door to south (F5); modern flush-panelled door in moulded narrow architrave. 16-light casement to north. Alcove in west wall is blocked window. Ceiling lath & plaster. Modern bathroom fittings.

Plate 22: F6, looking north-west. Note blocked window to left

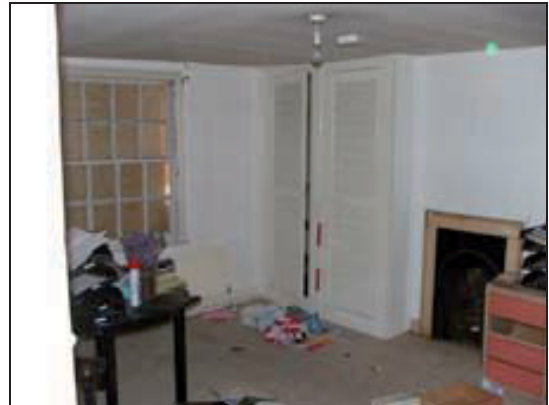
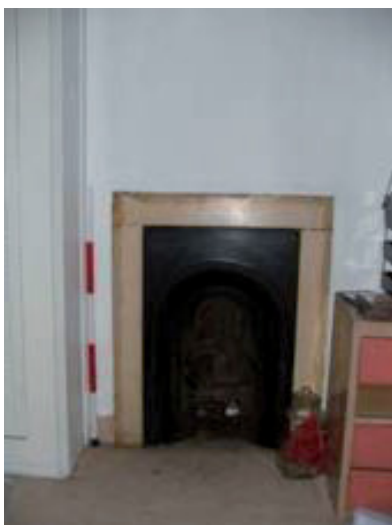
Size: 4.62 × 3.59m, height 2.27m

Location: South-east corner, between F4 and F8

Description: Office. Floor boarded north-south. Plain skirtings: moulded architrave as in F6, with flush panelled modern door to north (F5). Window to east (8-over-8 sash). Chimney breast centrally located in south wall, with small arched cast-iron fireback in plain surround, as in F4 but without mantelpiece. Modern built-in cupboards with louver doors either side of chimney breast. Ceiling lath & plaster.

Plate 23: F7, looking south-east

Plate 24: F7, fireplace, looking south

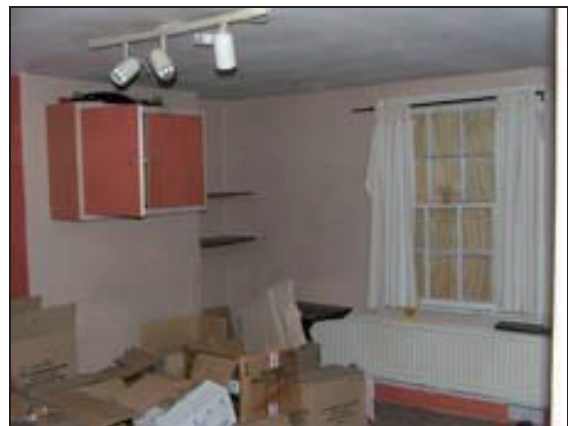
Size: 4.61 × 3.95m, height 2.25m

Location: North-east corner, between F6 and F7

Plate 25: F8, looking north-east

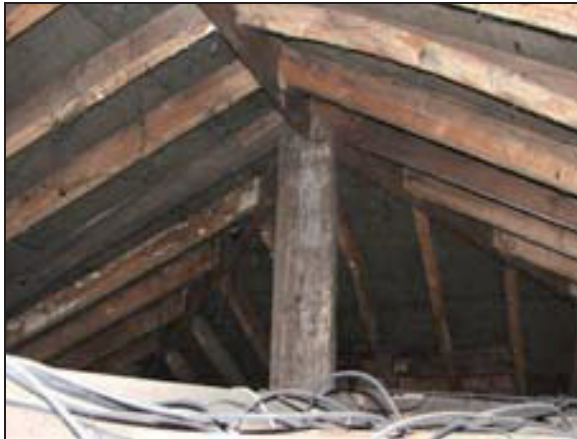
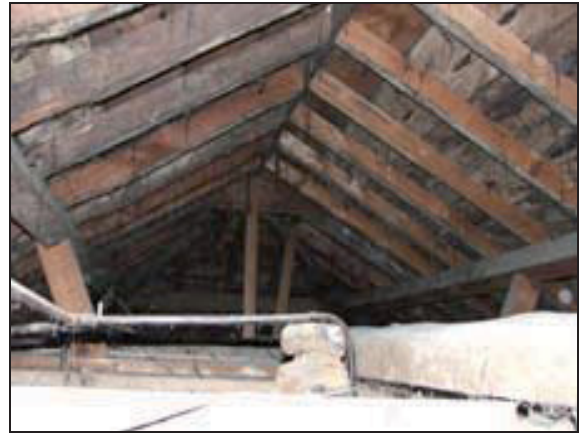
It was possible to examine only the roofs over the main part of the building, through the hatch in F5, and holes made for that purpose by the client's structural engineer. As previously noted, this roof is in three sections, above F1-F3, F4-F6, and F&-F8 respectively. The arrangement of roof timbers is similar in all three, with rafters running from the eaves to ridge boards, the junctions of which are supported by substantial vertical posts rising from the ceiling joists. All are constructed of sawn timber. The timbers in the F1-F3 roof are evidently newer than those elsewhere, and the roof is felted under the slates. The F4-F6 roof appears older, and is fully boarded, probably as

Plate 26: Roof structure above F7, looking south

Plate 27: Roof structure above F6, looking south

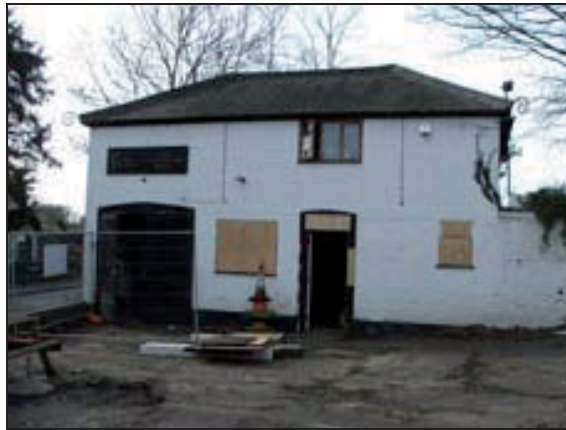
Plate 28: Coach House, east elevation

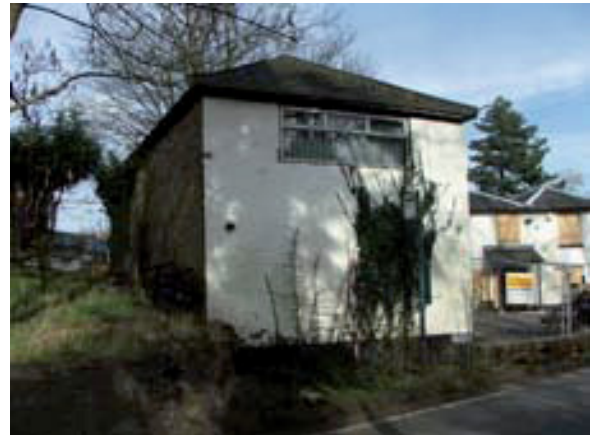
Plate 29: Coach House, west and south elevations

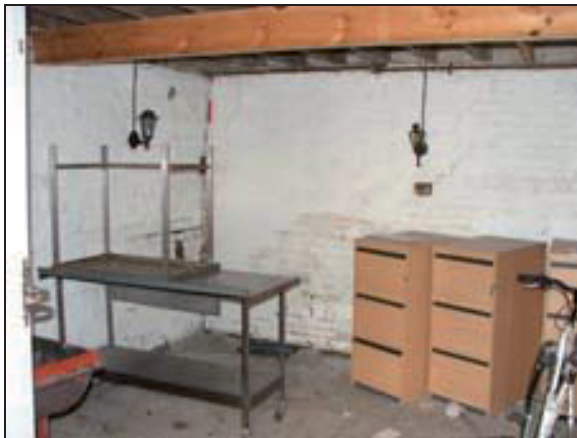
Plate 30: Coach House, ground floor interior

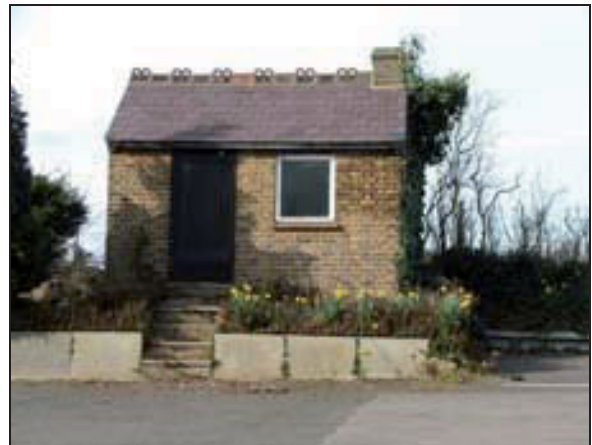
Situated on the north side of the car park, this small single-storey structure (c.4.0 × 2.8m) is constructed of buff brick, laid in Flemish Bond, under a slate roof incorporating some elaborate ceramic ridge tiles. Internally it consists of a single room, with entrance door and window to the south, and a fireplace at the east end. It has most recently been used as a store shed: its name (*bothy* is a Scots name for a shepherd's hut) almost certainly owes more to local folklore than to identifying its function.

Plate 30: The Bothy, south elevation
