STRIP AND RECORD EXCAVATION: 21 ST JAMES'S ROAD, NORTHAMPTON

on behalf of Westleigh Developments

June 2004

ASC: /583NJR/3

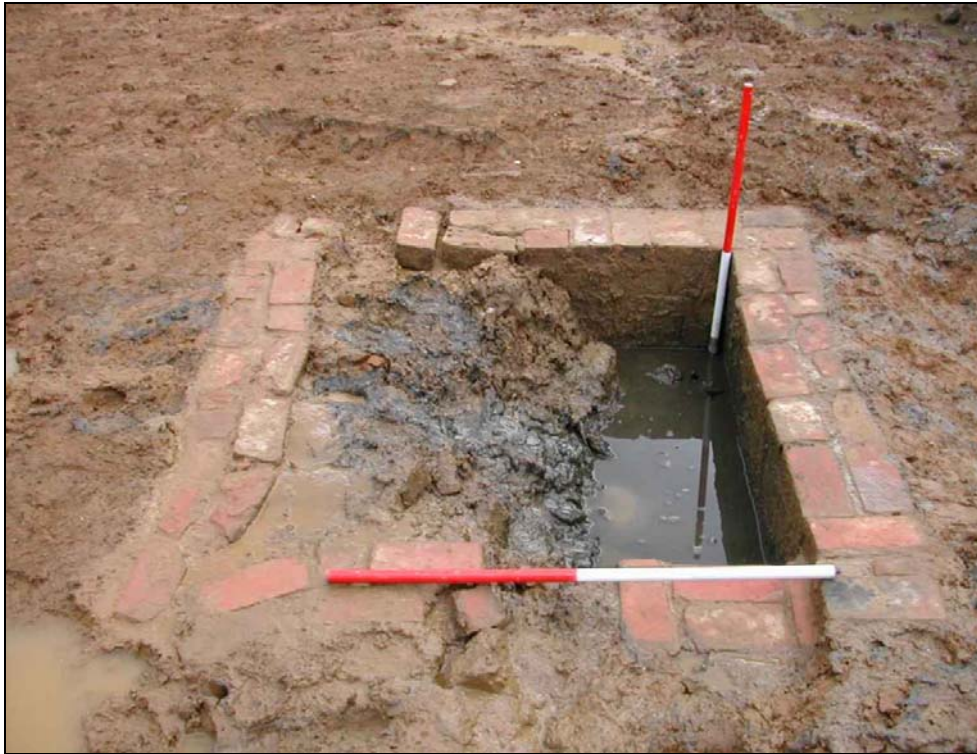
Plate 3 Cess pit/privy base 501 (Scale = 1m)

A square structure (501) was present in the northwest part of the site (Fig. 5; Plate 3). It measured 1.7m by 1.65m and had been cut into the natural alluvium. The west half was excavated to a depth of c.0.45m and it is interpreted as a 19th century cess-pit or the base of an external privy.

Four courses of brickwork in stretcher bond were exposed, bonded with hard beige mortar. The southeast corner had been disturbed, probably during the construction of the 1920s factory. A brick constructed drain ran from the northeast corner of the trench and flowed into the north side of the structure, where a gap of 0.28m in the brickwork was observed.

The cess-pit was filled with wet mid brown silty clay (502). This was a mixed deposit and had been contaminated with diesel oil. It contained a variety of artefacts, including fragments of leather shoes, modern building debris, glass bottles and clay pipe fragments. The fill is a disuse deposit, which probably accumulated after the cess-pit/privy had ceased to function. It is not related to activity associated with the occupation of the 19th century cottages and samples were not taken.

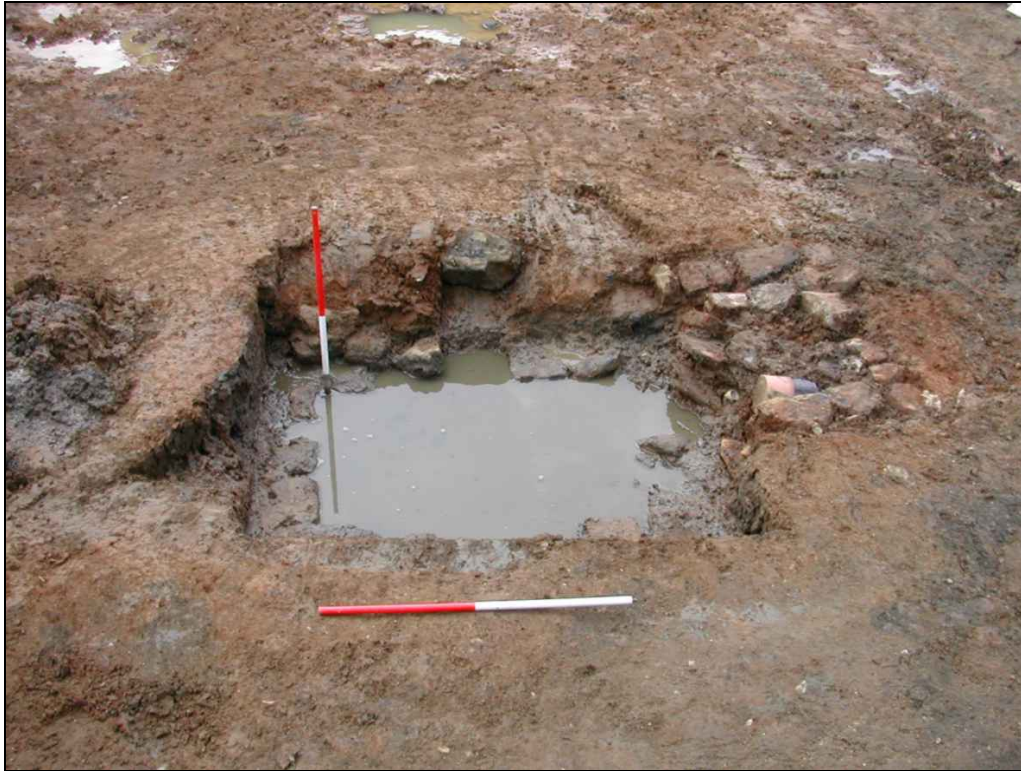
Plate 5: Coal Cellar 505 (*scale = 1m*)

A rectangular structure (505), interpreted as a coal cellar was situated at the junction of Walls 4 and 5 (Plate 5). It was in two parts and was partially bonded into Walls 4 and 5 (Fig. 9).

The southern part of the coal cellar was within the areas enclosed by Walls 4 and 5. It measured 1.9m north to south and 1.65m east to west and had been cut into the underlying alluvium. It was constructed of roughly hewn ironstone blocks *c.*0.3m in diameter. The southern wall was badly disturbed, probably by the construction of the overlying factory (section 3.13) and in this area only the lower courses survived. The north part of the coal cellar was narrower (*c.*1m) and 0.9m long but was of similar construction. Both parts had a clay floor which upon which a deposit of coal slack *c.*0.1m thick had accumulated. This deposit did not offer environmental potential and was not sampled.

The cellar was filled with a mixed deposit of brick and tile fragments and pieces of limestone (506). This is a disuse deposit and is not associated with the occupation of the houses. A variety of late 19th and early 20th century artefacts were present, including three decorated clay pipe bowls (including one with a birds foot moulding, of the style of local manufacturer A Roberts, produced *c.*1885-1920 (Moore type 59) and two broken yellow ceramic domestic bowls *c.*1840-1910 (L. Whittingham *pers comm.*).
