WATCHING BRIEF: DOVECOTE LAKES, LITTLE LINFORD, MILTON KEYNES

on behalf of Mr. D. Rambridge, Dovecote Lakes

May 2007

ASC: 912/LLD/1

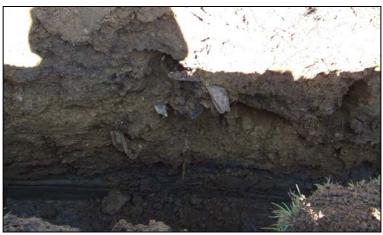
Plate 2: Section of NW-SE trench adjacent to lake, showing made-up layer containing modern debris

- **4.3** The topsoil consisted of a dark brown sandy loam, ranging from c.20mm up to c.300mm in thickness.
- 4.4 Below the topsoil was a mixed mid orange-brown / mid grey-brown / pale yellow-brown sandy and gravely clay deposit containing modern brick fragments, large lumps of concrete, plastic pipes, plastic sheeting and a variety of other debris (Plates 2 & 3). This deposit appeared to be a modern make-up layer, probably dating to the restoration of the quarry, and reached a depth of between 1.5m to 1.8m below ground level.

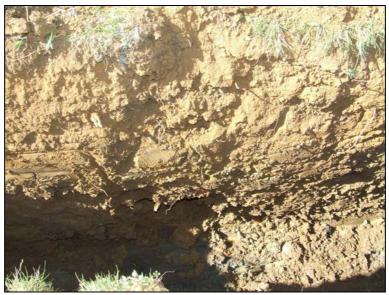
Plate 3: Section of NW-SE trench furthest from lake

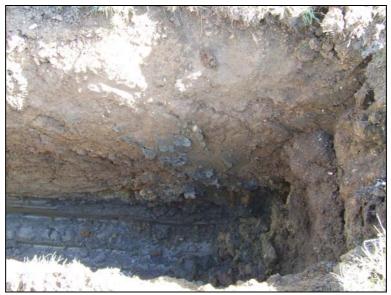
Plate 4: Section of NW-SE trench adjacent to lake, showing natural clay at base

- 4.5 The natural blue-grey clay was visible below this modern deposit and was waterlogged (Plate 4). Some dark staining was visible on the surface of the clay, probably relating to its previous exposure during quarrying. The bases of the trenches cut into the undisturbed natural clay by up to c.0.3m and no archaeological features, deposits or artefacts were observed.
