**ARCHAEOLOGICAL EVALUATION:
HAZELMERE UPHOLSTERY
CHURCH ROAD, TYLERS GREEN
BUCKINGHAMSHIRE**

on behalf of Cubique Construction

May 2007

ASC: 848/TGC/2

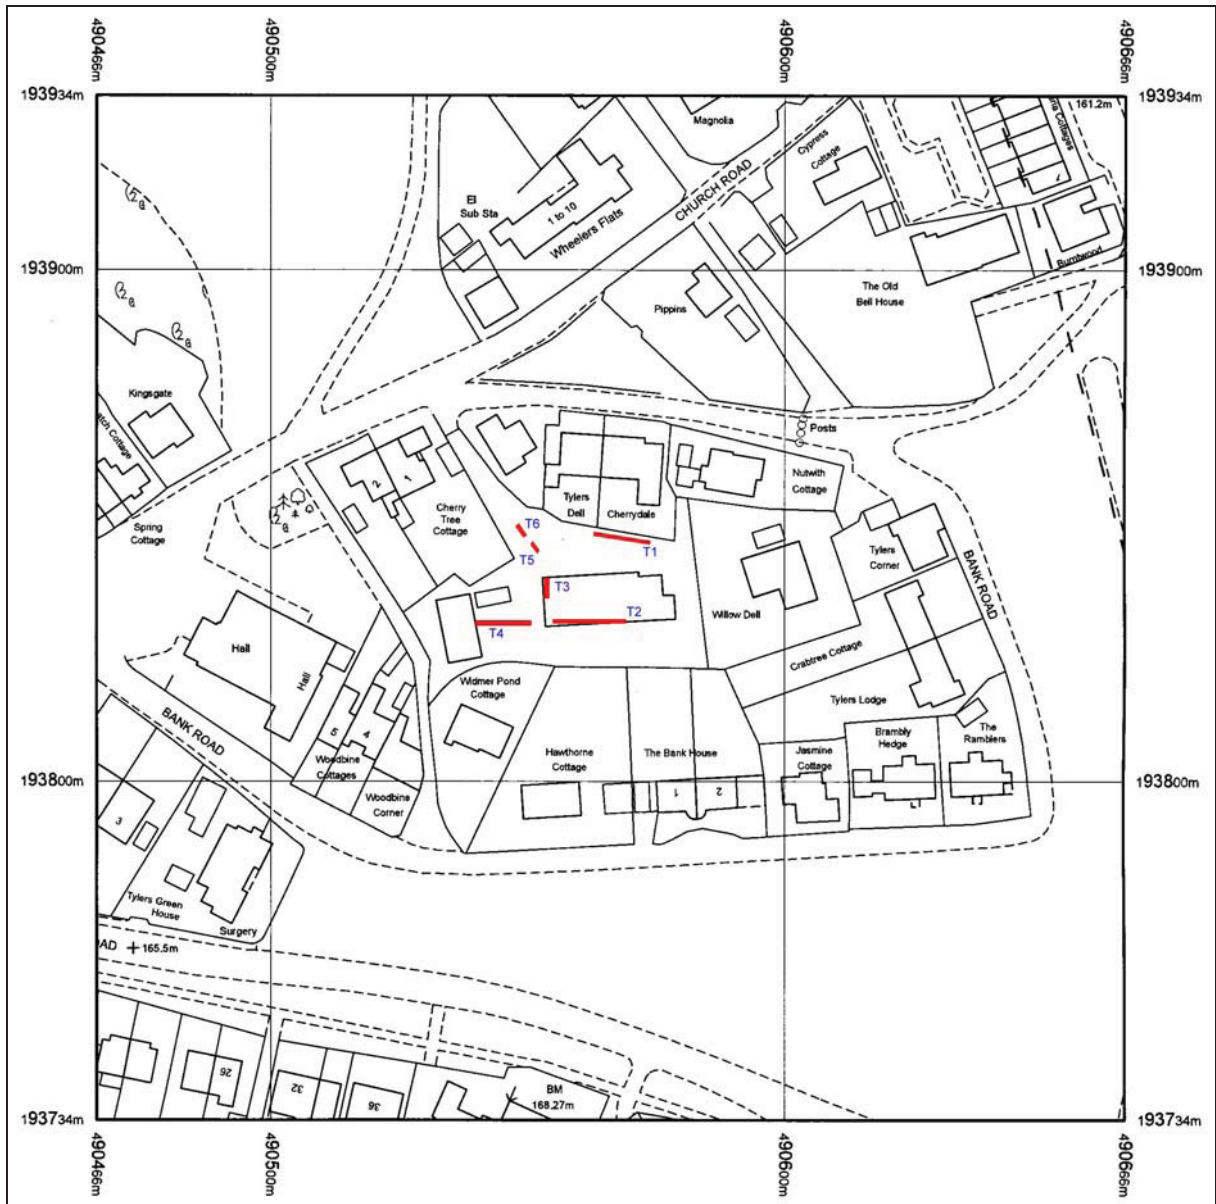
Figure 2: Site & trench location plan (scale 1:1,250)

- 70m of trial trenches to be excavated on the footprint of the proposed houses and access. The trench locations, which aimed to test the site entrance and footprints of the proposed buildings, are shown in Fig. 2.

- 4.1 Six trial trenches were excavated across the site (Fig. 2). The western side of the area was difficult to gain access to, since it was covered in demolition debris. However, it is most probable that the disturbed ground continued across this side of the site. Details of each trench are provided in Appendix 1.

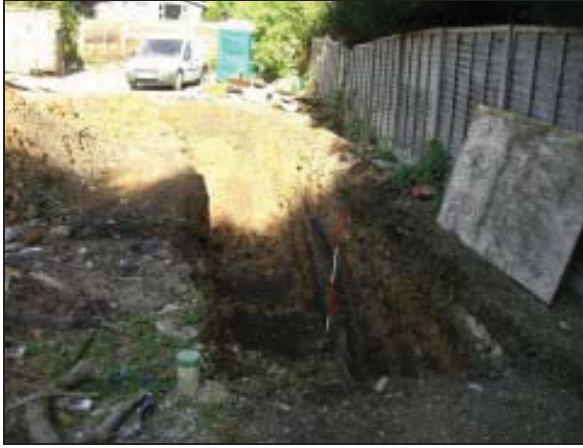
Plate 1: Trench 1 looking WNW at section

- 4.2 **Trench 1**
This was located on the northern side of the site and ran parallel to the Cherrydale property boundary (Fig. 2). It was 11.5m long by 1.85m wide and over 2.3m deep. It was cut through a series of modern tip lines consisting of industrial waste, building rubble, ash and clay fills. At the bottom of this trench the author retrieved a corroded penny belonging to the reign of King George V and dated to 1929. The trench was not bottomed (Plate 1-2).

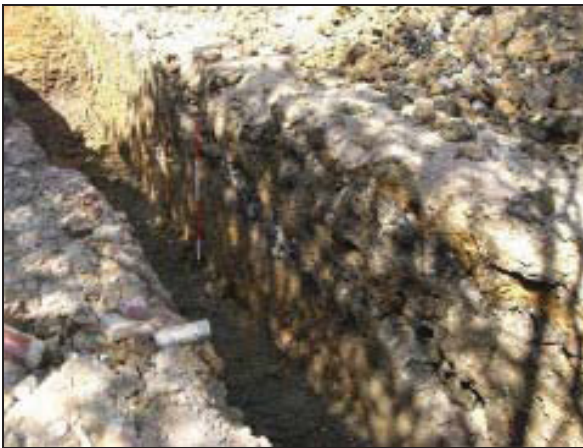
Plate 3: Trench 2 looking WNW at section

- 4.3 **Trench 2**
This was located more or less in the centre of the site and orientated E-W (Fig. 2). It was 13.5 m long and 2.55m deep. At the bottom the ground consisted of a dark brown gravelly layer above which was what looked like an old turf line. The trench cut through fills containing a variety of waste material in the form of building rubble, wire fences, perforated plastic matting and redeposited clay (Plates 3-4).

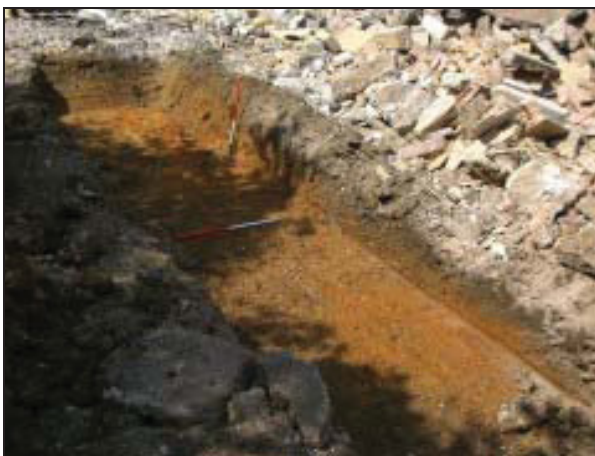
Plate 5: Oblique view of Trench 4 looking NW

- 4.5 **Trench 4**
This trench lay on the eastern side of the site some 6m from the eastern end of Trench 2 (Fig. 2). It was 9m in length and no more than 0.5m deep. The upper 0.3m consisted of a clayey overburden, above a sandy gravel layer (Plate 5). The ground showed no signs of ever having been disturbed.

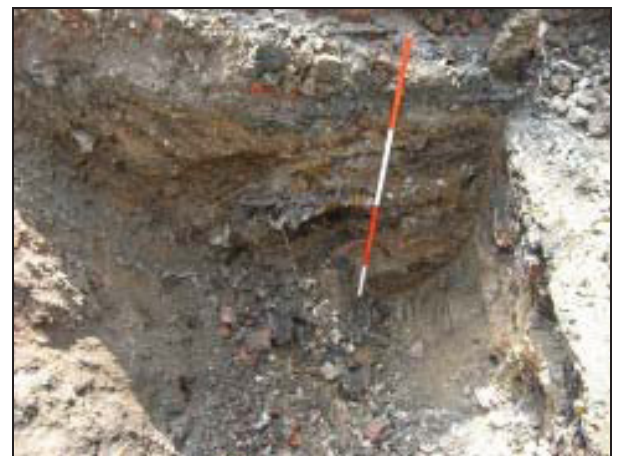
Plate 6: Oblique view of Trench 5 looking south

- 4.6 **Trench 5**
This was located towards the northwestern side of the site and orientated NW-SE (Fig. 2). The trench was 3m long by 2.1m deep, though it was never bottomed. The trench was full of redeposited debris in the form of clay, ash, tile, metal, plastic, mortary clay and slates (Plate 6).

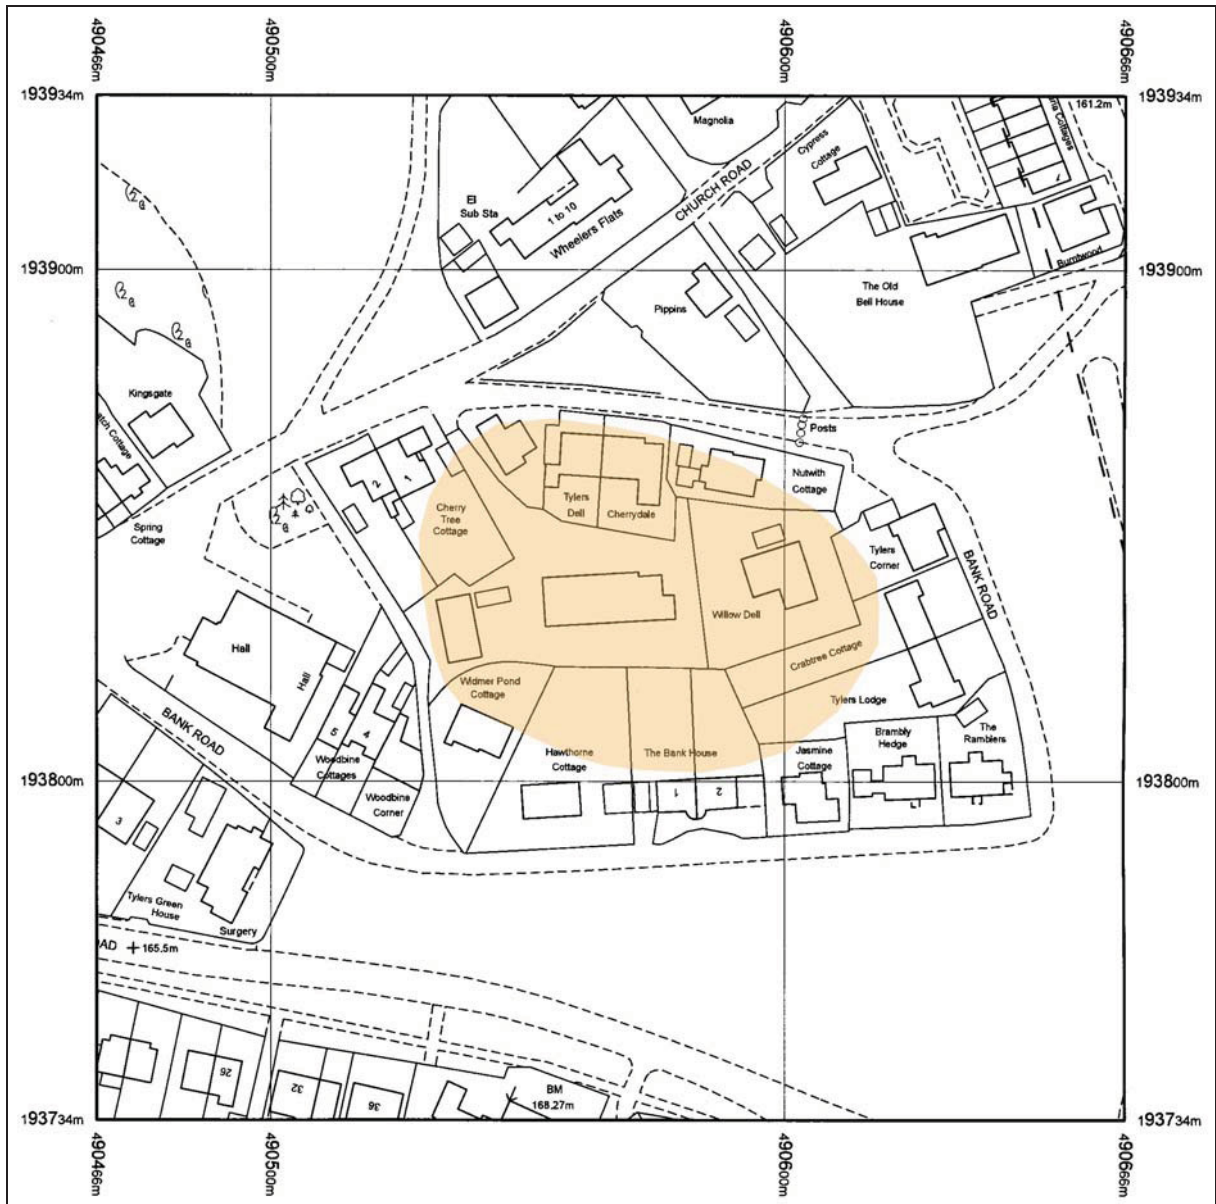
Figure 3: Suggested reconstruction of extent of pit (buff coloured) (scale 1:1,250)

- 5.2 The true extent of the extraction pit (the present site) is by no means certain, as its edges have long since been obscured by the dwellings that surround it. However, the present topography of the area does provide possible clues. The terrain to the south of the site rises some 3m above the interior ground level of the development area. There is also the evidence of the 1924 Ordnance Survey, which shows that the boundaries of the present dwellings on the south side of Bank Road lay further to the south, towards School Road. The unusual shape of Bank Road itself is also an indication that something irregular has gone on in the past. What has caused it to adopt an almost oval shape? The obvious answer is that it is merely reflecting the position of the various dwellings that front onto it. The next question is why should these dwellings, collectively, adopt such an unusual morphology? The answer must be that they were determined by some feature in the landscape, such as a quarry or series of quarries.

- 5.3 It is probably inaccurate to speak in terms of a single extraction pit, since most such activity was usually undertaken on a piecemeal basis. It is therefore perhaps erroneous to speak in terms of a single area being open at any one time. If this had been the case then it could be argued that this 'notional' pit measured some 100m east-west and perhaps some 60m north-south. The reality was probably different since there is evidence for extraction taking place up to Elm Road to the east and beyond and certainly to the north across Church Road. Most of these extraction pits have long since vanished, leaving only the largest and most obvious ones along the edge of Elm Road to the south. If it is argued that the full extent of the 'extraction zone' did not extend beneath the current dwellings around Bank Road, then this would create an area of about 90m east west by 50m north-south.

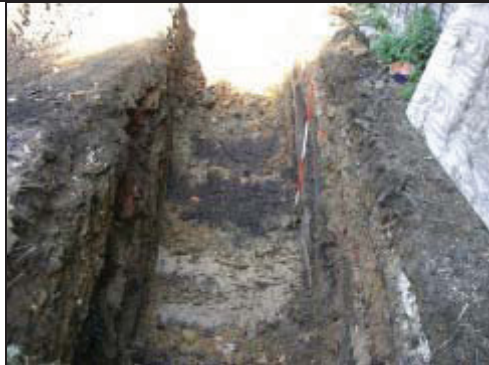
| Trench 1 | | | | | |

| Trench 1 | | | | | |
|---|---|---|---|---|---|
| | | Max Dimensions | | | |
| | | Width | 1.85m | Length | 11.5m |
| | | Depth | 2.3m | Level (top) | 165.03m AOD |
| | | At least ten tip lines (modern) | | | |

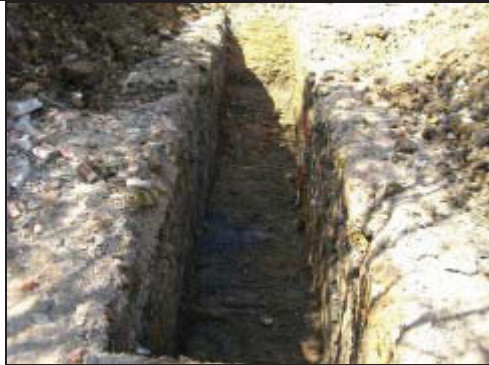
| Trench 2 | | | | | |

| Trench 2 | | | | | |
|---|---|---|---|---|---|
| | | Max Dimensions | | | |
| | | Width | 1.85m | Length | 13.5m |
| | | Depth | 2.55m | Level (top) | 164.96m AOD |

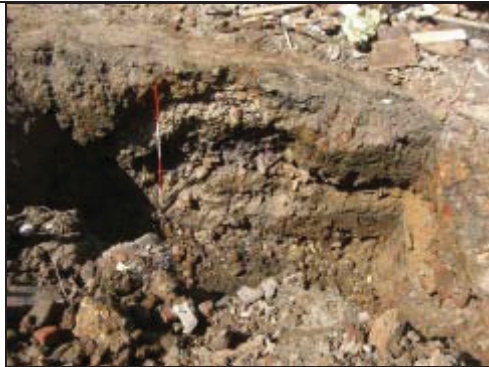
| Trench 3 | | | | | |

- 4.4 **Trench 3**
This was located at a right angle off the end of Trench 2 and orientated N-S (Fig. 2). Due to the very loose nature of the ground it was only 3m in length and 2.3m in depth. It was filled with a mix of building rubble and clay. It was not bottomed (see Appendix 1 for photograph).

| Trench 3 | | | | | |
|---|---|---|---|---|---|
| | | Modern tip material | | | |

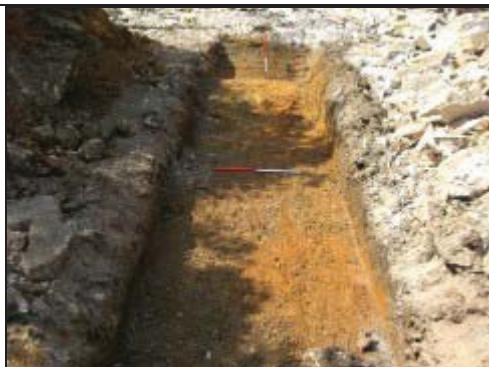
| Trench 4 | | | | | |

| Trench 4 | | | | | |
|---|---|---|---|---|---|
| 1 | | General overburden and topsoil | | 300 | 300 |
| | | Exposed natural sandy gravel subsoil | | | |

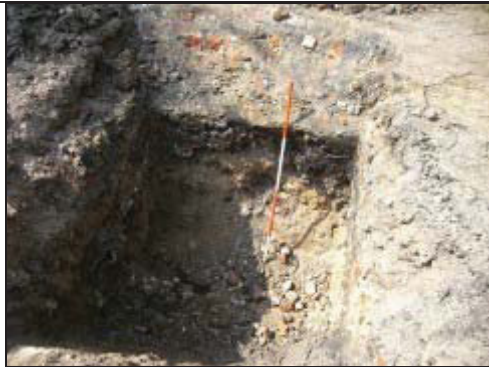
| Trench 5 | | | | | |

| Trench 5 | | | | | |
|---|---|---|---|---|---|
| | | Max Dimensions | | | |
| | | Width | 1.85m | Length | 3m |
| | | Depth | 2.1m | Level (top) | 165.10m AOD |
| | | Modern tip material | | | |

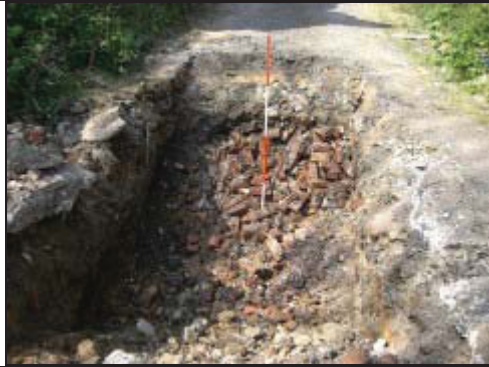
| Trench 6 | | | | | |

| Trench 6 | | | | | |
|---|---|---|---|---|---|
| | | Max Dimensions | | | |
| | | Width | 1.85m | Length | 4.1m |
| | | Depth | 1.4m | Level (top) | 165.44m AOD |
