**HISTORIC BUILDING RECORDING:
GRANARY
ORCHARD HOUSE
5 THE PADDOCKS
DOG KENNEL LANE
CHORLEYWOOD**

on behalf of Alison Phin

July 2007

ASC: 940/COH/2

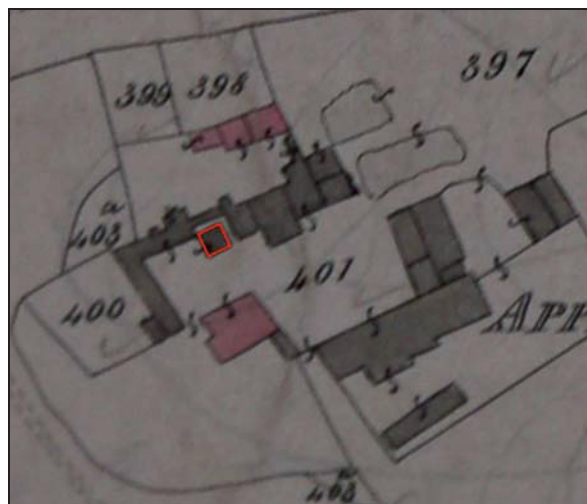
Figure 3: Tithe Map (*not to scale*)

The first map on which the granary is clearly depicted is the 1914 Ordnance Survey Plan (Fig. 5), although the Tithe Map of 1839 shows a building that is possibly the granary in a different location (Fig. 3). The granary remained a constant during the 20th century when other buildings were demolished or added as required (Figs 4-7)

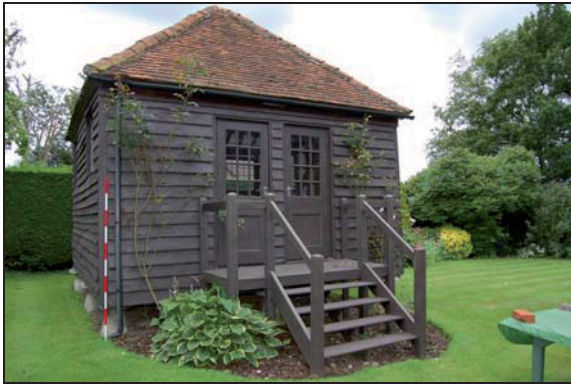
Plate 1: North elevation

The timber framing consists of primary bracing that has a hardboard lining between the framing and a weatherboarded exterior. The pyramid shaped roof is covered with clay tiles. There is an open tread staircase of 4 steps leading to a landing area with a waist height balustrade in front of the two doors in the north elevation. These, as well as the two windows in each of the other elevations, were installed in the 1980s and are described in more detail below.

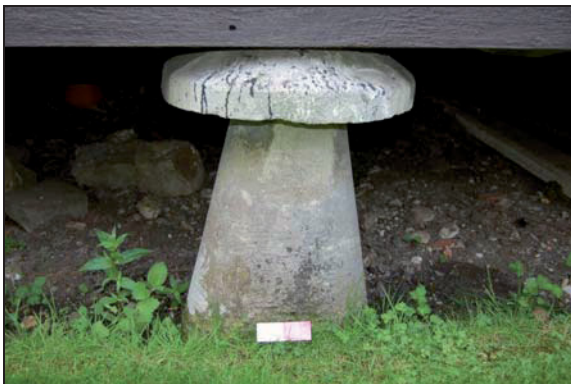
Plate 5: Staddle stone

The external dimensions of the granary are $4.93 \times 4.91\text{m}$ and it rests on staddle stones approximately 0.65m above ground level. The staddle stones are made of a fossiliferous, well-bedded limestone and have well defined vertical tool marks on the base. The base is *c.* 50cm high x 34cm wide and the cap is *c.* 15cm high x 40cm wide.

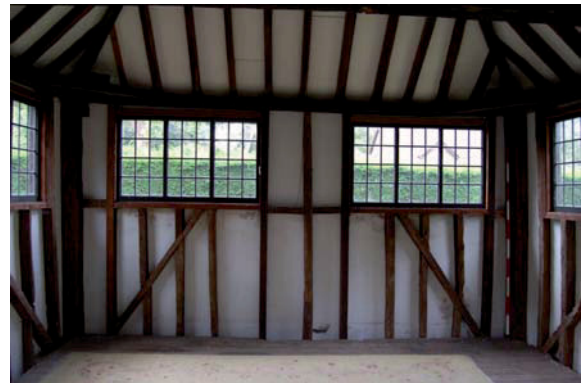
Plate 6: South wall

All the timbers are exposed inside the granary, but the nail holes in the timberwork and the paintline on the underside of the wallplates suggest that they may once have been concealed behind panelling. Most of the timbers are original, the exception being those associated with the recently installed windows and doors. The vertical posts, which appear to be of elm, are adzed and pit-sawn. Apart from the central post in the south wall, which is only 8cm wide, they measure approximately $15 \times 17\text{cm}$. The studs and braces are also pitsawn, and a very small number are waney edged. The stud to the south of the vertical post in the west elevation has been cut horizontally approximately 1.35m above the floor, as has the brace next to it. This is at the same height as the base of the window, and may have been done when the windows were installed. The vertical post in the south elevation has been spliced approximately 50cm above the floor.

The doors in the north wall are half glazed, and the two windows in the south elevation have 3 light fixed casements with 12 panes of glass in each. The two windows in the east and west elevations are 2 light casements also with 12 panes apiece.

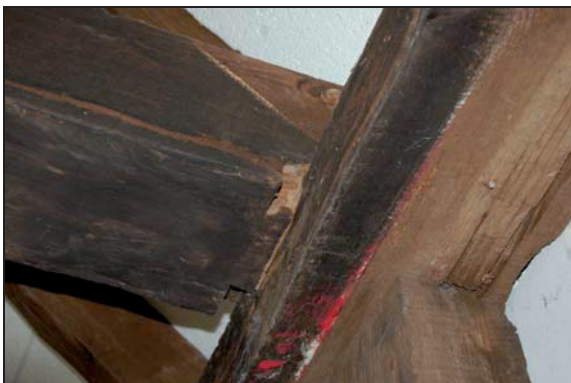
Plate 11: Tie beam joint

The wallplates run the full length of the east and west wall, and those on the north and south are tenoned into them. The walls are tied with a centrally located tie beam (Plate 11) and diagonal or dragon braces (Plate 12). The roof timbers are probably original.

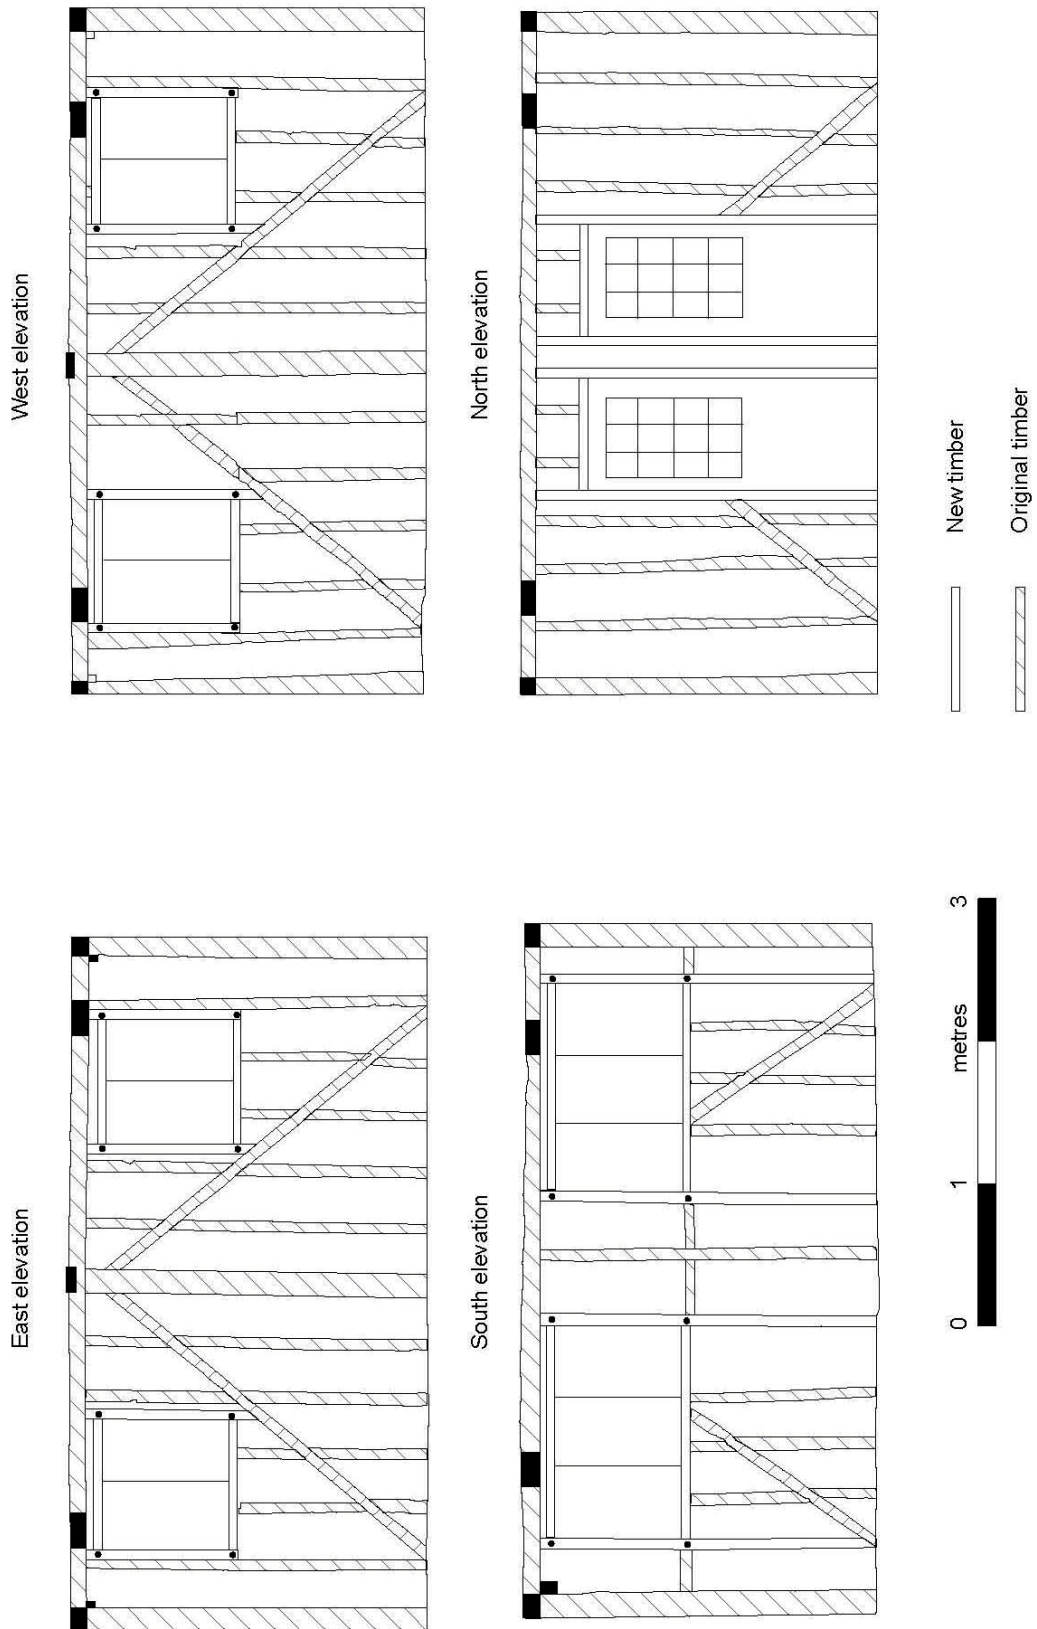
Figure 10: Elevations (scale 1:50)

Dimensions: $4.85 \times 4.85\text{m}$ overall, height 4.64m

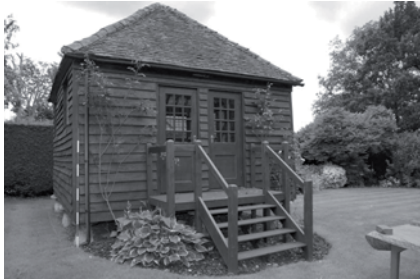
Shot 1

SITE NAME: Granary, Orchard House, Chorleywood			SITE NO/CODE: 940/COH
Shot	B&W	Digital	Subject
1	X	X	South elevation
2	O	X	South elevation
3	X	X	West elevation
4	X	X	North & west elevations
5	X	X	East elevation
6	X	X	Staddle stone
7	X	X	South wall
8	X	X	West wall
9	X	X	North wall
10	X	X	East wall
11	X	X	Roof
12	X	X	Mortice in the east end of the tie beam
13	X	X	Diagonal brace in NW corner
14	X	X	Diagonal brace in NW corner
