### **ARCHAEOLOGICAL EVALUATION: CLIFTON SEWAGE TREATMENT WORKS, BEDFORDSHIRE**

*on behalf of Anglian Water Services Ltd*

**ASC: 902/CSW/2**

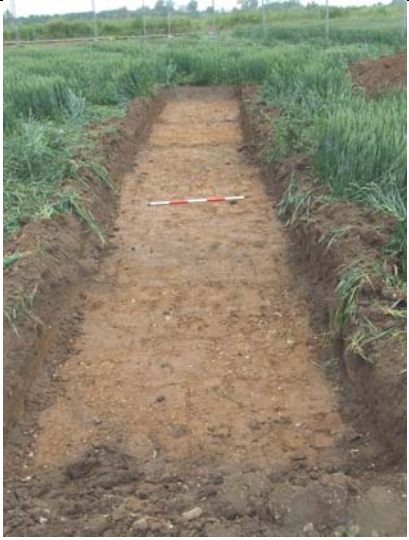
Trench 1

Max Dimensions (m)					
	Length	13.5	Width	1.8	Depth	0.6
	Levels					
	Trench base north west		34.20m OD			
	Trench top north west		34.75m OD			
	Trench base south east		34.22m OD			
	Trench top south east		34.86m OD			
	NGR Co-ordinates					
	TL	17586 40378		TL	17586 40378	
	Orientation			NW-SE		
Reason for Trench			Evaluate haul road area			
Context	Type	Description and Interpretation	Max Width (m)	Max Thckn (mm)	Depth BGL (mm)	
100	Deposit	Ploughsoil	1.8	450	0-450	
101	Deposit	Natural gravel sandy gravel	1.8	-	>450

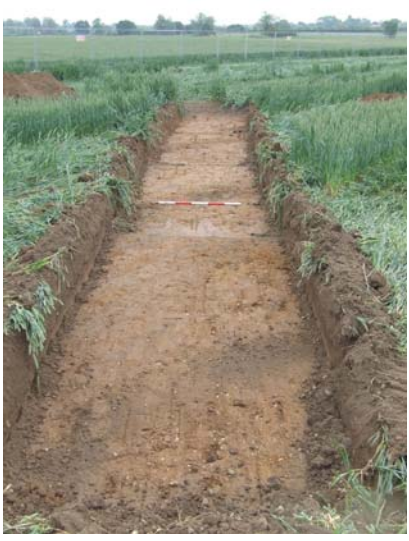
Trench 2

Max Dimensions (m)					
	Length	15.0	Width	1.8	Depth	0.45
	Levels					
	Trench base north east		33.89m OD			
	Trench top north east		34.31m OD			
	Trench base south west		33.95m OD			
	Trench top south west		34.42m OD			
	NGR Co-ordinates					
	TL	17661 40378		TL	17650 40369	
	Orientation			NE-SW		
Reason for Trench			Evaluate haul road area			
Context	Type	Description and Interpretation	Max Width (m)	Max Thckn (mm)	Depth BGL (mm)	
200	Deposit	Ploughsoil	1.8	400	0-400	
201	Deposit	Natural sandy gravel	1.8	-	>400

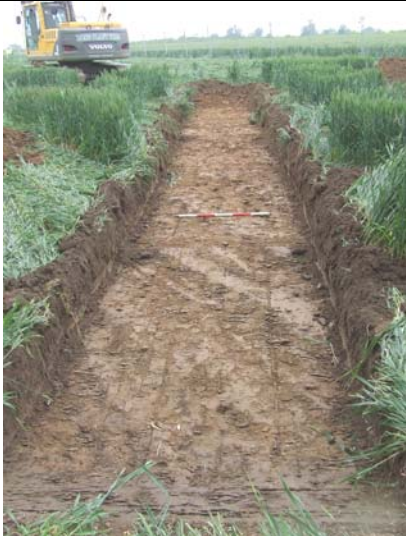
Trench 3

Max Dimensions (m)					
	Length	15.0	Width	1.8	Depth	0.4
	Levels					
	Trench base north west		33.54m OD			
	Trench top north west		33.89m OD			
	Trench base south east		33.25m OD			
	Trench top south east		33.67m OD			
	NGR Co-ordinates					
	TL	17713 40380	TL	17725 40371		
	Orientation		NW-SE			
Reason for Trench		Evaluate haul road area				
Context	Type	Description and Interpretation	Max Width (m)	Max Thckn (mm)	Depth BGL (mm)	
300	Deposit	Ploughsoil	1.8	350	0-350	
301	Deposit	Natural sandy gravel	1.8	-	>350

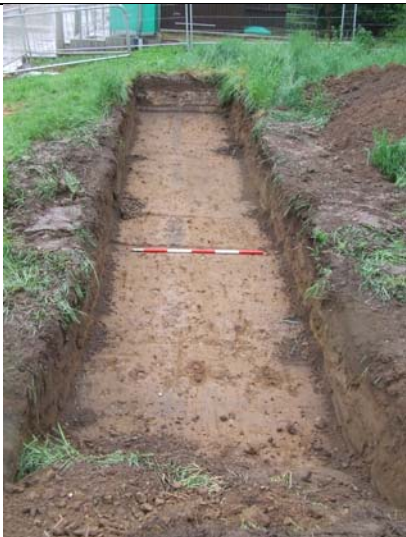
Apart from Trench 4 which had to be moved and reduced in size to 9m to avoid a live power cable, no constraints were encountered during the evaluation and the remaining trenches were laid out as proposed in the project design.

Max Dimensions (m)					
	Length	9.0	Width	1.6	Depth	0.55
	Levels					
	Trench base north east		35.5m OD			
	Trench top north east		35.15m OD			
	Trench base south west		35.56m OD			
	Trench top south west		36.08m OD			
	NGR Co-ordinates					
	TL	17560 40339		17556 40331		
	Orientation		NE-SW			
Reason for Trench		Evaluate compound area				
Context	Type	Description and Interpretation	Max Width (m)	Max Thckn (mm)	Depth BGL (mm)	
400	Deposit	Topsoil	1.6	200	0-200	
401	Deposit	Mid yellowish brown silty clay	1.6	350	200-550	
402	Deposit	Natural sandy gravel	1.6	-	>550

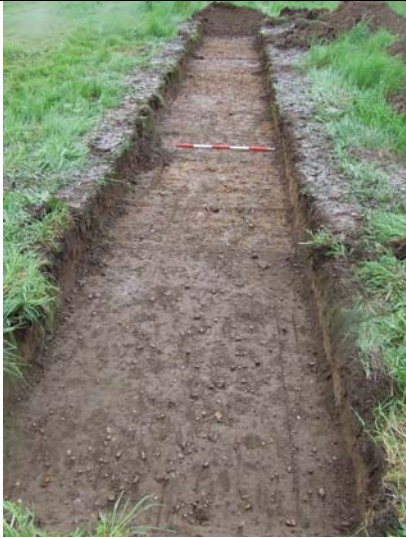
Trench 5

Max Dimensions (m)					
	Length	16.2	Width	1.6	Depth	0.35
	Levels					
	Trench base east		34.76m OD			
	Trench top east		35.00m OD			
	Trench base west		34.76m OD			
	Trench top west		35.21m OD			
	NGR Co-ordinates					
	TL	517623 240355		TL	517607 240355	
	Orientation			E-W		
Reason for Trench			Evaluate compound area			
Context	Type	Description and Interpretation	Max Width (m)	Max Thckn (mm)	Depth BGL (mm)	
500	Deposit	Topsoil	1.6	200	0-200	
501	Deposit	Mid yellowish brown silty clay	1.6	150	200-350	
502	Deposit	Natural sandy gravel	1.6	-	>350

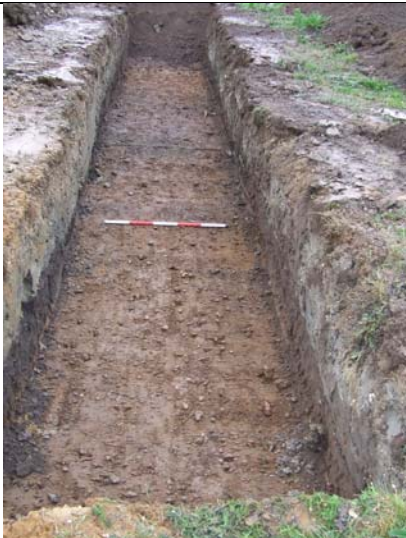
Trench 6

Max Dimensions (m)					
	Length	15	Width	1.6	Depth	0.8
	Levels					
	Trench base east		34.03m OD			
	Trench top east		34.87m OD			
	Trench base west		34.25m OD			
	Trench top west		35.31m OD			
	NGR Co-ordinates					
	TL	17671 40351		TL	17656 40351	
	Orientation			E-W		
Reason for Trench			Evaluate compound area			
Context	Type	Description and Interpretation	Max Width (m)	Max Thckn (mm)	Depth BGL (mm)	
600	Deposit	Disturbed topsoil layer from the construction of the existing sewage works.	1.6	480	0-480	
601	Deposit	Mid grey brown humic silt	1.6	300	480-700	
602	Deposit	Natural sandy gravel	1.6	-	>700
