**SURVEY OF FOUR WORLD WAR II
AIR RAID SHELTERS,
HARPENDEN,
HERTFORDSHIRE**

on behalf of Harpenden Town Council

MAY 2007

ASC: 896/HAS/1

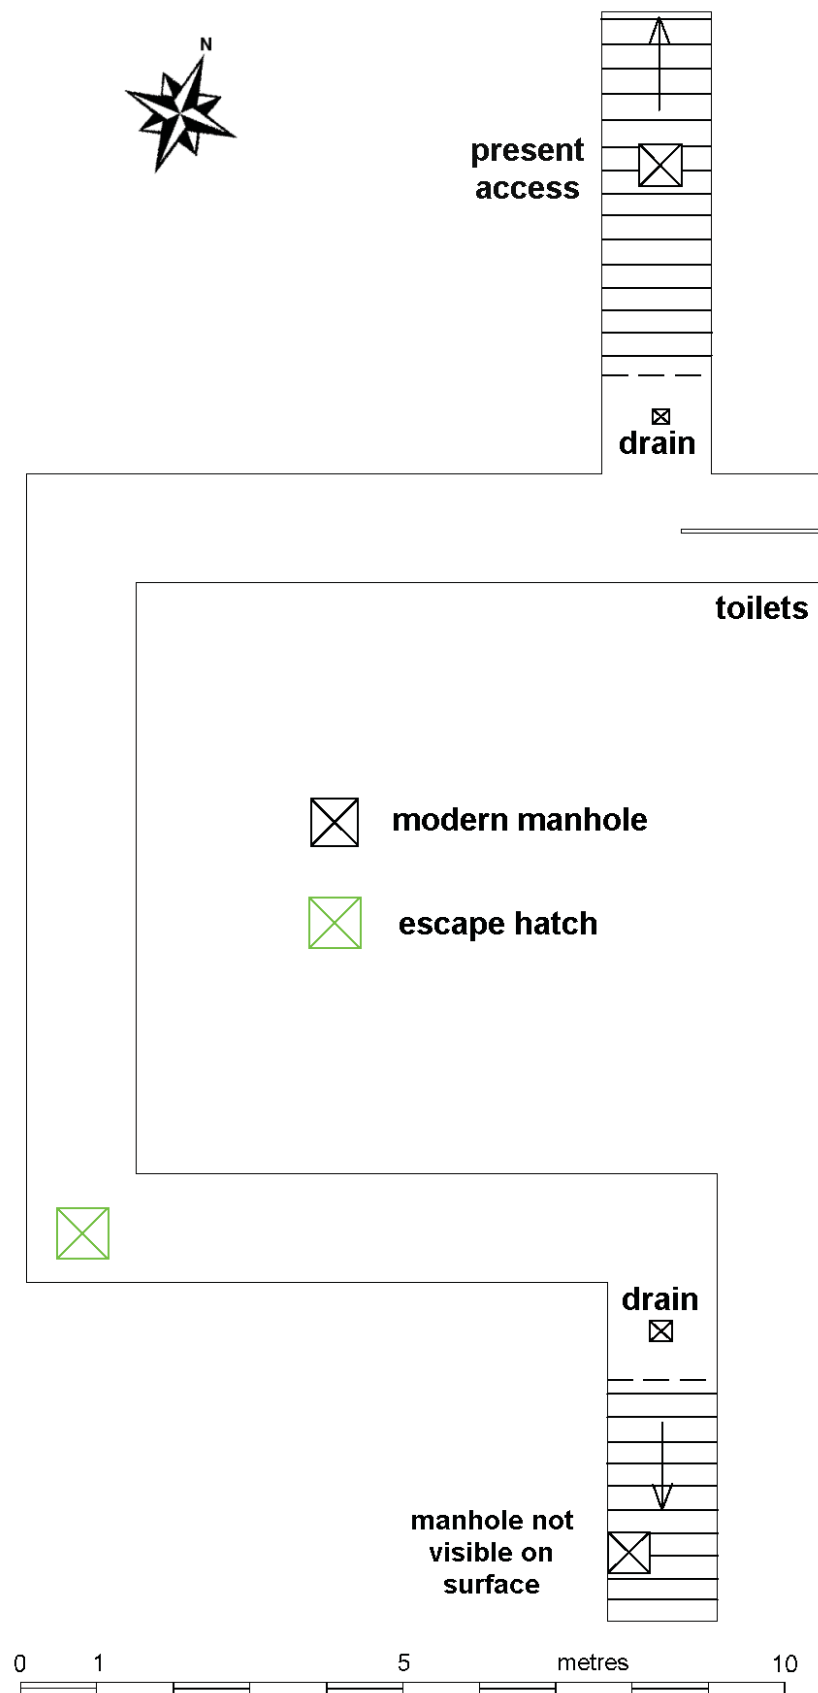
Figure 8: Leyton Green north shelter (scale 1:100)

Layout: Some 29m length of passage (excluding stairways and toilet), in three sections, with stairways at each end, toilets adjacent to the north entrance, and one escape hatch.

Capacity: c.100, allowing for benches on both sides of the passage.

Condition: Generally sound and dry. Access is presently by the north manhole. The manhole at the south entrance is not visible on the surface.

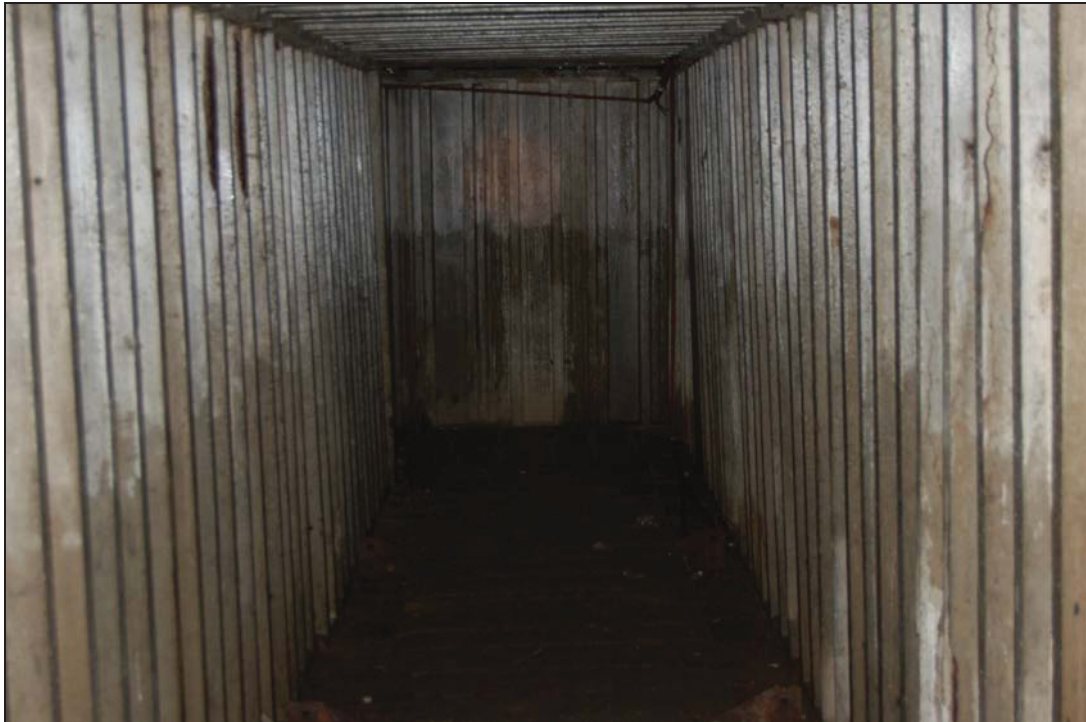
Plate 1: Bowers Parade, interior

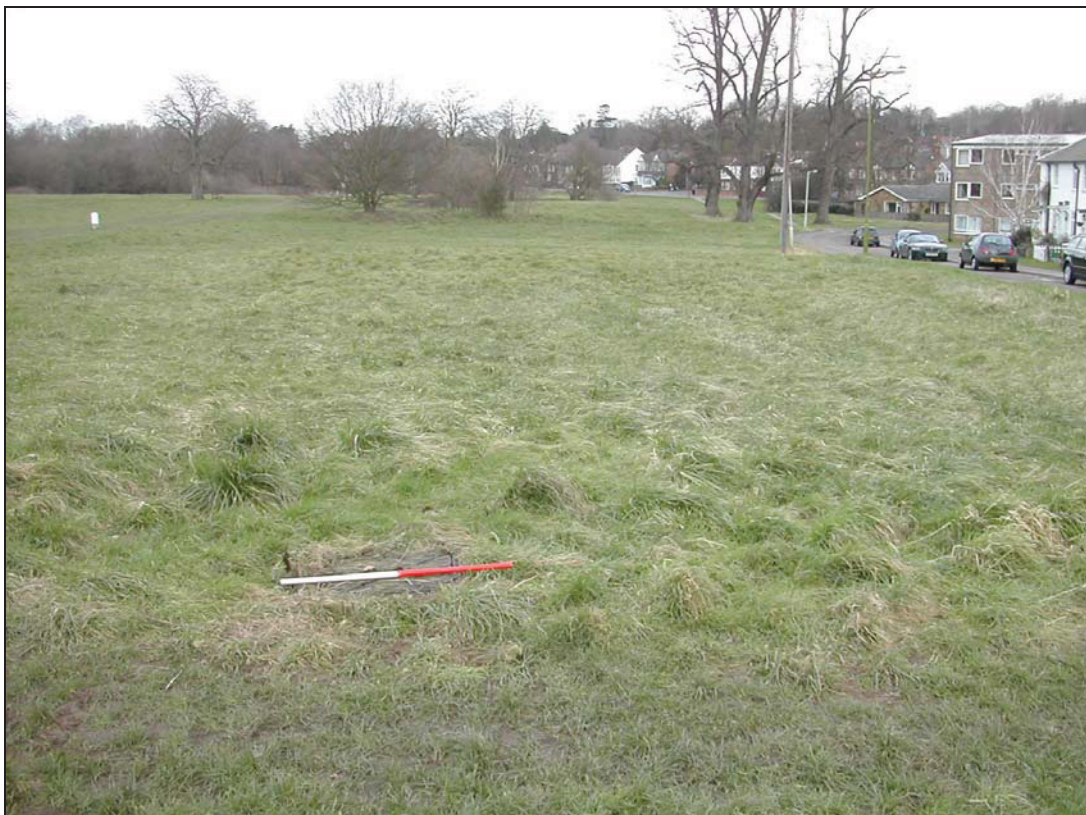
Plate 2: Queens Road, exterior (entrance in foreground)
