**ARCHAEOLOGICAL EVALUATION:
HILTON PARK CARE CENTRE
HIGH STREET
BOTTISHAM**

National Grid Reference: TL 5522 6019

November 2007

ASC: 991/BHP/2r

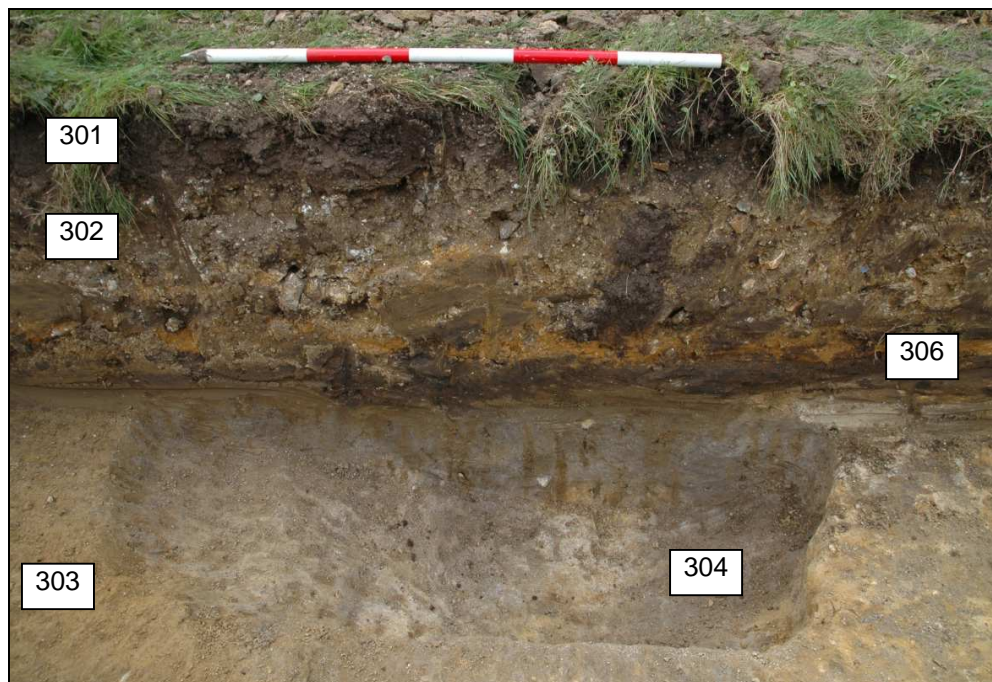
Plate 1: Trench section and sondage in Trench 3 (*Scale = 1m*)

A larger quantity of material had been deposited in Trench 3, where a 0.23m thick deposit of greyish brown silt, containing fragments of modern brick (303) was present beneath the buried topsoil (Figure 7; Plate 1). Three small sondages were excavated through this deposit, revealing an underlying layer of natural grey silt (304).

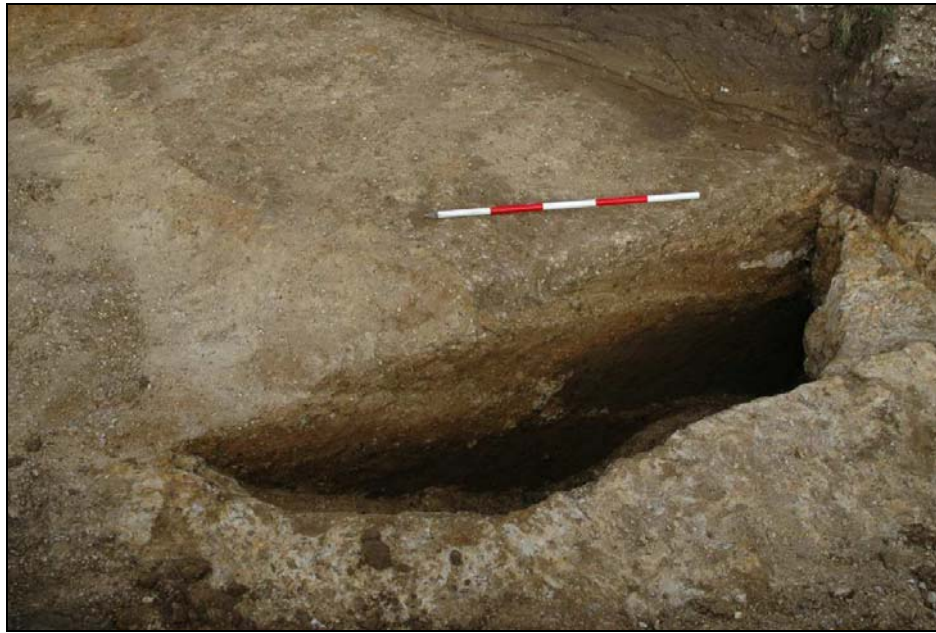
Plate 2: Tree bole [111] (*Scale = 1m*)

A substantial feature [111] was present in the centre of Trench 1 and the trench was extended to the south, in order to reveal its southern extent. It was subcircular in plan, with an asymmetrical profile *c.*3m in diameter and was *c.*0.8m deep. The south edge was almost vertical and was slightly concave towards the base. The base was flat and the north edge rose at an angle of *c.*45° to the surface of the trench. Eight separate deposits were defined within it (103)- (110), comprising alternating layers of brown sandy silt (110), (108), etc., and chalk fragments (109), (106), etc. These layers generally sloped down from southwest to northeast and the chalk is interpreted as material weathered from the edges. Fill (108) was a thicker deposit of mid brown sandy silt, with a near vertical southern edge. A single extremely small sherd of abraded post-medieval redware pottery and the tooth of a cow were present in fill (110). The irregular nature of these fills suggests that this feature may be a tree bole. Fill (108) may have accumulated within the hollow, created by the uplifting of the root ball, as the tree fell to one side (Moore and Jennings 1992, fig.6).

- 5.3 A substantial irregular feature [111] was present in Trench 1, in the south part of the site. It was subcircular in plan with an irregular profile. It was filled with alternating layers of weathered chalk fragments and silt and is interpreted as a tree bole. A single extremely small sherd of pottery was present close to the base of the tree bole.

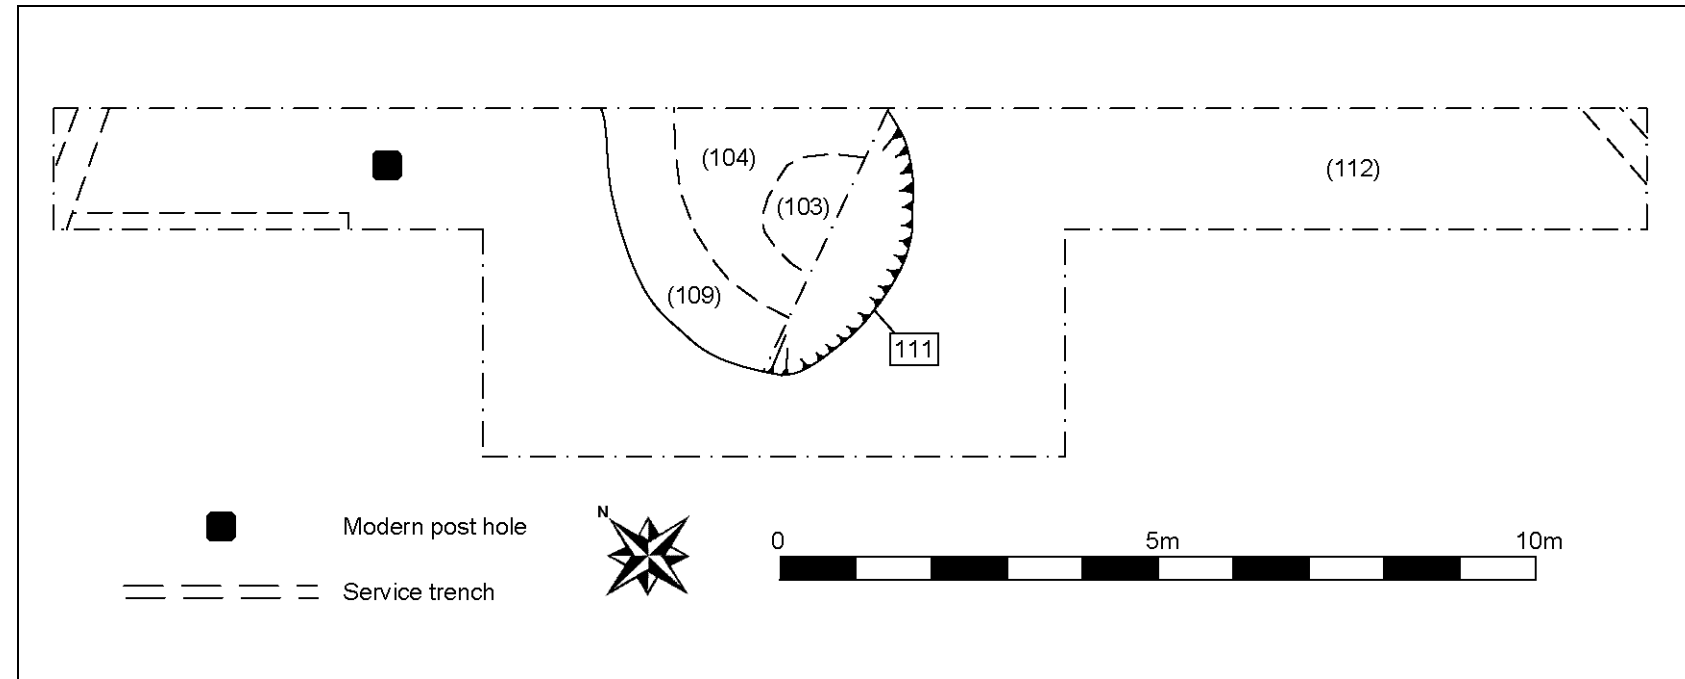
Figure 5: Plan of Trench 1 (Scale = 1:100)

Trench 1 was situated close to the southern boundary of the site and revealed a similar sequence of soil deposits. The only minor variation being that the natural strata, which was present at a depth of *c.* 0.8m was more variable in character and comprised areas of light greyish chalk (113).

A number of service runs were present cutting into the natural strata and a modern square post hole was present towards the west end of the trench (Figure 5).

The overlying soils comprised a layer of topsoil (102) *c.*0.5m thick which was buried beneath a spread of obviously modern re-deposited soil (101). The contemporary topsoil (100) comprised mid brown loam and was *c.*0.13m thick.

No significant archaeological features were observed in Trench 1.

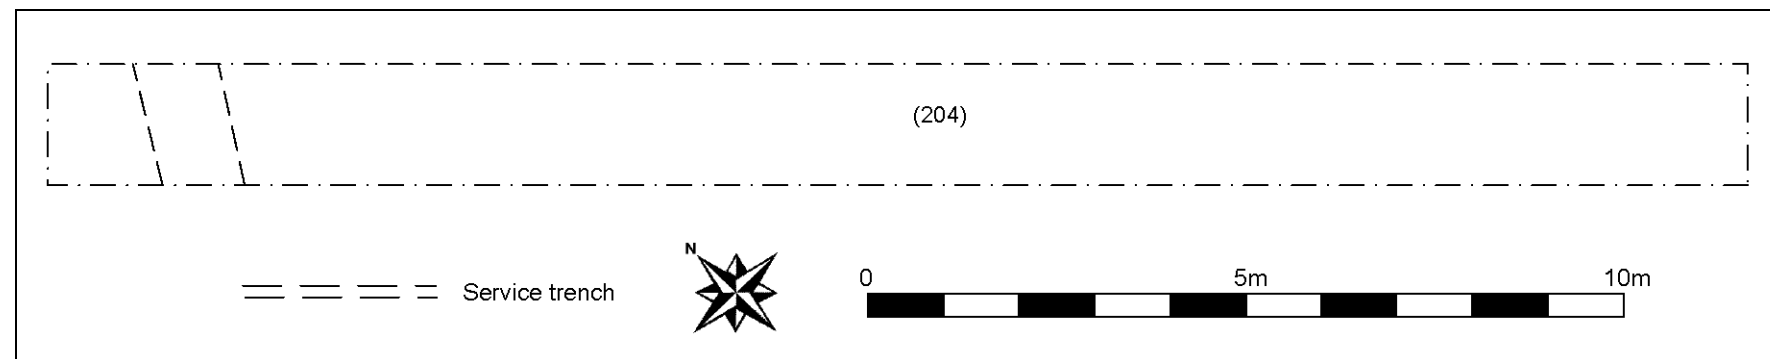
Figure 6: Plan of Trench 2 (Scale = 1:100)

Trenches 2, 3 and 5 were situated in the central and north parts of the site and all the trenches contained a similar sequence of deposits. The natural strata was present at depths of between 0.59m and 0.83m and generally comprised brownish orange silty sand (204), (305), etc.

These trenches all exhibited signs of disturbance, probably caused by the construction of the adjacent buildings. With the exception of modern service runs, the area had not been significantly truncated, but all the trenches contained deposits of re-deposited natural strata (202), (302) and (502). It was between 0.25 and 0.43m thick and in Trenches 2 and 3 had been spread directly over the topsoil (203) and (306).

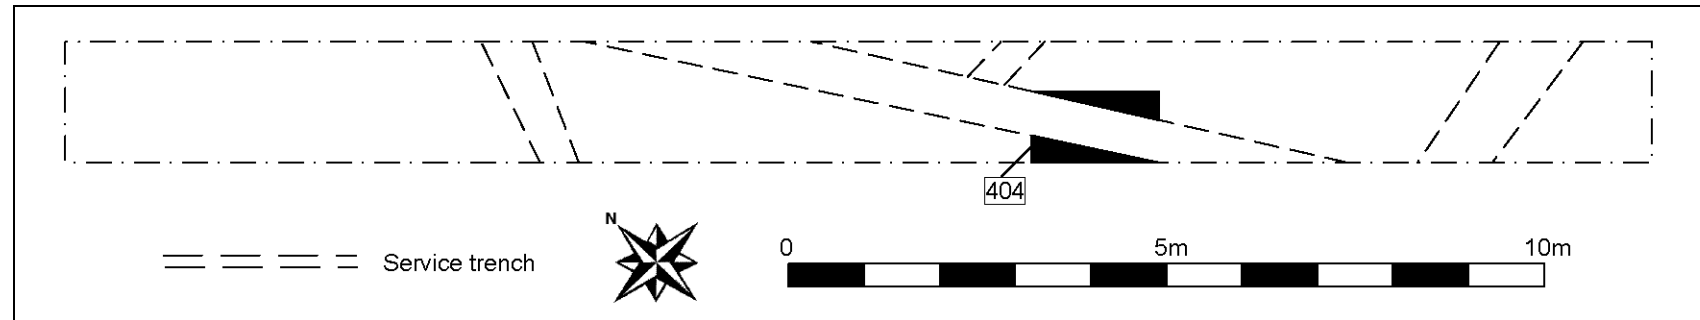
Figure 8: Plan of Trench 4 (Scale = 1:100)

Trench 4 aimed to evaluate the central part of the site and revealed a sequence of natural soil deposits. The natural strata comprised mid brownish orange silty sand (402) and was recorded at a depth of *c.*0.55m. A number of modern service runs were present, and an obviously modern rectangular pit [404] was present in the east part of the trench.

The natural strata was overlain by a 0.25m thick layer of light to mid brown subsoil (401) which was overlain in turn by topsoil (401), which was *c.*0.3m thick.

With the exception of the service runs, this part of the site was relatively undisturbed and no significant archaeological features were observed in this trench.

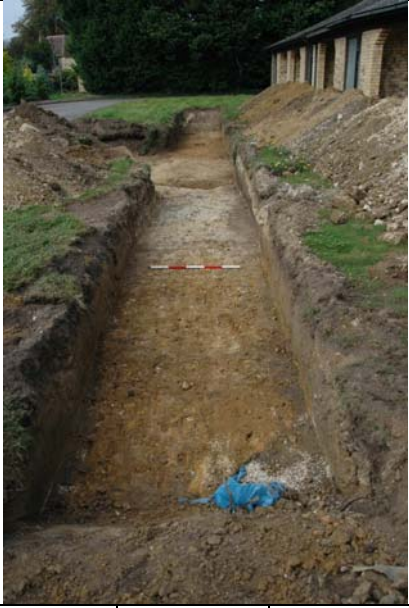
Trench 1

Max Dimensions (m)					
	Length	21.8	Width	1.6	Depth	0.85
	Levels					
	Trench base east		13.33m OD			
	Trench top east		13.95m OD			
	Trench base west		13.60m OD			
	Trench top west		14.08m OD			
	NGR Co-ordinates					
	WNW	TL5514 6014		ESE	TL 5516 6013	
	Orientation		ESE-WNW			
Reason for Trench		Evaluation				
Context	Type	Description and Interpretation	Max Width (mm)	Max Thckn (mm)	Depth BGL (mm)	
100	Layer	Mid brown loam. Topsoil	-	c.130	0	
101	Layer	Light brownish grey marl with frequent inclusions of flint nodules and fragments of plastic. Recently redeposited soil	-	125	c.120	
102	Layer	Mid brownish loam. Buried topsoil	-	504	270	
103	Fill	Light yellowish grey crushed chalk	1.1m	90	803	
104	Fill	Mid brown sandy silt. Final silting/filling of tree bole [111]	2.23m	130	933	
105	Fill	Mid greyish brown sandy clay silt. Secondary silting	1.09m	203	1.14m	
107	Fill	Mid yellowish brown clay silt mixed with chalk frags. Secondary fill, probably weathering from edges	302	90	1.23m

106	Fill	Light yellowish grey chalk frags. Secondary fill, probably weathering from pit edges	2.23m	281	1.51m	
108	Fill	Mid brown sandy silt. Silting within hollow of tree bole [111]	1.41m	600	2.10m	
109	Fill	Light yellowish grey chalk frags. Secondary fill, probably weathering from pit edges	2.0m	243	2.35m	
110	Fill	Mid yellowish brown sandy clay silt containing occasional chalk frags. Primary silting of tree bole [111]	20m	444	2.79m	
111	Cut	Sub circular cut with steep sided asymmetrical profile and a flat base. Tree bole	3.0m	c.800	2.79m	
112	Layer	Mid brownish orange silty sand with patches of grey marl and frequent flint nodules. Natural strata	-	Un-exc	803	
113	Layer	Light greyish chalk. Natural strata	-	Un-exc	803

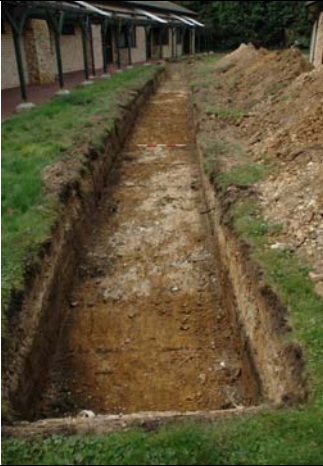
Trench 2

Max Dimensions (m)					
	Length	22.50	Width	1.6	Depth	1.00
	Levels					
	Trench base east			12.76m OD		
	Trench top east			13.77m OD		
	Trench base west			13.05m OD		
	Trench top west			13.73m OD		
	NGR Co-ordinates					
	WNW	TL 5517 6015		ESE	TL 5515 6016	
	Orientation			ESE-WNW		
Reason for Trench			Evaluation			
Context	Type	Description and Interpretation	Max Width (mm)	Max Thckn (mm)	Depth BGL (mm)	
201	Layer	mid brown loam. Topsoil	-	160	0	
202	Layer	Light brownish grey marl with frequent inclusions of flint nodules. Redeposited soil	-	250	160	
203	Layer	mid brown loam. Buried topsoil	-	200	410	
204	Layer	mid brownish orange silty sand with patches of grey marl and frequent inclusions of flint nodule. Natural strata.	-	Un-exc	610

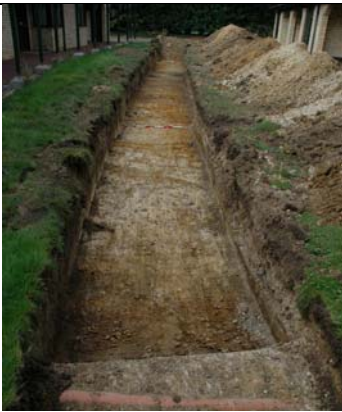
Trench 3

Max Dimensions (m)					
	Length	26.10	Width	1.6	Depth	1.03
	Levels					
	Trench base east			13.09m OD		
	Trench top east			13.69m OD		
	Trench base west			12.93m OD		
	Trench top west			13.71m OD		
	NGR Co-ordinates					
	NW	TL 5518 5515		SE	TL 5515 6017	
	Orientation			NW-SE		
Reason for Trench			Evaluation			
Context	Type	Description and Interpretation	Max Width (mm)	Max Thckn (mm)	Depth BGL (mm)	
301	Layer	Mid brown loam. Topsoil.	-	190	0	
302	Layer	Light brownish grey marl with frequent inclusions of flint nodules. Redeposited soil	-	340	190	
306	Layer	Mid brown loamy re-deposited topsoil with occasional inclusions of modern brick. Buried topsoil	-	170	430	
303	Layer	Dark greyish brown silt-with frags. of modern brick. Modern soil spread.	5.60	230	600	
304	Layer	Mid grey silt with occasional inclusions of snail shell natural soil deposit.	-	-	830	
305	Layer	Mid brownish orange silty sand natural with patches of grey marl and frequent flint nodules. Natural strata	-	Un-exc	830

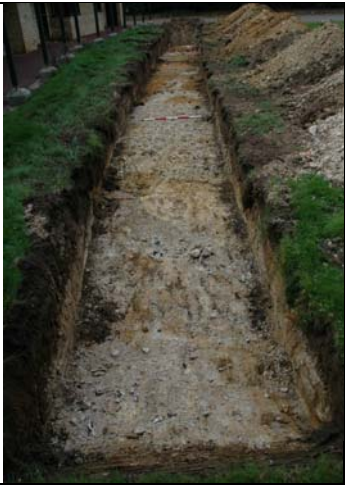
Trench 4

Max Dimensions (m)					
	Length	21.00	Width	1.6	Depth	0.75
	Levels					
	Trench base east			13.00m OD		
	Trench top east			13.69m OD		
	Trench base west			13.09m OD		
	Trench top west			13.75m OD		
	NGR Co-ordinates					
	NW	TL 5518 6018		SE	TL 5515 6018	
	Orientation			NW-SE		
Reason for Trench			Evaluation			
Context	Type	Description and Interpretation	Max Width (mm)	Max Thckn (mm)	Depth BGL (mm)	
401	Layer	Mid brown loam. Topsoil	-	300	0	
402	Layer	Light to mid brown silty clay. Subsoil	-	250	300	
405	Fill	Mid brown silty clay. Filling of modern pit [404]	-			
404	Cut	Square cut. Construction cut of modern pit	-			
403	Layer	Mid brownish orange silty sand with patches of grey marl and frequent flint nodule. Natural strata	-	Un-exc	550

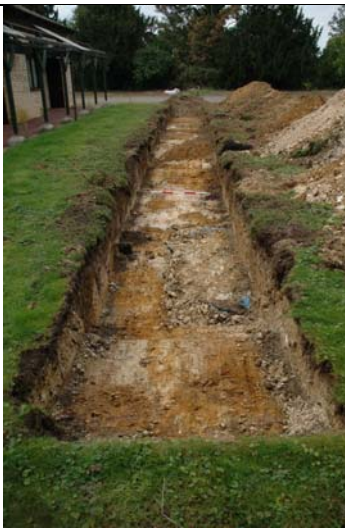
Trench 5

Max Dimensions (m)					
	Length	19.10	Width	1.6	Depth	0.73
	Levels					
	Trench base north			13.30m OD		
	Trench top north			13.76m OD		
	Trench base south			13.27m OD		
	Trench top south			13.84m OD		
	NGR Co-ordinates					
	NW	TL 5518 6021		SE	TL 5516 6020	
	Orientation			NW-SE		
Reason for Trench			Evaluation			
Context	Type	Description and Interpretation	Max Width (mm)	Max Thckn (mm)	Depth BGL (mm)	
501	Layer	Mid brown loam. Topsoil	-	160	0	
502	Layer	Natural light brownish grey marl with frequent flint nodules. Redeposited natural strata	-	430	160	
503	Layer	Mid brownish orange sandy silt with patches of light yellowish grey chalky marl. Natural strata	-	Un-exc	590
