**ARCHAEOLOGICAL EVALUATION:  
BEVERLEY, JASONS HILL  
LEY HILL, CHESHAM  
BUCKINGHAMSHIRE**

NGR: SP 9883 0224

ASC: 1032/CJH/2r

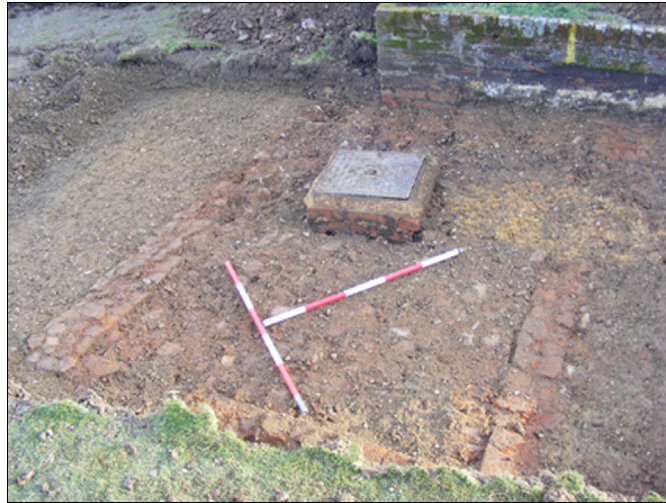
Trench 1 contained the predicted kiln structure (117), which was found in the 1950's, just below the topsoil (100) and cut into the subsoil (115) (Fig. 4; Plate 1). To determine the full extent of the kiln, without demolishing the patio under which the kiln runs, an extension of 0.75×1.10m was added to the southern side of the trench (Plate 6). The full extent of the firing chamber was established, though the flues extended beneath the patio to the south. Kiln (117) was positioned on a north-south alignment and the internal dimensions of the firing chamber were 2.90m by 1.80m.

**Plate 1:** Trench 1 with kiln (117) and gully [107] on the far left, view to the southeast, 2x 1m scale

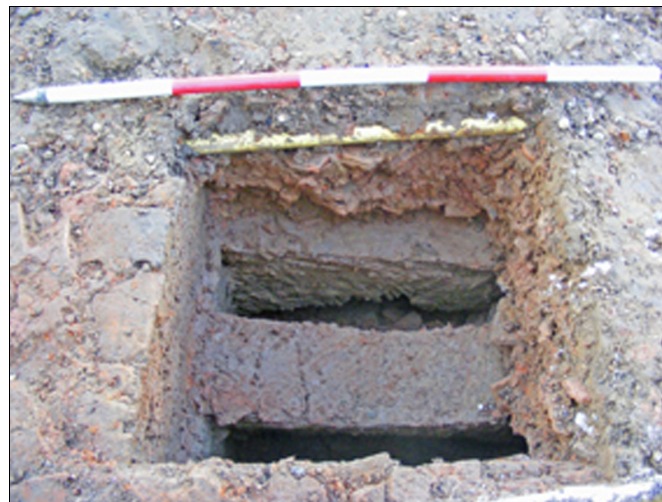
A sondage was excavated in the southwestern corner of the kiln in order to inspect the type and preservation of the structure (Plate 2). The base of the kiln was not reached due to the limited size of the sondage, but it did reveal that the rectangular cut [108] for the kiln was at least 0.95m deep. This cut was lined initially with a 0.58m high lower wall (109) constructed of ceramic tiles laid in stretcher courses, bonded with grey clay. All the tiles appeared to have been seconds, broken prior to their use in the kiln. The largest tile found had dimensions of 170×160×14mm. In the south side of this lower wall a flue had been constructed. A view of this flue was gained by inserting a camera into the cavity, showing that kiln (117) extended several meters beneath the patio (Plate 7). Above wall (109) is an upper wall (110) of red waster peg tiles, which seem to be in a worse condition than those in (109) and are again stretcher coursed with clay bonding and had a height of 0.37m. The largest of these was 160×190×13mm.

The floor in the firing chamber would have been carried above the flues by parallel tile-built flue arches (Plate 2), of which two, (111) and (112), were recorded within the sondage. These were constructed at the same time and with the same materials and methods as the lower outer wall (109), to which they were connected. There are likely to be between six to nine of these east west internal walls running throughout the firing chamber.

**Plate 2:** Sondage into kiln (117) showing flue arches (111) and (112), view from south, 1m scale

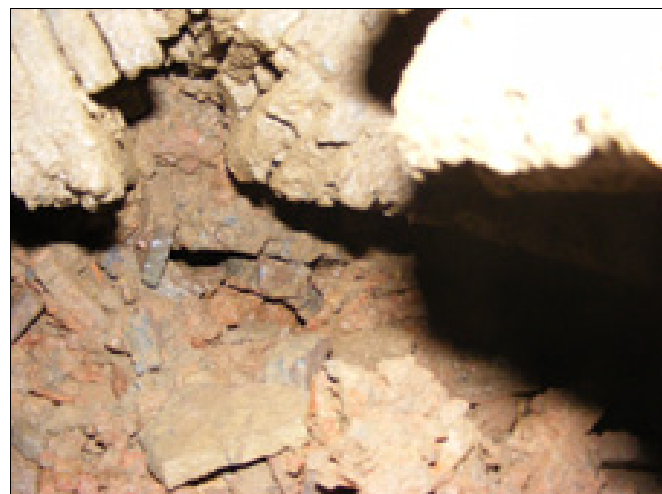
After kiln (117) was decommissioned the upper walls were demolished and the inside of the firing chamber was backfilled with a mixture of mid grey brown clay with approximately 50% tile and 3% rounded nodules of flint inclusions. The flue arches within the firing chamber support much of this, creating voids beneath. The sondage in the southwestern corner of the kiln into one of these voids, but it was evident that much of the back fill had fallen in (Plate 8). Much of this backfill collapse may have resulted from the excavation of the service trenches above.

**Plate 3:** View inside the firing chamber, looking north beneath flue arches, showing backfill collapse

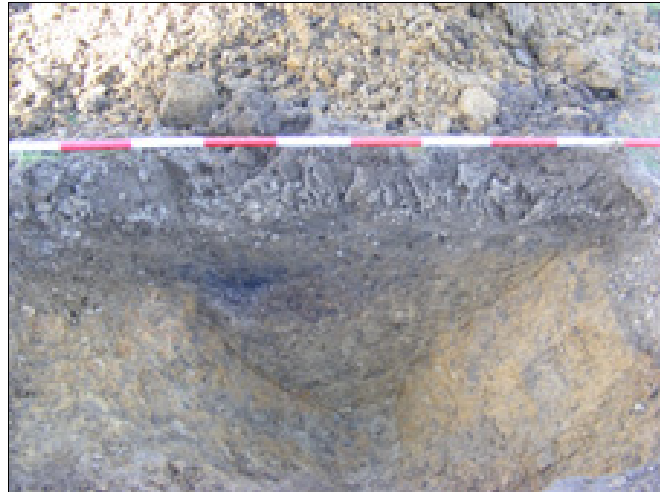
In the northern corner of Trench 1 a large ditch [105] was discovered, entering from the northwestern baulk on a northeast-southwest axis and quickly curving to exit through the northeastern baulk (Fig. 5, Section 100; Plate 9). This ditch, 1.46m wide by 0.80m deep, seems to have been largely filled by a secondary deposit (104) before it was recut much shallower by [118]. Recut [118] contained two separate tips, (103) and (102), of burnt material, probably related to the kiln, and was then further filled by secondary deposit (101). The only artefact recovered from both the original ditch [105] and its recut [118] was a piece of tile from near the bottom of (104), indicating the original ditch was possibly open when the kiln was at least still exposed. However the tile does appear quite abraded and so may not provide very secure dating.

Cutting the last deposit in the ditch and recut sequence (101) was gully [107], aligned on a northwest-southeast direction parallel to the present house and filled by secondary fill (106) (Plates 1, 2, & 9). This gully, 0.50m wide by 0.14m deep, has probably been truncated. No finds were recovered though it is probably Post Medieval and is possibly unrelated to the kiln. The continuation of this gully was seen in Trench 2.

**Plate 4:** Ditch [105] with recut [118] gully [107], viewed from the southeast, 2m scale

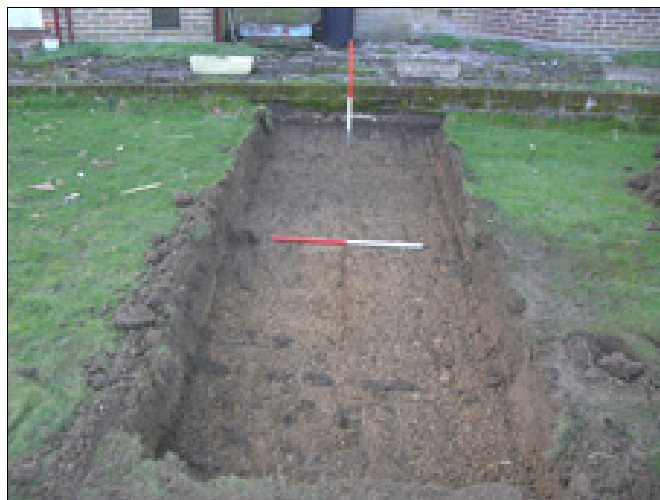
Trench 2 contained a northwest-southeast gully [202] that seemed to be a continuation of that found in Trench 1 [107]. Gully [202] was 0.30m wide by 0.08m deep and filled with secondary despite (203), a soft mid grey brown silty clay containing no finds.

**Plate 5:** Trench 2 containing gully [202] and pit [204], Viewed from the northeast 2x 1m scale

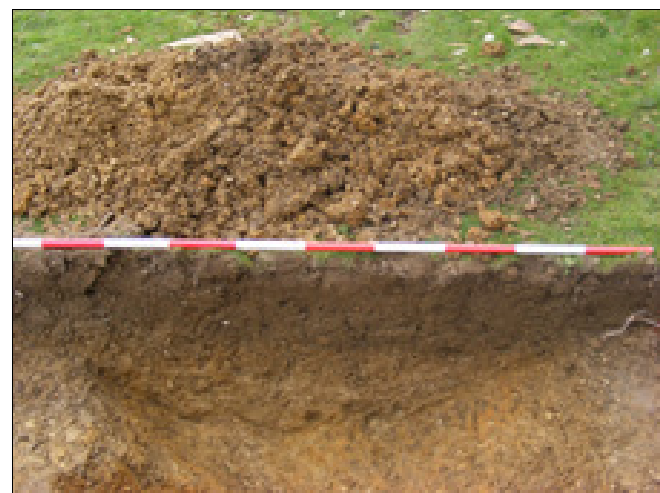
Gully [202] cut through a possible pit [204] on the southern side of the trench (Fig 5, Section 200). Pit [204] was only partially within the trench forming a semi circle 0.95m wide, 1.50m long and 0.25m deep (Plate 6). Pit [204] is truncated to the west by a cut for a gas mains pipe. The fill of pit [204], (205), contained no finds and the possibility remains that is a natural tree bole.

**Plate 6:** Section 200, pit [204] cut by gully [202], 2m scale

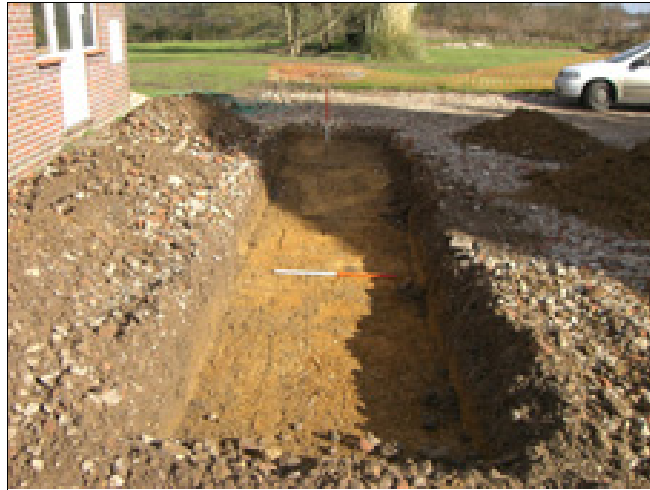
This was an 8m by 1.6. northeast-southwest trench along the southern edge of the proposed footprint where no archaeology was observed (Plate 7). Trench 3 was excavated through 0.17m of rubble hardcore (300) below which was 0.15m of firm silty clay subsoil (301) (Plate 8). The natural mid brown orange clay was reached 0.32m below the surface.

**Plate 7:** Trench 3 viewed from the southwest, 2x 1m scale

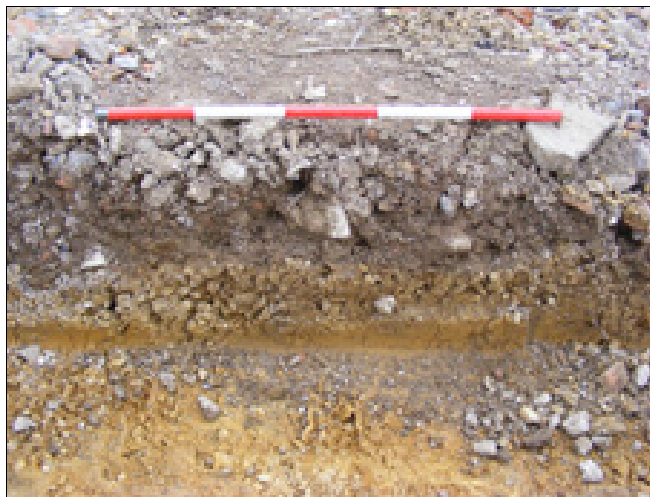
**Plate 8:** Trench 3, section, viewed from the northwest, 1m scale

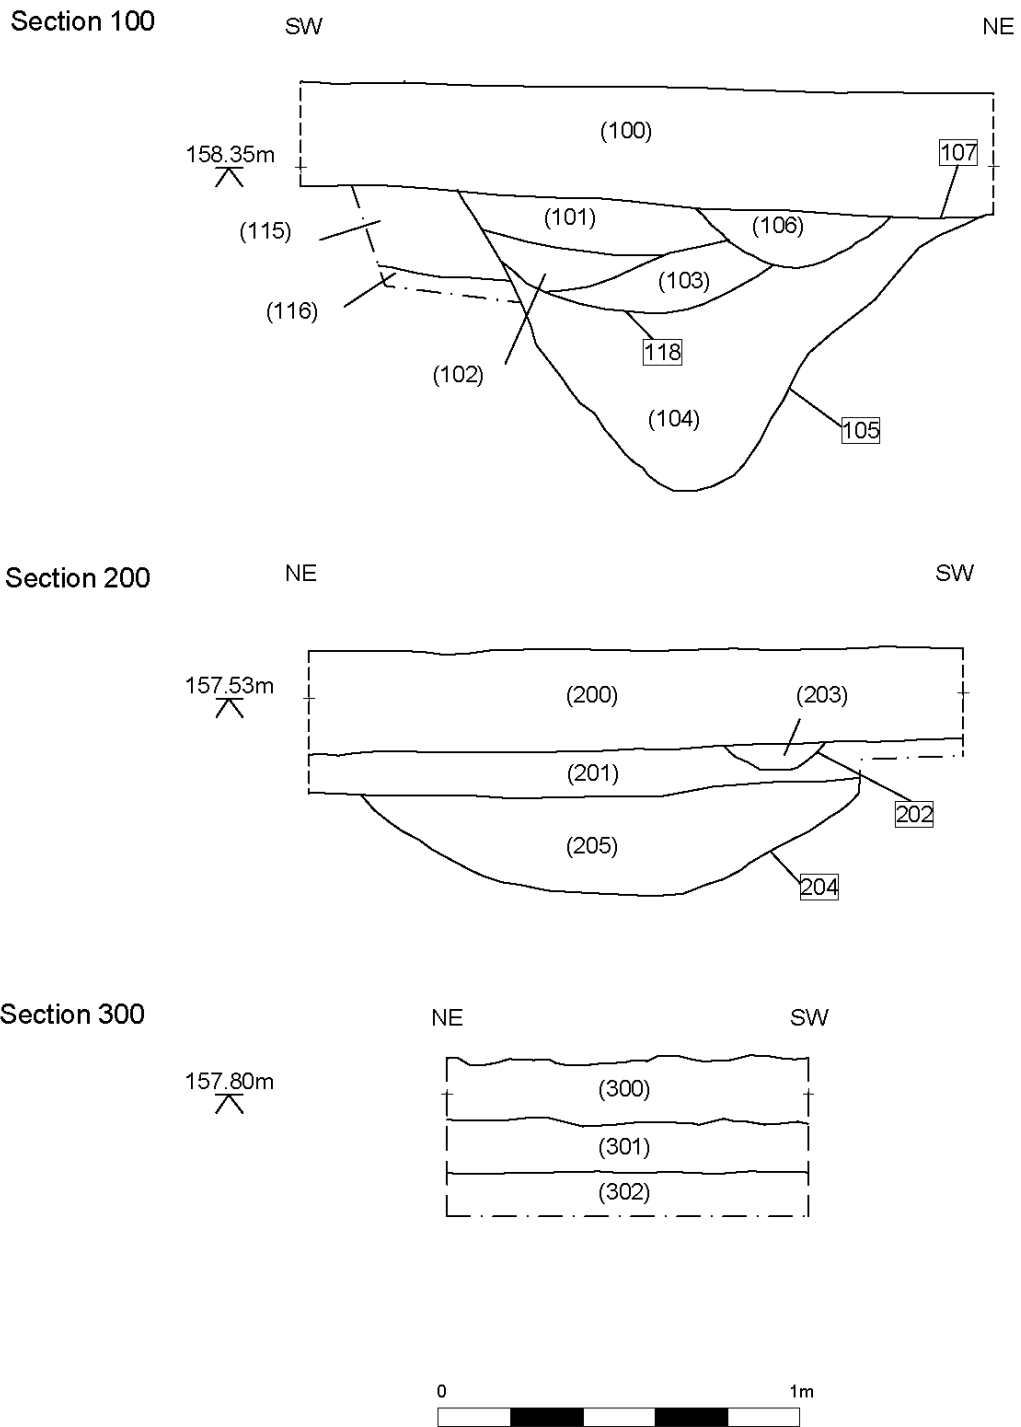
**Figure 4:** Sections (scale 1:20)

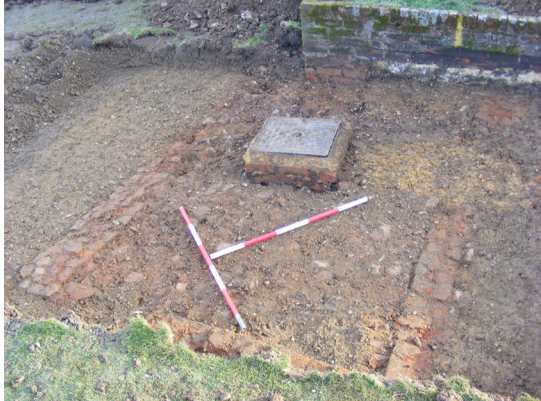
<b>Trench 1</b>

<b>Max Dimensions (m)</b>			
		<b>Width</b>	3.10	<b>Length</b>	5.00
		<b>Depth</b>	0.35	<b>Level (top)</b>	157.70mOD
		<b>NGR Coordinates</b>			
		<b>Centre</b>		SP 2496 7556	
<b>Orientation:</b>		E-W			
<b>Reason for Trench:</b>		Examination of Kiln discovered in the 1950's			
<b>Context</b>	<b>Type</b>	<b>Description and Interpretation</b>	<b>Width (max: m)</b>	<b>Length (max: m)</b>	<b>Thickness (BGL: m)</b>
100	Layer	Topsoil- Soft dark grey brown silty loam	>3.10	>5.00	0.35
101	Fill of 118	Tertiary fill of ditch, soft mid grey brown silty clay	0.75	>0.80	0.14
102	Fill of 118	Burnt tipped deposit, soft black red silty clay	0.50	>0.80	0.13
103	Fill of 118	Tipped deposit, soft mid brown red silty clay	0.60	>0.80	0.18
104	Fill of 105	Secondary fill firm, mid grey orange silty clay	1.31	>0.80	0.53
105	Cut	Boundary/Drainage ditch	1.46	>0.80	0.80
106	Fill of 107	Secondary fill, soft mid grey brown silty clay	0.50	>0.80	0.14

107	Cut	Small gully probably drainage	0.50	>0.80	0.14
108	Cut	Rectangular pit for kiln	2.45	>3.99	-
109	Structure	Lower outer tile built wall of firing chamber of kiln	>0.52	0.72	0.58
110	Structure	Upper outer tile built wall of firing chamber of kiln	0.35	9.49	0.37
111	Structure	Tile built wall holding firing chamber floor E-W	0.18	>0.69	0.52
112	Structure	Tile built wall holding firing chamber floor E-W	0.18	>0.62	0.52
113	Fill of 117	Backfill of disused kiln filling firing chamber	1.80m	2.90m	0.40
114	Layer	Re-deposited natural containing tile fragments	0.27	0.82	-
115	Layer	Subsoil- Firm mid brown grey silty clay	>3.10	>5.00	0.23
116	Layer	Natural-Tenacious mid brown orange clay, occ. stone	>3.10	>5.00	-
117	Group	Tile Kiln inc. 108-114	2.48	>3.24	>0.95
118	Cut	Recut of Ditch 105 filled with burnt deposits	>0.87	>0.80	0.31

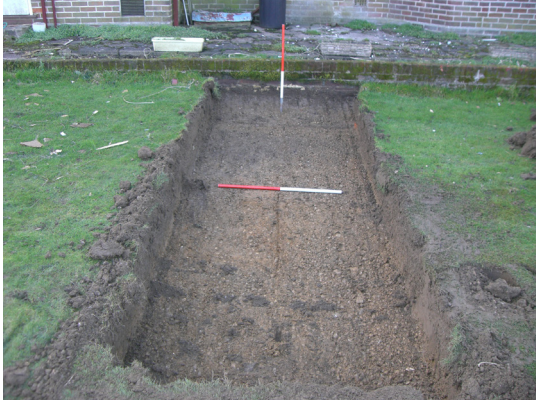
<b>Trench 2</b>

<b>Max Dimensions (m)</b>			
		<b>Width</b>	1.60	<b>Length</b>	4.70
		<b>Depth</b>	0.39	<b>Level (top)</b>	158.20mOD
		<b>NGR Coordinates</b>			
			SP 5498 7548	SP 2503 7549	
<b>Orientation:</b>			NE-SW		
<b>Reason for Trench:</b>		Pre-Planning Application			
<b>Context</b>	<b>Type</b>	<b>Description and Interpretation</b>	<b>Width (max: m)</b>	<b>Length (max: m)</b>	<b>Depth (BGL: m)</b>
200	Layer	Topsoil- Soft dark grey brown silty loam	>1.60	>4.70	0.28
201	Layer	Subsoil- Firm mid brown grey silty clay	>1.60	>4.70	0.12
202	Cut	Gully NW-SE	0.30	>1.60	0.07
203	Fill of 202	Secondary fill, soft mid grey brown silty clay	0.30	>1.60	0.07
204	Cut	Probable pit, sub circular concave	>1.38	>0.93	0.29
205	Fill of 204	Firm mid orange grey silty clay	>1.38	>0.93	0.29
206	Layer	Natural-Tenacious mid brown orange clay	>1.60	>4.70	-

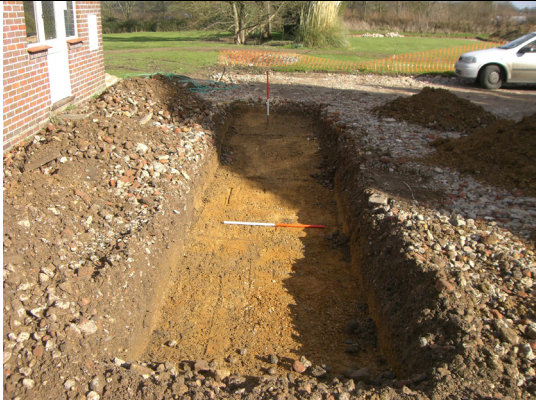
<b>Trench 3</b>

<b>Max Dimensions (m)</b>			
		<b>Width</b>	1.60	<b>Length</b>	8.00
		<b>Depth</b>	0.44	<b>Level (top)</b>	158.03mOD
		<b>NGR Coordinates</b>			
			SP 5492 7535	SP 2500 7538	
<b>Orientation:</b>			NE-SW		
<b>Reason for Trench:</b>		Pre-Planning Application			
<b>Context</b>	<b>Type</b>	<b>Description and Interpretation</b>	<b>Width (max: m)</b>	<b>Length (max: m)</b>	<b>Depth (BGL: m)</b>
300	Layer	Compacted rubble layer	>1.60	>8.00	0.17
301	Layer	Subsoil- Firm mid brown grey silty clay	>1.60	>8.00	0.15
302	Layer	Natural-Tenacious mid brown orange clay	>1.60	>8.00	-
