WATCHING BRIEF: WILLISHAM TO SOMERSHAM WATER MAIN REPLACEMENT SCHEME SUFFOLK

TM 0699 5072 to TM 0724 4928

on behalf of Anglian Water Services Ltd

ASC: 931/WSM/2

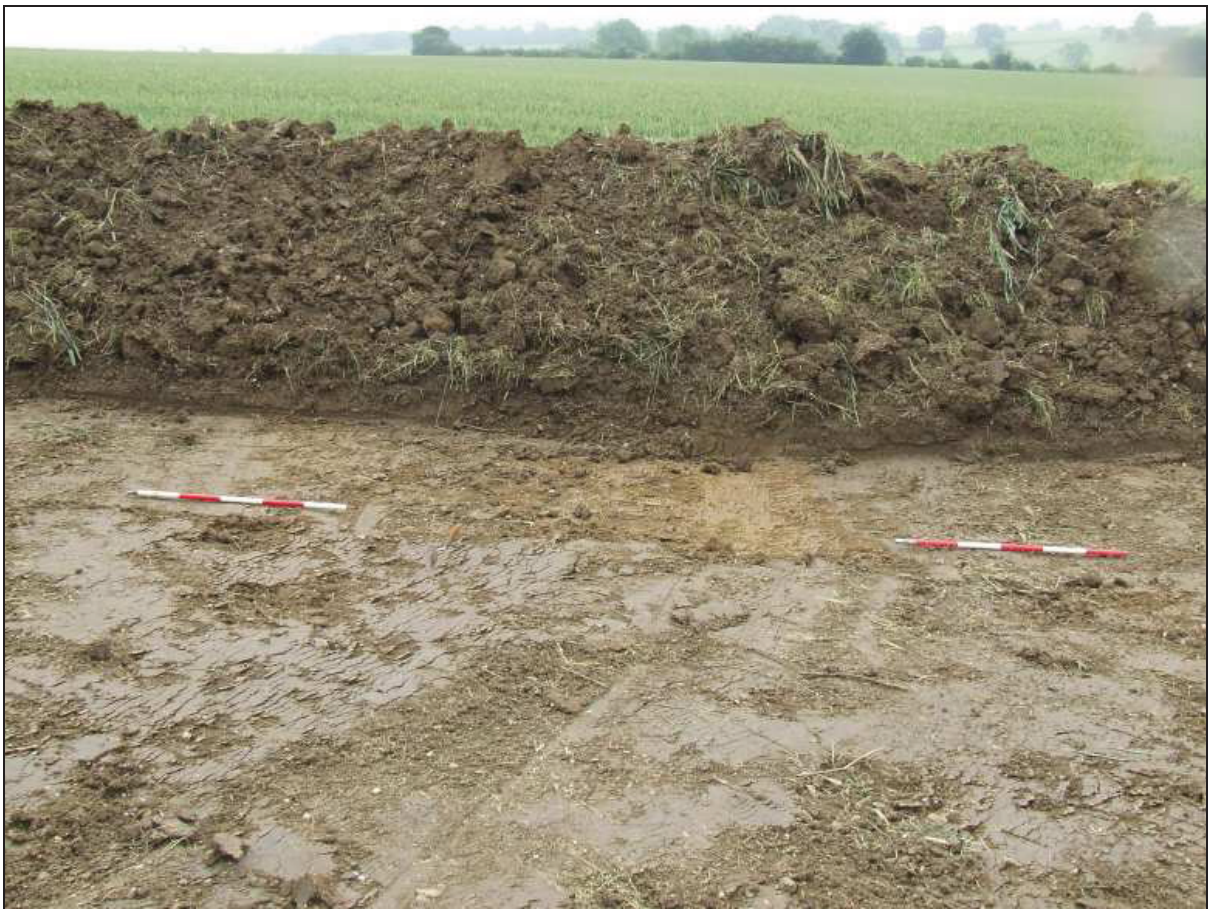
- 4.3 Along much of the monitored route regular east west orientated bands of slightly darker soil spaced between 4.5–5.0m apart were observed. Though upon excavation these feature were very shallow (50-100mm) it is possible that they represent evidence of medieval “stetch” ploughing a local form of ploughing which produced smaller ridges and furrows than the more traditional medieval ploughing seen across much of the country.

Plate 1: Possible medieval plough furrows to the west of Ipswich Road
