**WATCHING BRIEF:  
THE BARN, LIME STREET,  
OLNEY,  
BUCKINGHAMSHIRE**

NGR: SP 88730 51170

February 2008

ASC: 1040/1

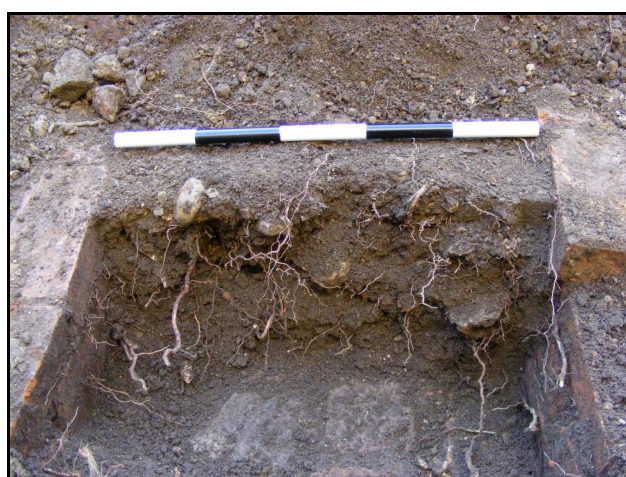
**Plate 3:** Section through brick-lined Feature B. Scale 50cm

- 4.5 A brick-lined pit also cut through the surface of the natural (Fig. 5, B: Plate 3). The section above it was checked for signs that it was cut from higher up in the stratigraphy, but this was absent. It was constructed with three courses of bricks, which were hand-made, un-frogged and measuring 190 x 88mm to 90 x 55mm. The sides were five bricks in length laid end-to-end and the sides three, measuring a maximum of 1.07 x 0.80m and 0.2m deep. The base was lined with burnt limestone and brick, and infilled with very loose dark brown silt containing very frequent late 19<sup>th</sup> century pottery, chicken and pig bones, iron nails and roots. A large limestone block in the top of the fill had the remains of an iron lid adhered to its rear.

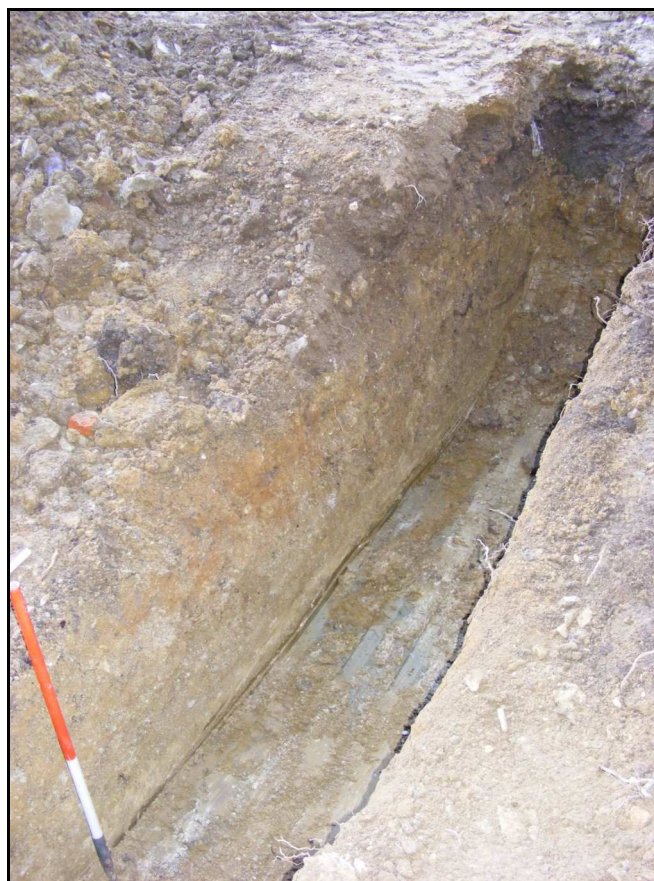
**Plate 4:** Section of northern foundation trench showing blue-grey boulder clay and yellow/brown and orange silty natural, overlain by topsoil and made ground. Scale 1m

- 4.3 A watching brief was maintained during ground reduction within the footprint of the extension and the excavation of the foundation trenches. All deposits were removed using mini-excavators fitted with 0.60m wide toothed ditching buckets. The stratigraphy across the footings was fairly consistent (Plate 4). The natural comprised grey-blue very stiff boulder clay, which was exposed in the lowest 0.50m of the southern trench and parts of the northern and western trench. This was overlain by brown/yellow and orange mixed sandy silt with limestone and gravel natural, some in slight involution hollows, between 0.70 and 1.20m in depth, whose surface rose up towards the west. This was also exposed within the barn and in the service trenches.
