**ARCHAEOLOGICAL EVALUATION:
MIDDLE MILL ROAD
COLCHESTER
ESSEX**

NGR: TL 9970 2559

on behalf of N R Powell Developments Ltd

ASC: 1018/CMM/1

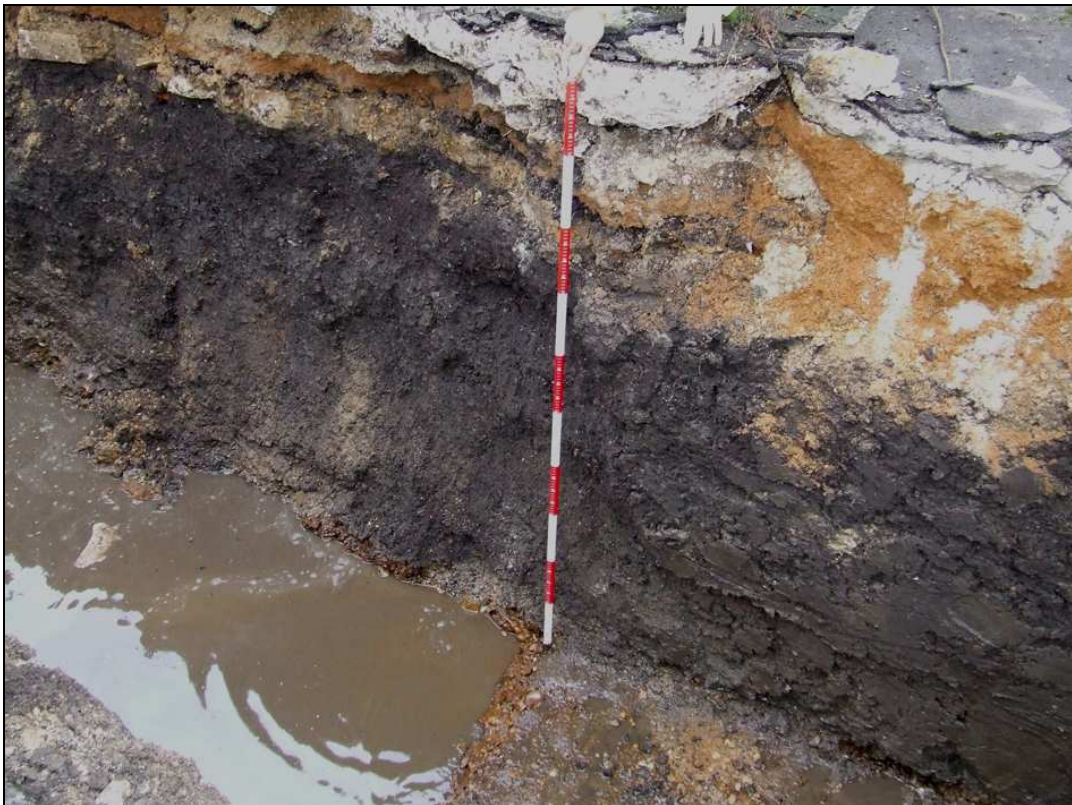
Plate 1: Trench 2, stratigraphy

The stratigraphy of Trench 2 consisted of the existing concrete and modern construction layers to a depth of 0.35m, overlying up to 1.55m of very dark grey silty clay alluvium. The natural geology consisted of dark orange sandy gravel (Plate 1).

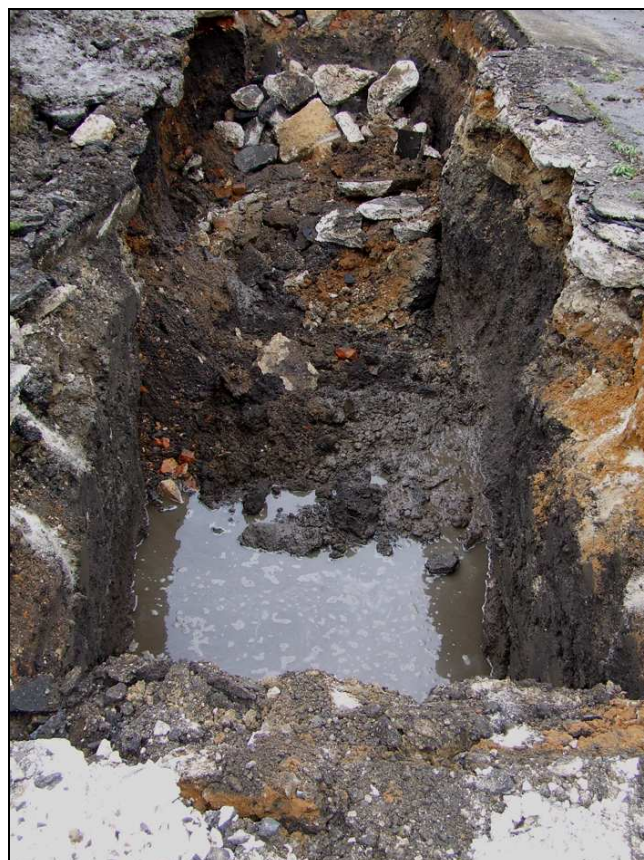
Plate 2: Trench 2, facing north

4.3 The site is located c.7m south of the river Colne, within the historical flood plain. The trench was excavated to the first archaeological horizon or the natural geology, and its depth was such that the water table was encountered. The combination of the machining action and the depth of the water led to the sides of the trench being eroded and undermined. The resulting collapses meant the trench had to be abandoned 3m short of its intended length (Plate 2).

4.4 Despite the severity of the subsidence within the trench, it was possible to observe the natural geology as it was freshly exposed, and no archaeological cut features or deposits were noted.

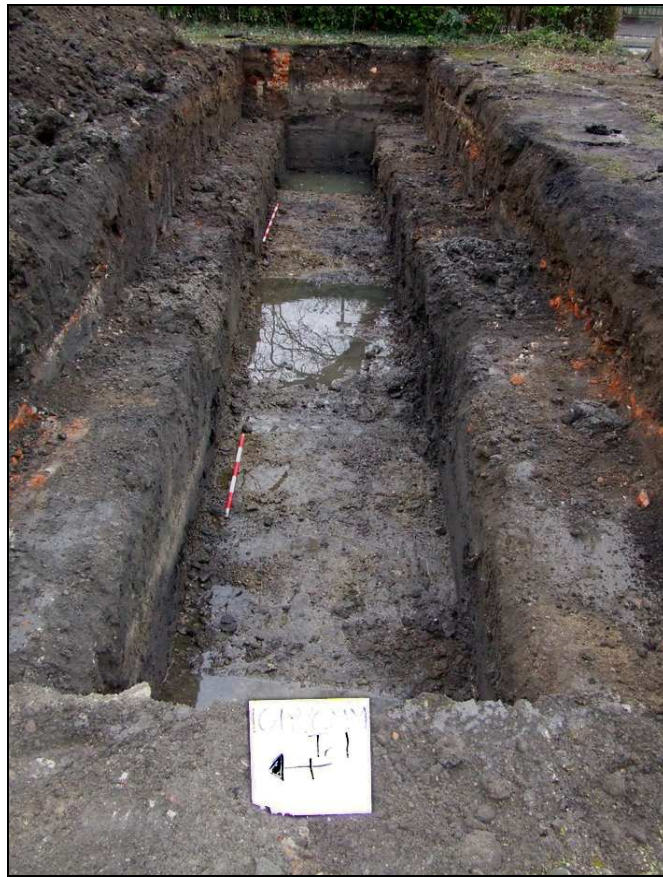
Plate 3: Trench 1, facing east

Trench 1 was 15.5m in length and orientated east-west. It was extended by 3m from its proposed length to compensate for the reduction in Trench 2. As the ground had proved to be unstable, the second trench was widened and stepped to allow safe access to the base.

4.7 The stratigraphy consisted of the existing tarmac surface and construction layers overlying a mid orange brown, sandy gravel layer of made ground, 0.6m in depth. Below this was up to 0.8m of alluvial deposit overlying the sandy gravel natural. Within the alluvial deposit, at the western end of the trench, was a lens of yellowish, fine sandy gravel, up to 0.4m in depth and at least 3m in length.

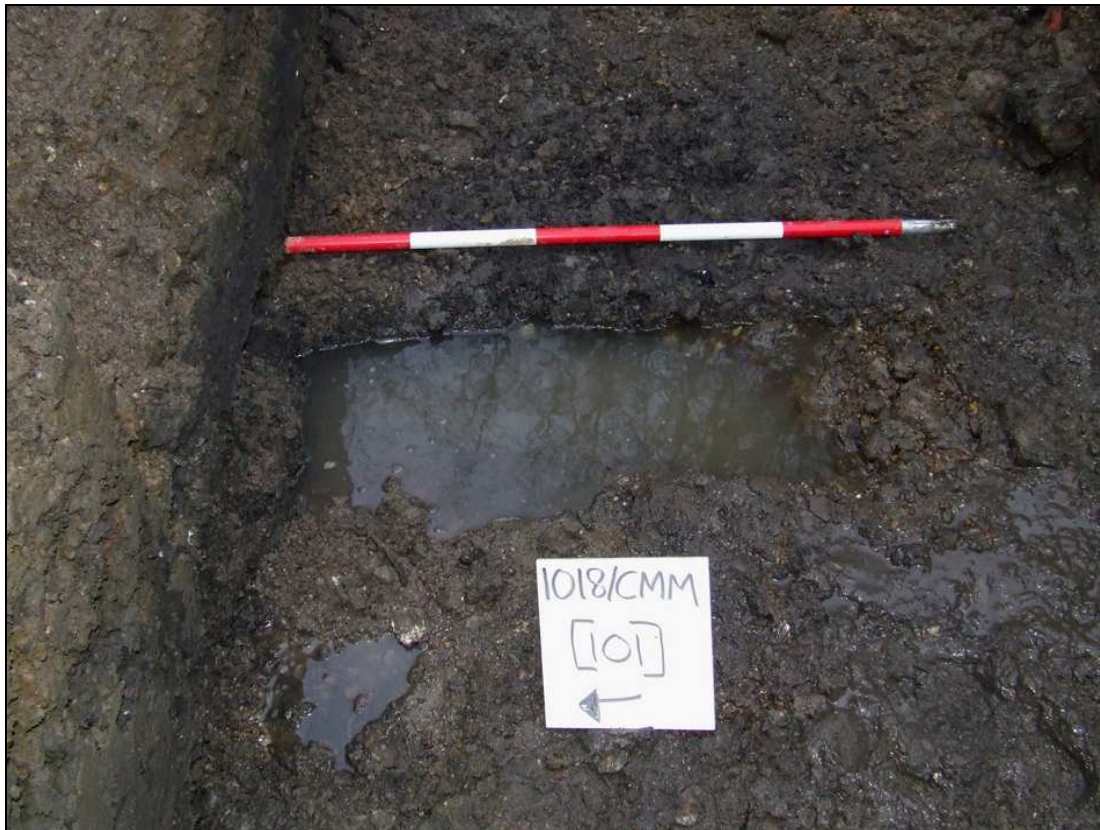
Plate 4: Pit [101], facing east

- 4.11 At the base of the trench, cut into the natural gravel, five sub-circular features were observed while the trench was being excavated. Due to the rapid rise in the water level, only two of the features [101] and [103] were accessible for investigation (Plates 4 & 5). Both were shallow, measuring less than 0.15m, and both contained the same very dark grey, silty fill, with frequent sub-ovoid flint <80mm in diameter, (102) and (104). Both fills also contained low grade CBM, and (104) contained oyster shell and one fragment of cattle bone.

- 4.12 Whilst the CBM is fragmentary, the size and fabric of some of the pieces would suggest it may be Roman in date. Other fragments of CBM, also probably Roman in date, were recovered from unstratified contexts. Detailed information regarding the trial trench and its contents appears in Appendix 1.

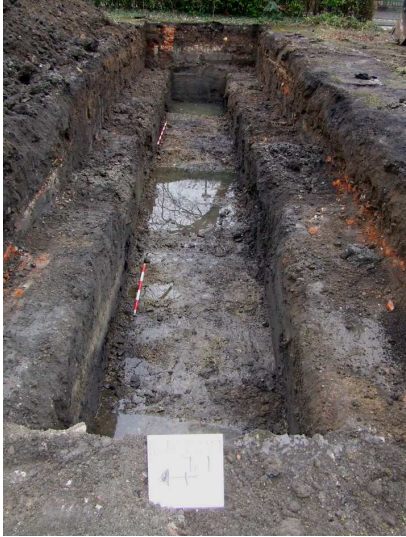
| Trench 1 | | | | | | |

| Trench 1 | | | | | | |
|---|---|--|---|---|---|---|
| | Length | 15.5 | Width | 1.6 | Depth | 1.9 |

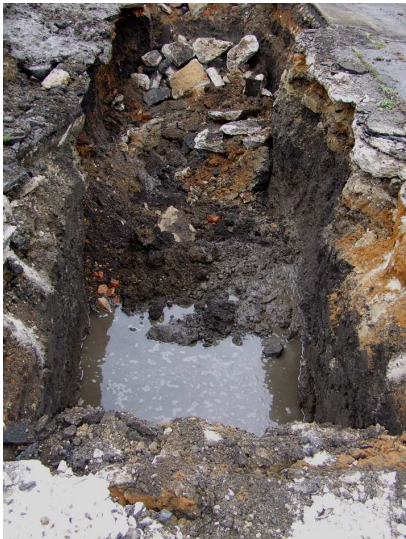
| Trench 2 | | | | | | |

| Trench 2 | | | | | | |
|---|---|---|---|---|---|---|
| | Length | 9.5 | Width | 1.6 | Depth | 1.9 |
