**HISTORIC BUILDING ASSESSMENT:
SHENLEY DENS FARMHOUSE
CALVERTON ROAD
WHADDON
MILTON KEYNES**

on behalf of Persimmon Homes

November 2007

ASC: 992/SDF/1

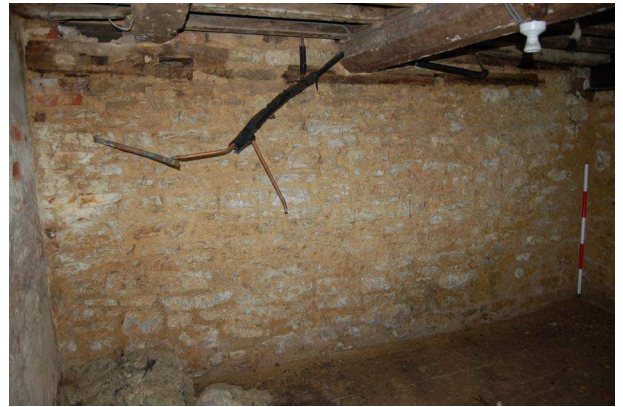
Plate 8: Cellar C1: east wall

Description: External walls of limestone blocks, internal dividing wall of hand made bricks set in lime mortar. The floor is also of brick. It is accessed by a brick staircase of 11 treads in the north wall. The topmost riser appears to have been reduced in height. The ceiling is of re-used timbers with a chamfered beam (9cm wide straight chamfer) and joists measuring c.10 x 10cm on 30cm centres. The joists show evidence for lath and plaster. The floorboards above are 24-25cm wide. There is an RSJ along the south wall of the cellar. Two cupboards are located above the axial beams at the northern end of the cellar. There is an opening in the west wall to Cellar C2.

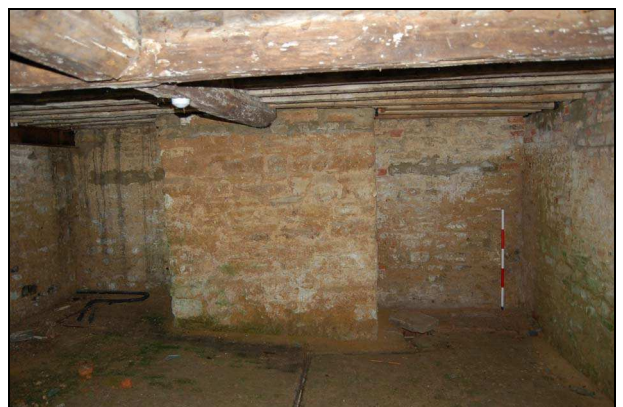
Plate 12: Cellar C2: west wall

Description: This is similar to C1 in that the walls are stone and the ceiling is of re-used timbers. The brick internal wall has a bonding timber on either side of the opening to Cellar C1. The axial beams, which also have straight chamfers, cross in the centre of the room and the joists are 12 x 10cm on 30cm centres. Some reinforcement and repair has occurred fairly recently with some of the joists having been replaced in the northwest corner and a buttress built of Fletton brick now supports the southern end of the binding beam. There is a runnel in the brick floor that empties into a drain in the northwest corner of the room. There is a chimney stack in the west wall and a blocked up window in the south wall.

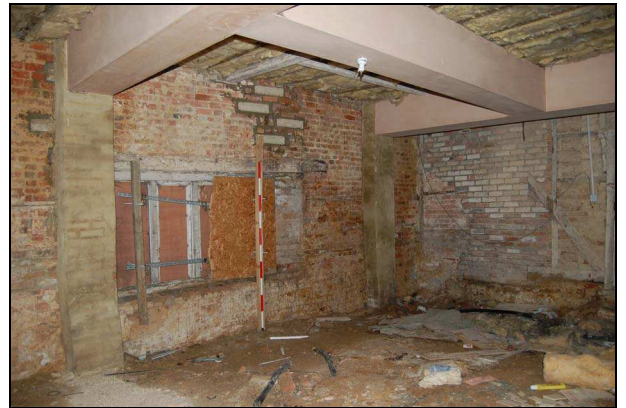
Plate 16: Room G1: northeast corner

Description: Known as 'The Ballroom', this room has been denuded of its floor, wall coverings (including plaster) and lath and plaster ceiling. The exposed walls reveal part of a timber frame as well as some modern brickwork in the east wall and bonding timbers in the other walls. There is a blocked, 4-light casement window in the north wall and another window under a timber lintel in the west wall.

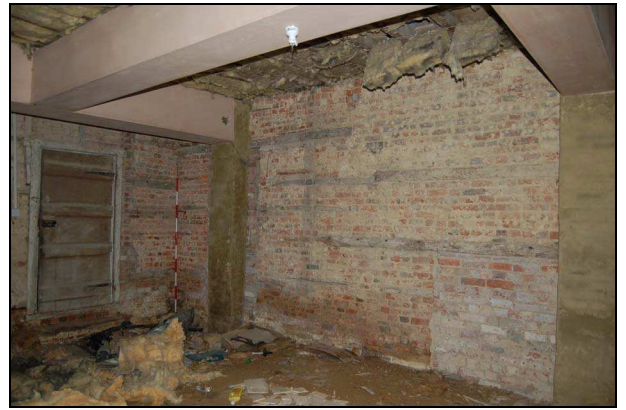
Plate 20: Room G1: southeast corner

There are three steps up to the lobby (G6) and the plank and batten lobby door has 5 planks with bead moulding. A number of modern RSJs help to support the ceiling. There is, however, a chamfered beam with no stops at the west end of the room

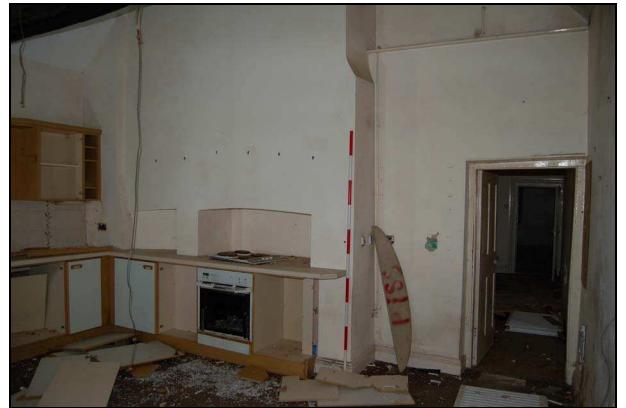
Plate 22: Room G2: west wall

Description: This is the kitchen, which lies in the single storey extension at the eastern end of the building. The walls are mainly painted, although there is some tiling along the south and east walls. There is a modern 4 over 8 light sash window in the south wall and a 4-light window with two opening casements in the north wall. The door into the kitchen is located in the northwest corner, beside the fireplace that now houses a cooker. The door itself is now missing. There is a recess in the alcove above the door opening and another to the south of the fireplace. Modern kitchen units have been installed along the south, east and west walls. There are carpet tiles over the original York stone floor. The roof truss is partially exposed and there are two raking struts to the west of it.

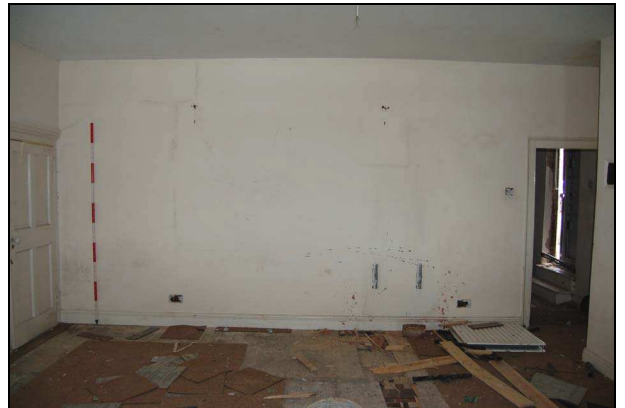
Plate 28: Room G3: north wall

Description: This reception room has a door opening in the north wall to the lobby (G6), another in the east wall to the kitchen (G2), and two in the west wall; one to the hall (G4) and the other to the cellar (C1). Only the cellar door opening has retained its door, which is a Victorian design of 4 panels. The window in the south wall consists of two 4 over 4 sash windows flanking a 6 over 6 light sash set within a full height recess.

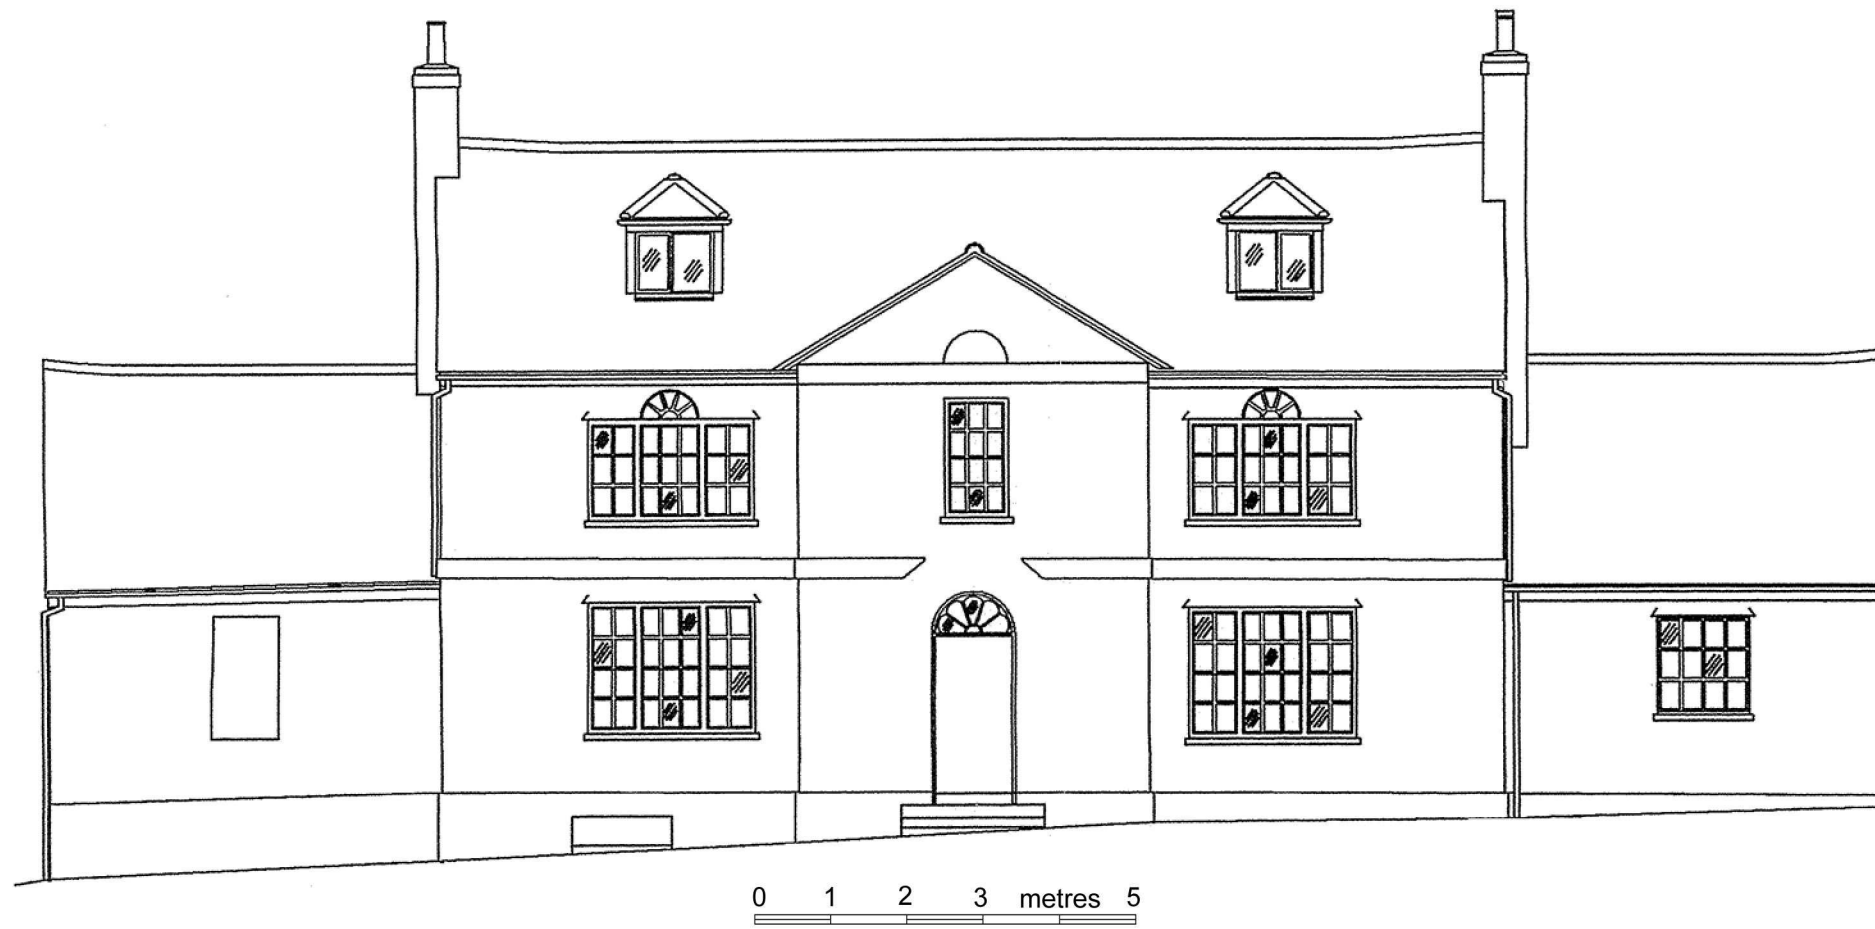
Figure 8: South elevation (scale 1:100)

This is the front elevation of the farmhouse, which has a single storey side extension to either side. The walls are rendered but a plat band is still apparent between the ground and first floors. There are four windows on the ground floor and three on the first floor. The window in the eastern extension has been bricked up and rendered. The front door has two steps leading up to it.

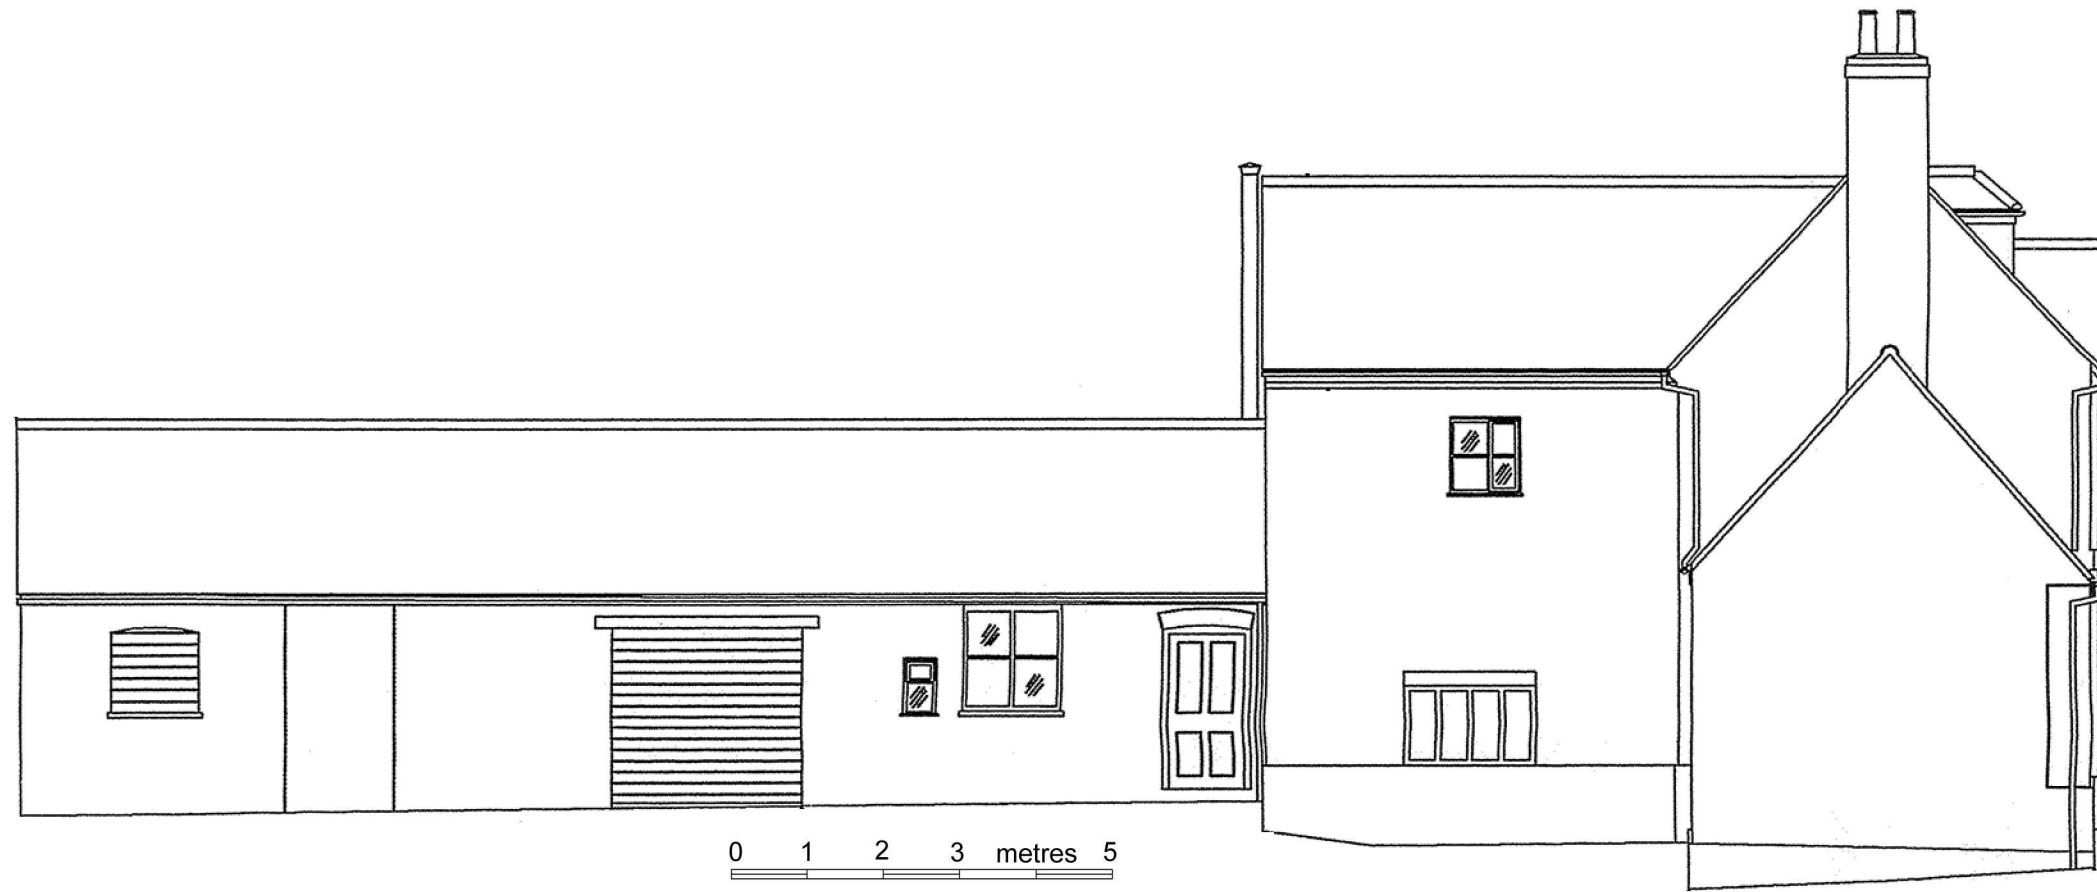
Figure 9: West elevation (scale 1:100)

This has no doors in the main build and no openings in the side extension at all. The main build has a window on the ground floor with a timber sill and a soldier course above. The window on the first floor has a timber sill and lintel.

The brickwork is as before, but queen closers were noted on the side of the extension. In addition, the main build has two courses of protruding brickwork under the eaves.

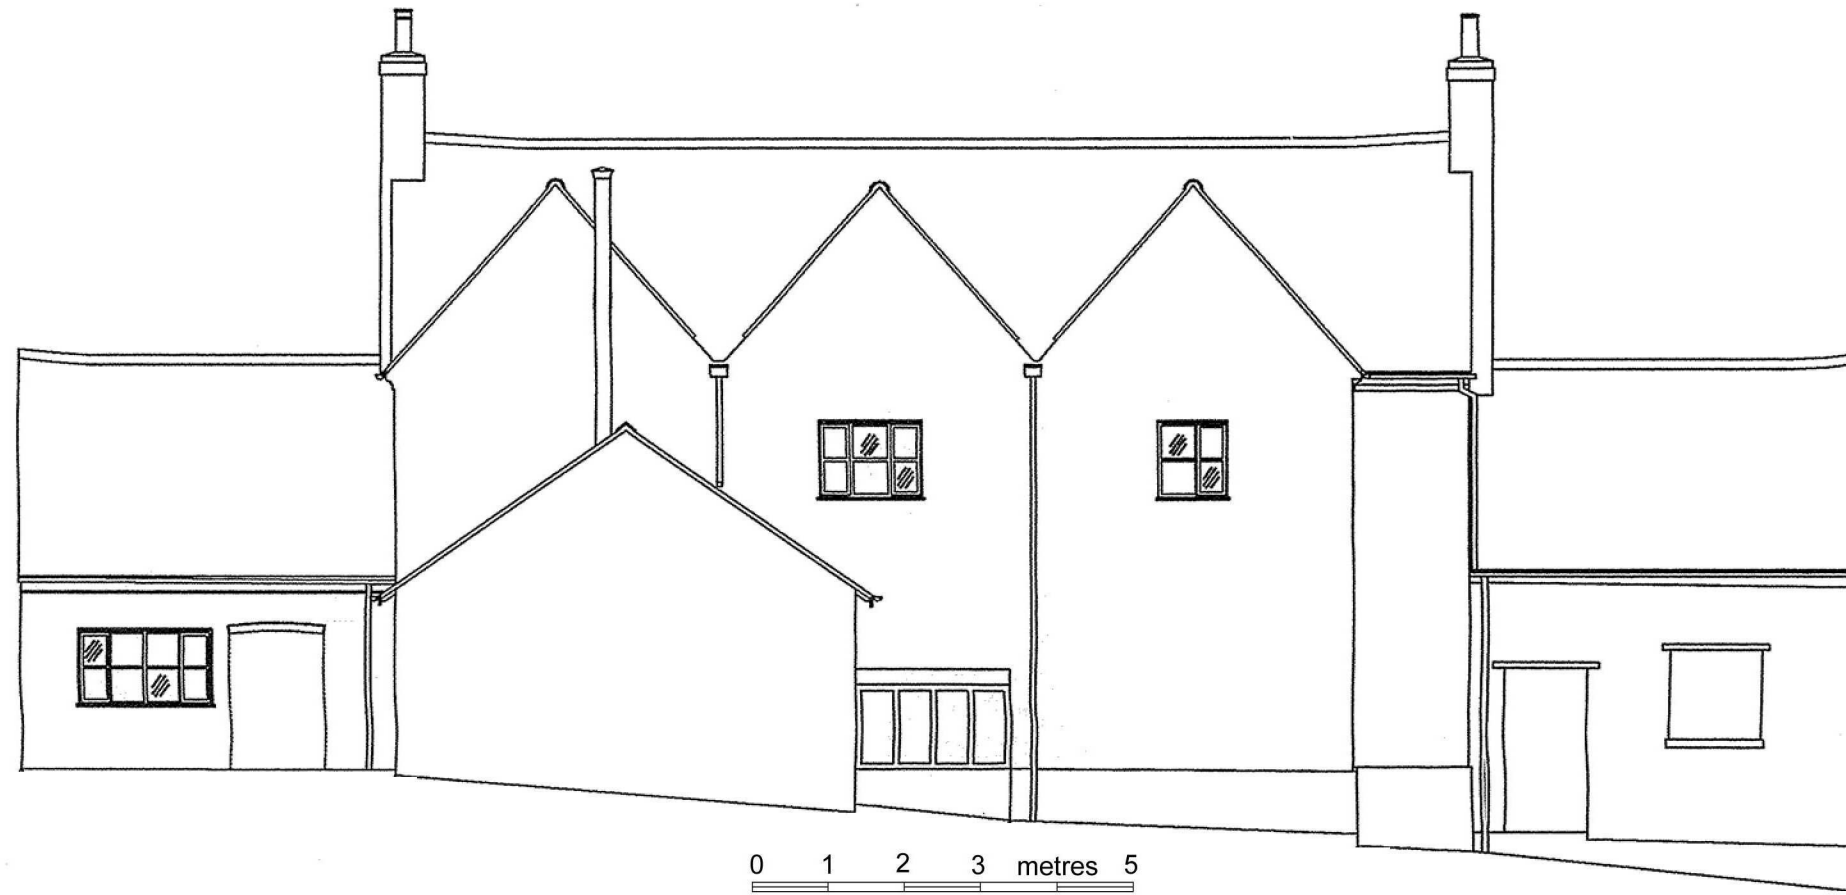
Figure 11: North elevation (*scale 1:100*)

The north elevation of the main build has three gables, the western two of which have a window at first floor level and a blocked door in the centre. There is a door and window in the north elevation of the west addition and a window in the eastern addition.
