### **ARCHAEOLOGICAL EVALUATION: THE OLD RECTORY, LATHBURY, MILTON KEYNES**

*on behalf of Mr & Mrs Tice*

**September 2007**

**ASC: 963/LOR/2**

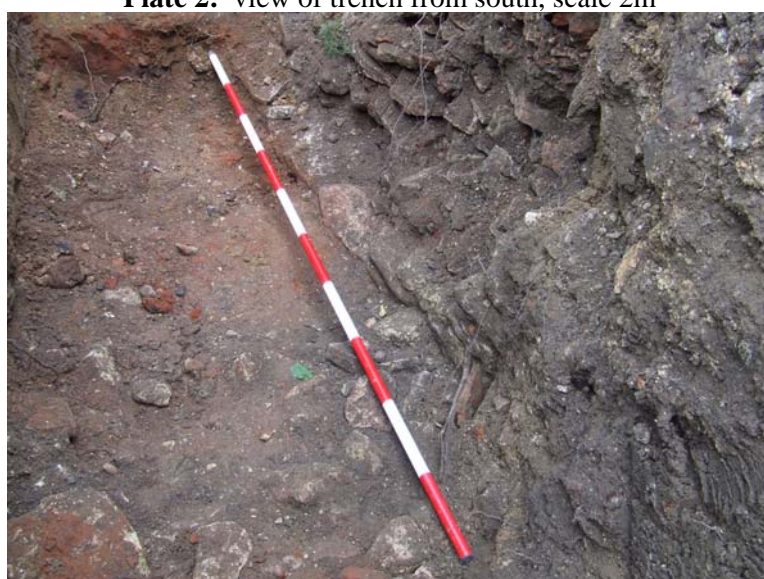
**Plate 3:** view of wall footings from north east, scale 2m

- 4.3 The footings of a limestone wall (1006), interpreted as being the wall of a cess-pit were observed beneath this rubble layer at a depth of 1.80m below the current ground surface. A deposit of dark red sand (1007) was associated with the footings. The three courses of un-mortared footings were within cut [1008], which was excavated into the yellow sand natural strata (1009) (Plates 3-4 and 6).

- 5.1 The remains of unmortared limestone wall-footings (1006), [1008] were observed 1.70m below the existing ground surface. These were associated with deposits of dark red sand (1007), which may have been decomposed bricks (again, unmortared). No floor was observed within this structure, and it has been interpreted as being a cess-pit. It is likely to have been constructed at the same time as the house in the 17<sup>th</sup> century, and to have gone out of use by the 19<sup>th</sup> century. A thick layer of limestone rubble with roof tiles and occasional broken brick fragments (1005) overlay the wall footings. This has been interpreted as being the demolition rubble from a superstructure over the cess-pit. No cess remains were observed within the trench, and it is therefore likely that the pit had been cleaned out prior to the superstructure being demolished.

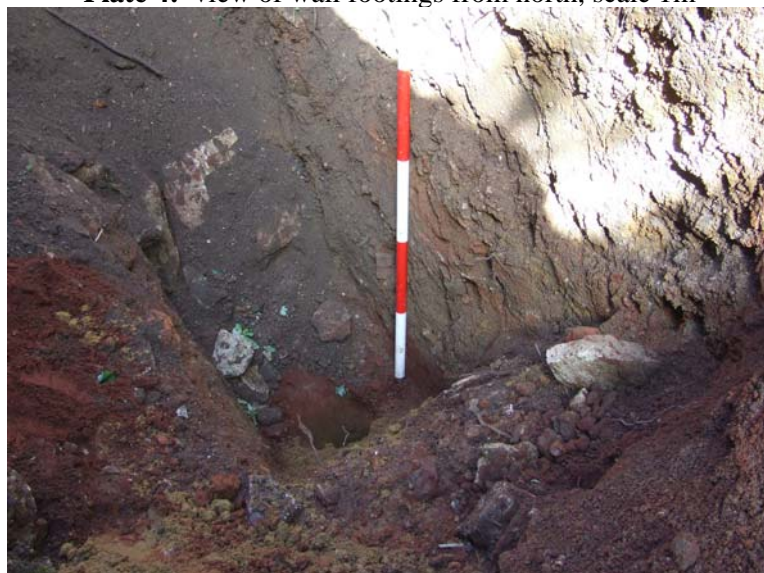
**Plate 5:** base of cess pit from south, scale 1m

- 4.5 A 0.50m wide test pit was excavated by machine to a depth of 2.30m below ground level, adjacent to the wall footings, in order to investigate the deposits in this area. A further 20cm by 20cm test pit was excavated by hand in the base of this test pit to a depth of 0.40m below the base of the trench as the machine could no longer reach the base of the trench (Fig. 6). The dark red sandy deposit (1007) extended a further 0.10m, the remaining 0.30m consisted of yellow sandy natural (1009) (Plate 5).

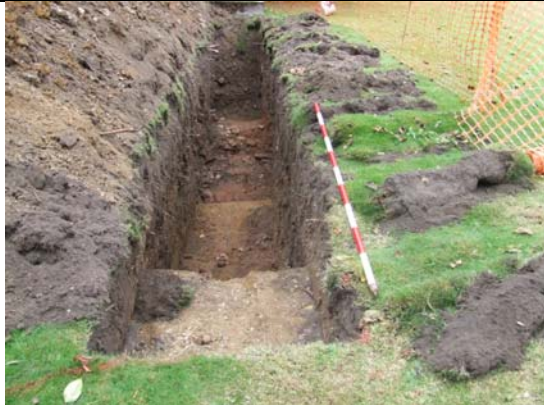
Trench 1

Max Dimensions (m)				
		Width	1m	Length	10m	
		Depth	2m	Level (top)	58.42mAOD	
		NGR Coordinates				
		Orientation:		WNW-ESE		
Reason for Trench:		Within footprint of swimming pool				
Context	Type	Description and Interpretation	Max Width (mm)	Max Thckn (mm)	Depth BGL mm)	
1001	Deposit	Dark greyish black silty clay, topsoil	-	350	0	
1002	Deposit	Pale yellow gravel, redeposited natural soil	-	150	300	
1003	Deposit	Dark grey subsoil with rubble inclusions, modern debris	-	2000	300	
1004	Deposit	Pale yellow gravel with rubble and charcoal inclusions – demolition layer	-	400	700	
1005	Deposit	Limestone and tile rubble, demolition rubble from superstructure over cess-pit	-	800	700	
1006	Wall	Limestone wall footings for cess-pit	-	400	1800	
1007	Fill	Dark red sand, possible degraded bricks, within cut for footings	-	300	1700	
1008	Cut	Cut for wall footings, contained (1007) and (1008)	-	500	1700

1009	Natural	Yellow sand natural substrata	-	-	1300

- 4.2 The topsoil (1001) was a dark greyish black silty clay soil, and was between 0.20m and 0.35m in thickness. This overlay a 0.15m thick deposit of light yellow sand and gravel (1002). Below this, a dark grey silty clay soil with occasional inclusions of limestone and tile (1003) overlay a 0.35m thick, compacted deposit of light yellow sand and gravel with occasional inclusions of limestone and roof tile fragments and frequent inclusions of charcoal (1004). This overlay a 0.80m thick deposit of loose limestone pieces and roof tile fragments (1005).
