### **WATCHING BRIEF: BRADWELL ABBEY MILTON KEYNES**

National Monument No. 19062

**ASC: 950/BAG/2**

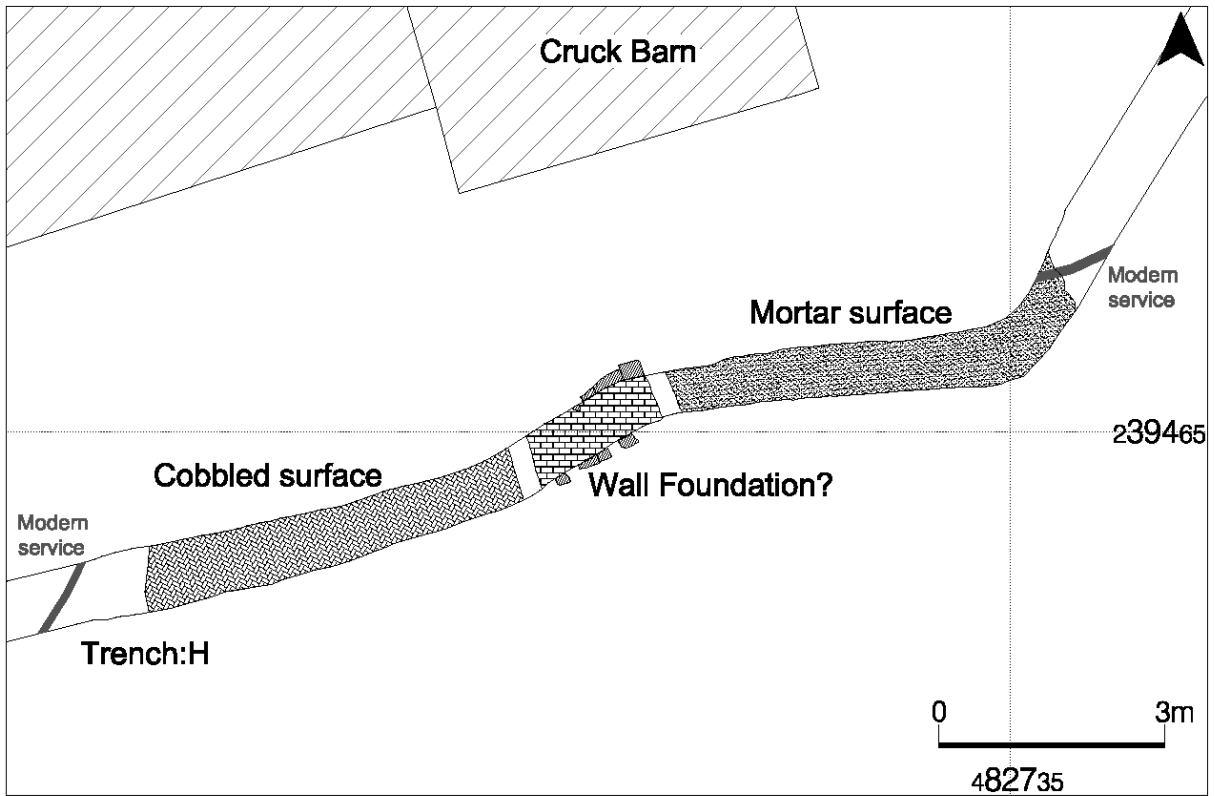
Figure 3: Trench H, detail (scale 1:100)

Trench H was c.0.3m wide, 0.4-0.6m deep and c.50m long. It ran east-west through the south farmyard, to the south of the cruck barn. Excavation revealed possible structural remains (Plates 9,11 & 13) as well as a possible cobbled (Plates 8, 9 & 12) and mortar (Plate 10) surfaces. These were located to the immediate south of the extant cruck barn midstrey.

The structural remains comprised a possible north-south stone wall footing, aligned with the west wall of the midstrey. The footing was c.1.6m in width. To the west was a cobbled surface, at least 5m in width, and to the east was a mortar surface of similar extent.

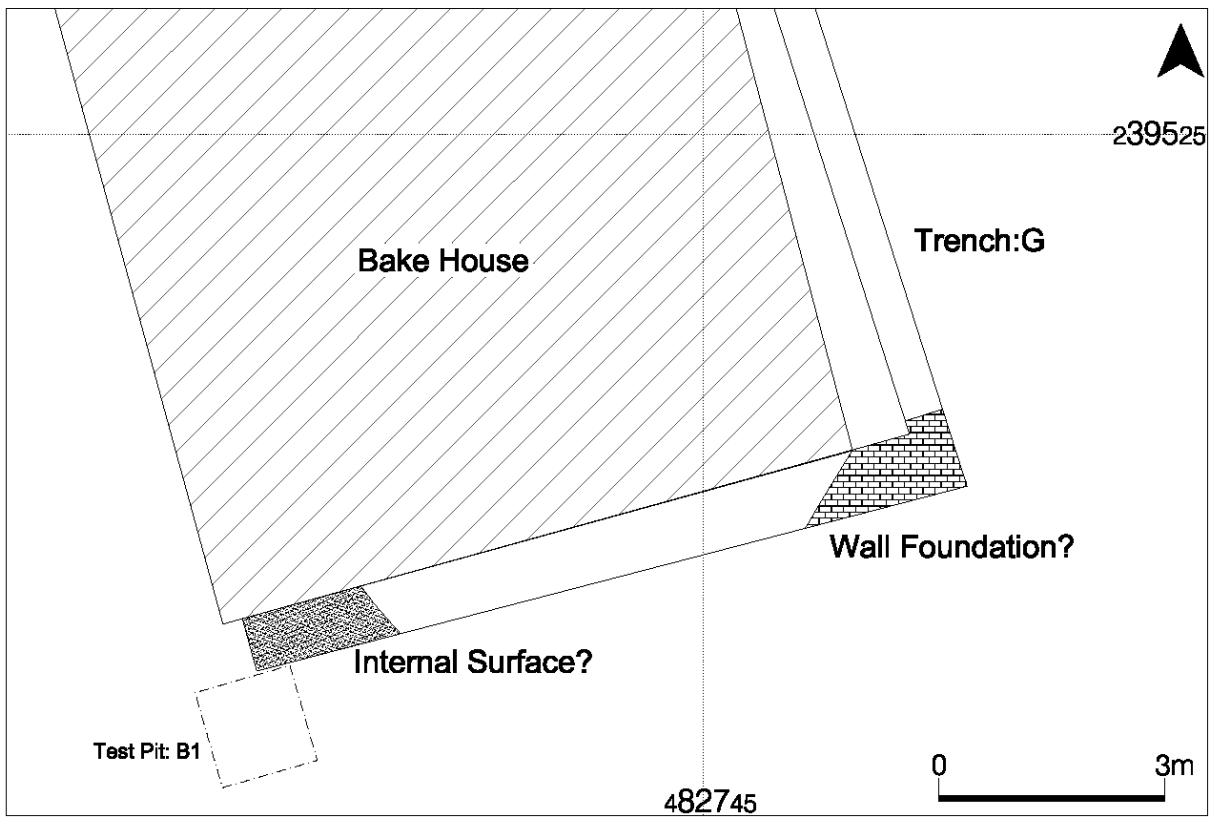
Figure 4: Trench G, detail (scale 1:100)

This section of pipe trench extended from Pit B1 around the south and east sides of the bakehouse (Figs 2 and 3). At the west end of the trench an area of limestone cobbles was revealed at a depth of 0.5m, while an area of flatter larger stones by the south-east corner of the bakehouse may represent a wall footing. Mortar and further stones could also be seen in section at the east end of the trench.

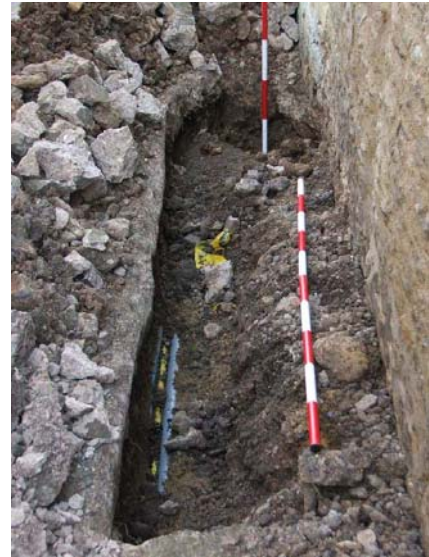
**Plate 2:** Test pit A, facing W.

This was 3.5m in length, 0.6m wide and 0.5m deep, and was located against the south wall of the interpretation centre (Fig. 2). On excavation, the wall footings on the north side of the trench were noted to be c.200mm deep. Beneath the modern concrete surface was c.100mm depth of redeposited topsoil, overlying c.200mm of brick rubble. It was evident that this pit was largely located on the line of the gas main installed in the 1980s.

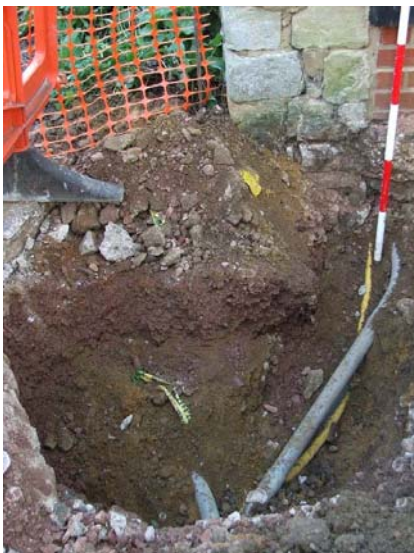
**Plate 3:** Test pit B1, facing N

Two pits were excavated at the south end of the bakehouse to locate the existing main (Fig. 2). Below the modern concrete, Pit B1 revealed 300mm depth of rubble overlying natural orange clay. Below the modern concrete in Pit B2 was 500mm depth of redeposited topsoil, overlying natural orange clay. Both pits were excavated within areas previously disturbed by the laying of the original gas main, and no archaeological remains were observed.

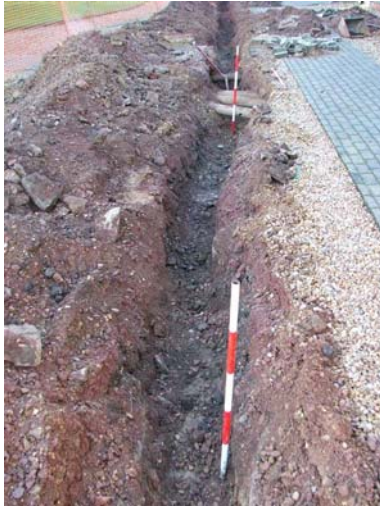
**Plate 7:** Centre of Trench H showing services, facing W

A number of modern service trenches were also encountered (Plate 7).

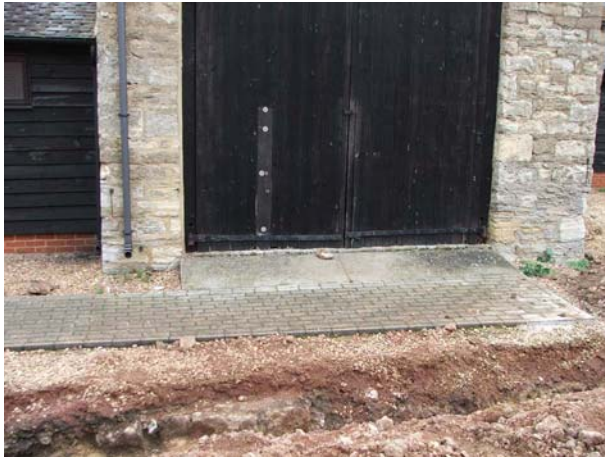
**Plate 13:** Alignment of Cruck barn and possible wall structure in foreground, facing N (note different thickness of Cruck barn walls)

- 5.4 Both discoveries in Trench G and H were not of surprise due to their close proximity to the still standing Benedictine abbey buildings, although the potential relationship with the wall found in Trench H and the Cruck barn were. The direction and significance of the possible wall and floor surface within Trench G cannot be determined due to the restraints of the size of the pipe Trench.

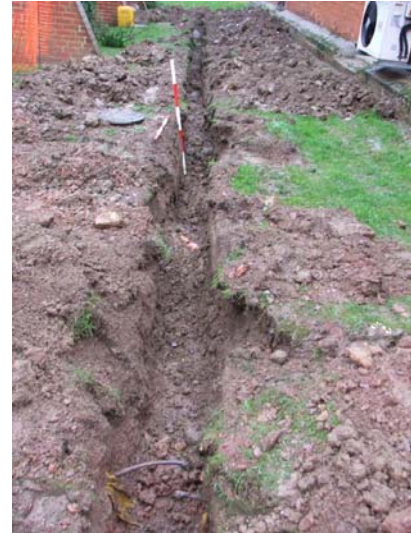
**Plate 14:** Trench I, facing S

This trench was c.0.3m wide, c.0.5m deep and c.20m long and ran southwards from Trench H, entering the Discovery Centre near its south-west corner (Fig. 2). No archaeological finds or features were observed. The revealed soil profile consisted of:
