HISTORIC BUILDING RECORDING: 50 MARKET PLACE BRACKLEY NORTHAMPTONSHIRE

on behalf of MP Brackley Ltd

May 2007

ASC: 916/BMP/1

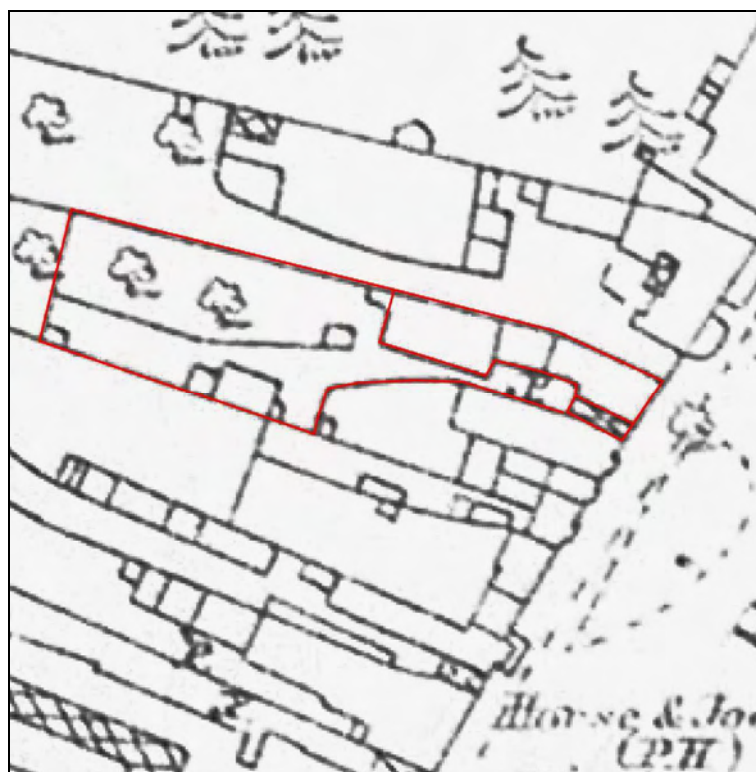
Figure 3: Extract from the 1855 Ordnance Survey Map (*not to scale*)

The earliest cartographic evidence for the site is from the 1830 Enclosure Map, where it is recorded that the house and garden belong to William Cave. Although not depicted here, the map shows a similar layout to that on the 2nd edition Ordnance Survey map of 1885 (Fig. 3). The current configuration of buildings is already present with an additional structure at the western end and more outbuildings than today.

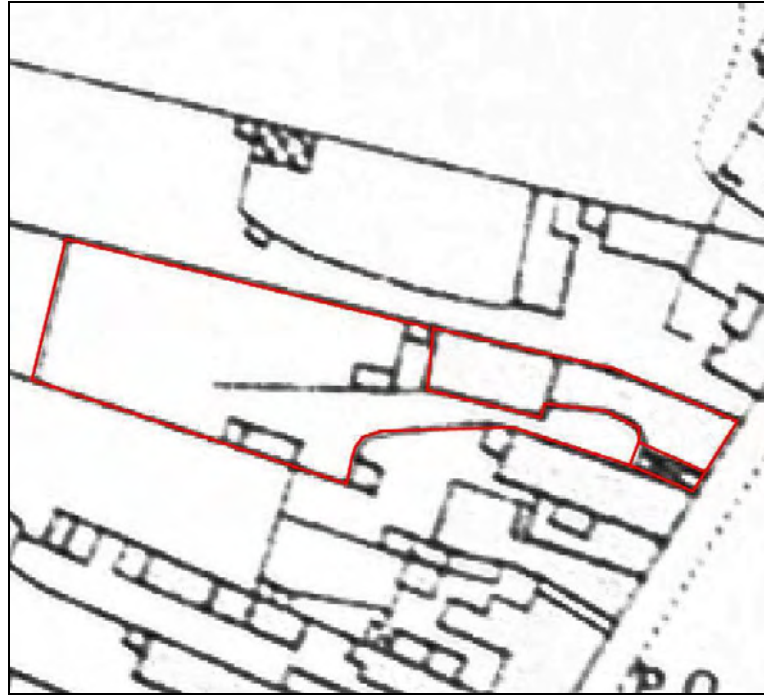
Figure 4: Extract from the 1922 Ordnance Survey Map (*not to scale*)

The 1922 Ordnance Survey Map (Fig. 4) shows the western end as having even more additional structures, and what appears to be the present shed has been built.

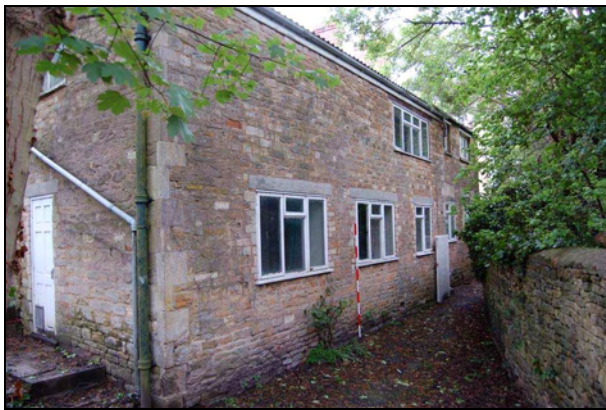
Plate 3: South elevation: Building 3

The south elevation of Building 3 is also of rubble limestone under a slate roof. The eastern arris is rounded with run out stops. There are five modern timber casement windows on the ground floor in total. The two in the older, eastern part of the building are under wooden lintels that in turn lie below stone lintels with a raised keystone. The lintels over the ground floor windows in the western, more recent addition are concrete. All the lintels over the first floor windows are of timber. There are four small ventilation holes measuring 21 x 14 cm near the bottom of the elevation.

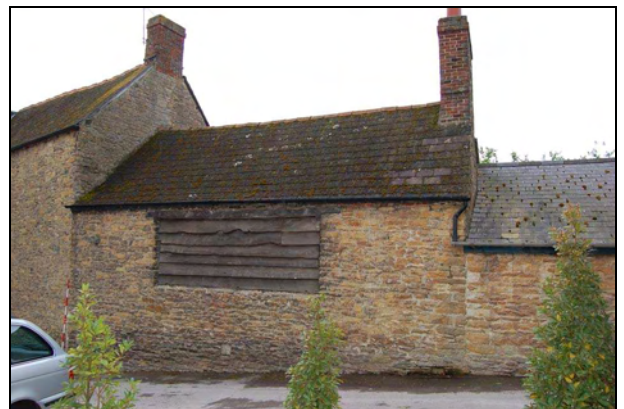
Plate 6: North elevation: Building 2

The north elevation of Building 2 is dominated by a large rectangular opening that is now weatherboarded. This lies beneath a timber lintel. That this former opening is

actually on the first floor of the building clearly demonstrates the sharp rise in the ground level at the northern site boundary.

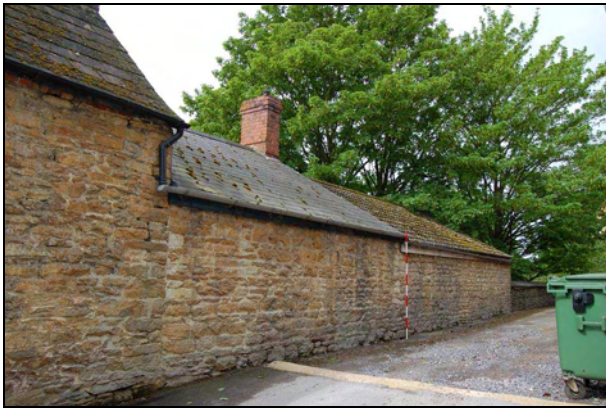
Plate 7: North elevation: Building 3

The north elevation of Building 3 is largely featureless, other than the change from slates to a tiled roof at its western extent.

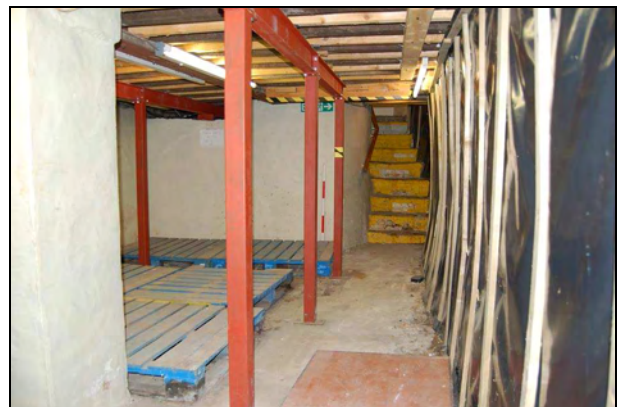
Plate 12: Cellar 2

Description: This cellar is accessed by a brick stair in the northwest corner, which leads to Room (G6). At the other end of the cellar is a single step leading down to C1, and the floor in this area is York stone. Elsewhere it appears to be concrete. The walls are plastered and painted, except the north wall, which was obscured by plastic sheeting. The ceiling consists of the joists and floorboards above and vary to either side of the centrally located pillar supporting agro props. The floorboards to the west of the pillar run east-west and are oak with additional joists. Those to the east are softwood and run north-south.

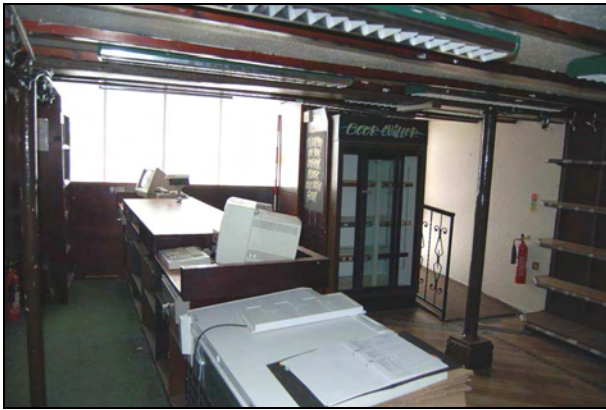
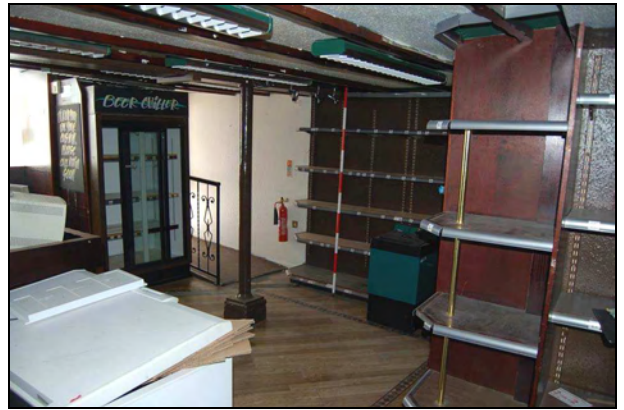
Description: This and Room G1b (see below) have been united to form the shop. The walls are papered and painted and covered with shelves and fridges. There is a counter running parallel to the north wall and a display window at the eastern end of the room. The shop door is located immediately south of the window in a passage created by the return wall of the window, a fridge and some decorative ironwork running alongside a ramp. The ceiling is also papered and painted with modern timbers added for decorative purposes. Two iron columns support a north-south orientated axial beam. The timber floor is now covered with vinyl.

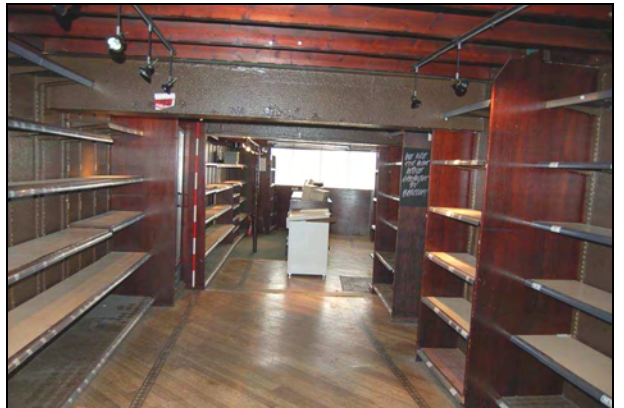
Plate 16: Room G1b looking east

Description: The décor is exactly as in Room G1a, described above. There are no windows, but a modern door in the south wall leading to Room G3 and another in the west wall leading to Room G2. A slight ramp leads up from Room G1a and the floor slopes slightly towards the west.

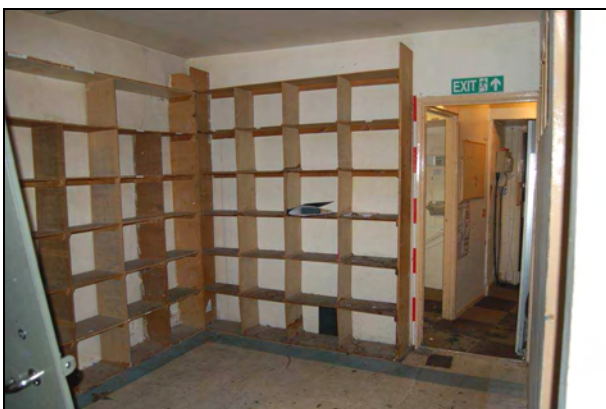
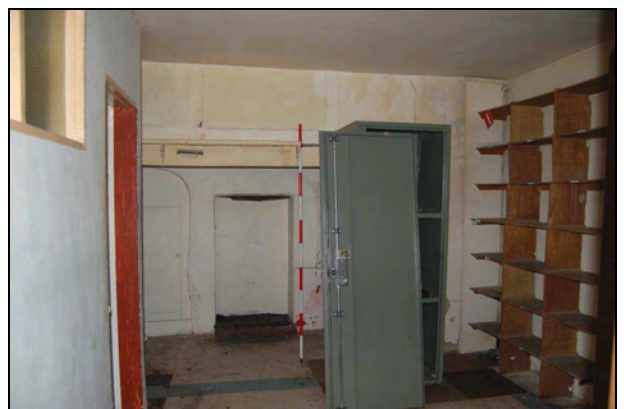
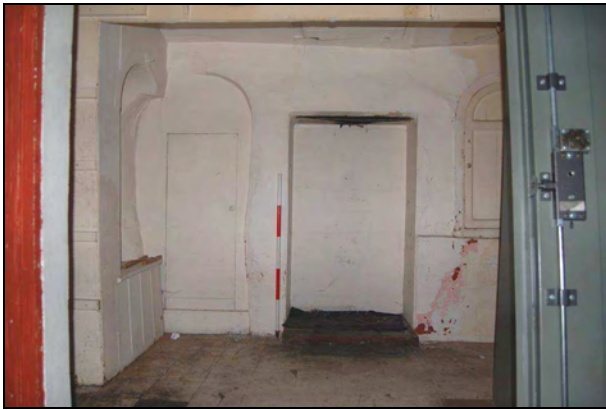
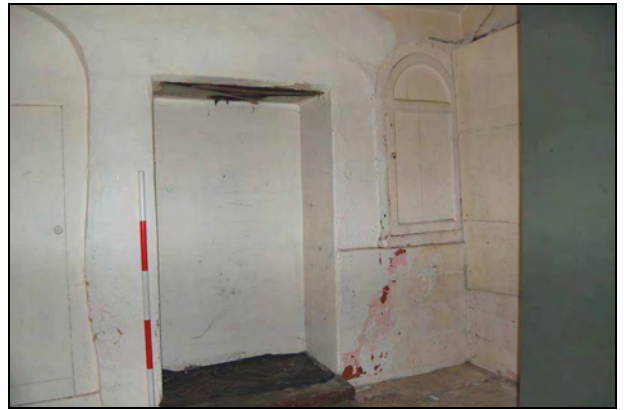
Description: This room has also been subdivided to form this and Room G5 described below. This room has a door in the east wall to Room G3 and the south wall to Room G5. The south wall also has 3 fixed windows with frosted glass allowing indirect light in from the yard beyond Room G5. There is also a single tilting window with a scroll catch and frosted and meshed glass above the door in the southwest corner. There is shelving on the east and north walls and a large inglenook fireplace in the west wall. This has been modified to include a vaulted ceiling with a trap door allowing access to the double chimney. On either side of the reduced fireplace is a cupboard; that to the north is arched with fielded panels and that to the south has a plank and batten door. There is a seat in the south wall of the recess.

The walls and ceiling are painted and the floor has vinyl covering over an unidentifiable stone floor.

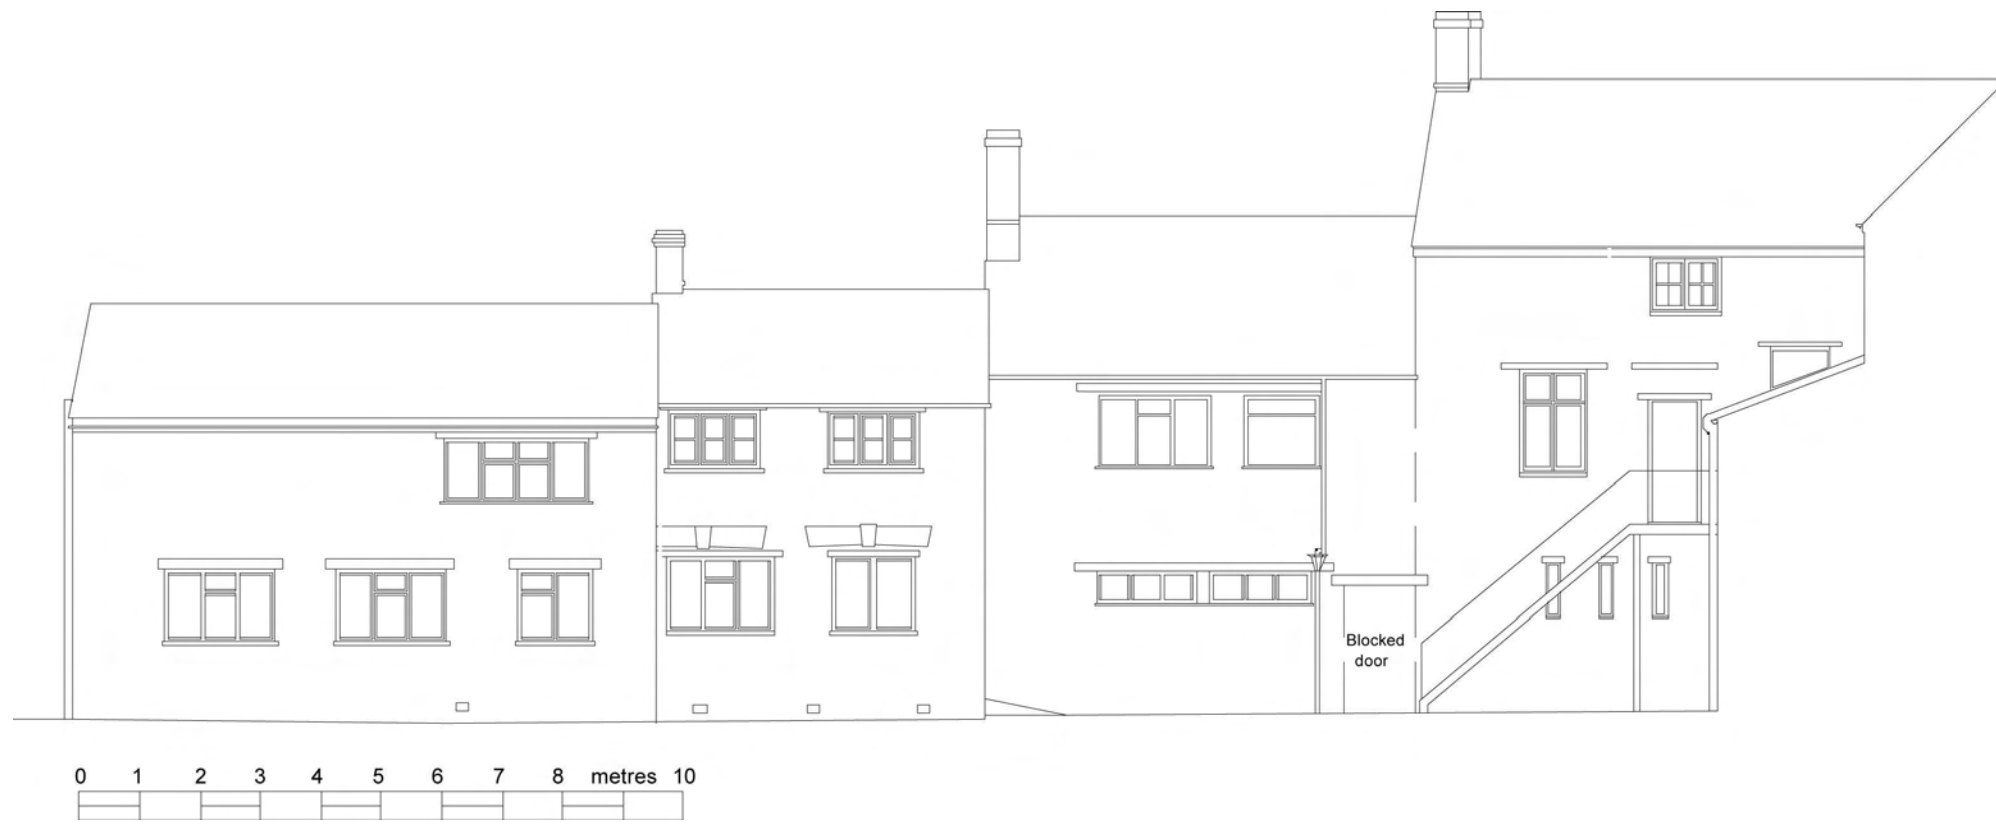
Figure 5: South elevation (scale 1:125)

The only accessible part of the south elevation of Building 1 is that of the west range. There is a modern iron staircase leading to a door on the first floor that is now the main entrance to one of the flats. There are three single light, fixed pane windows on the ground floor with limestone lintels and tile sills. All are modern insertions. A trapezoidal window has been inserted into the first floor wall to the east of the door. This lies beneath a wooden lintel, as does the 4-light casement window to the south of the door. A casement window also lights the second floor. The door has also been cut into the wall in recent times as is apparent in the stonework and the earlier wooden lintel. There is a stone and brick chimney at the end of the south elevation.

The south elevation of Building 2 has also undergone some alteration in recent years. There is a blocked door on the ground floor with a concrete lintel and ironstone infill. To the south of this is a line of 6 single pane windows containing frosted glass with a tile sill. The first floor windows are modern; the eastern one is of 2-lights with frosted glass and a tilting light to the top. The western window is a 4-light casement with an opening casement on either side of the central double light arrangement, which has a fixed pane below a tilting upper light.

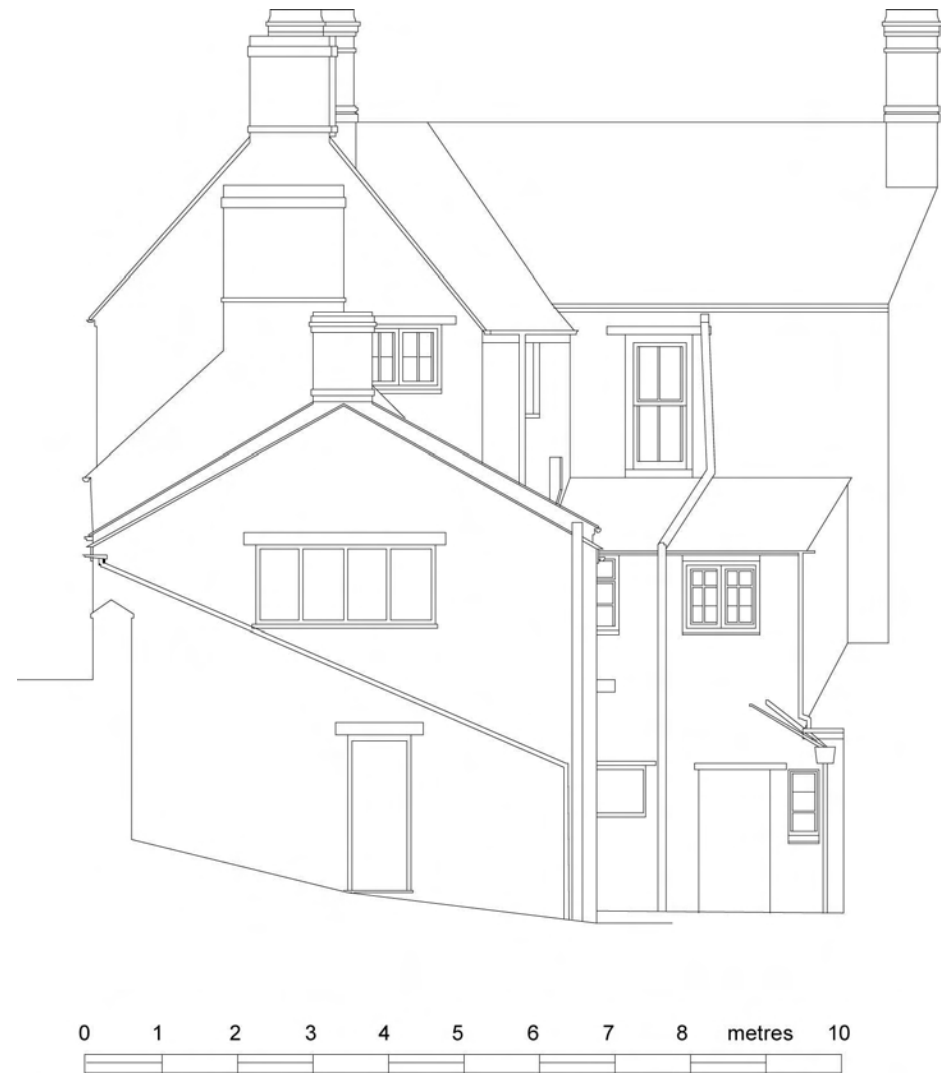
Figure 7: West elevation (scale 1:100)

The west elevation of Building 1 shows two phases of construction. The earlier build, made of stone, has a 2-over-2 sash window beneath a timber lintel. Below this is a brick extension housing an office on the ground floor and a toilet and bathroom on the first floor. It also encompasses the carriageway to the south of the building, which can be entered by a door in the west and the east, and an outside WC in the southwest corner of that. The windows are of various styles and other than the sash window on the second floor fairly modern. They are described in the entries for the individual room below.

There is a brick chimney at the western end of Buildings 1 and 2 and in the middle of Building 3.

The west elevation of Building 3 has a door with a wooden lintel on the ground floor and a 4-light casement window on the first floor. As the ground rises to the north, the door is reached by two steps.

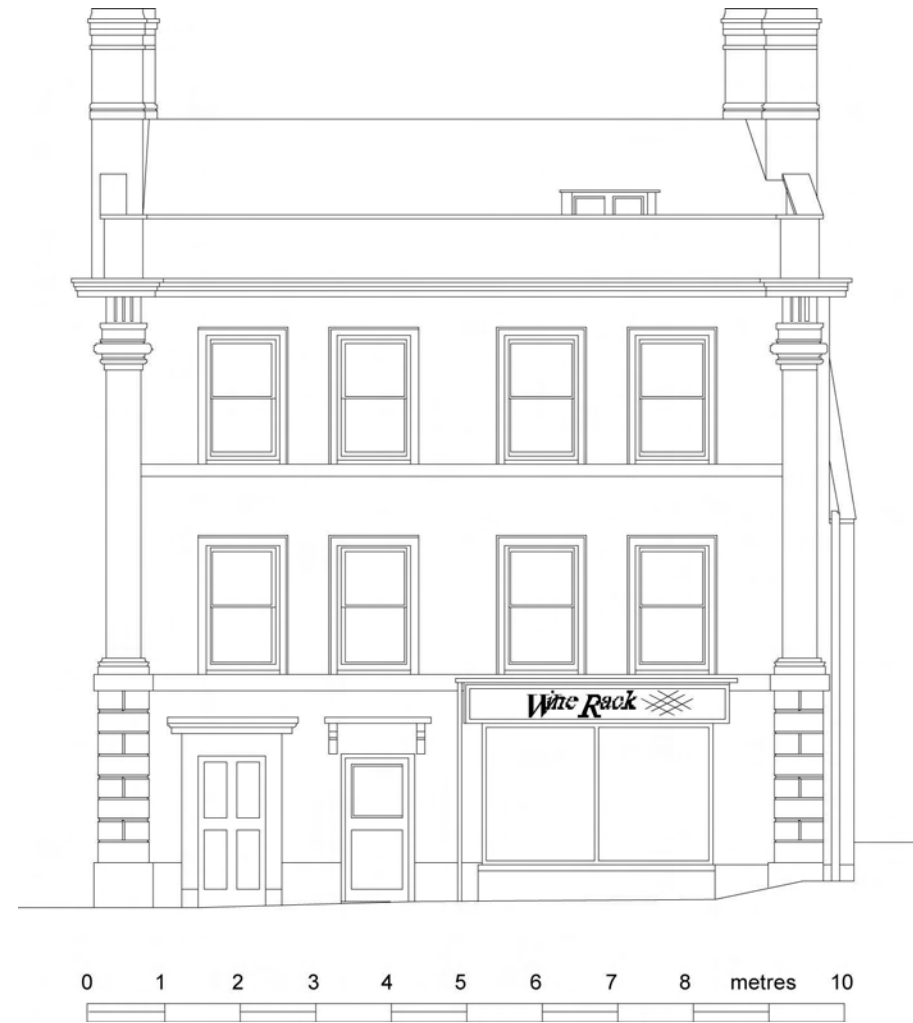
Figure 8: East elevation (scale 1:100)

This is the main elevation of the site, and has been modified to include a shop frontage, modern metal windows to all floors, except a timber dormer window, rendered walls and Doric style pilasters at either end. Each floor is defined by a plat band and a cornice above the second floor, which has been extended forwards, creating a lead lined terrace behind the parapet wall.

The east elevation of Building 3 has a ramp leading up to the 6-panelled front door with a rectangular light above it. Both arrises of the east wall are rounded with runout stops.

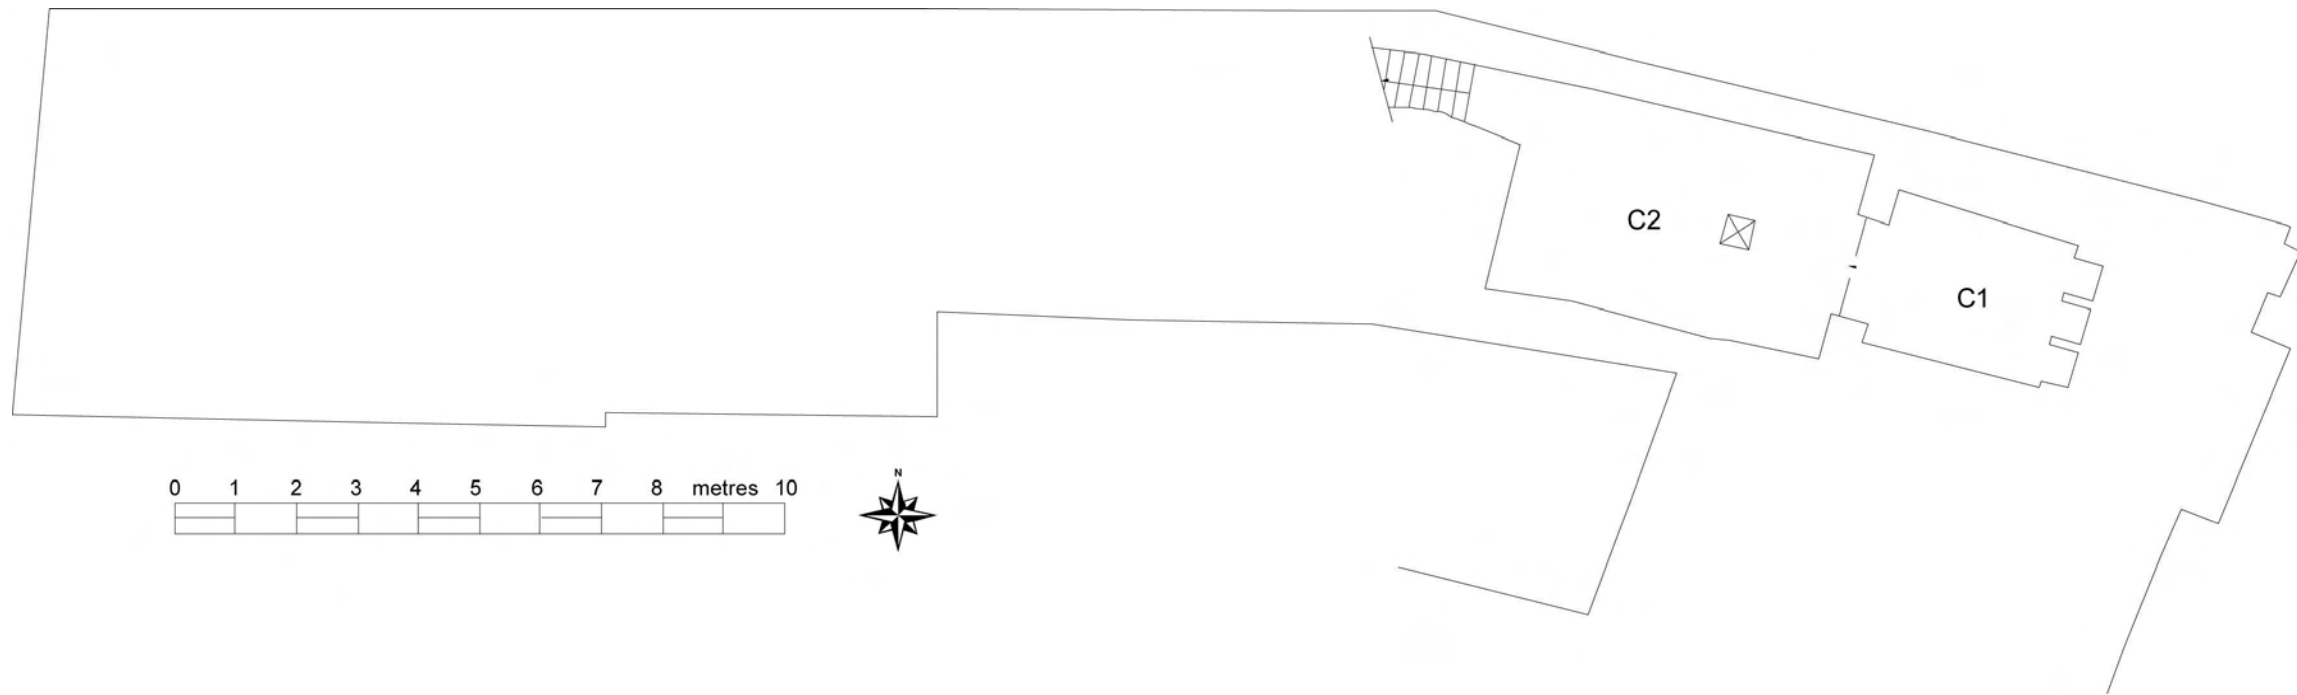
Figure 9: Cellar floor plan (scale 1:125)

Size: 3.53 × 2.42m, height 1.62m

Location: Below G1a

Description: This vaulted cellar lies towards the front of the shop and is accessed via another cellar (C2) described below. It has a York stone floor, stone and brick vaulting, storage recesses at the eastern end and a curve to the southwest corner. The walls are painted white, and both cellars have electric light.

Size: 3.79 × 3.46m, height 1.91m

Location: West of Cellar C1
