**WATCHING BRIEF:  
CHURCH OF ALL SAINTS  
DATCHWORTH  
HERTFORDSHIRE**

*on behalf of Datchworth Parochial Church Council*

**December 2006**

**ASC: 853/DAS/1**

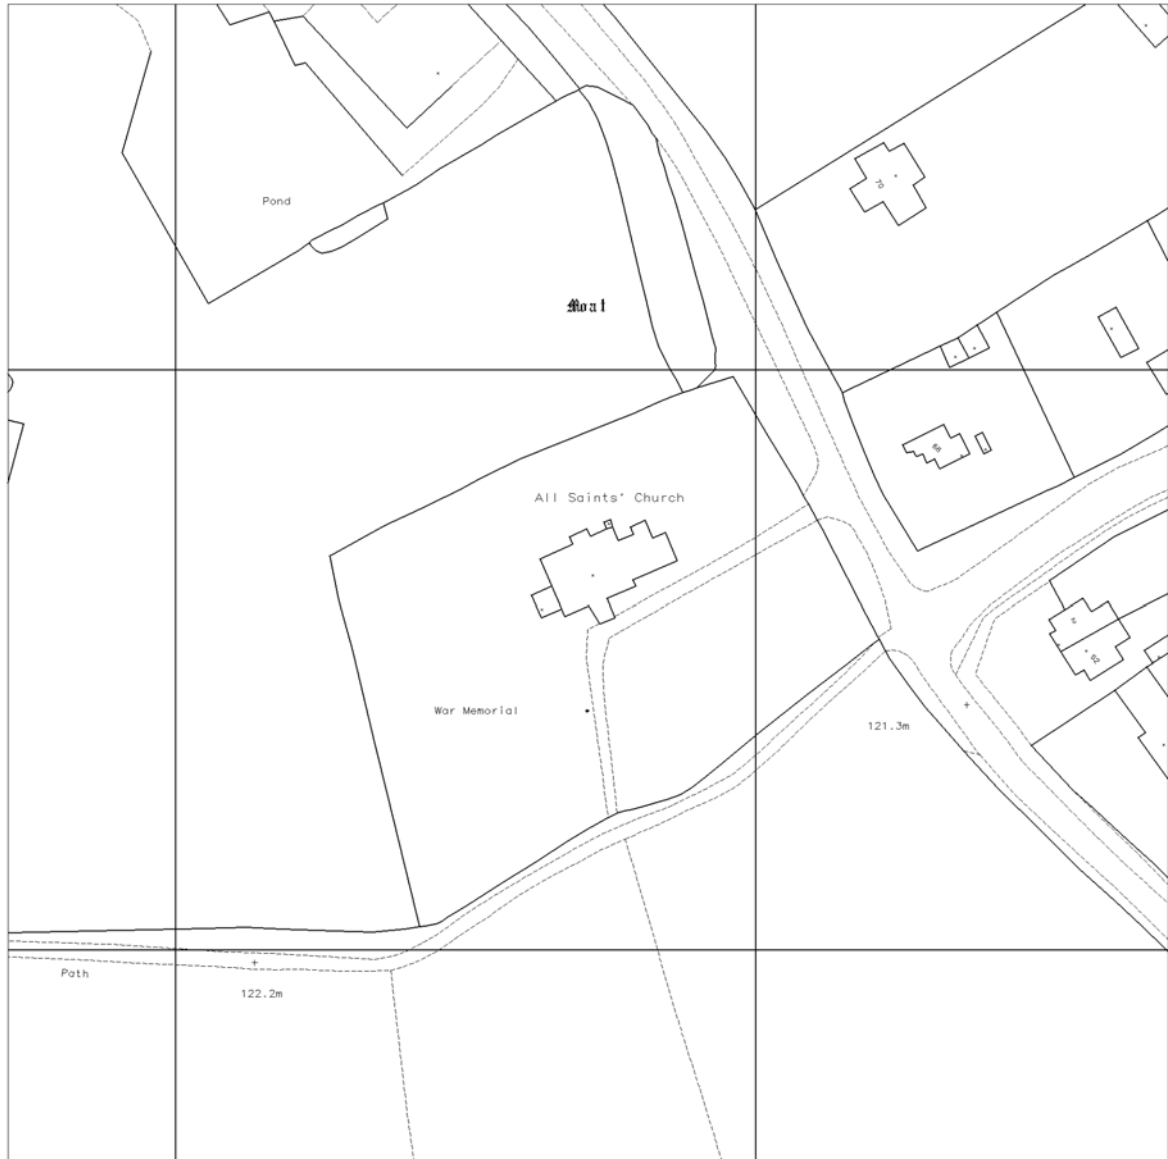
**Figure 2:** Site plan (scale 1:1250)

The village of Datchworth is located in East Hertfordshire, in the parish of Datchworth. The Church of All Saints is located at the northern edge of the village at NGR TL 2678 1926, to the east of Pound Farm (fig. 2).

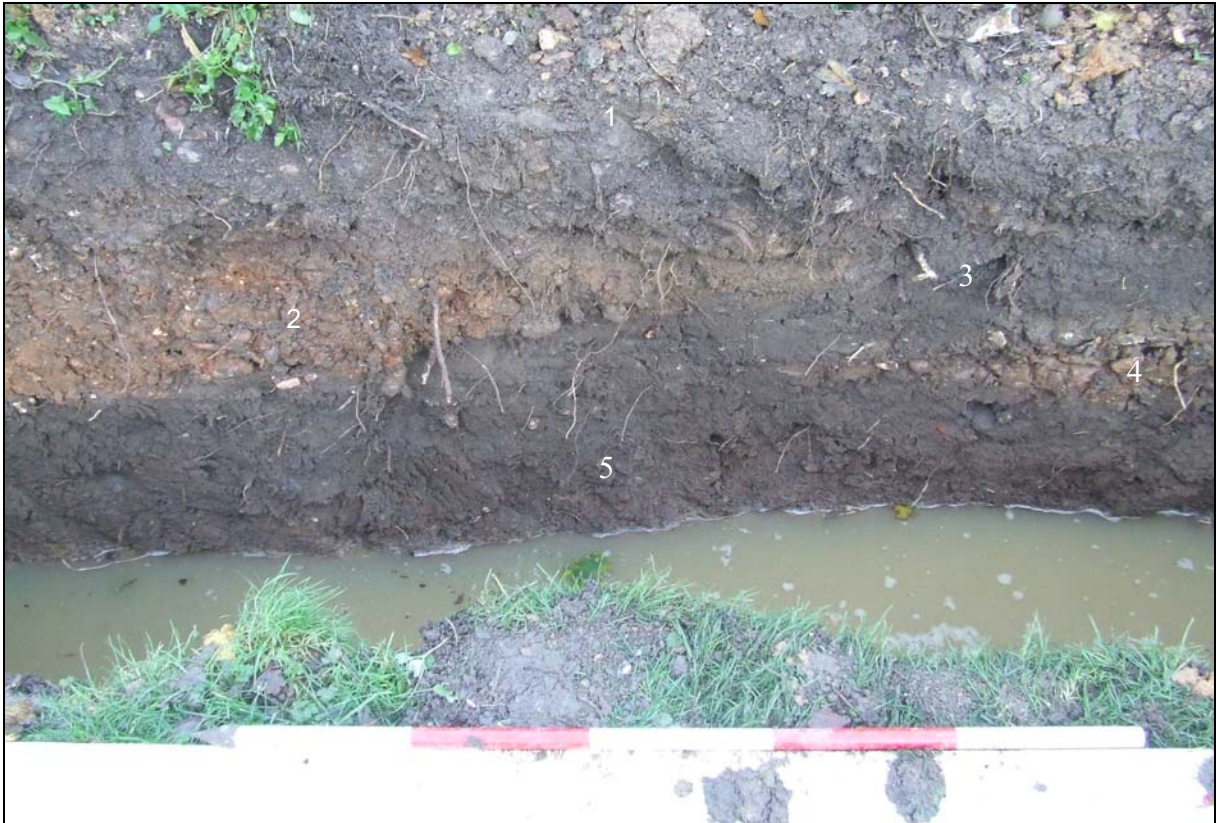
**Plate 1:** Soakaway 1 (Scale = 1 metre)

Soakaway 1 was located to the north of the church and measured 4.50m by 1.10m with a depth of 1.20m. A 0.45m thick, light grey, silty clay topsoil layer (1) was observed beneath the turf and covered a 0.35m thick modern, mixture of make up layers (2, 3 and 4). Layer 2 was a dark orange mixture of gravel and silty clays, layer 3 was a mid grey silty clay and layer 4 was a light grey silty clay which contained frequent large stones. Beneath these was a dark grey, silty clay subsoil (5) of which the first 0.30m could be observed after which water obscured any further detail.

- 5.1 Soakaway 1 contained a mixture of modern make up layers (2, 3 and 4) beneath the topsoil (1). These make up layers covered a subsoil layer (5).
- 5.2 Soakaway 2 contained a topsoil and subsoil layer (11 and 12), which are the same as those observed in soakaway 1 (1 and 5). In addition to these the natural strata (13) was also exposed.
- 5.3 The investigation comprised a small part of the site and served to demonstrate that no archaeological remains were present in these particular areas.
- 5.4 Although it was not possible to observe the drainage trenches it seems unlikely that any archaeology would have been encountered as they would not have extended beyond the topsoil layer. The impact of the works on the church and graveyard deposits would appear to be negligible.

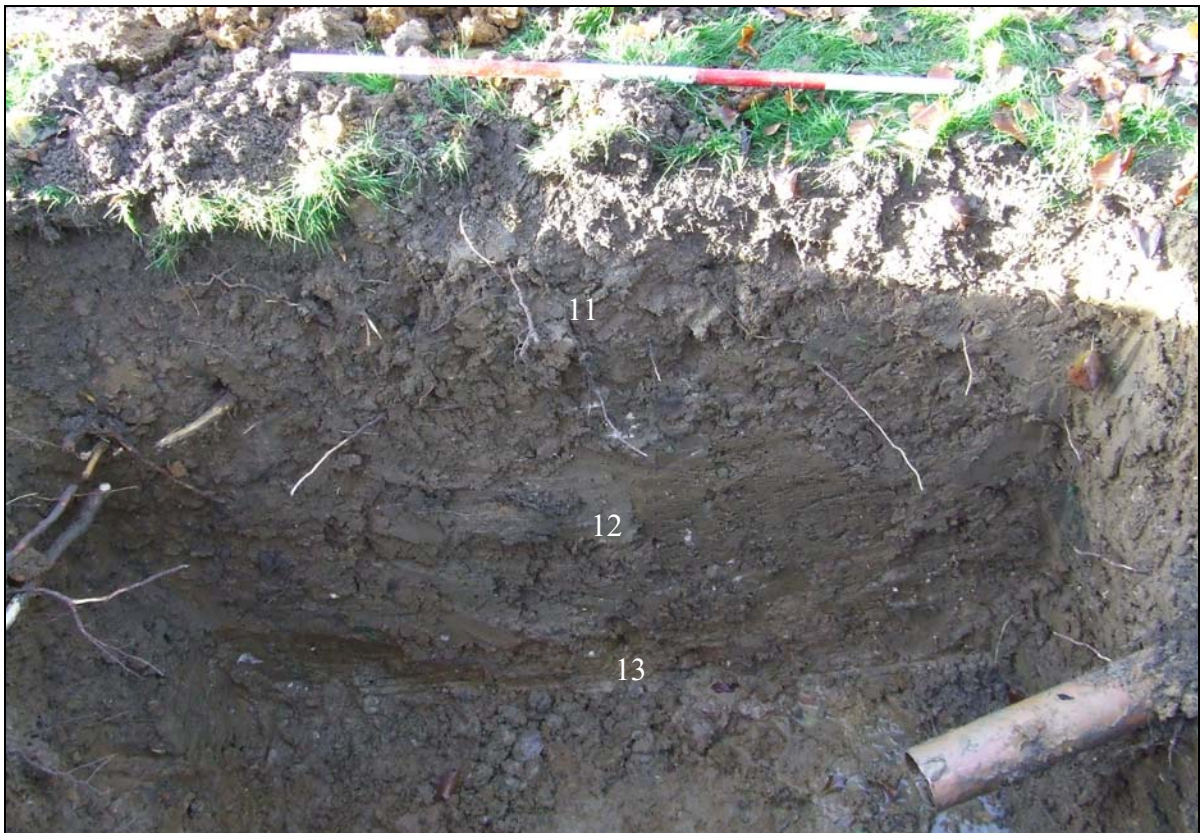
**Plate 2:** Soakaway 2 (Scale = 1 metre)

Soakaway 2 was located close to the south east corner of the church and measured 2.00m by 1.40m with a depth of 1.30m. It contained a topsoil layer (11), measuring 0.50m thick, and subsoil layer (12), measuring 0.60m thick. A mid yellowish brown silty clay layer (13) was also uncovered at a depth of 1.10m. This represents the natural strata.
