**HISTORIC BUILDING RECORDING & WATCHING BRIEF:
STEWARD'S HOUSE GARAGE
WROTHAM PARK
POTTERS BAR
HERTFORDSHIRE**

on behalf of Wrotham Park Settled Estates

July 2007

ASC: 852/PBW/2

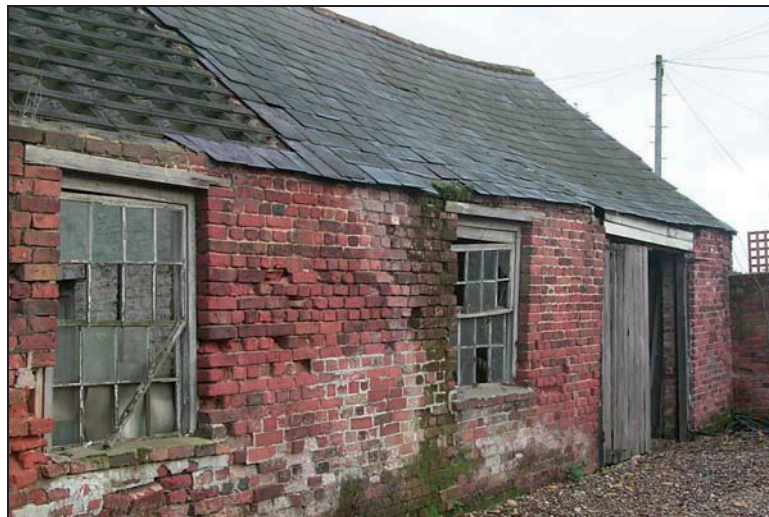
Cover: West elevation

The building was constructed in plum-coloured bricks, similar to those used in the farm buildings (Zeepvat 2001, 13), laid in English bond, with lime mortar bonding. The east and south walls, the only parts of the building to survive demolition, also form part of the walls around the garden of the Steward's House. There are no openings or other features in either of these elevations. The west elevation, which formed the front of the building, was pierced by a wide double door (Room 1), an 8-over-8 sash window under a timber lintel (Room 2), and a second similar window and adjacent door (Room 3). No evidence survived for details of the structure north of this point, which was dismantled some time ago.

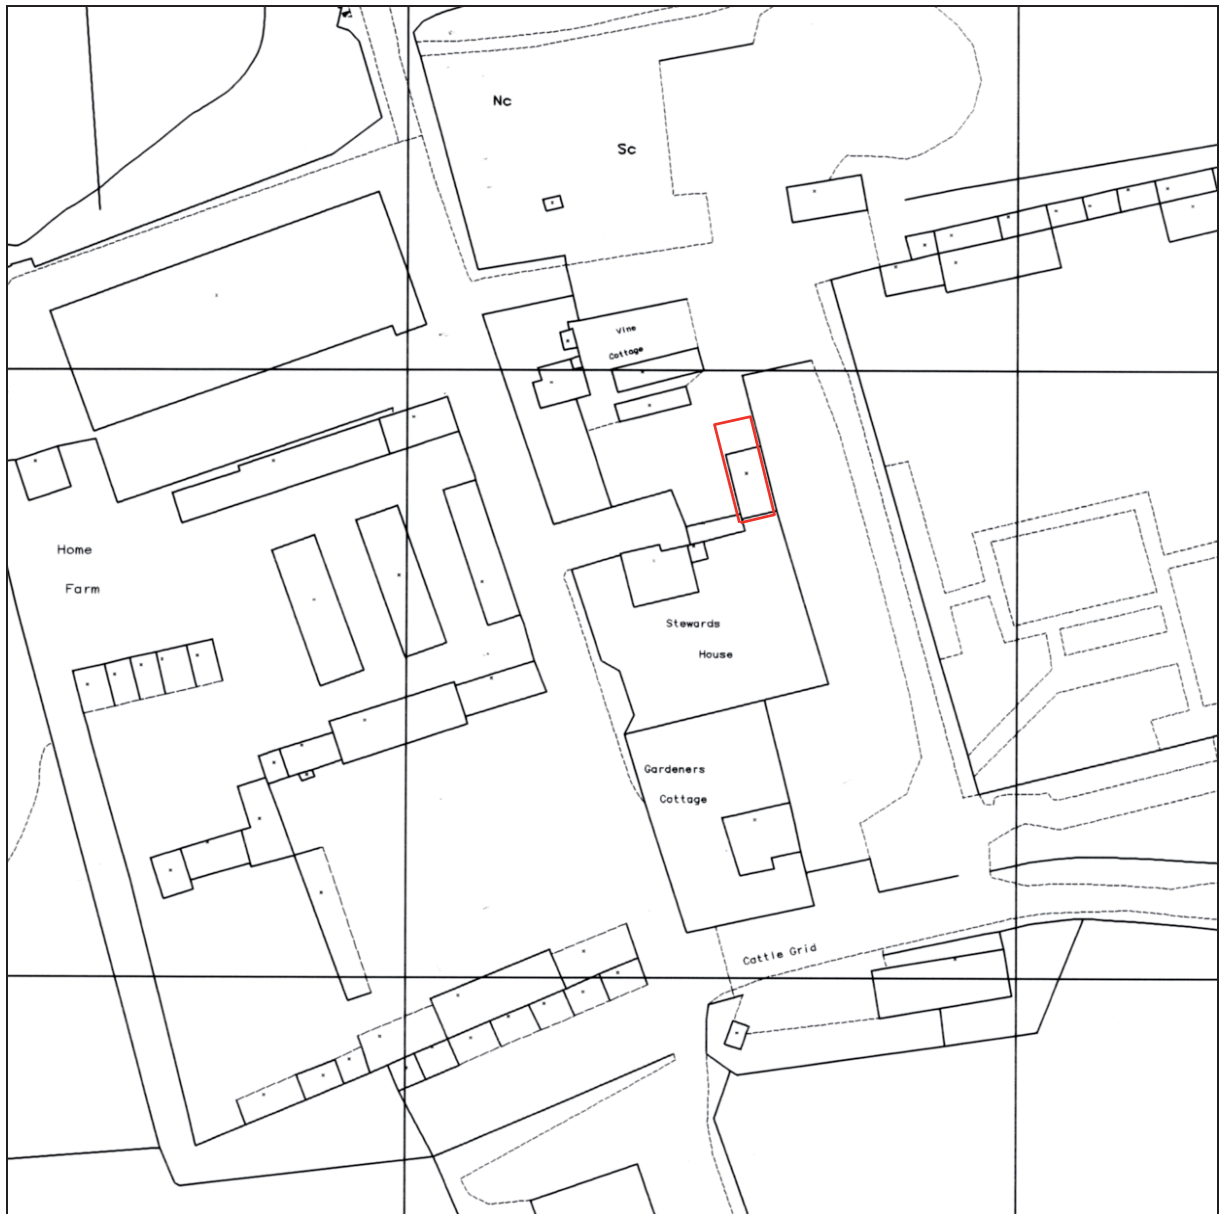
Figure 3: Site plan. The outline of the original building is shown in red (*scale 1:1,250*)

Home Farm is a 19th-century model (planned) farm, constructed in the mid 19th century by William S Cubitt for the Byng family. There are twenty farm buildings in all, located in and around three yards (Fig. 3). The buildings are listed Grade II, and their group value is noted. Home Farm was the subject of a historic building survey carried out by ASC in 2001 (Zeepvat 2001), in response to proposals to convert the farm buildings for commercial use, and a watching brief carried out during building works in 2002/3 (Hunn & Zeepvat 2003). The three adjoining estate cottages, intended for the Bailiff, Steward and Gardener (Fig. 3), and other associated structures were not part of that scheme, and therefore were not included in that survey.

From information provided by the Estate, the south part of the building was used as a garage within living memory, while the north part was a potting shed. This latter function was presumably connected with the nearby greenhouses (Fig. 3).

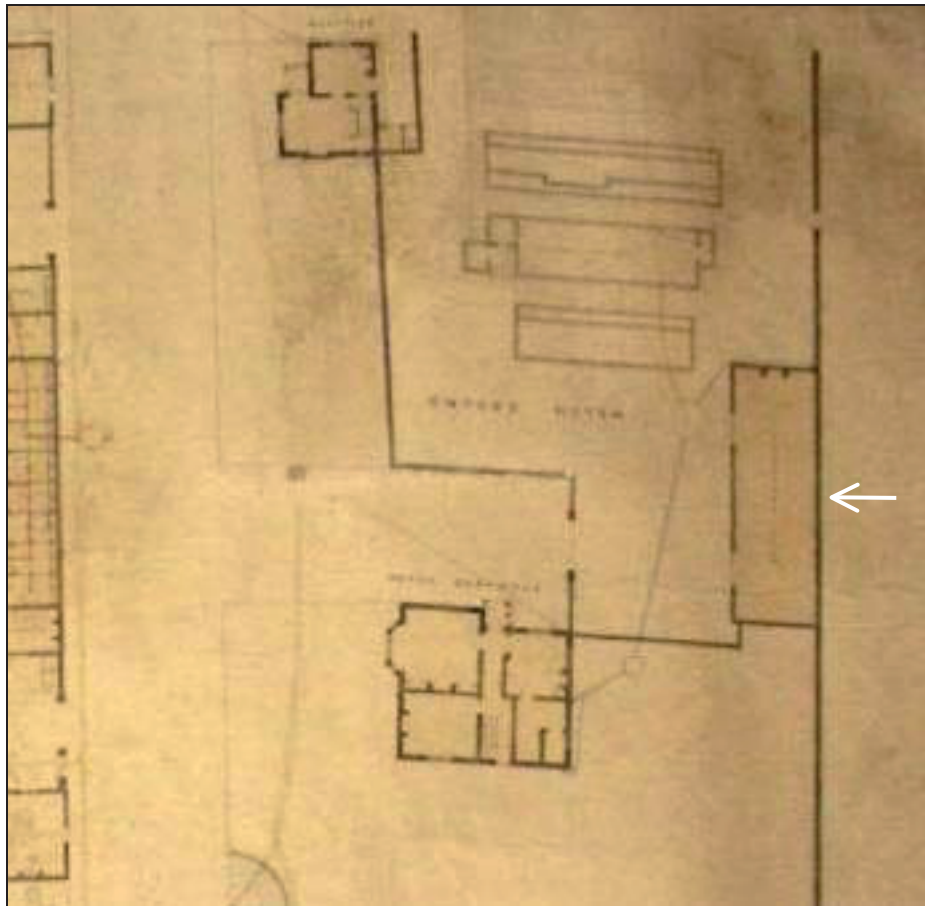
Figure 4: Extract from Cubitt plan, 1855, showing building as proposed

The earliest cartographic representation of the building is on Cubitt's general arrangement plan of Home Farm, showing the proposed layout of buildings and services (Fig. 4). It stands within an area labelled 'Melon Ground', along with three greenhouses. Melon grounds first appear in association with country houses in 18th-century England, and became more common in the 19th century, when sheet glass for the construction of greenhouses became more readily available. Surviving invoices from Cubitt for work undertaken at Home Farm include the following entries:

The building is shown in the Cubitt plan at its original size, with two double doors to the west, and no windows. Internally it has no cross walls, and at its north end is a hearth and chimney breast. A drain, presumably for water run-off from the roof, runs from its north-west corner to a chamber or soakaway in the yard to the west. While there are some differences between the plan and the building as constructed, experience shows that this was also true of several buildings in the farm complex, and that detail changes were made during construction.

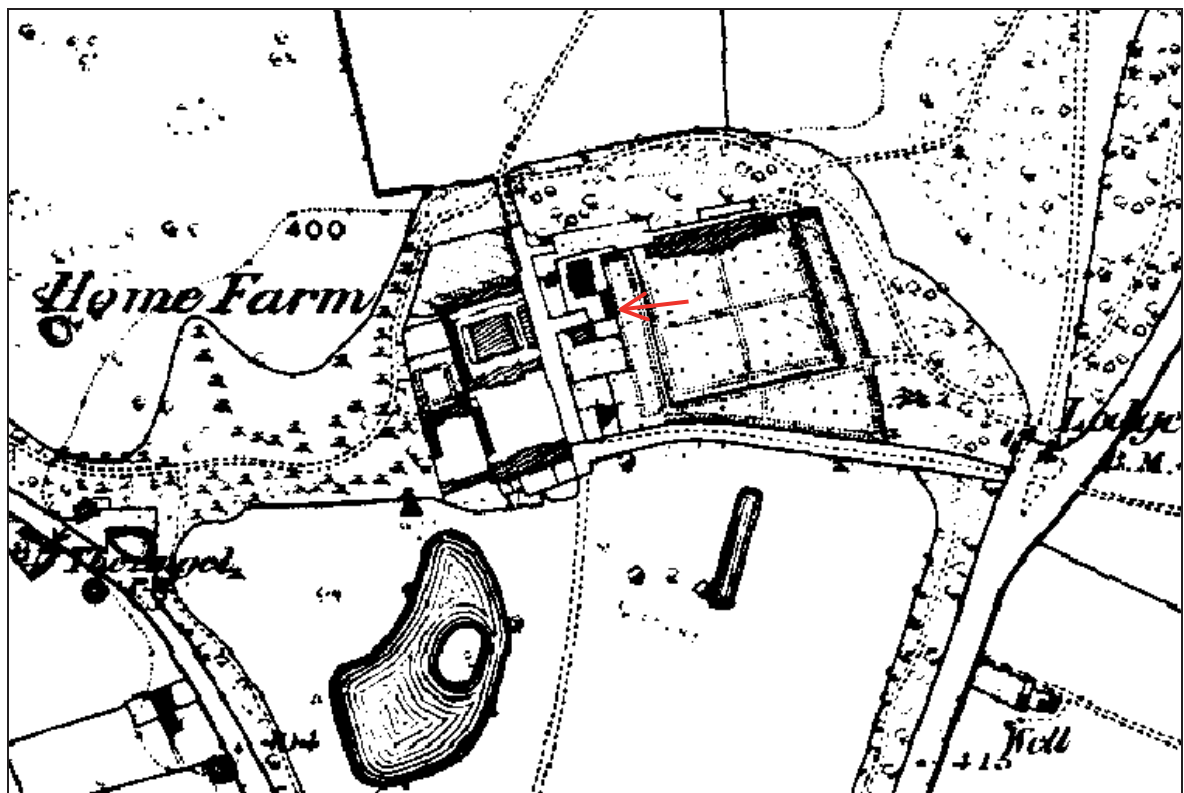
Figure 5: Extract from Ordnance Survey First Edition, 1877, showing Home Farm

Subsequent maps of Home Farm from the First Edition Ordnance Survey sheet of 1877 (Fig. 5) onwards show that the building and its environs have changed little since the mid 19th century.

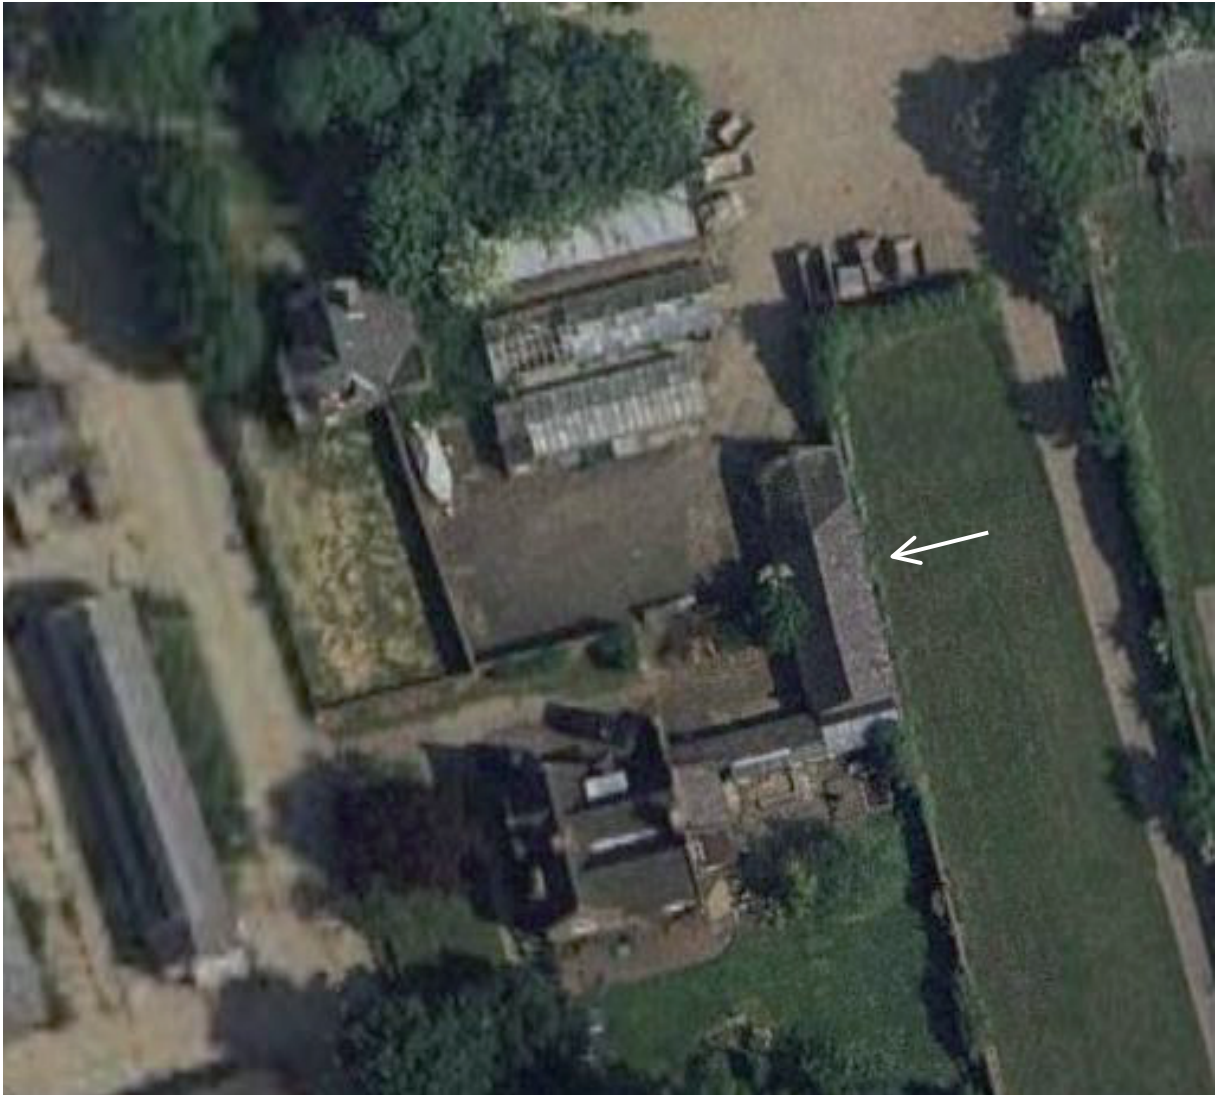
Plate 1: Aerial photo of the building and its surroundings, c.2000

The building that forms the subject of this report was a single-storey gable-ended brick structure under a slate roof. It was located *c.*10m north-east of the Steward's House, on the east side of the Home Farm complex. The building originally measured *c.*15.8 × 5.3m, aligned nearly north-south, but had been reduced to a length of *c.*10.5m some time before its demolition by the removal of its north end, which had apparently fallen into a derelict state. An aerial photograph of the site taken *c.*2000 (Plate 1) clearly shows the full extent of the original building, with the slates removed from the north part of the roof. Demolition was completed in May 2006, leaving only the east and south walls standing to the height of the adjoining garden walls (Plate 2).

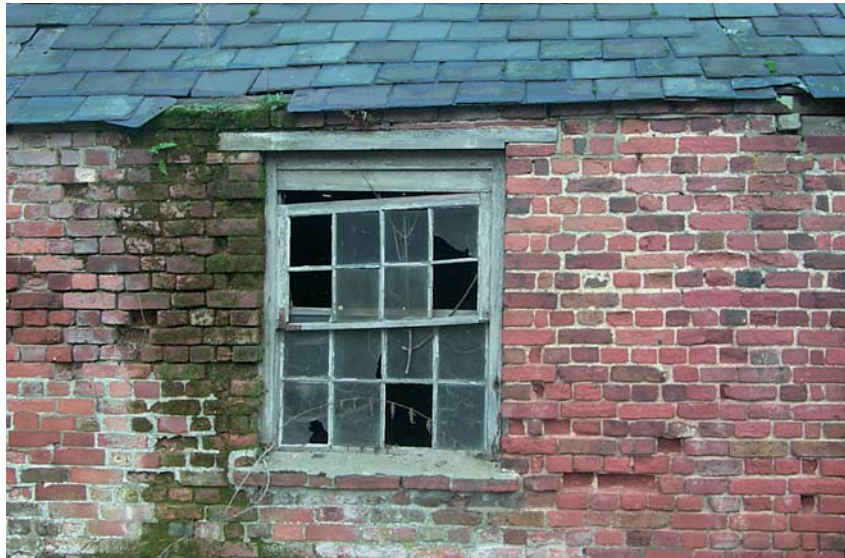
Plate 3: East elevation (south end)

Plate 4: South elevation

Plate 5: West elevation

Plate 6: West elevation, garage door

Plate 7: West elevation, window

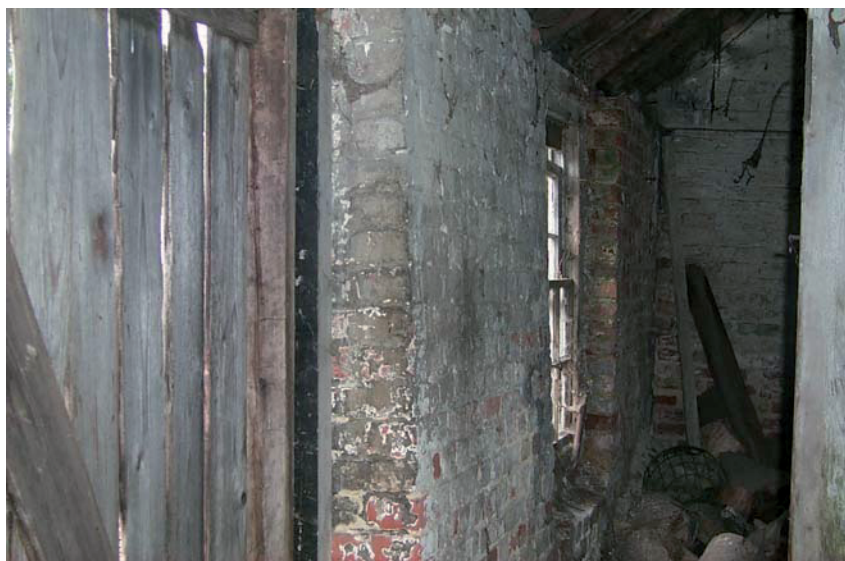
Plate 8: Room 1, interior

The interior of the building appears to have been divided into four rooms. The brick walls were all limewashed, and floors in Rooms 1, 3 and 4 were concrete. The floor in Room 2 was covered with soil: on balance, it is also likely to have been concrete. The interior cross-walls had all been removed, but the available evidence reveals that they were constructed of brick in Flemish bond, bonded into the east (and presumably west) wall.

Description: This was used as a garage within living memory. No diagnostic features.

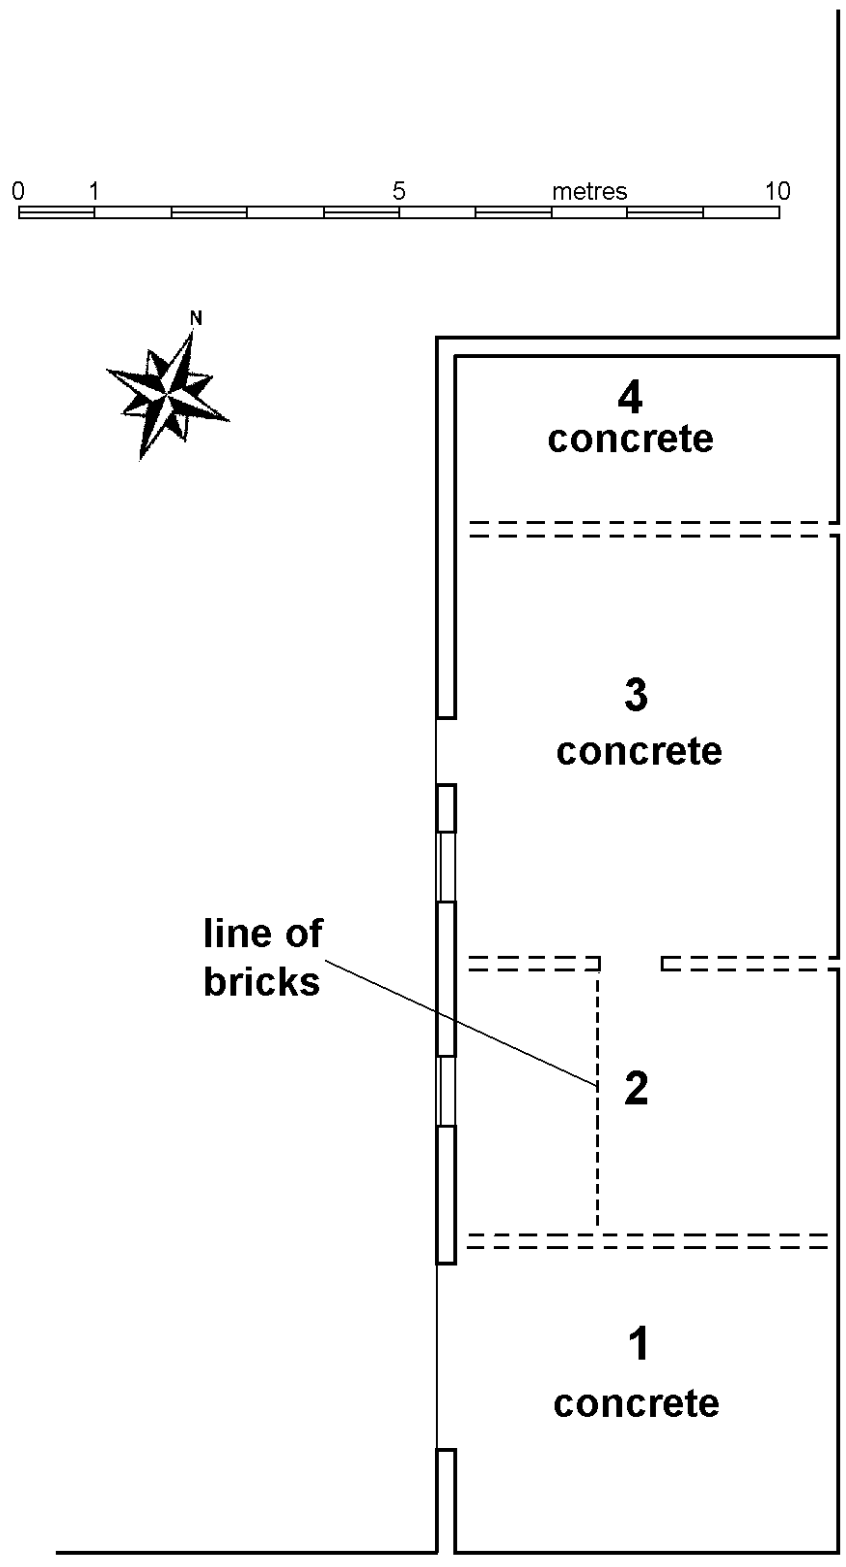
Figure 6: Reconstructed plan of the building (*scale 1:100*)

4.1 *General* (Fig. 6)

- 5.2 The new garage (Plate 10) occupies the area of Rooms 1 and 2 of the original building on the site (Fig. 6). Its west wall follows the same alignment as the west wall of the earlier building, and its north wall the north wall of Room 2. The footing trenches were machine excavated, 0.6m in width and *c.* 1.0m below the present ground level.

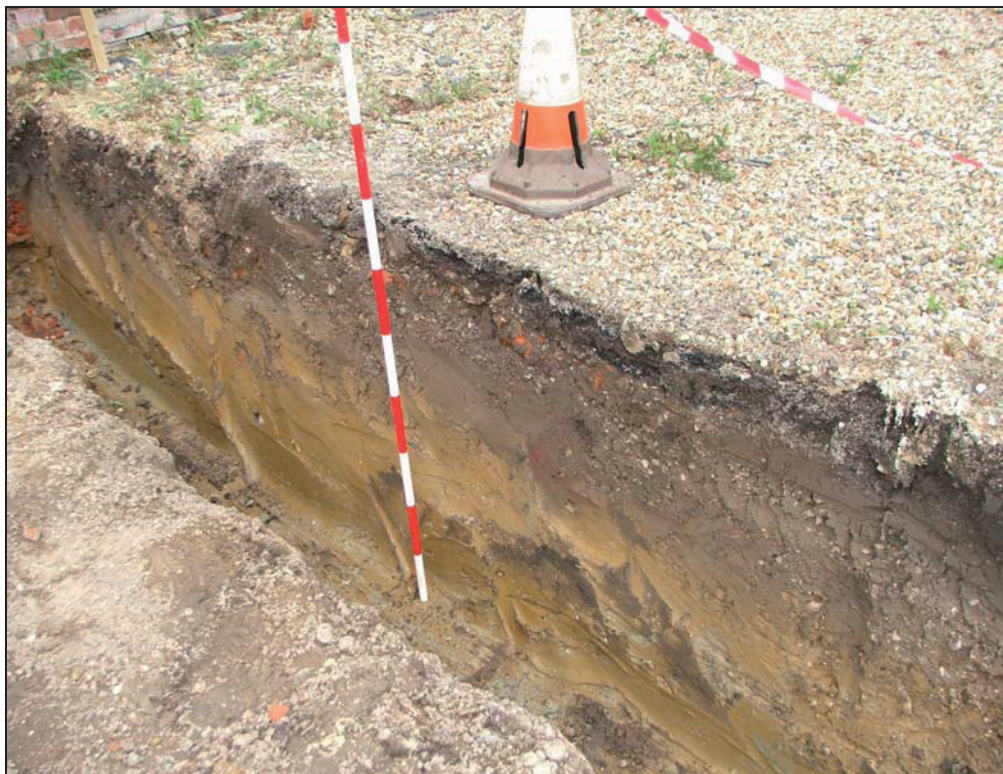
Plate 11: West footing trench, showing site stratigraphy

- 5.3 The following deposits (Plate 11) were encountered in the footing trenches:
- 0 – 400mm: Dark brown clayey soil, containing quantities of brick and building debris. Presumably the original topsoil.

- 400 – 1000mm: Yellow-brown clay. Natural.
- 5.4 Excavation of the footing trenches did reveal the footings of the garden walls forming the east and south sides of the proposed garage (Plates 12 & 13). These were constructed of brick, laid in the same bond as the above-ground part of the walls, to a depth of *c.* 0.9m below the present ground level.
