**ARCHAEOLOGICAL WATCHING BRIEF:
BEACHAMPTON TO SHENLEY GROUNDS
REPLACEMENT WATER MAIN
BUCKINGHAMSHIRE & MILTON KEYNES**

on behalf of Anglian Water Services Ltd

September 2007

ASC: 847/SGB/1

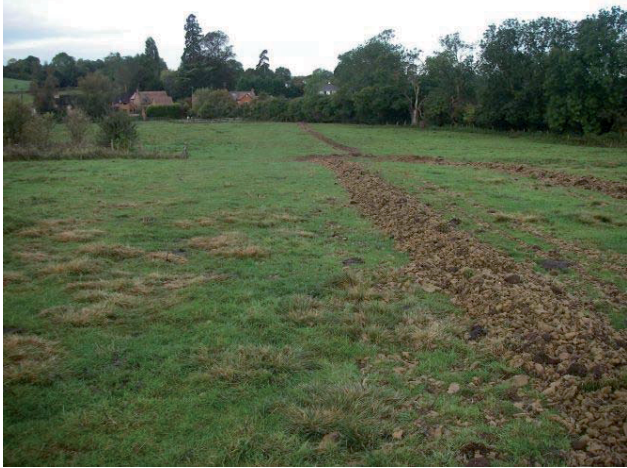
Field 1

<p style="text-align: center;">Facing west</p>	NGR	
	West	East
	SP 77205/36966	SP 77504/36974
Topsoil 0-300mm		
Natural limestone		
Comments		
<p>This field was trenched using a trenching machine. Ridge and furrow run roughly north south across the field. Four ridges (4.8m ridge to ridge) survived at the eastern end of the field. Height from base of furrow to top of ridge 0.2–0.5m. The western end of the field contains earthworks, house platforms? Not disturbed during the trenching.</p>

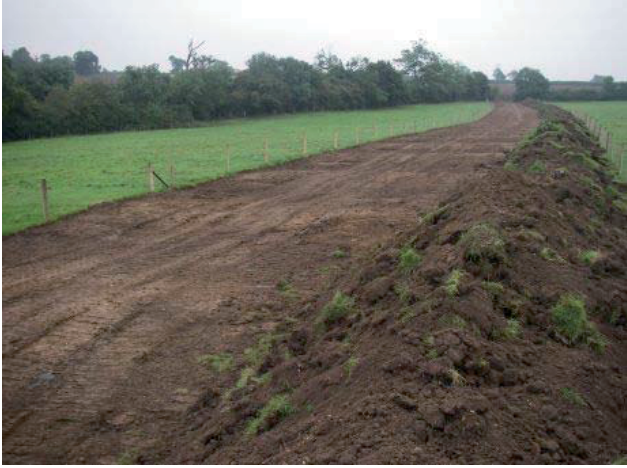
Field 2

<p style="text-align: center;">Facing east</p>	NGR	
	West	East
	SP 77504/36974	SP 77745/36986
Topsoil 0-300mm		
Natural subsoil clay		
Comments		
<p>North south orientated ridge and furrow (31 ridges, 4.8m ridge to ridge) continues from Field 1. Height from the base of furrow to top of ridge 0.2–0.5m. Only topsoil removed shape retained for reinstatement.</p>

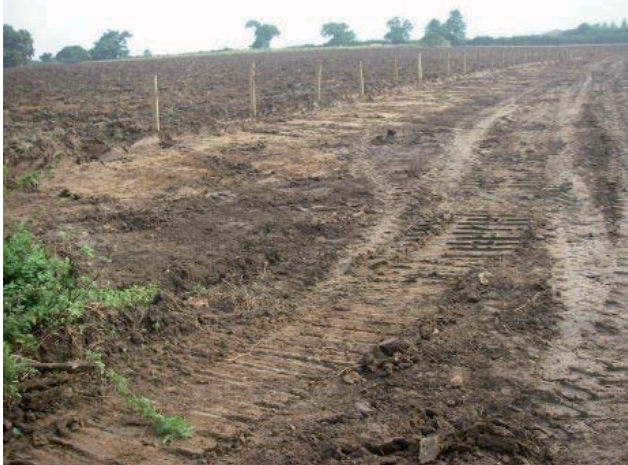
Field 3

NGR	
	West	East
	SP 77745 36986	SP 78024 37057
Facing northeast		
Topsoil 0-350mm		
Natural subsoil clay		
Comments		
Deep ploughed into the natural clay. Old field boundary observed at western end of the field, filled relatively recently as it is still shown on the OS 1:25000 map. Possible bases of two shallow discontinuous N-S furrows observed at the eastern end of the field (ploughed out).

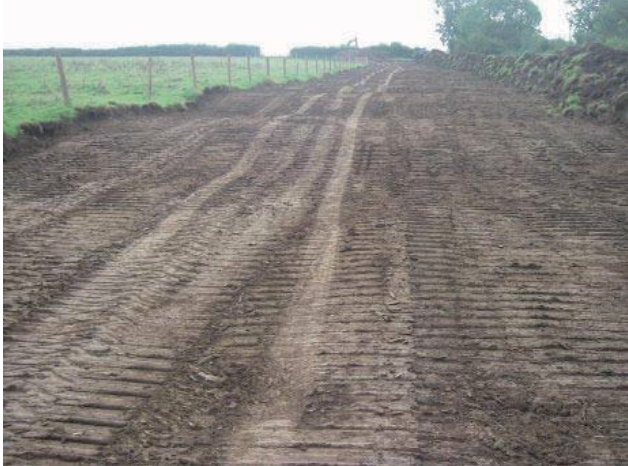
Field 4

NGR	
	West	East
	SP 78024 37057	SP 78317 36980
Facing southeast		
Topsoil 0-300mm		
Natural subsoil clay		
Comments		
Distinct north to south orientated ridge and furrow (34 ridges, 6.9m ridge to ridge) crossing the trench. Height from base of furrow to top of ridge 0.3-0.5m, very well preserved. Only topsoil removed shape retained for reinstatement.

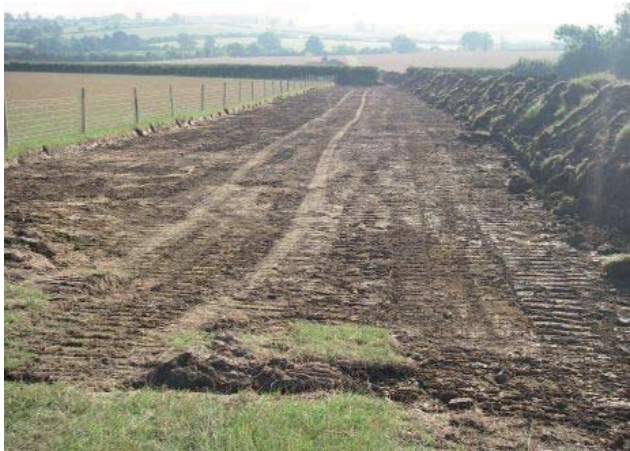
Field 5

<p style="text-align: center;">Facing east</p>	NGR	
	West	East
	SP 78317 36980	SP 78642 36930
Topsoil 0-300mm		
Natural subsoil clay		
Comments		
Pasture no ridge and furrow.

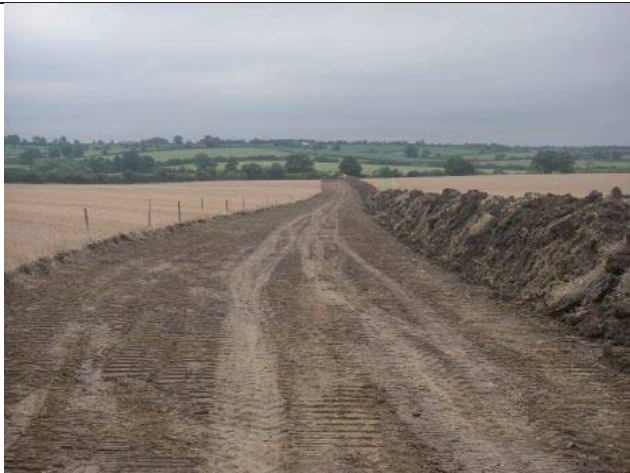
Field 6

<p style="text-align: center;">Facing east</p>	NGR	
	West	East
	SP 78642 36930	SP 79181 36926
Topsoil 0-300mm		
Natural subsoil clay		
Comments		
Arable, no ridge and furrow

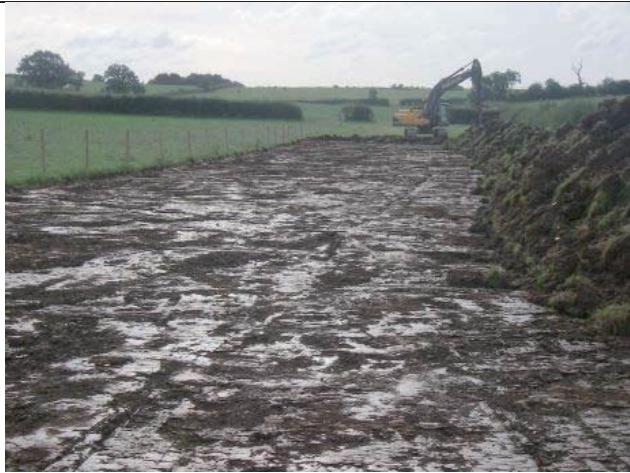
Field 7

NGR	
	West	East
	SP 79181 36926	SP 79261 36929
Facing east		
Topsoil 0-250mm		
Natural subsoil silty clay		
Comments		
Colluvial deposit in the valley bottom, ground damp. No archaeology

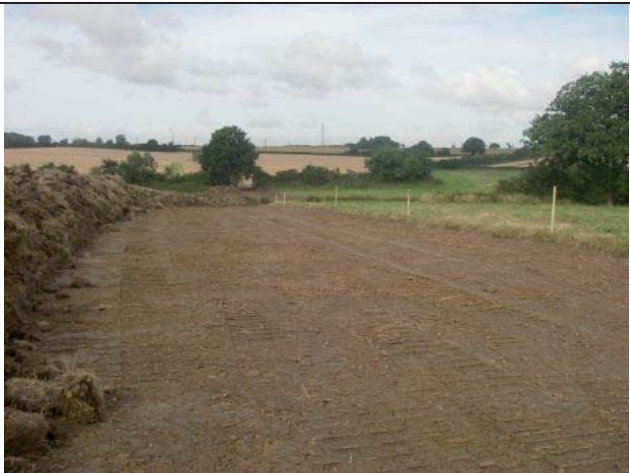
Field 8

NGR	
	West	East
	SP 79261 36929	SP 79570 36935
Facing west		
Topsoil 0-250mm		
Natural subsoil clay		
Comments		
Modern field boundary at the western end of the field continuation to the north still marked by a hedge. Series of NE-SW sectional clay pipe field drains cross this field. No archaeology

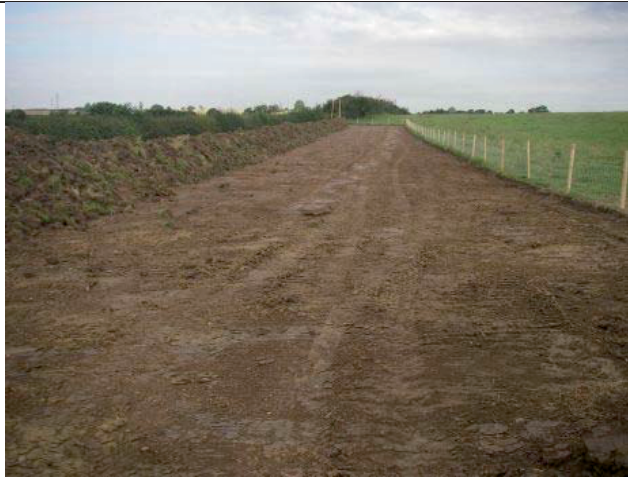
Field 10

NGR	
	West	East
	SP 79677 36874	SP 79941 36865
Facing west		
Topsoil 0-250mm		
Natural clay		
Comments		
Series of NE-SW sectional clay pipe field drains cross this field. No archaeology

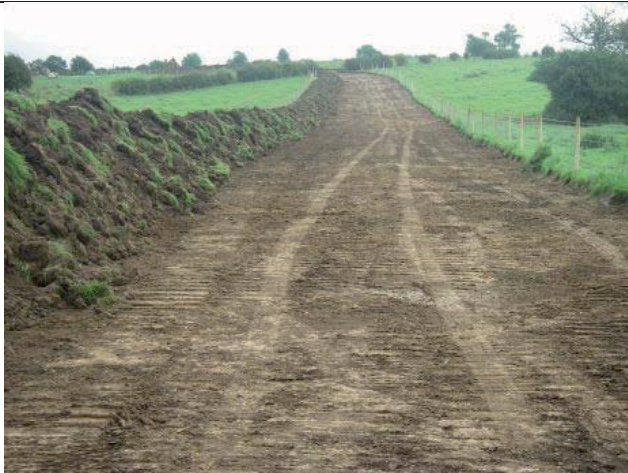
Field 12

NGR	
	West	East
	SP 79941 36865	SP 80077 36850
Facing East		
Topsoil 0-250mm		
Natural subsoil clay		
Comments		
No archaeology, or field drains

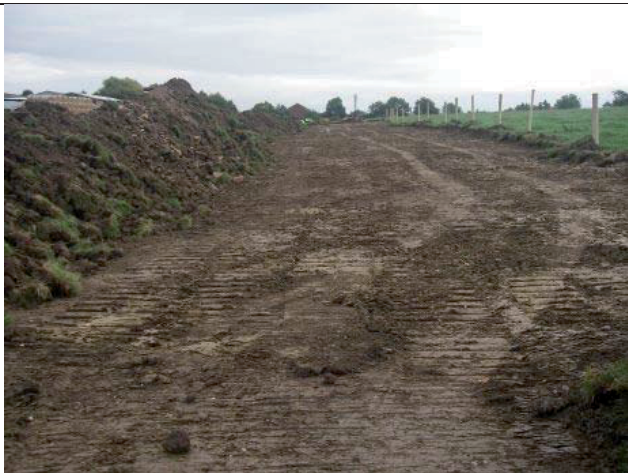
Field 11

NGR	
	West	East
	SP 80077 36850	SP 80335 36957
Facing northeast		
Topsoil 0-250mm		
Natural subsoil clay		
Comments		
No archaeology or field drains. Topsoil cover as little as 150mm in places
