**WATCHING BRIEF & EXCAVATION:
CHURCH OF ST. NICHOLAS
GREAT HORMEAD
HERTFORDSHIRE**

on behalf of Hormead & Wyddial Parochial Church Council

July 2007

ASC: 844/GHC/2

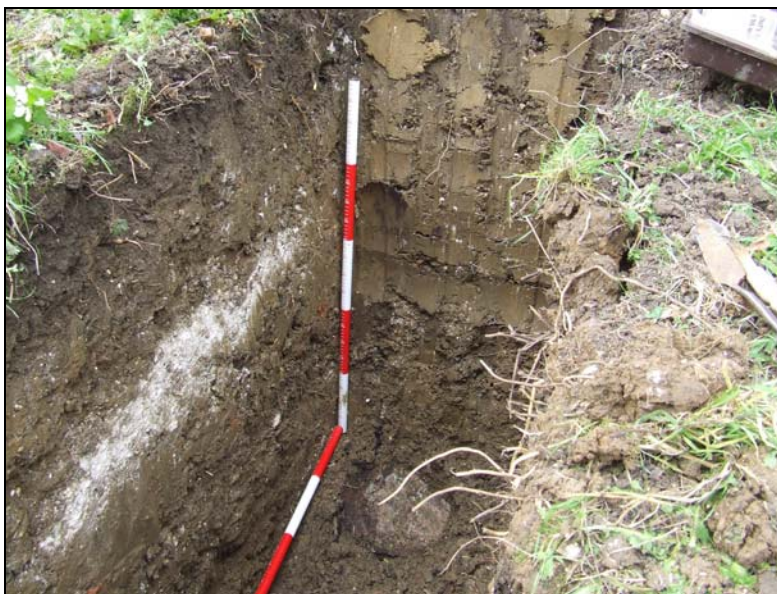
Plate 1: Pit 2, showing layer of redeposited chalk and Burial HB3

- 4.1.4 The churchyard was probably levelled in the past. This was a common practice during the medieval and post-medieval periods to allow burial to continue in an already full churchyard. Possible evidence of this was seen in the form of a layer of redeposited chalk, which was visible in several of the pits towards the western area of the site (Plate 1). This layer was up to 0.25m thick and was *c.*0.3 – 0.5m below ground level. Grave cuts were more frequently visible in the eastern area of the site, adjacent to the church tower, where the redeposited chalk was not encountered.

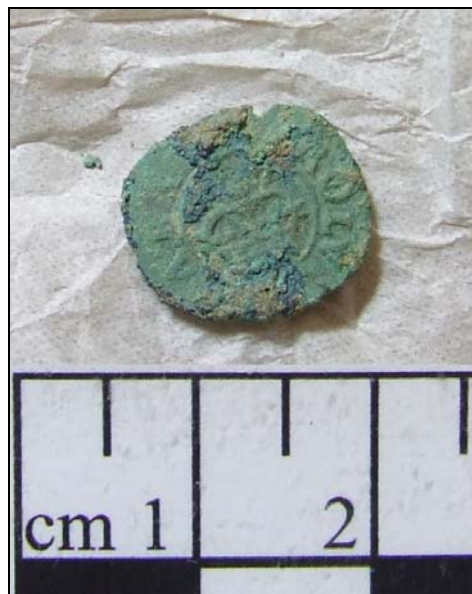
Plate 2: Coin from the backfill of Burials HB 40 & 41

- 4.1.6 Several artefacts were retrieved that were not directly associated with burials. These included a fragment of animal bone, tile fragments, a metal button, a coin (Plate 2) and a fragment of pottery (see Section 4.5: Appendix 1). Any artefacts directly associated with burials, such as coffin fittings, shroud pins and buttons from clothing, were boxed up with the relevant burial, to be reburied with them.

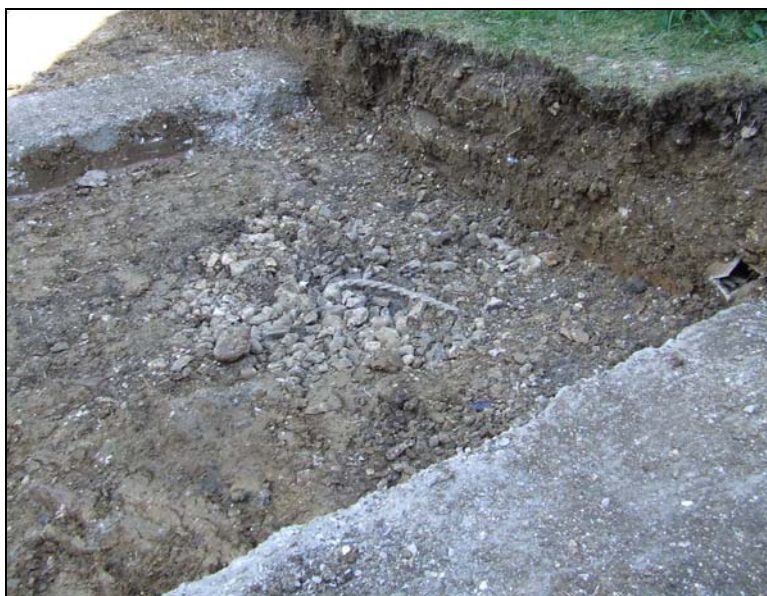
Plate 3: Modern soakaway between Pads 5 & 6

- 4.2.1 No articulated burials were encountered during the main ground reduction works. A modern soakaway was uncovered between Pits 5 and 6 (Plate 3: Fig. 8) and one grave cut was visible to the southwest of Pit 5 (Plate 4: Fig. 8).

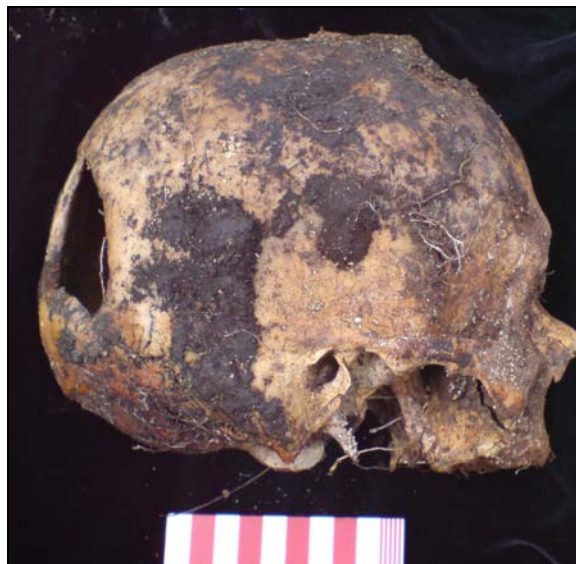
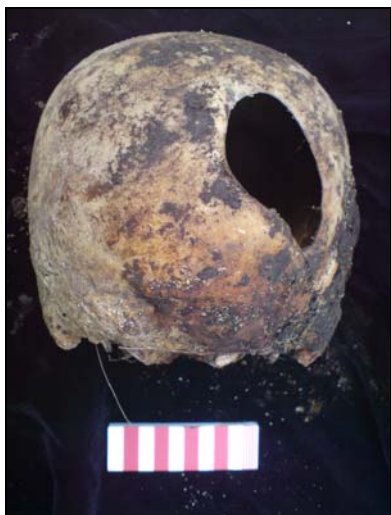
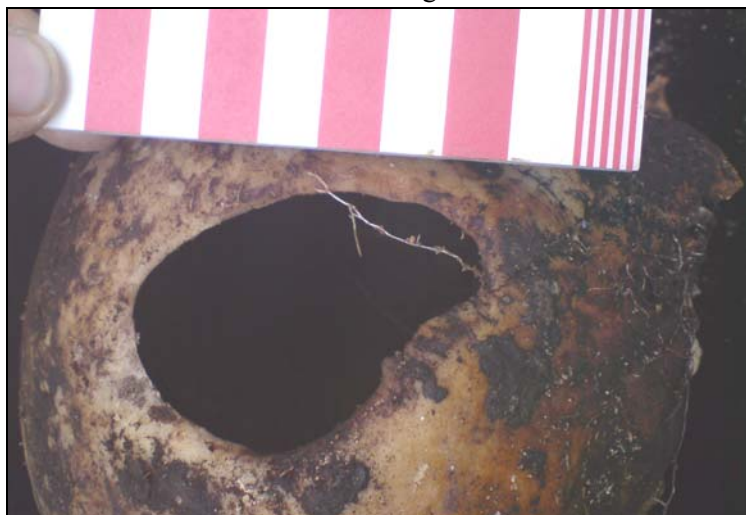
Plate 34: Burial HB 4 skull with perforation, right side

Plate 35: Burial HB 4, rear view showing perforation

Plate 36: Burial HB 4, detail of perforation

- 4.4.6 The cranium of Burial HB 4 had a irregular rounded hole in the right occipital (Plates 34-36) measuring approximately 6 × 4cm. The edges were smooth and well-healed, indicating that the individual had survived for a substantial period of time after the injury had occurred. Without further analysis it is difficult to determine the cause of the injury. It could be a trepanation hole or a depressed fracture where the displaced bone has been surgically removed. This burial was of a similar depth, alignment and state of preservation to Burial HB 3 and was probably 20th century in date.
