Archaeological Services & Consultancy Ltd

**HISTORIC BUILDING RECORDING:
AMWELL BARN
DOWN GREEN LANE
WHEATHAMPSTEAD
HERTFORDSHIRE**

August 2006

ASC: 828/WAB/1

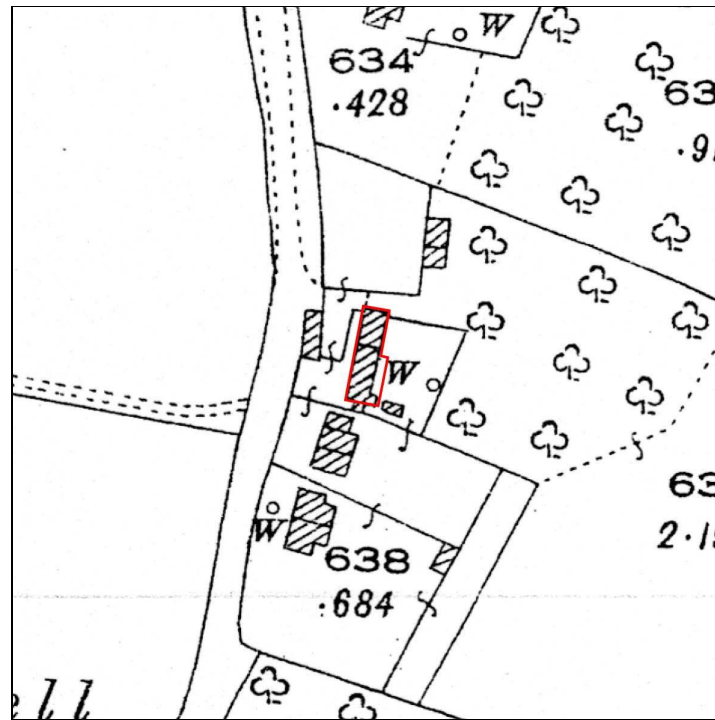
Figure 5: Extract from the 1923 Ordnance Survey Map (scale 12½ inch to 1 mile)

The 1923 Ordnance Survey Map (Fig. 5) shows yet another outhouse had been built, this time to the east of the property. The porch clearly post-dates this map and is likely to have been added in the 1930s or 1940s.

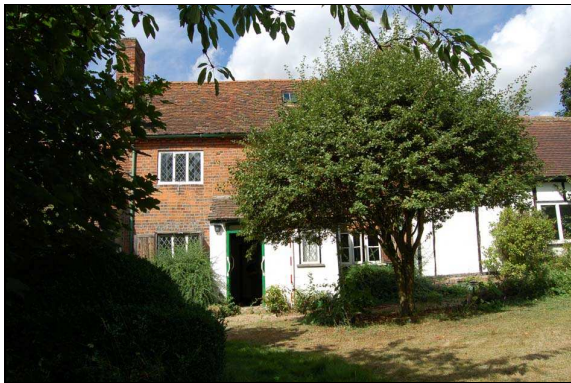
Plate 3: Building 1: east elevation

This is the rear elevation of the property with a small porch to Building 1 that has a ledge and braced stable door to the south of a single light, leaded casement window. There is a 3-light leaded casement window with shutters to the south of the porch and a 6-light, shuttered casement window to the north. The first floor fenestration matches that of the ground floor, but both windows are unshuttered. The brickwork is predominantly set in an English Bond that has been repointed and the bricks, which are handmade reds, measure 22 x 10 x 6cm (8⁵/₈ x 4 x 2³/₈ inches). There is dentilation below the eaves.

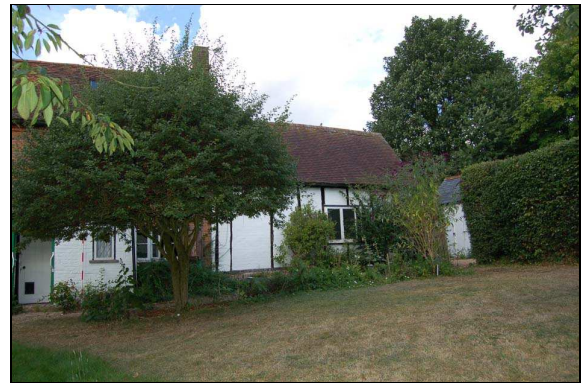
Plate 4: Building 2: east elevation

The east elevation of Building 2 consists of slender timber framing with brick infill set in a Stretcher Bond that has been painted. It rests on a brick built supporting dwarf wall some 47cm high. The elevation contains a single 3-light casement window.

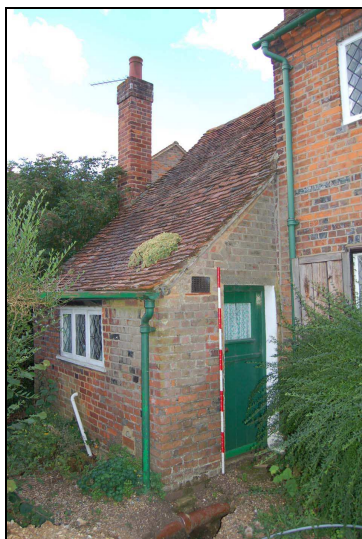
Plate 5: Building 3: east elevation

The east elevation of Building 3 is the brick built outshut that is a mixture of Stretcher and Flemish Bond repointed with cement mortar. The bricks, which are similar to those in Building 1, measure 22 x 10 x 6cm (8⁵/₈ x 4 x 2³/₈ inches). It is nonetheless clear that the outshut is a later addition. It has a single 3-light, leaded casement window.

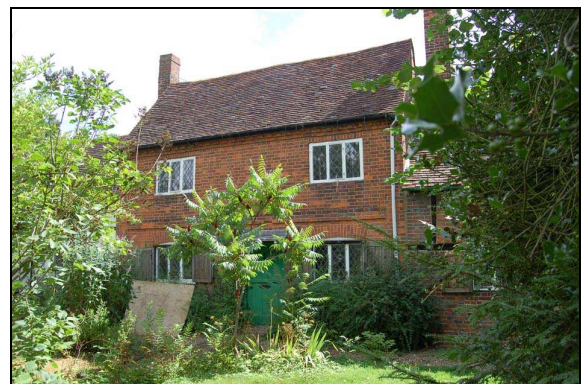
Plate 6: Building 1: west elevation

This is the front elevation of the property and Building 1 has a centrally located 4-panelled under a canopy. There is a 3-light, leaded casement window with shutters and cambered arches on either side of the door. The first floor also has two 3-light casement windows, but without shutters, arches or windowsills. The bricks measure 22 x 11 x 6cm (8⁵/₈ x 4¹/₄ x 2³/₈ inches) and are set in an English Bond that has been repointed. The elevation is decorated with a plat band and dentilation below the eaves and the openings are defined by queen closers.

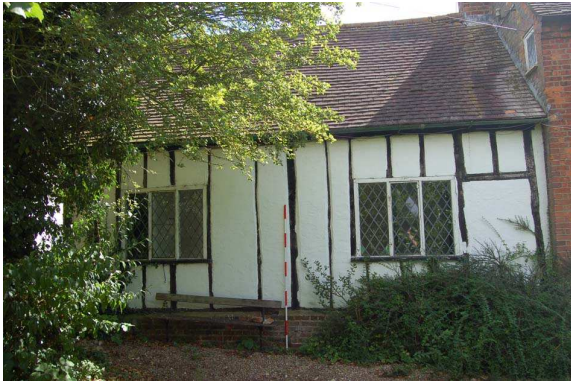
Plate 7: Building 2: west elevation

The west elevation of Building 2 rests on a brick built supporting dwarf wall that is 58cm at its highest. The brick infill has been rendered but the timbers are exposed and a former opening is still evident at the southern end. Two 3-light leaded casement windows have been inserted into the timber frame.

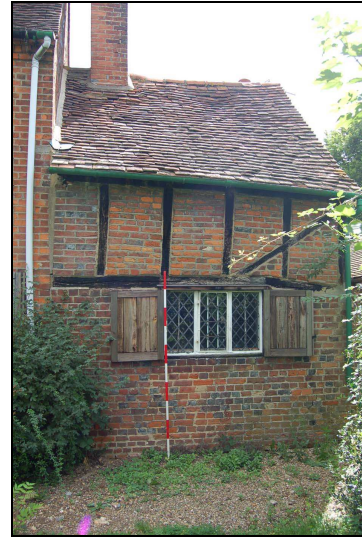
Plate 8: Building 3: west elevation

The west elevation of Building 3 consists of timber framing with brick infill set on a half height supporting dwarf wall, which contains great deal of repointing. The bricks in the dwarf wall measure 21 x 10 x 6cm (8¹/₄ x 4 x 2³/₈ inches) and those making up the infill measure 22 x 10 x 5cm (8⁵/₈ x 4 x 2 inches). There is a single 3-light leaded casement window with shutters below the timber framing.

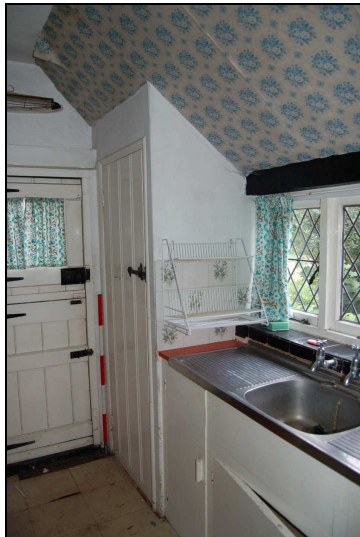
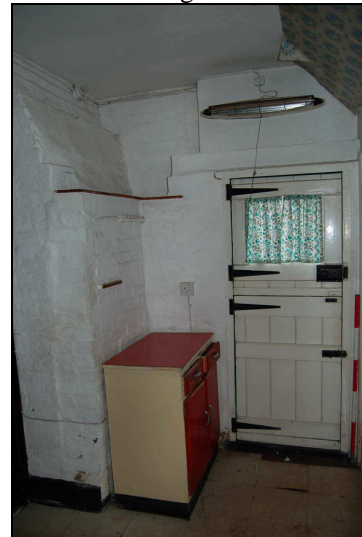
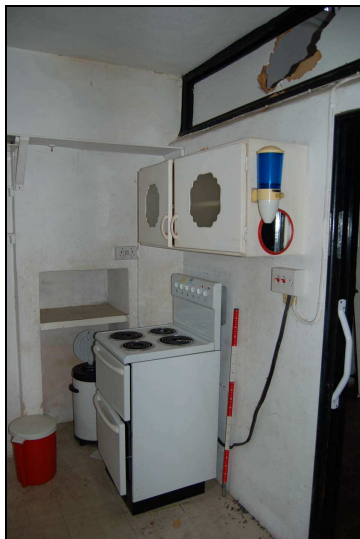
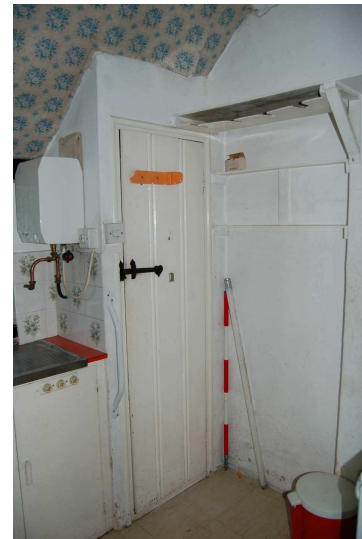
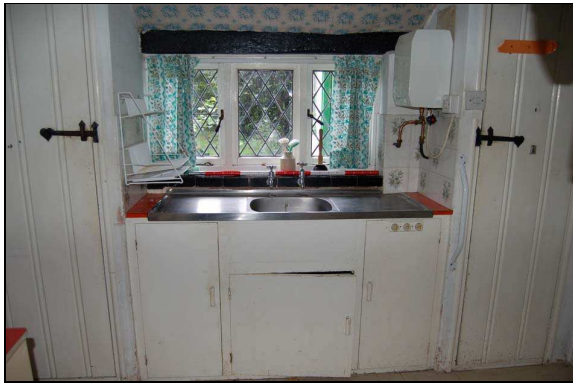
Description: This is the kitchen that lies within the outshut to the east of Building 3. It has a plank and batten stable door in the north wall opening into the garden and a ledge and braced door in the west wall opening into Room G2. A single 3-light, leaded casement window with side openings is located in an alcove created by a cupboard on either side of the sink in the east wall. The cupboard doors are plank and batten with bead moulding and heart shaped latch ends. The wallplate above the window is exposed, as is a timber frame in the west wall above the door where the floor in Room F1 has been raised to allow more headroom in the kitchen. There is a fireplace in the south wall and the chimneybreast of the fireplace in Room G3 is evident in the northwest corner of the room.

The walls are painted and there are tiles around the sink and skirting to the north of the door leading to Room G2. The ceiling, which is lath and plaster, is partly papered and partly painted. The floor is covered with vinyl tiles.

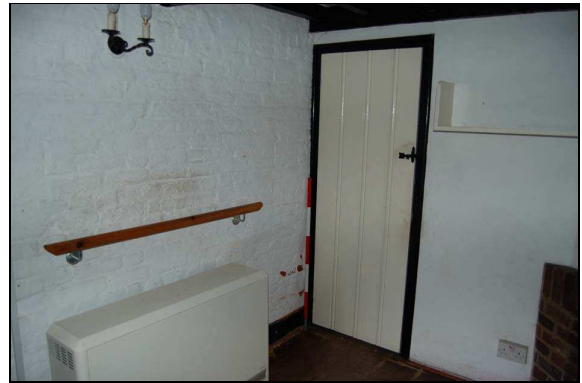
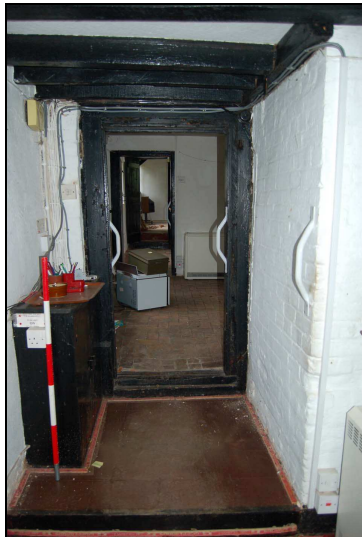
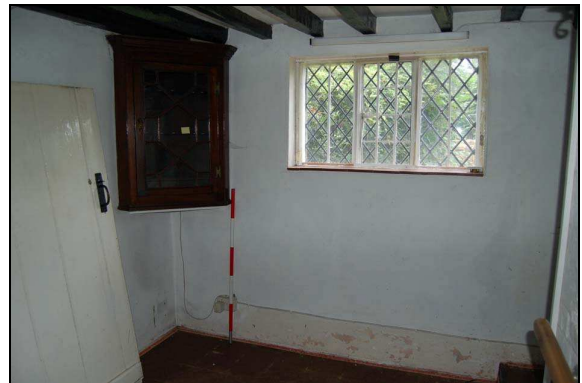
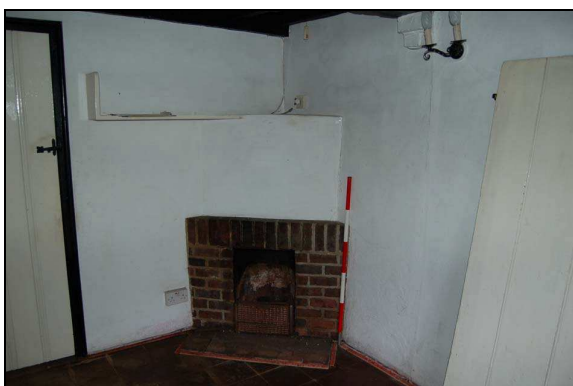
Description: This is an L-shaped room where the return is little more than a raised passage to the west of the fireplace in Room G3. The door in the north wall to Room G3 has been removed, but was a plank and batten door with 4 planks and bead moulding. There is a similar door in the east wall to the kitchen (G1), which is ledged and braced. There is a single 3-light, casement window with side openings and a spiral catch in the west wall. The central light has rectangular panes and the outer lights have a centrally located mullion. The exterior has been embellished with leading. There is a diagonally set fireplace with a brick surround and quarry tiled hearth in the southeast corner of the room. The floor is also quarry tiled.

The bridging beam, which is unchamfered, is 17cm wide and the joists, which are 5.5-7cm wide, are set 26-28cm apart.

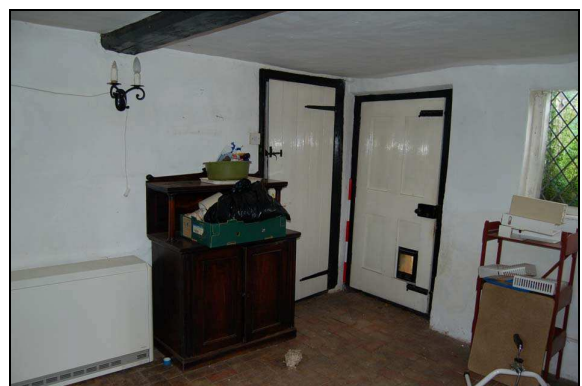
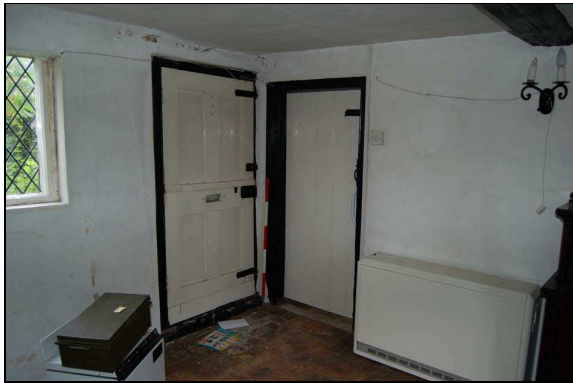
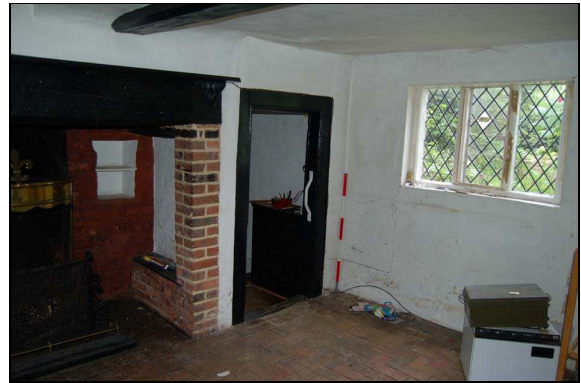
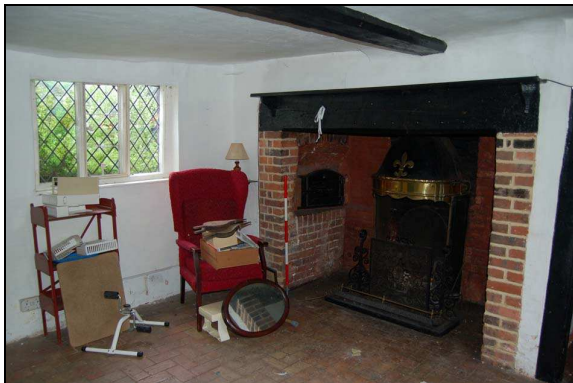
Description: This is the central room of the property with at least one door in each wall. The doors to the front and the rear are 4-panelled, but the latter has 4 planks with bead moulding on the outer face. The plank and batten doors in the north wall have 5 planks and bead moulding, whereas that in the south wall had 4 planks. There is a 3-light casement window with a central opening in the east and west walls. Both have a spiral catch and a tulip handle.

The bridging beam is approximately 17cm wide and has a 4cm wide chamfer, which is likely to indicate an early 16th century date for the beam. The joists have been obscured by a lath and plaster ceiling. The floor is of herringbone brick.

The eastern door in the north wall opens onto an 11-tread straight flight staircase with a winder leading to the first floor.

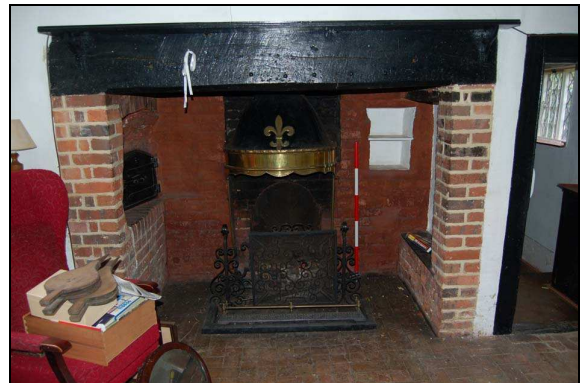
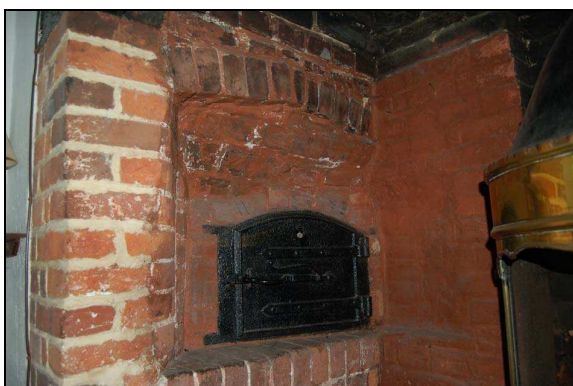
There is an inglenook fireplace in the south wall with a bread oven in the east wall and a bench and store in the west wall. The grate has an ornate hood decorated with a fleur-de-lys, a sun motif on the back panel and shamrock and thistle in alternate squares on the fender.

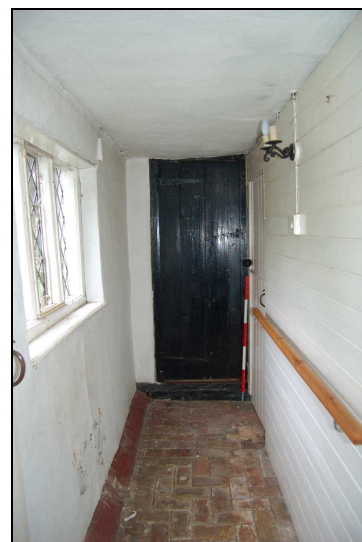
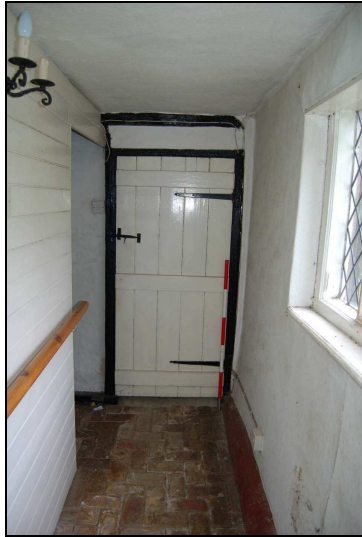
Description: This is a passage that leads from Room G3 to Room G4 and Building 3. There is a recess under the staircase in the southeast corner where the stud wall between Rooms G3 and G4 is exposed. The east wall has horizontal tongue and groove panelling but the west wall is painted above a 10cm high concrete plinth. The ceiling is painted lath and plaster and the floor is also herringbone brick. There is a plank and batten door with four overlapping planks in the north wall leading to Room G6. The door to Room G5 is also plank and batten with 7 planks, which suggests that this is a later replacement. The 3-light casement window in the west wall is similar to those in Room G3.

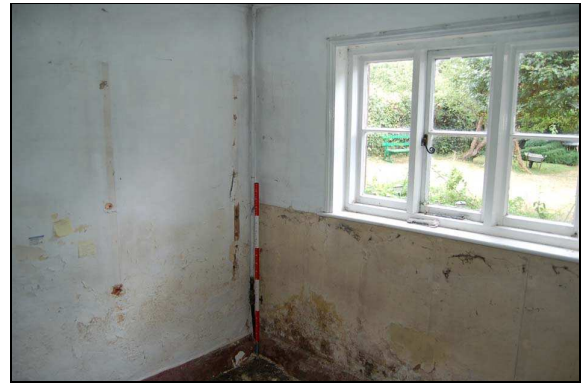
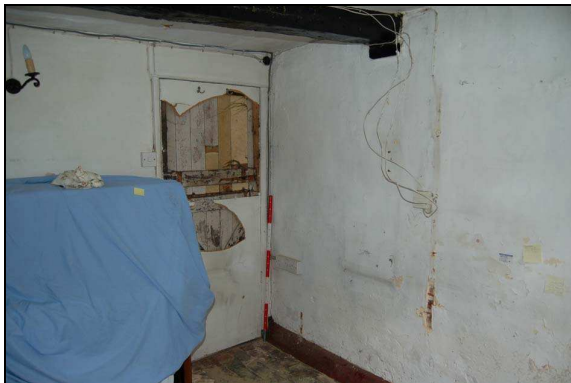
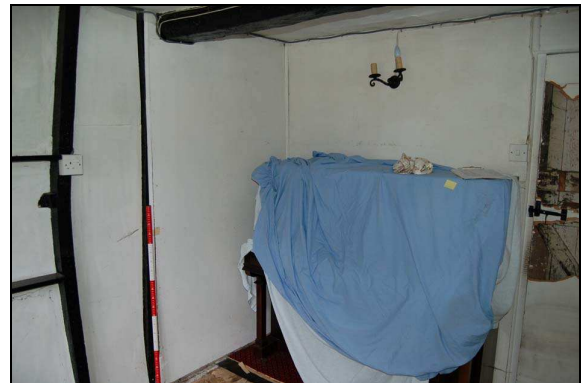
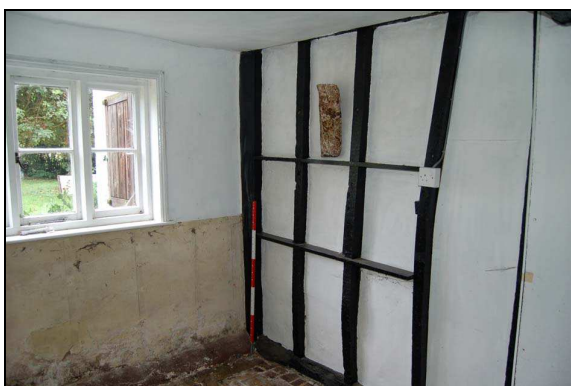
Description: There is a single, poor quality plank and batten door in the west wall, a replacement 3-light casement window in the east wall and some exposed studwork at the eastern end of the south wall. There is a 17cm wide bridging beam with 6cm wide chamfers, which may indicate an early 16th century date for the beam.

The north and west walls have a concrete plinth similar to that in the passage (G5), all of which may have been added in an attempt to prevent damp. The floor is of large black bricks.

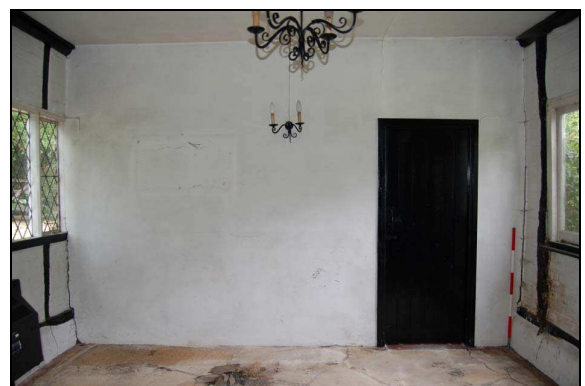
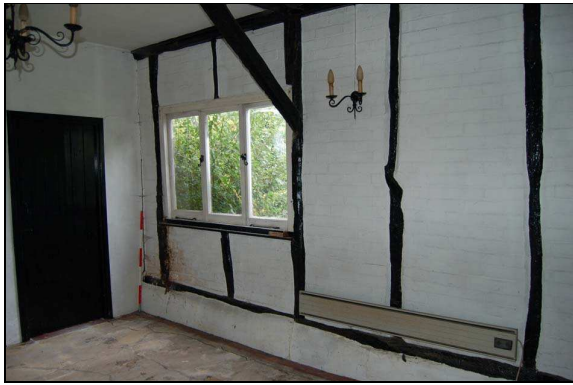
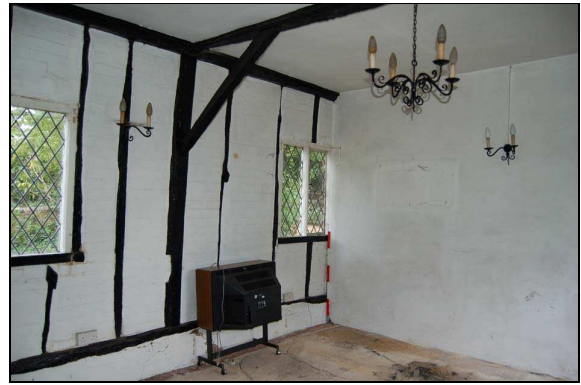
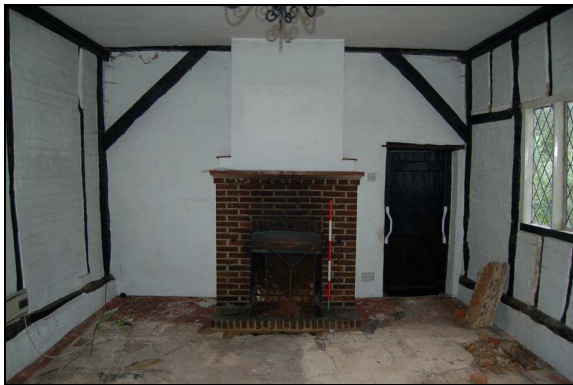
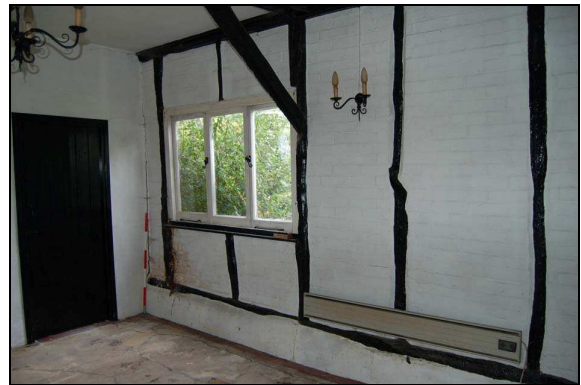
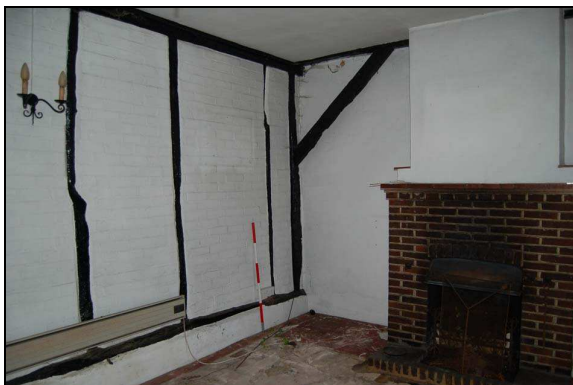
Description: The floor of this room is two steps higher than the passage (G5). There is a ledge and braced door in the north wall leading to a small subdivision of the building. The south door has been described above. There are two 3-light leaded, central opening, casement windows in the west wall, the northern one of which has been truncated by the partition wall. A 3-light, unlead, side opening casement lights the northern end of the east wall. There is a fireplace with a brick surround and hearth and a tile shelf in the south wall. The floor is concrete.

The timber framing is exposed in the east and west walls and there is still evidence for the primary bracing. There are two braced trusses in the room. The northwest and southeast posts have been re-used as has the southern tiebeam and both its braces.

Building 2 initially had primary bracing and weatherboarding, which was replaced by brick infill with cement mortar in fairly recent times. The timberwork consists of rather slender studs and a number of re-used timbers. The dimensions of the studs and the straight bracing suggest an 18th century date for the building. The bay widths indicate that this was not purpose built for the site but brought in from elsewhere. The style of the chimney and location of the fireplace suggest that it was added to Building 1 in the 18th century as part of the larger rebuilding programme.

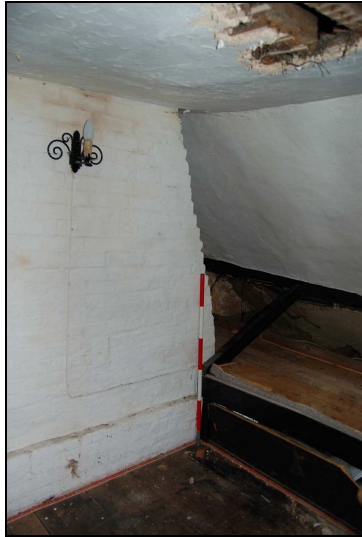
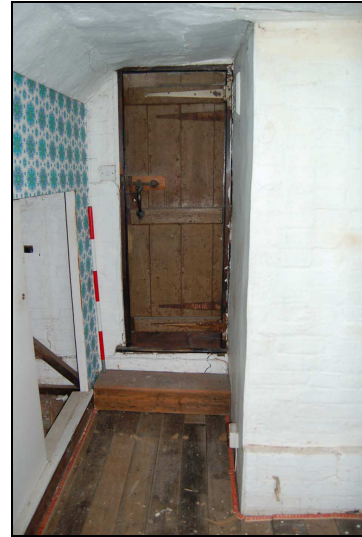
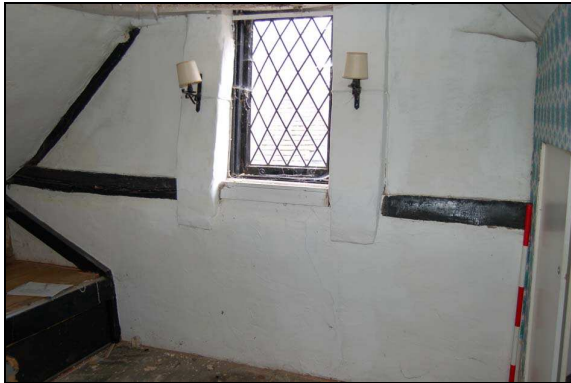
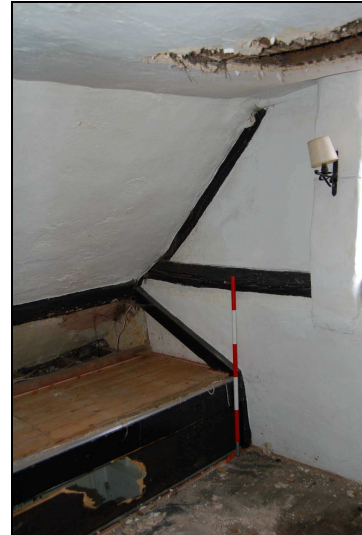
Description: Timber framing is still in evidence in the east, west and south walls. The north wall is dominated by the chimneystack serving the fireplace in Room G3 below. To the west of the chimneystack are two steps leading up to a plank & batten door. A single light, leaded casement window is located in the south wall. Cupboards with sliding doors have been built along the west wall and the floor is raised along the east wall to allow to headroom in the kitchen below. The ceiling is lath and plaster and the floor has 14cm wide timber boards running north to south.

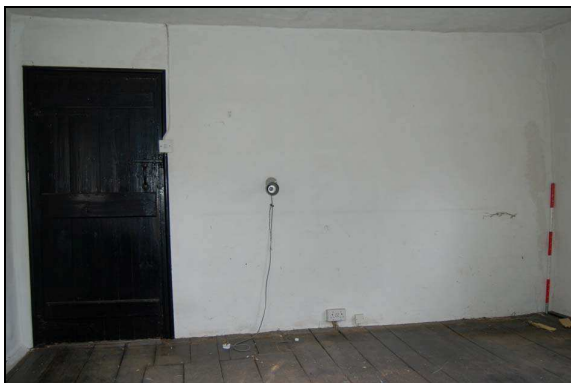
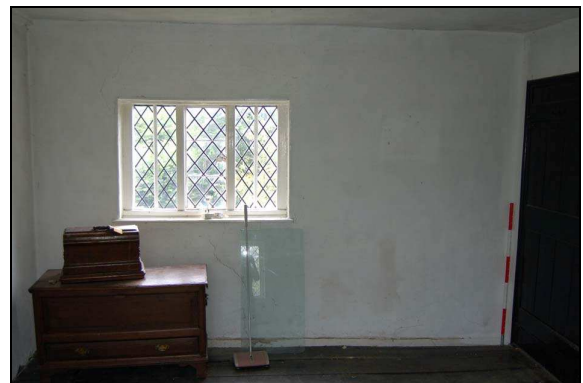
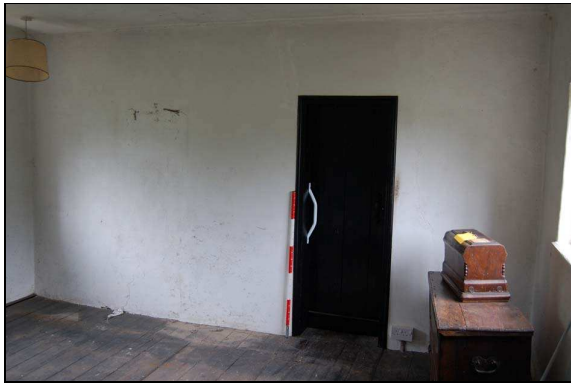
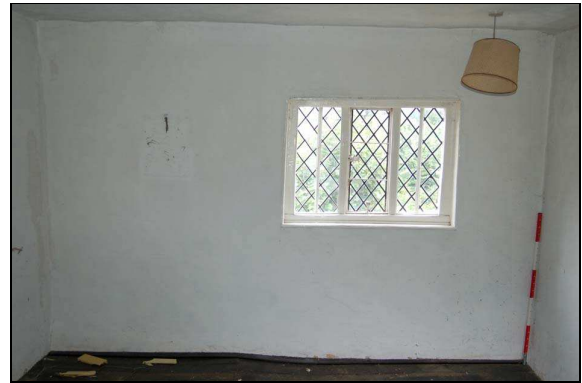
Description: This bedroom has a plank and batten door in the south wall leading to Room F1 and another in the north wall leading to the landing (F3). The 4 planks in the north door overlap on the outer face. The windows in the east and west walls are 3-light, leaded casement windows with central openings and tulip handles and scroll catches. Both have a vertical stanchion in the sidelights. The ceiling is lath and plaster and the floor has 16cm wide timber boards running north to south.

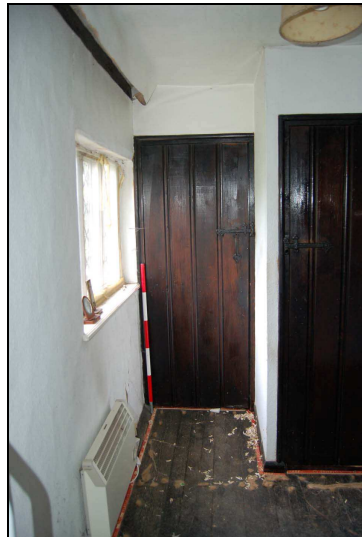
Plate 45: Room F3: northwest corner

Description: This is the landing with an 11-tread straight flight staircase with a winder leading to the ground floor in the southeast corner and a similar one behind a flush door to north of it leading up to the attic. The doors in the north wall to the airing cupboard, WC (F4) and bathroom (F5) are plank and batten type with large bead moulding. The window in the west wall is similar to those in Room F2, as is the ceiling and timber floor.

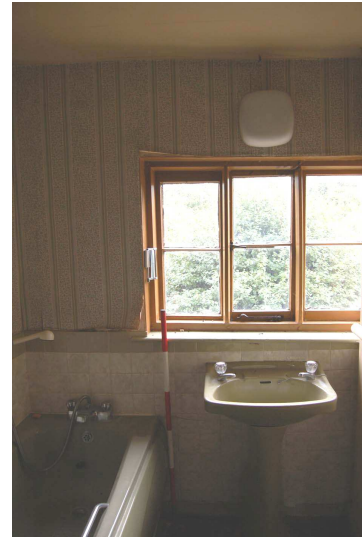
Plate 46: Room F5: east wall

Description: This is a bathroom with a bath along the north wall and a basin against the east wall. The walls are tiled over the bath and basin but are otherwise papered. The lath and plaster ceiling is also papered. The replacement casement window in the east wall is partly concealed by a return in the south wall. The timber floor runs north to south.

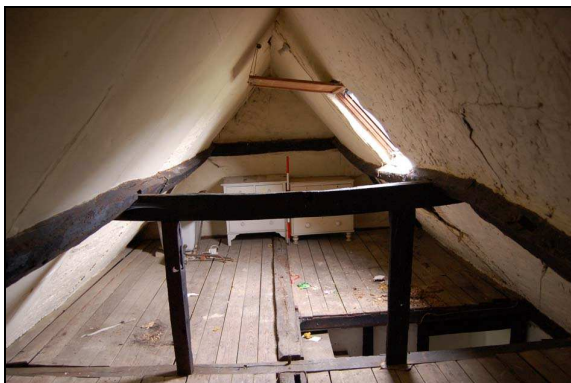
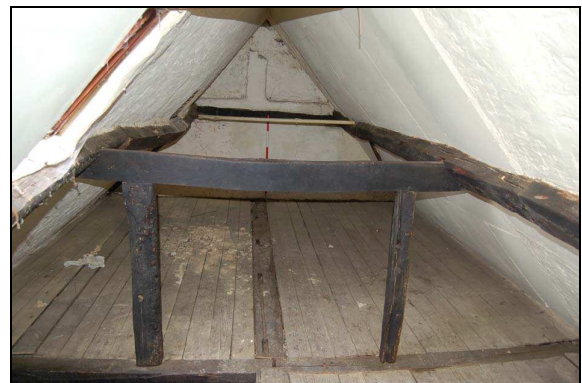
4.10 *Second Floor / Attic* (Fig. 12)**Room S1** (Plates 47-48)*Size:* 6.92 × 3.64m, height 2.17m*Location:* Building 2*Description:* This is accessed by an 11-tread staircase in the centre of the room. The walls and ceiling are plastered and the floorboards run north to south. The laths that are exposed in the southern end of the room appear to be fairly recent. The room is lit by a fanlight in the east roof.

There is a queen strut roof with trenched purlins. The purlins are braced in the four corners and nearly all the timbers are re-used. A face edged and bridled scarf joint is present in the western purlin.

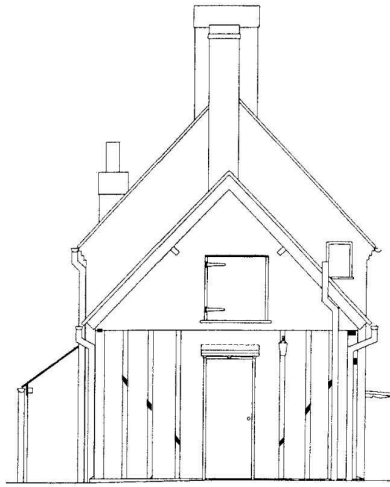
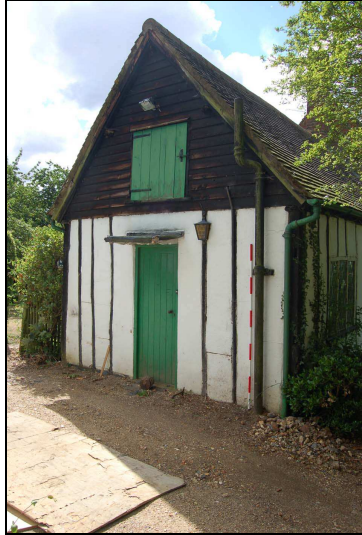
Figure 6: North elevation (*scale 1:100*)
(*Base plans courtesy of Terrain Surveys Ltd.*)

The north elevation of Building 1 has a centrally located chimneystack and a single light casement window to the west of it. A plank and batten stable door has been inserted into the north wall of the outshut.

Building 2 is weatherboarded above eaves level and has a plank and batten door with external fasteners set within it. Another plank and batten door is set in the centre of the ground floor with a lamp to the west of it. There are no windows in the elevation. The purlins and wallplates protrude slightly from the wall.

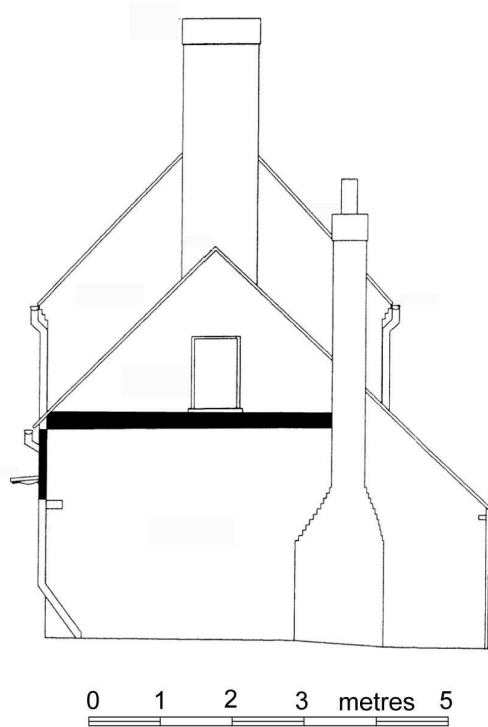
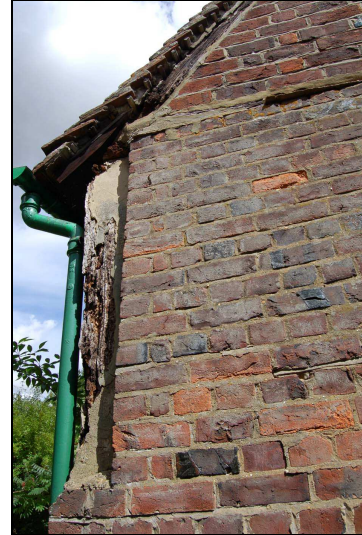
Figure 7: South elevation (*scale 1:100*)
(*Base plans courtesy of Terrain Surveys Ltd.*)

The south elevation is predominantly brick built but with the western corner post and the wallplate of the timber framed structure exposed. The southernmost rafters of the catslide roof and the main roof are also exposed. A brick built chimney has been built over the eastern corner post. The bricks in the south elevation, which measure 22 x 10 x 7cm (8⁵/₈ x 4 x 2³/₄ inches), are set in a variation of an English Bond. The wall has been repointed with cement mortar. There is a single light leaded window at first floor level.

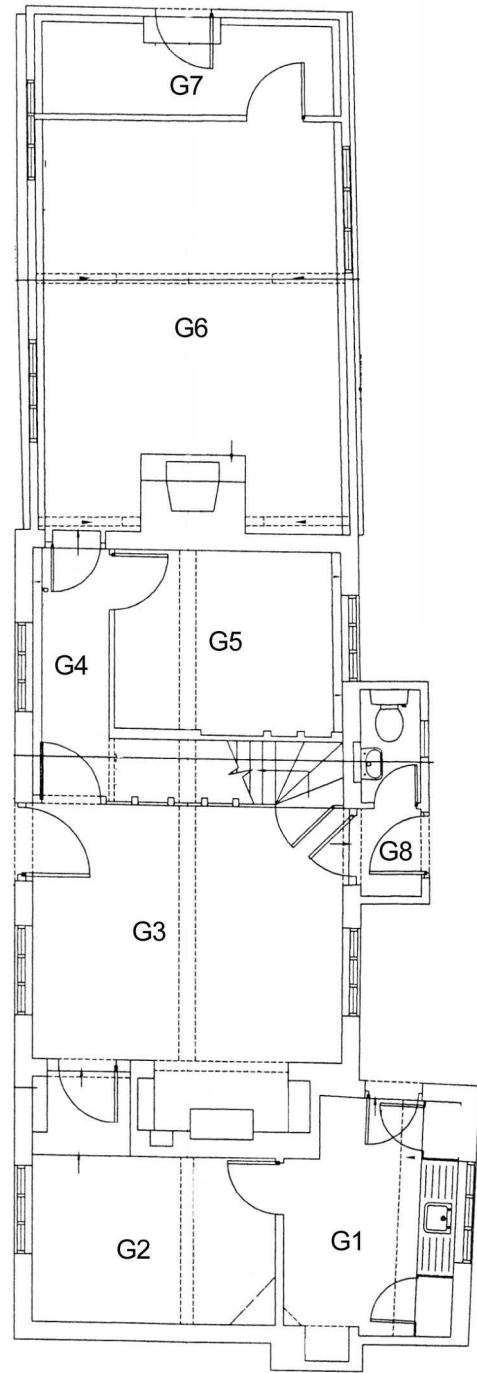
Figure 10: Ground floor plan (scale 1:100)
(Base plans courtesy of Terrain Surveys Ltd.)

4.6 *Ground Floor* (Fig. 10)

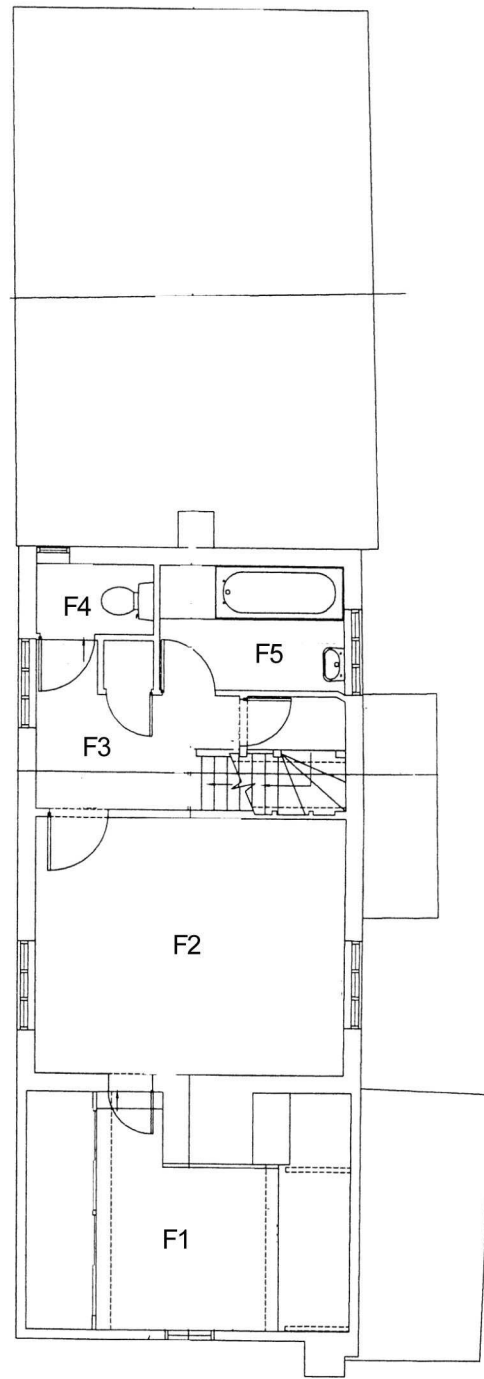
Figure 11: First floor plan (scale 1:100)
(Base plans courtesy of Terrain Surveys Ltd.)

4.9 *First Floor* (Fig. 11)
