**WATCHING BRIEF:  
TUDOR COTTAGE  
12 LITTLE HORWOOD ROAD,  
GREAT HORWOOD,  
BUCKINGHAMSHIRE**

**February 2007**

**ASC: 816/HTC/02**

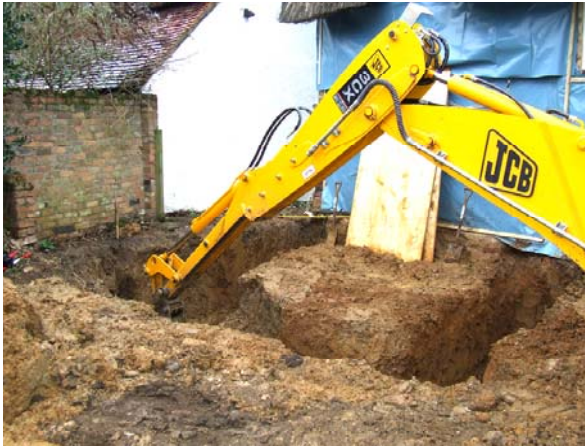
**Plate 1:** Excavation of western half of footings, facing NW

- 4.1 A thin (c.0.15m) layer of reworked top and subsoil were machine stripped from the western half of the footprint of the extension by a JCB fitted with a toothless ditching bucket. The c.0.6m wide and c.1.2m deep footing trenches (Plate 1) were subsequently machined into a deep deposit of natural mid reddish orange gravelly/sandy clay (Plate 2).

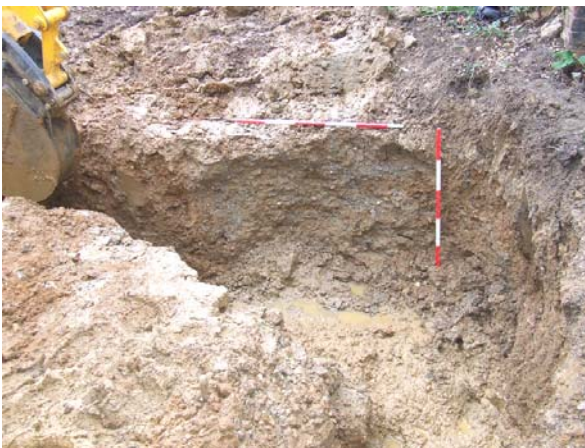
**Plate 3:** Natural feature at SW of footing, facing S

- 4.2 Excavation of the western half of the footing trenches revealed an infilled feature with a steep western side at the southwestern corner of the extension (Plate 3). The depth or full extent of the feature could not be determined because of its location and adverse site conditions caused by extremely wet weather. Its fills consisted of lenses of mid reddish orange sand and mid grey clay, both included frequent small rounded pebbles. Organic fills were entirely absent and archaeological finds were not observed.

- 4.3 The sand and clay lenses filling the feature described in the previous section suggest natural deposition in a glacial or drainage feature. The differing sediment may have resulted from depositional conditions affected by seasonal climatic variation operating in a periglacial or proglacial environment. Other archaeological or natural features and archaeological finds were not observed in the western half of the extension or the spoil resulting from this phase of groundwork.

- 5.5 A feature of indeterminate form and depth and containing inorganic sand and clay fills was revealed at the southwestern corner of the area affected by the extension. The absence of organic material and archaeological finds within the fills suggested that this was a natural glacial or drainage feature that gradually infilled through the action of natural processes.

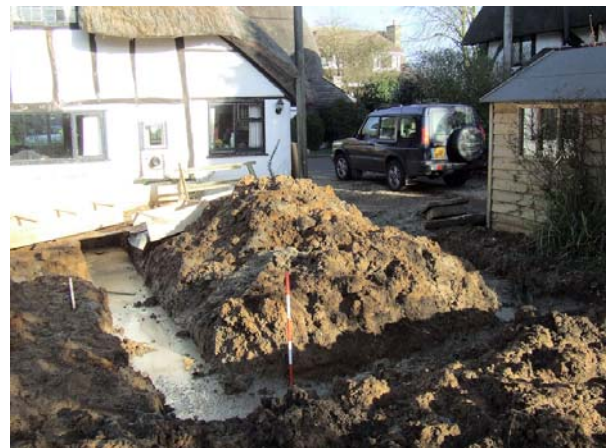
**Plate 4:** Eastern half of footings, facing NE

- 4.5 A subsequent watching brief visit illustrated that the concrete had not completely filled the footing trenches and the top c.0.6m of the natural mid reddish orange gravelly sand was inspected for the presence of archaeological features (Plate 4). No archaeological features were visible cut into the natural deposit in the sides of the footing trenches.

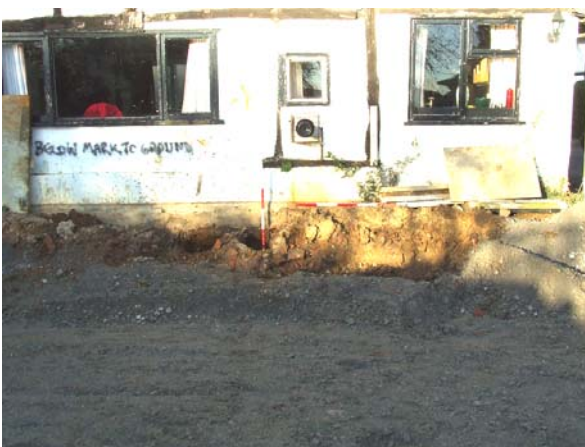
**Plate 5:** Modern brick and tile rubble at southeast of house, facing N

- 4.6 Ground reduction on the eastern half of the extension revealed a deposit of mid brownish sandy loam containing frequent fragments of 19<sup>th</sup> or early 20<sup>th</sup> century brick and tile adjacent to the southeastern corner of the extant house (Plates 5 and 6).

- 5.3 A dump of 19<sup>th</sup>/early 20<sup>th</sup> century brick and tile fragments was present adjacent to the southeastern corner of the extant house. It seems unlikely that this material originated from the extant house and it may represent the remnants of a dump of rubble accumulated during demolition of two buildings shown at the rear of 12 Little Horwood Road on first edition OS mapping. Alternative explanations could suggest that it was laid to aid drainage or as hardcore for a pathway.
