**WATCHING BRIEF:  
KEEPERS COTTAGE  
GORHAMBURY ESTATE  
ST ALBANS  
HERTFORDSHIRE**

*on behalf of the Gorhambury Estate*

**July 2006**

**ASC: 806/VPW/2**

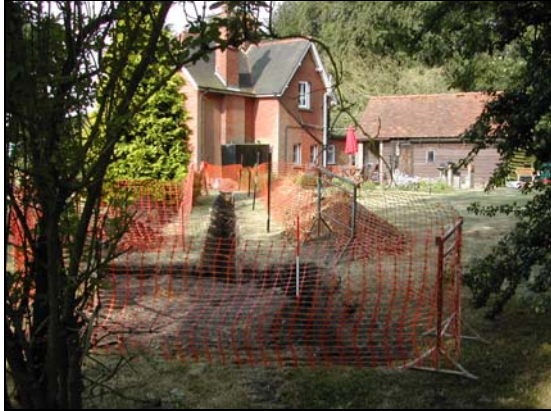
- 3.2 The pipe trench running from the house (Plate 1) to the Klargestep pit was excavated to a depth of 0.3m, except at the junction with the Klargestep pit, where it measured c.0.5m in depth, and at the eastern end where it was 1.05m. It was 0.35m in wide throughout. The trench was cut through c.0.25m of topsoil (Context 100), below which was a natural sandy, gravelly clay (Context 101) (Plates 2 & 3).

**Plate 1:** View of service trench between house and Klargester pit, looking west north west , 2m scale 30/06/06

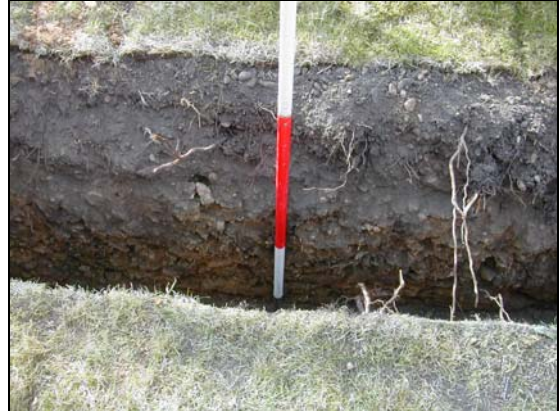
**Plate 2:** Detail of soil profile in service trench between house and Klargester pit, 2m scale 30/06/06

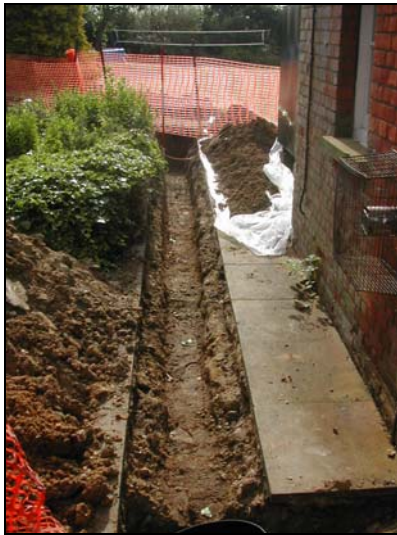
**Plate 3:** Service trench outside house, looking east 30/06/06

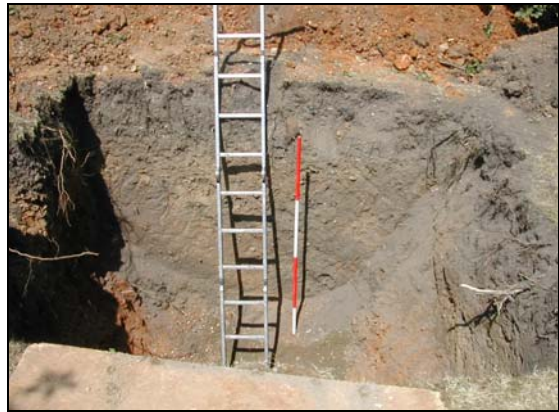
- 3.3 The Klargestep pit measured 2.8m by 2.8m, and was 2m in depth (Plate 4). The topsoil (Context 100) in the pit reached to the same depth as in the pipe trench. Below this was a brown gravelly clay (Context 102) which made up the entire western side of the pit. The remaining three sides had a yellowish brown silty sand and gravel (Context 103) below the brown gravelly clay.

**Plate 4:** View of Klargester pit, looking west , 2m scale 03/07/06

- 4.3 The western side of the Klargester pit completely comprised a brown gravelly clay (Context 102), which was distinctly different from the soils observed in the cut of the pipe trench. This soil is almost certainly re-deposited, and is likely to be fill of one of the ditches. No archaeological artefacts were recovered from the Klargester pit.

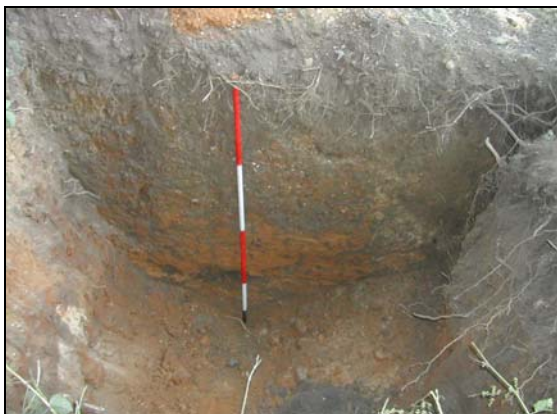
- 3.4 The soakaway was located between 6m and 7m to the north of the Klargestep pit, and measured 2m by 2m, and was 2m deep (Plate 5). It was cut through 0.2m of topsoil (Context 100), below which was the same gravelly brown clay (Context 102) that was observed in the Klargestep pit. The clay was 0.6m thick, and below this was a sandier version of the yellowish brown silty sand and gravel (Context 103) observed in the Klargestep pit.

**Plate 5:** Detail of soakaway, looking east , 2m scale 03/07/06

- 4.4 The same gravelly clay (Context 102) was observed in the soil profile of the soakaway, although here it was only 0.6m thick. No manmade features or artefacts were observed within the soakaway, however it is probable that the gravelly clay represents upcast from the suggested ditch to the south.

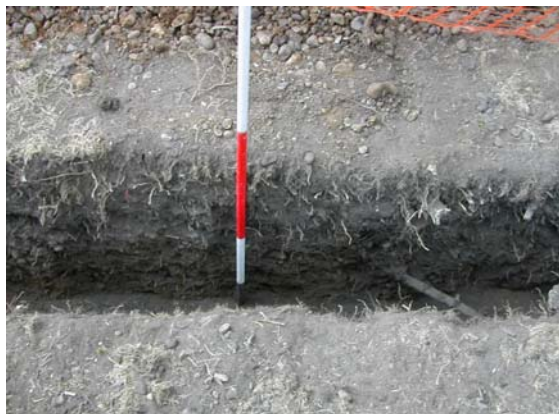
- 3.5 The connecting drainage run between the Klargestep pit and the soakaway was excavated to a depth 0.9m and a width of 0.4m. The topsoil (Context 100) was c.0.4m deep, becoming shallower towards the northern end of the trench. Beneath the topsoil was a brown, pebbly soil (Context 104) (Plate 6).

**Plate 6:** Detail of service trench between soakaway and Klargester pit, looking south east , 2m scale 04/07/06

- 4.5 The connecting drainage run between the Klargester pit and the soakaway revealed a brown pebbly soil (Context 104) beneath the topsoil. On examination, it was concluded that this soil could be disturbed. The drainage run was too shallow and constricted to establish the presence of the ditch, but it is probable that it is in this area. No archaeological finds were recovered from the drainage run.
