### **HISTORIC BUILDING RECORDING: CHAPEL ADJ. THE OLD HOUSE CHURCH STREET GREAT MISSENDEN BUCKINGHAMSHIRE**

*on behalf of Mr. & Mrs. R. Bellis*

**JUNE 2005**

**ASC: 676/MCS/1**

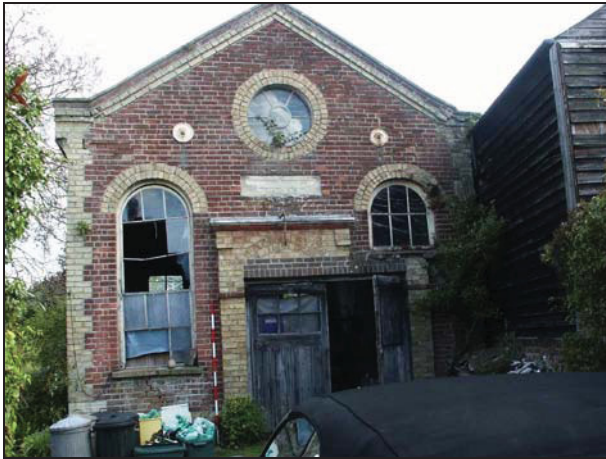
**Plate 1:** South elevation

The south elevation is dominated by two arched windows with a centrally-located circular window at clerestory level. The western window has 15 lights but the eastern window has been truncated by the addition of double doors, and now has only 6 lights. A tie rod is offset over each of the arched windows. There is a rectangular stone block set into the brickwork above the doorway, which is recessed as if to contain a plaque. Further stone blocks are set into the base of the south-east and south-west corners of the building.

- 5.3 The installation of a double door led to the original doorway being cut into, the construction of a lintel consisting of a soldier arch and two further courses of red brick above, and the truncation of the eastern window. It is interesting to note, however, that the original eastern pillar of the door way has been re-used as part of the replacement doorframe.

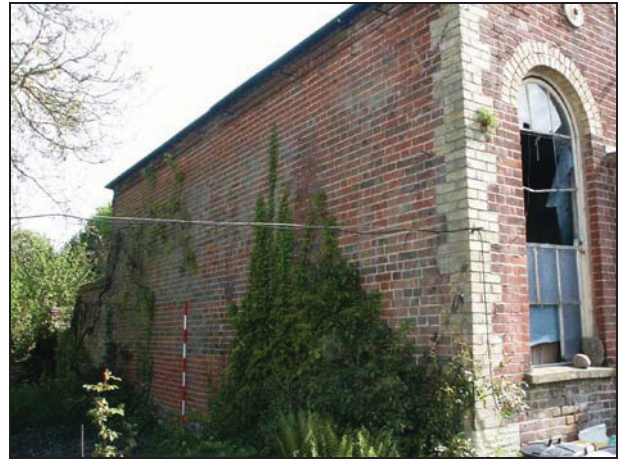
**Plate 2:** West elevation, southern end

There are no openings in the west elevations of either the chapel or the annexe. There is, however, a brick wall extending northwards from the end of the west elevation and a chimney at the northern end of the west elevation of the annexe.

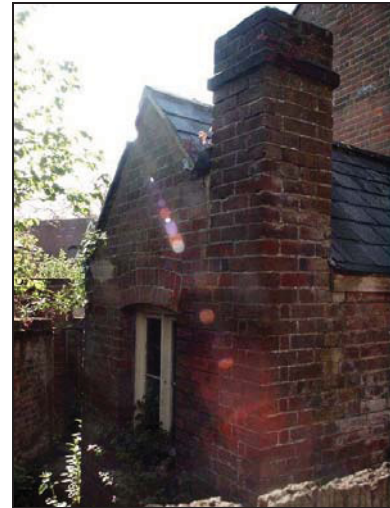
**Plate 4:** North elevation and chimney of the annexe

The north elevation of the chapel has two large arched windows, similar to those in the south elevation but with only 10 lights below a blocked head. The relieving arches here, however, are also of red brick rather than the contrasting yellow brick that adorns the main elevation. There are buttresses at the east and west end of the elevation and a circular opening, which provides ventilation for the roof space, lies immediately below the gable. The tie rods are also apparent in the northern elevation.

The annexe, which is set in the centre of the north elevation of the chapel, has a centrally located, 4-light window and a chimney in the north-west corner.

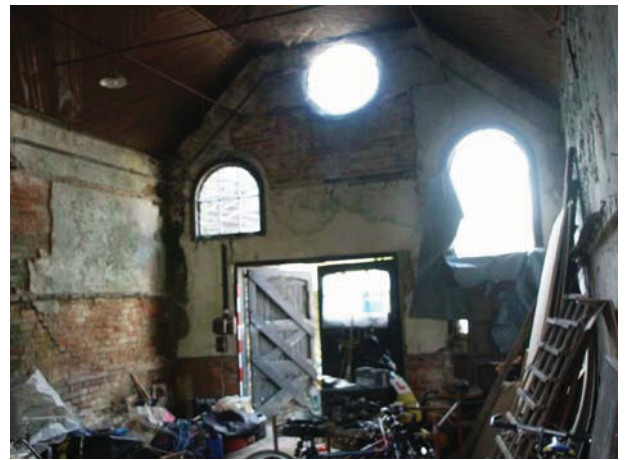
**Plate 6:** Interior of the chapel looking south

*Description:* This is a single open space with remnants of painted plaster on the walls above the height of the door into the annexe. The plaster appears to have been painted predominantly green with floral and scroll motifs in blue, red, brown and gold. A timber moulding echoes the line of the ceiling. The walls may have been wainscoted below the plasterwork, as is suggested by the presence of a number of timbers set into the brickwork.

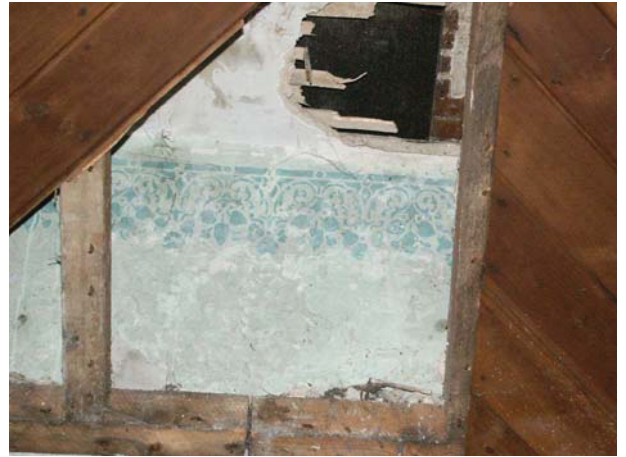
**Plate 8:** Plasterwork detail behind the ceiling

There is a sloping matchboarded ceiling with the boards set diagonally to create lozenge-based patterns. This appears to have replaced an earlier, probably flat ceiling, as painted plasterwork has been revealed behind the present ceiling. Tie rods have been set into the ceiling as well as the north and south elevations, and are now also used to support the electric lighting.

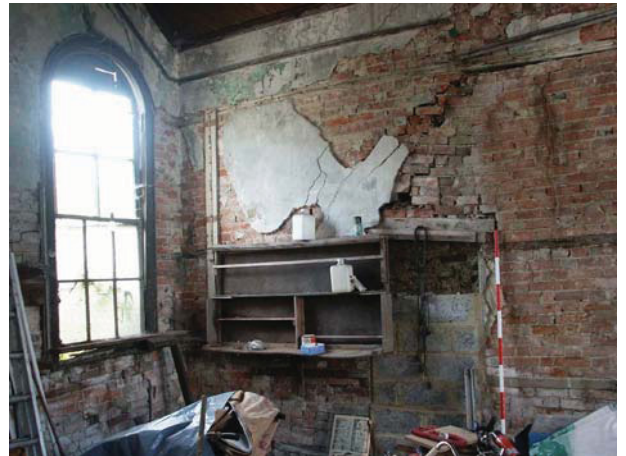
The door in the east wall has been partially blocked on the inside with breeze blocks, and the wall above is suffering from subsidence.

**Plate 10:** East wall showing the blocked doorway and subsidence in the brickwork

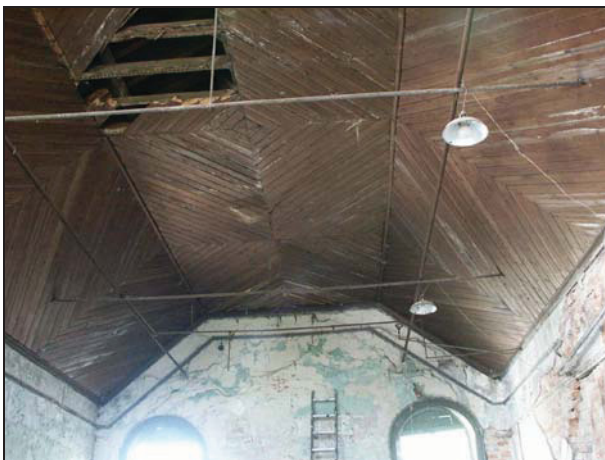
**Plate 11:** Wooden ceiling and tie rods

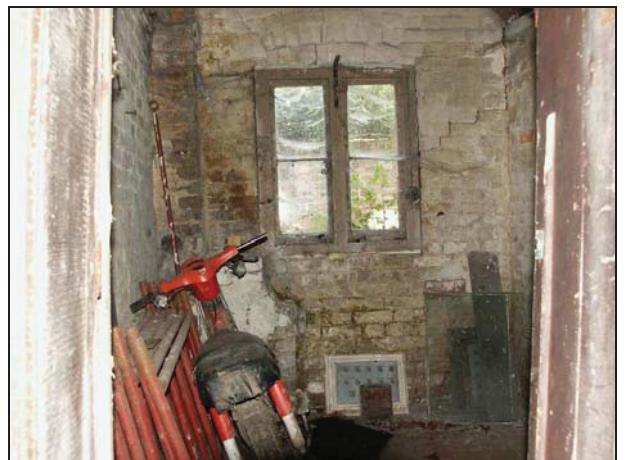
**Plate 12:** Interior of annexe looking north

*Description:* The annexe is also a single open space with unplastered brick walls, a quarry tiled floor and open to the roof. The door in the east wall is a simple ledge-type door with a wooden rack with pegs for coats to the right of it. The window in the north wall is a 4-light casement window, below which is a modern ventilation grid.

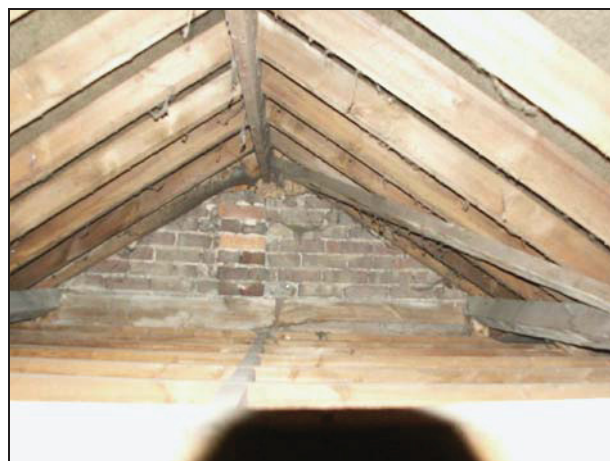
**Plate 14:** Roof looking south

There is a common rafter roof to the main body of the chapel, with a pitch of 30°. There is a single purlin on each side, each comprising machine-cut timber of c.75 × 100mm section. The rafters, of machine-cut timber c.50 × 100mm in section, are set at c.350mm centres. The joists supporting the horizontal section of ceiling are nailed to the rafters: some are notched to accommodate the purlins. The present slate cladding is laid on battens above a layer of roofing felt. The presence of machine-cut timbers and roofing felt, combined with the evidence for the replacement ceiling, could suggest that the building was re-roofed in fairly recent times.
