**WATCHING BRIEF:
65-75 HIGH STREET SOUTH
DUNSTABLE
BEDFORDSHIRE**

On behalf of Hearne-Holmes Developments Ltd

June 2008

ASC: 657/DHS/3r

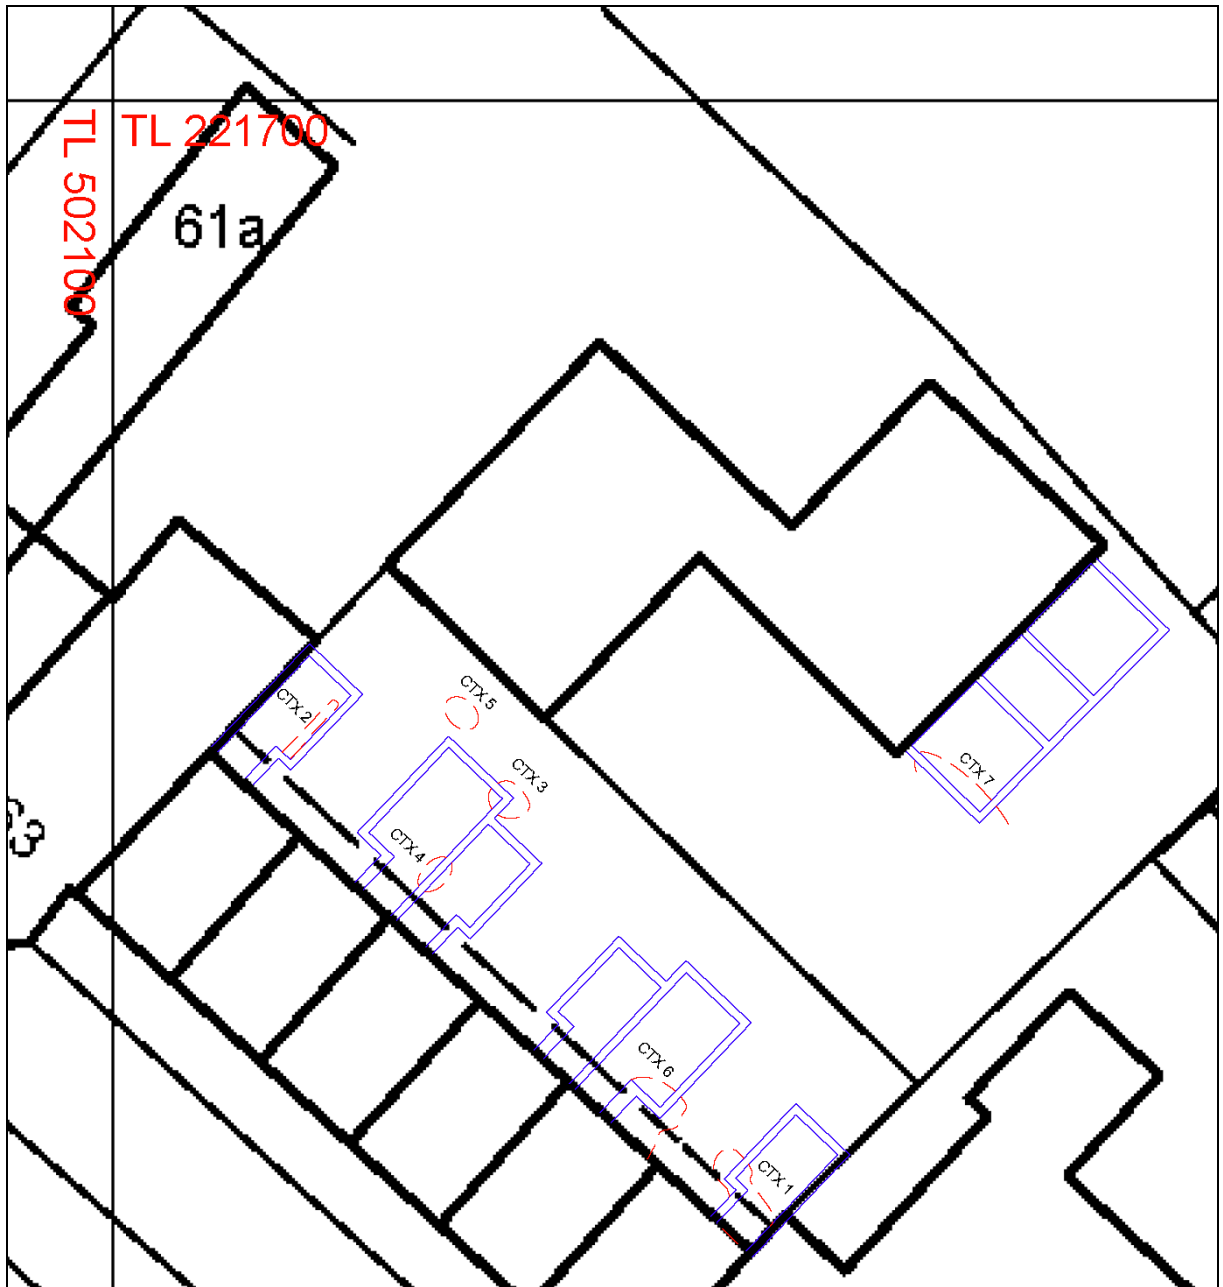
Figure 4: Features observed during watching brief (scale 1:250)

After stripping the ground was too dirty to see the subsoil clearly, although occasional patches of chalk were visible through the disturbance (Area 1, Fig. 3). Artefacts recovered from this disturbed layer (Context 1, Fig. 4) all dated from the 19th century or later (e.g. willow pattern pottery).

During groundworks in Area 2 (Fig. 3) a linear feature was observed (Context 2 Fig. 4). This feature was c.0.3m deep and at least c.1.2m wide. Blocks of Totternhoe clunch stone were observed on the southern side of the feature (Plate 1).

In Area 3 (Fig. 3) the footing trenches were mostly cut directly into the natural chalk. A rectangular piece of worked clunch (310 × 390 × 190mm) was recovered from a feature (Context 3, Fig. 4), on the north-east side of the area. The stone (Plate 2) was broken on one side, with tooling on the remaining three sides, and was probably a window mullion from the medieval or late medieval period. An area to the north-west of the extension (Context 5, Fig. 4), outside of the footprint of the building, was observed to contain oyster shell and occasional fragments of tile. As the feature was located outside the outline of the extension its existence was noted, but it was not examined in detail. In addition, an area of brown chalky material with occasional tiles (Context 4, Fig. 4) was detected in the cut of the footing trench, in the centre of Area 3.

Observation of the footing trenches excavated in Area 4 (Fig. 3) revealed another patch of disturbed ground (Context 6, Fig. 4). This was situated in the southeast corner of the extension, and contained brown chalky material with occasional tile fragments.

The only feature of potential archaeological interest, a possible ditch terminal, lay on the eastern side of the development area. In this area the overlying soil was comparatively shallow, being no more than 0.25m deep. In the south-east corner of the new foundations a possible ditch terminal was observed (Fig. 4, Context 7; Fig. 5; Plate 4) as a possible linear feature orientated roughly NW-SE, terminating at its north-west end and extending beyond the footings to the south-east. It was estimated to be about 5m wide and about 1m deep. At the base of the feature lay fragments of roof tile, below a predominantly dark grey silty fill.

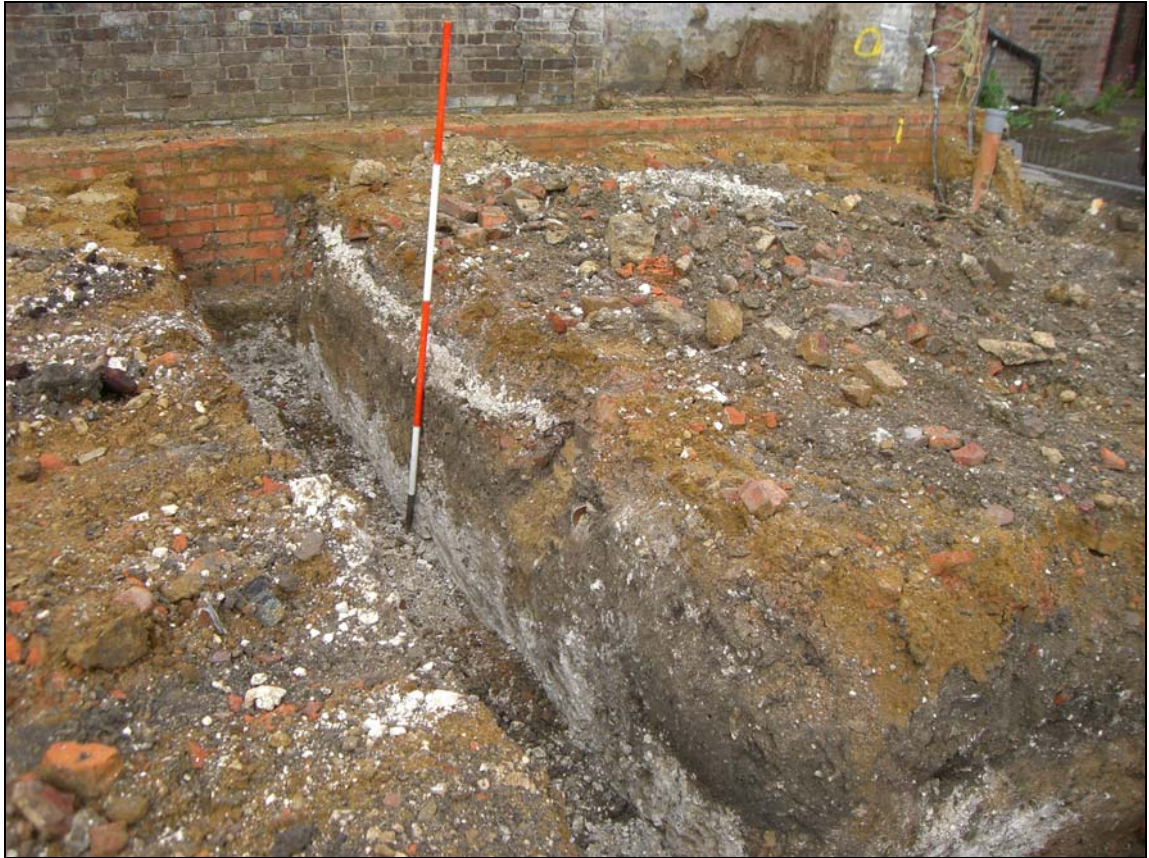
Plate 3: South-west-facing section of 2007 footing trench

A single visit established that this phase of the development (Fig. 3) made considerable use of the existing foundations of a relatively modern building. The extent of new foundation trenches was limited to the south-east side of the existing footings (Fig. 4; Plates 3-4). The average width of the new foundations was 0.65m and the depth was about one metre where the ground had been newly excavated. The natural chalk subsoil was reached about 0.8m down from the surface. It was overlain by a varying matrix of dark grey soils containing chalk, tile, brick fragments and glass. Some 19th century drains were present, along with two shallow brick footings, which demarcated a thin spread of chalk (Plate 3). This lay on the south side of the site and almost certainly formed part of a floor of an outhouse, or possibly a privy.

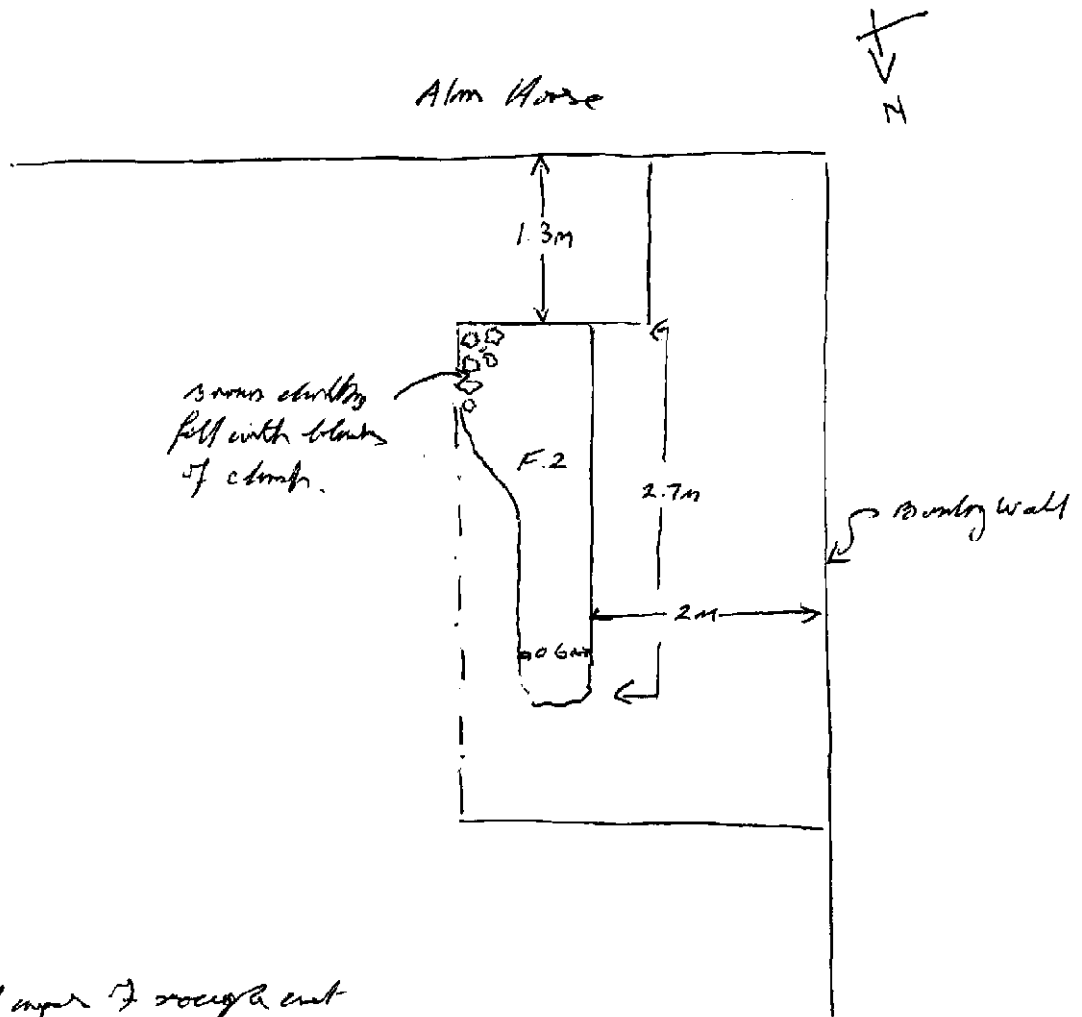
F.2. Layer of rough cast
clunch c.o. 20 dia.

one piece has been carved. Possible window mullion
260mm x 1 mm x 160mm
