**ARCHAEOLOGICAL EVALUATION:
LAND AT BERNHARDS GARDEN CENTRE
BILTON ROAD
RUGBY
WARWICKSHIRE**

on behalf of Miller Homes

ASC: 630/RBR/2

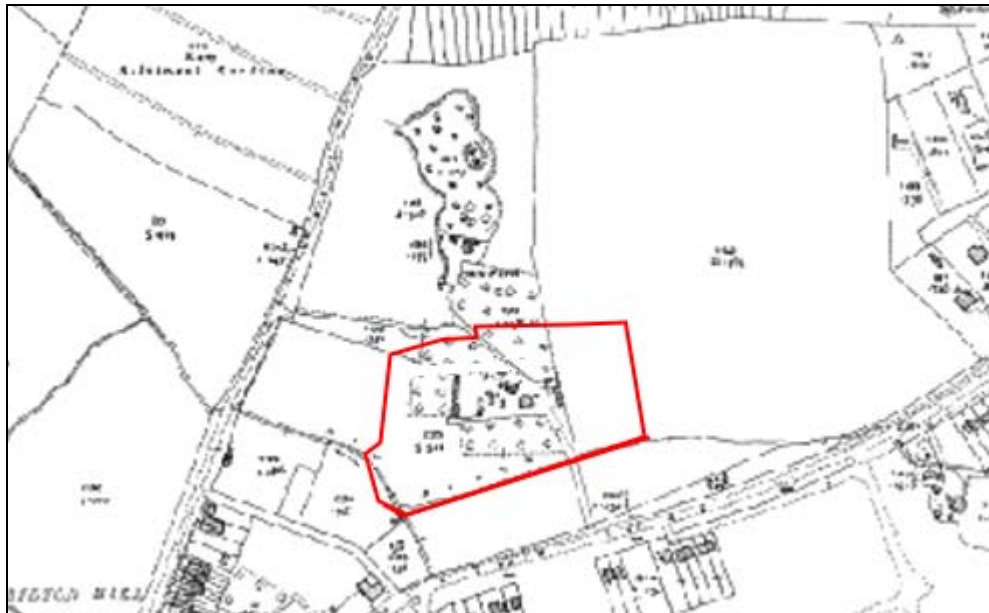
Figure 8: Extract from the 1939 1:2500 Ordnance Survey map (not to scale)

- 3.9 The site developed during the mid 20th century and is shown on the 1939 Ordnance Survey map (Fig. 7), with much of the central area of the site and land to the north being occupied by trees, possibly an orchard. A glass house is also shown in the northern part of the site.
- 3.10 A housing estate now occupies the site of the brickworks and was probably constructed during the second half of the 20th century. The site itself was until recently occupied by a nursery and contained a variety of low rise buildings and glass houses, which have now been demolished.

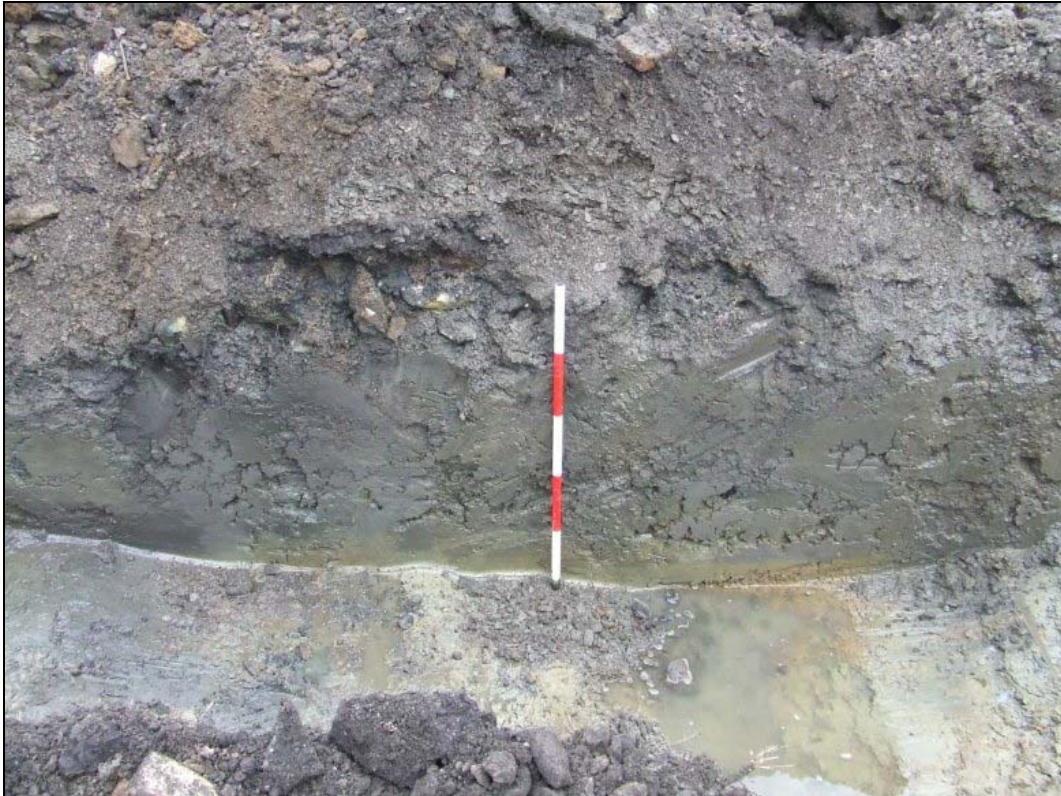
Description: The only feature of significance in this trench was a 3.7m wide ditch which was orientated NW – SE. Prior to the ditch being filled a sectional clay drain was placed in its base, probably indicating that the ditch was filled in deliberately. The only other feature observed in this trench was a modern water pipe which had been cut into the natural towards the SW end of the trench.

Plate 1: Clay fill of boundary ditch [105]

- 5.2 From the cartographic evidence it is clear that the ditch exposed in Trench 1 was a field boundary which was filled in sometime during the 1930's, as the boundary is shown on the 1938 map but has disappeared on the 1939 map where a new wood is shown, possibly a small orchard. The four parallel trenches identified in Trench 2 remain an enigma but it would seem likely that they post date the closure of the brickworks.

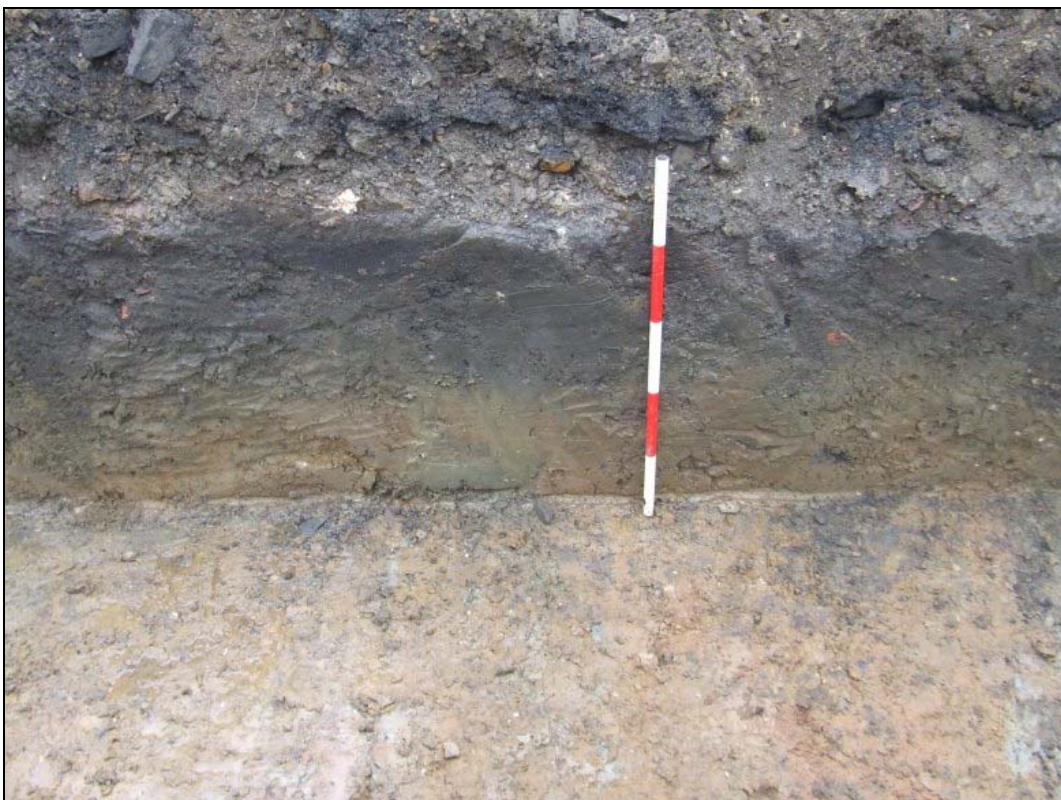
Description: No features other than modern were identified in this trench. However of some interest there were four N - S orientated vertical sided trenches [204] - [210] towards the western end of the trench. These features were sealed by the upper rubble makeup layer. No clear function could be attributed to these trenches but modern porcelain (late C19th/ 20th) was recovered from the fill of trenches [210] and [206]. The only other features identified in this trench were three sectional clay pipe drains and an electricity cable.

Plate 2: Trench [208] unexcavated

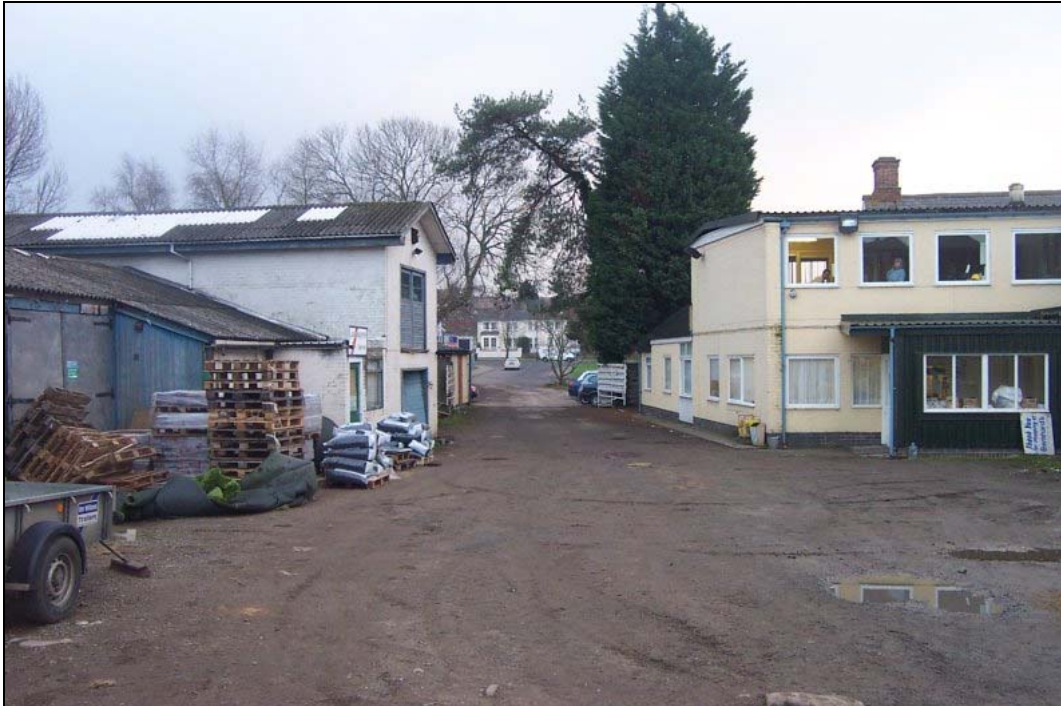
Plate 3: The possible old brickworks buildings

- 5.1 The historical research associated with this project has demonstrated that by 1888 several buildings presumably associated with the brickworks were present within the proposed development area. A track leading to Bilton Road also passed over the proposed development area. No detailed consideration was given to the standing buildings before they were demolished as a first phase of the sites current redevelopment work. However, it is likely that the garden centre utilised the old brick-built buildings for their offices and warehousing (Plate 3).

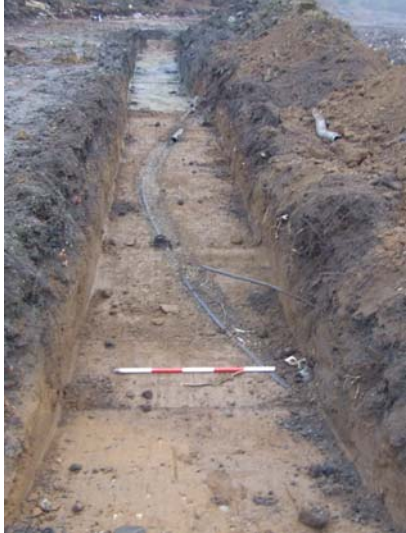
Trench 1

Max Dimensions (m)					
	Length	25.0	Width	1.6	Depth	1.00
	Levels					
	Trench top SW		91.81m OD			
	Trench base SW		90.91m OD			
	Trench base NE		91.50m OD			
	Trench top NE		92.40m OD			
	NGR Co-ordinates					
	SW	448913 274571	*NE	448936 274582		
	Orientation		SW-NE			
Reason for Trench		Evaluation of potentially undisturbed NW corner of site				
Context	Type	Description and Interpretation	Max Width (mm)	Max Thckn (mm)	Depth BGL (mm)	
100	Layer	Modern debris	>1600	100	0-100	
101	Layer	Tarmac surface	>1600	50	100-150	
102	Layer	Makeup of bricks and concrete	>1600	150	150-300	
103	Layer	Loamy soil	>1600	100	300-400	
104	Natural	Mid orange brown sandy clay silt	>1600	n/a	>400	
105	Fill	Fill of 106, mid blue grey clay	4000	700	300-1000	
106	Cut	Modern in-filled field ditch with a sectional clay pipe land drain in the base.	4000	700	300-1000

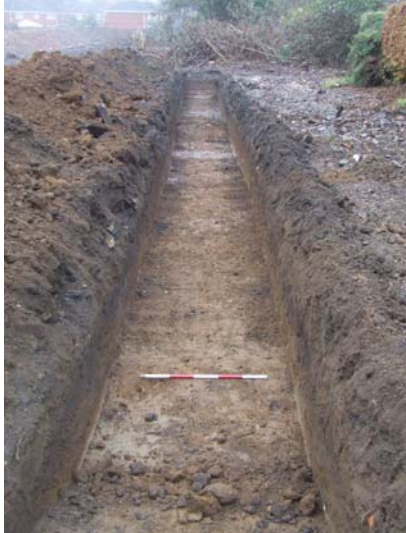
Trench 2

Max Dimensions (m)					
	Length	25.0	Width	1.6	Depth	
	Levels					
	Trench top E		94.56m OD			
	Trench base E		93.44m OD			
	Trench base W		92.71m OD			
	Trench top W		93.76m OD			
	NGR Co-ordinates					
	E	449008 274595	W	448982 274592		
	Orientation		E-W			
Reason for Trench		Evaluation of potentially undisturbed northern part of site

Context	Type	Description and Interpretation	Max Width (mm)	Max Thckn (mm)	Depth BGL (mm)
200	Layer	Makeup material, brick and stone in dark soil matrix	>1.6	350	0-350
201	Layer	Yellowish orange clay moderate charcoal fleck and small brick fragments.	>1.6	400	350-700
202	Natural	Orange clay	>1.6	n/a	>700
203	Slot	N-S orientated slot cut from base of (200)	500	>400	>700
204	Fill	Fill of 203, mixed orange and blue grey clay	500	>400	>700
205	Slot	N-S orientated slot cut from base of (200)	500	>400	>700
206	Fill	Fill of 205, mixed orange and blue grey clay. Modern glazed tile and porcelain	500	>400	>700
207	Slot	N-S orientated slot cut from base of (200)	500	>400	>700
208	Fill	Fill of 207, mixed orange and blue grey clay	500	>400	>700
209	Slot	N-S orientated slot cut from base of (200)	500	>400	>700
210	Fill	Fill of 209, mixed orange and blue grey clay. Modern glazed tile	500	>400	>700
211	Cut	Cut for service trench running along the full length of the northern side of the trench.	n/a	400	350-750
