**WATCHING BRIEF:
ST MARY MAGDALENE CHURCH
BARKWAY
HERTFORDSHIRE**

NGR: TL 38309 35594

*on behalf of
Barkway Parochial Church Council*

August 2008

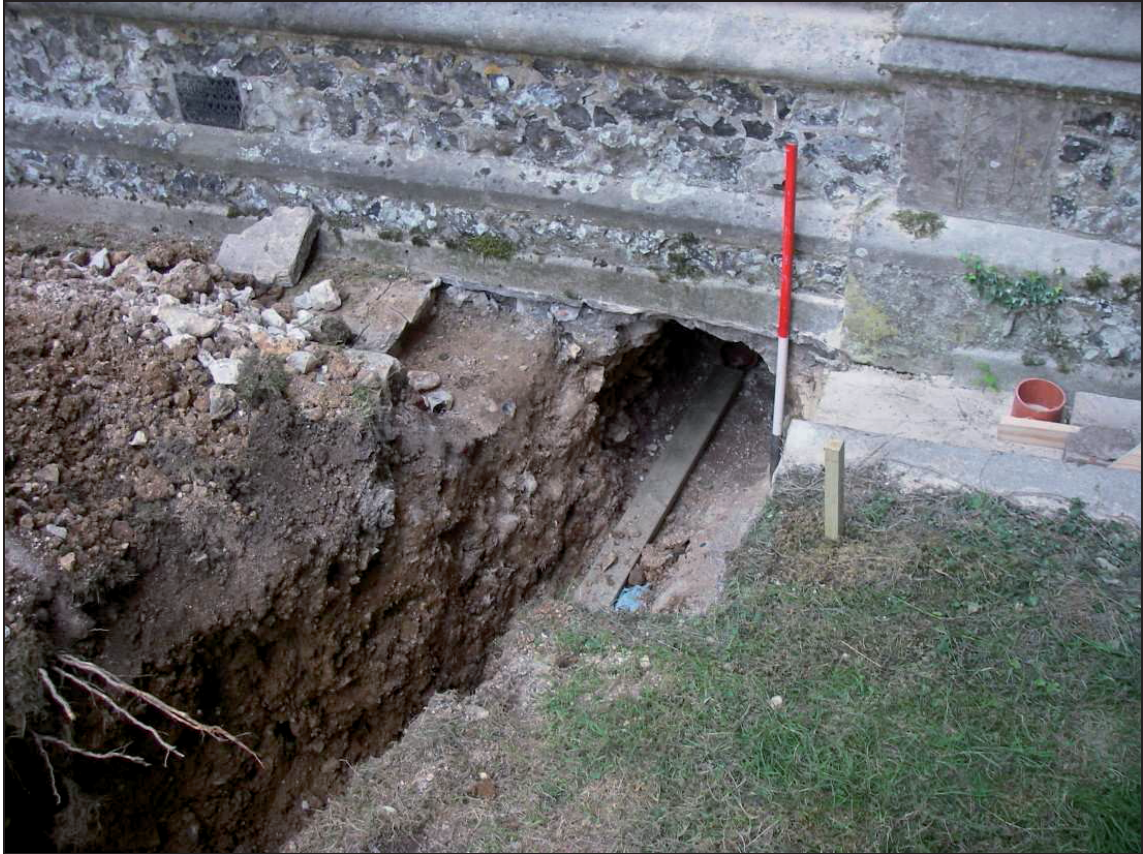
The footings for the west wall of the north aisle (Plates 1, 2) were 900mm wide and 800mm deep. These footings were constructed using chalk fragment and flint nodules set in a loose pale white lime mortar. The cut of the foundation trench extended 0.7m west of the foundation, and was filled with yellowish brown clay. Inclusions of flint nodules and chalk fragments accounted for c.10% of the footing trench fill.

Plate 1: The hole through the north aisle footing

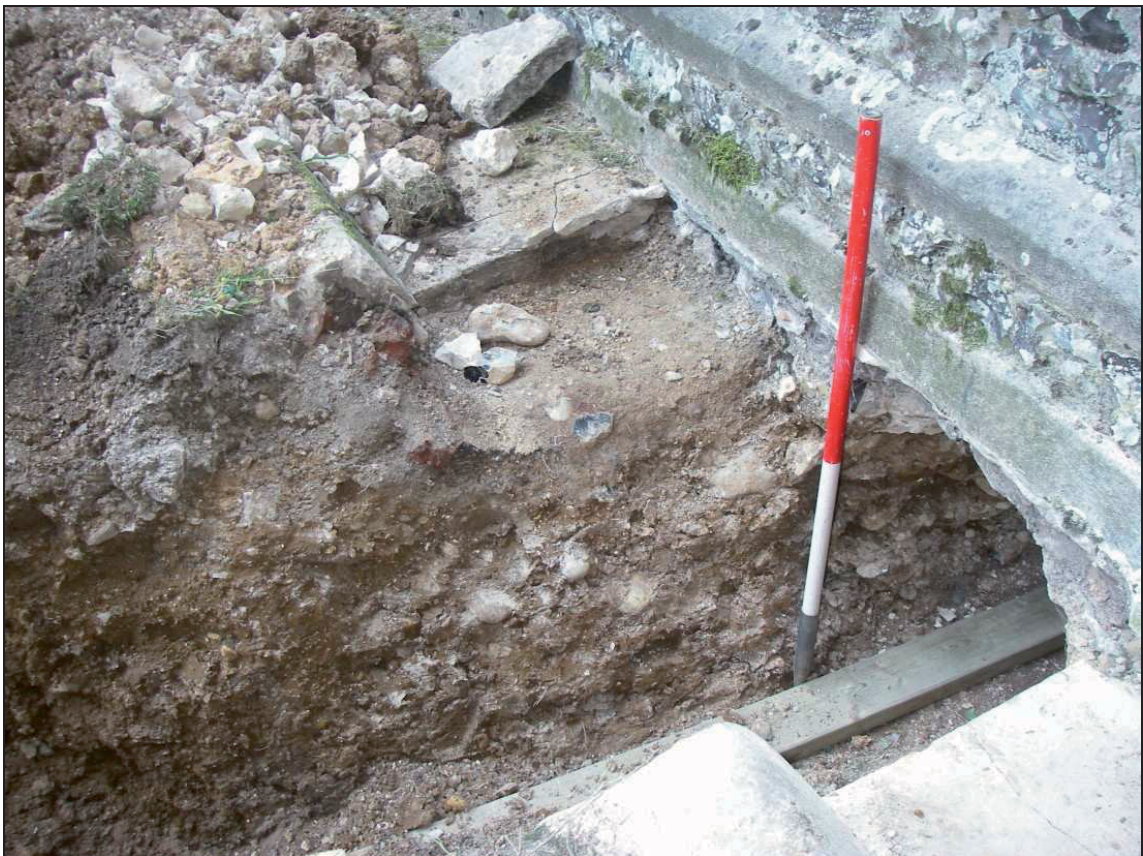
Plate 2: Detail of the north aisle footing trench

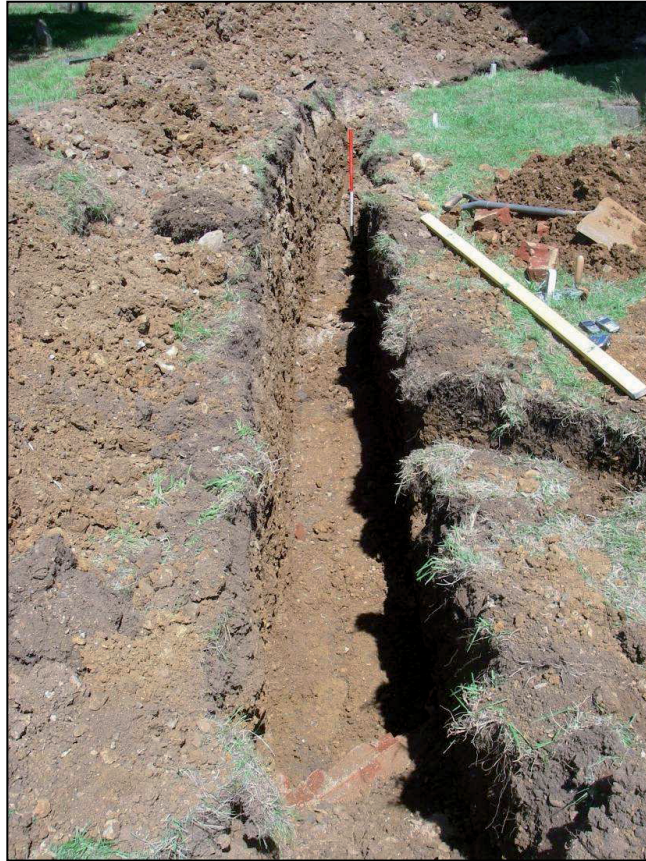
This trench commenced inside the church at the western end of the north aisle where a hole was cut through the footings of the west wall c.1.5m north of the tower. It then continued in a north westerly direction across the graveyard for c.8m before turning south easterly for a further 10m, terminating where a pit to house a septic tank was excavated. A modern French Drain runs round the church and a section of this was removed during the cutting of the trench.

Beyond the footing trench the fill of the sewer trench was generally orange brown friable clay with occasional fragments of peg tile and medium sized flint nodules.

Plate 3: The sewer trench looking north east

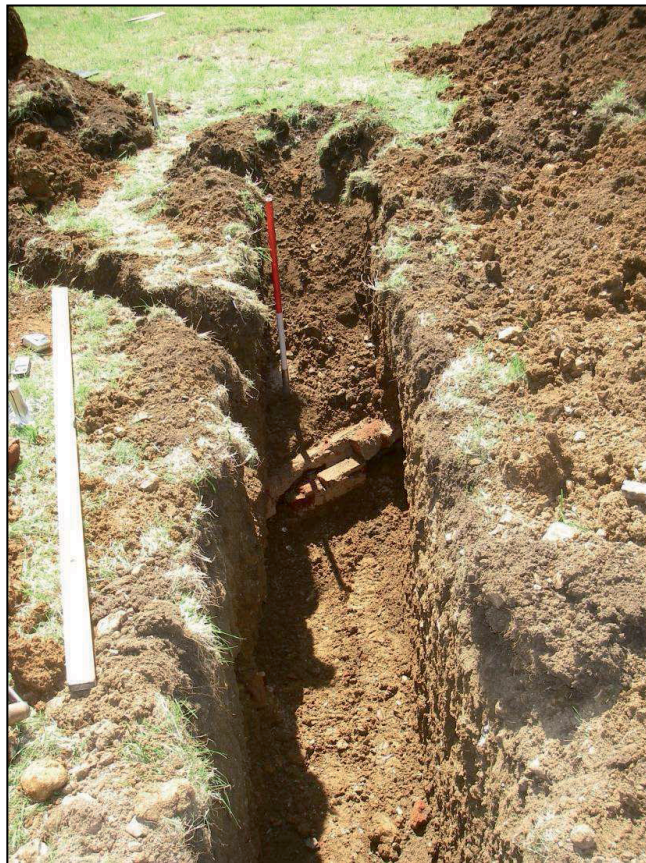
The only features identified in this trench were the tops of two skulls and a brick burial vault. These features were all identified on the south western leg of the trench run. It is likely that the skulls belonged to undisturbed burials, but they were not investigated as they lay below the required level of the trench. The brick vault was orientated east to west and was 1.2m wide externally. It had vertical sides and a vaulted top. The dark red frogged bricks were mortar bonded and measured 222x106x68mm. The upper part of the vault was removed during the excavation of the trench and the interior walls appeared to have been painted white, presumably limewash. As the burial was below the depth of the trench, it was left undisturbed and covered with sand to protect it.

Plate 4: The sewer trench and part of the brick vault

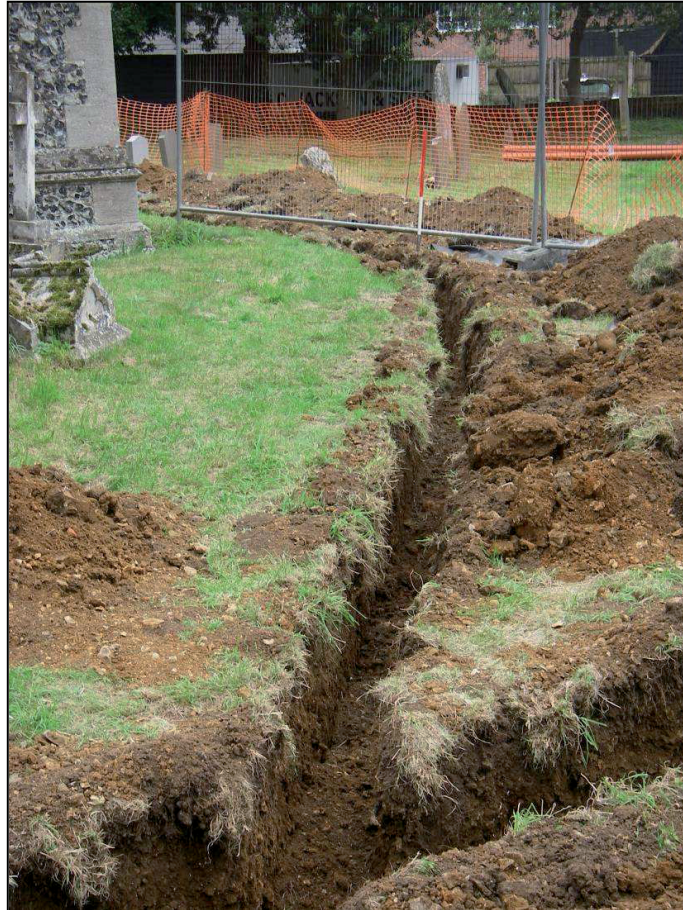
This trench branched off the sewer trench and continued round the west and south sides of the tower from where it headed in a south easterly direction to the cobbled pathway leading to the main south door of the church. The trench crossed the pathway using an earlier trench cut and then followed the south side of a pathway running through the churchyard for c.16m. It then turned northwards following another path for c.15m at which point it entered a small annex on the south side of the church housing the boiler and electricity cupboard.

No features or burials were encountered along the length of the trench, and the soil profile was as described above.

Plate 5: The electricity cable trench on the SW side of the tower

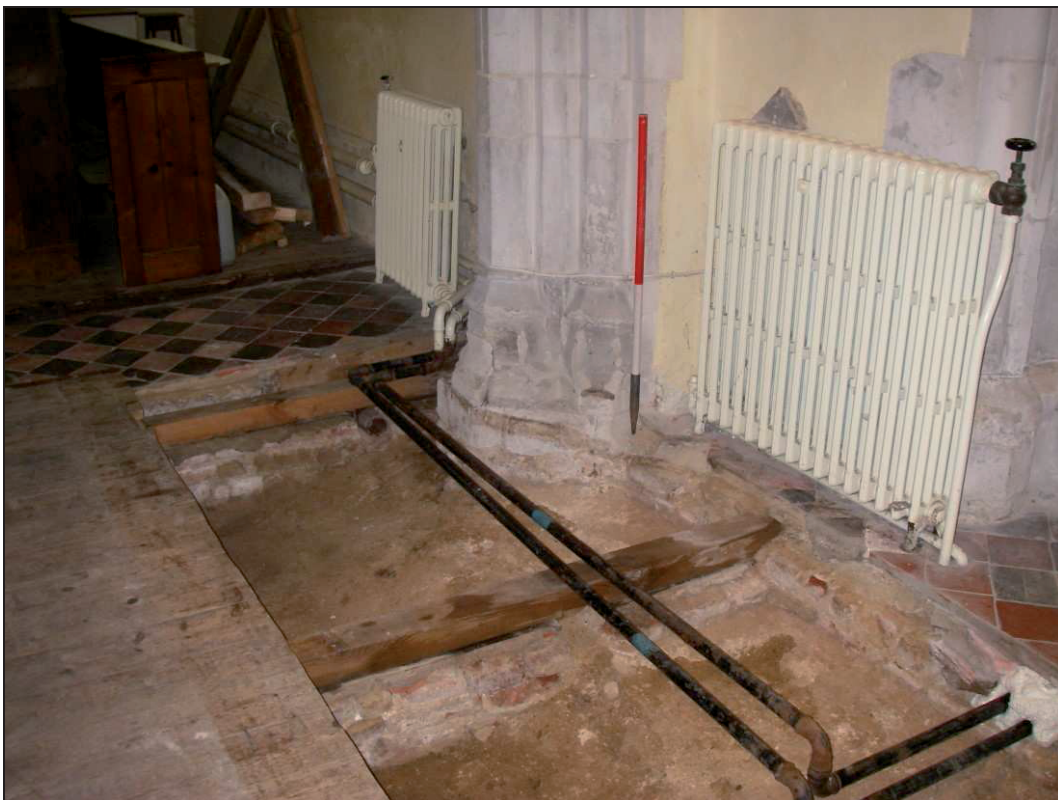
Work inside the church mostly involved the construction of a stud wall in the northwest corner of the north aisle. However a section of the raised central floor in the chancel was lifted. The floor comprised wooden boards sitting on 3 rows of brick supports (Plates 6, 7). The brick supports run east to west along the chancel and comprise 2 courses of stretcher bonded bricks. A wooden beam sat on top of the bricks. Pipes for the central heating system and other services were located in the void under the floor. As the bases of the internal columns are obscured by this raised floor it is obvious that the raised floor is an addition. No features were observed in the earthen floor but it did not appear to be natural. Further investigation of this deposit was not undertaken as it will not be disturbed during the building works..

Plate 6: The raised floor support beams in the chancel

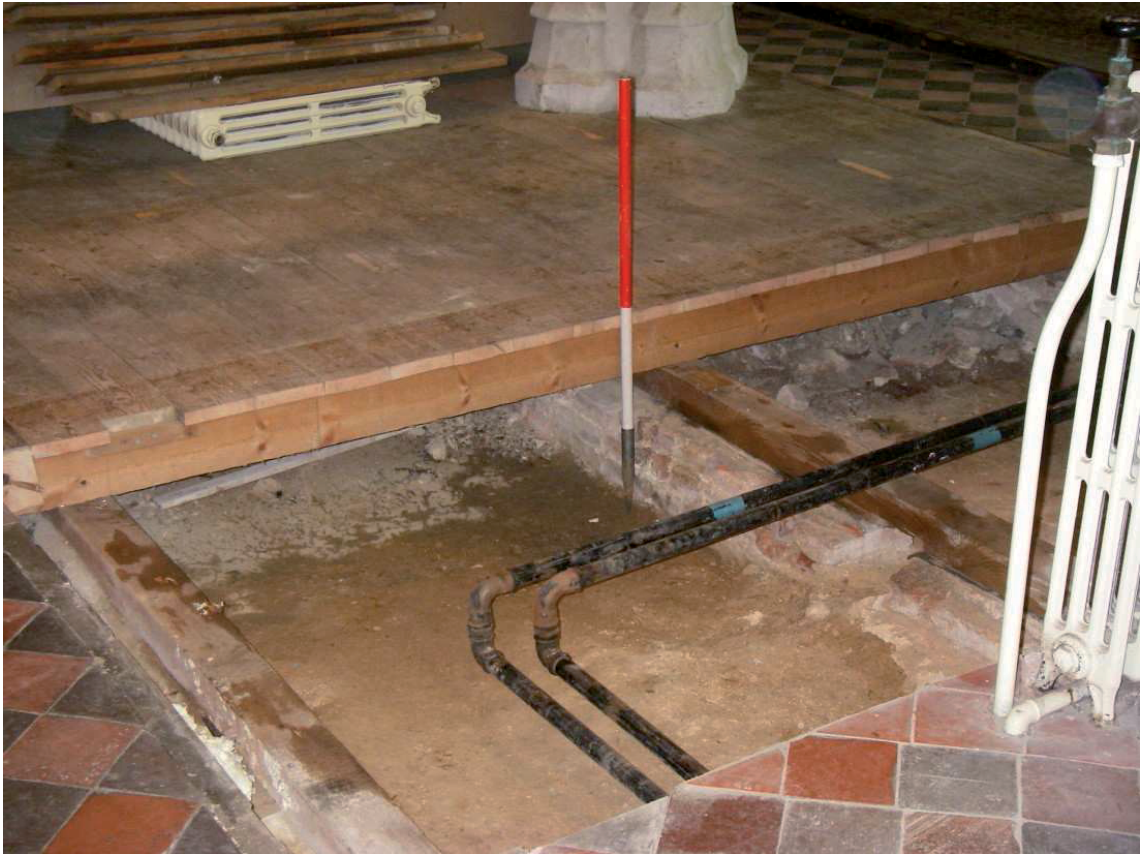
Plate 7: Detail of the void under the raised floor

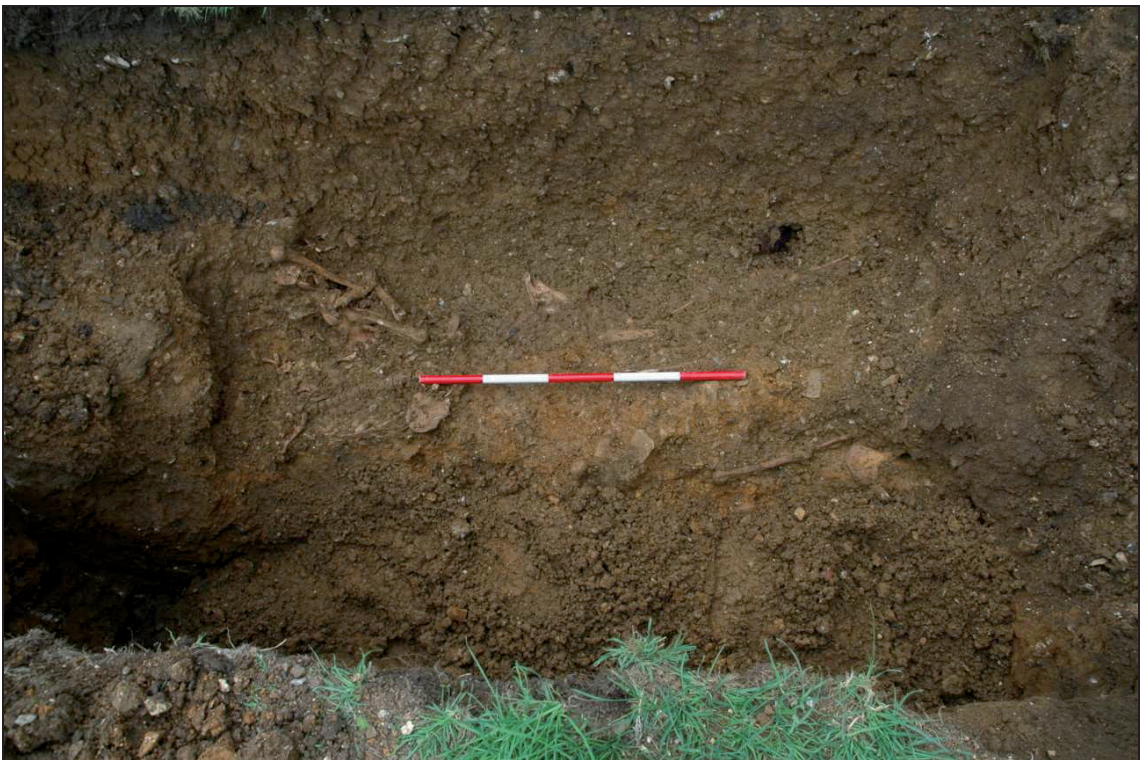
Burial 1 was located towards the southern side of the tank pit. The northern (left hand) side of the burial had been truncated by Burial 2, on to which several of the long bones had been placed. The surviving arm was straight and to the side of the body.

Plate 8: Burial 1

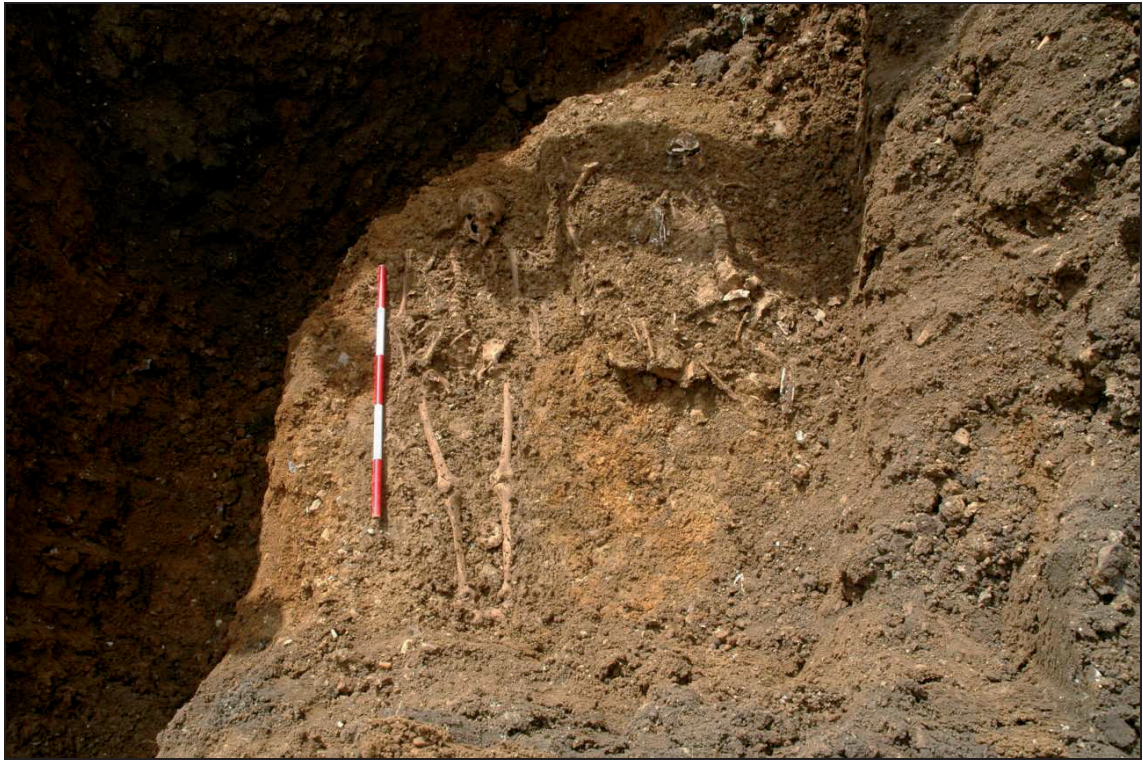
Burial 2 was located to the north of Burial 1 which it cut. This was the only complete burial. The arms were straight and to the side of the body. Examination of the skull and pelvis indicates that the individual was an adult male. A green (copper alloy) stain on the skull could be an indication that the body was buried with a pinned shroud, though no pins were found.

Burial 3 was located to the north of Burial 2 and stacked above Burial 4. The skull and legs were damaged, and the feet were entirely missing along with much of the northern (left hand) side of the body. From the surviving diagnostic bones, especially the pelvis, it is possible to tentatively suggest that this was a male. The right arm was straight and to the side of the body.

Plate 8: Burials 2 (left) & 3 (right)

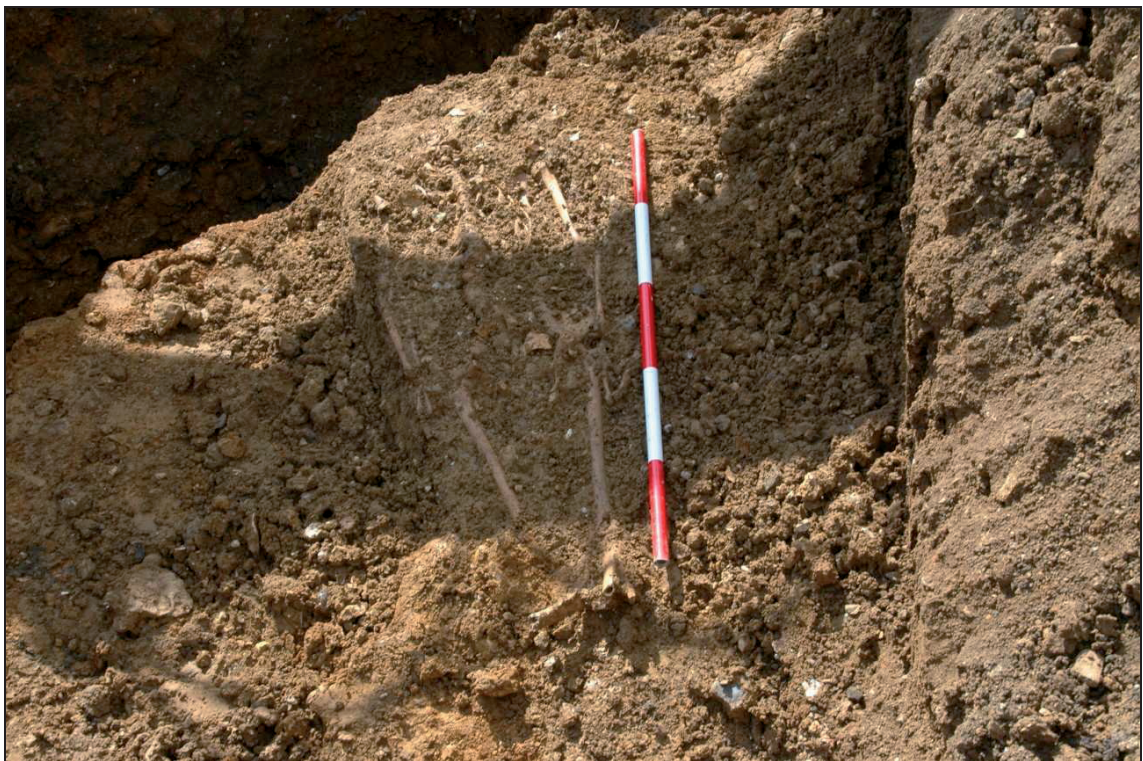
Burial 4 was below Burial 3. The skull was crushed and fragmentary, the torso arms and upper legs were present the rest of the body was disturbed and or missing.

Plate 10: Burial 4
