**HISTORIC BUILDING RECORDING:
36 LATTIMORE ROAD
ST ALBANS
HERTFORDSHIRE**

on behalf of Leighton & Henley PLC

November 2007

ASC: 1003/SAL/1

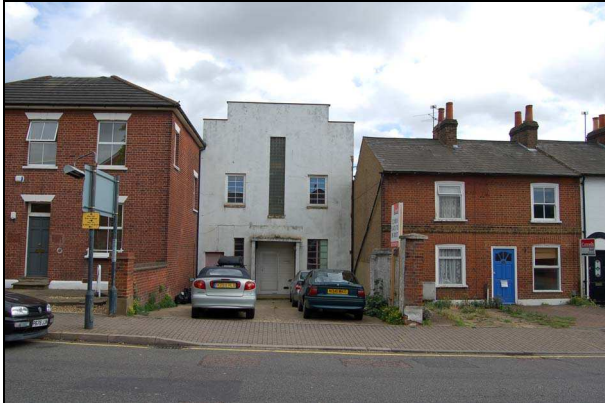
Plate 1: West elevation

4.2 *West Elevation* (Fig. 9, Plate 1)

This is the main elevation with an Art Deco façade that has a centrally located roller door with a wicket door to one side under a triangular porch and a wooden door to the north. There is a tall window above the main door made up of blocks of glass and a modern window to either side of that. There are two Crittal type metal windows on the ground floor. The façade is concrete and plaster.

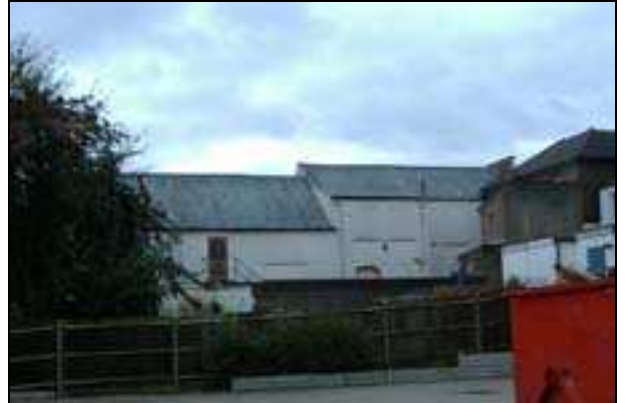
Plate 2: North elevation

4.3 *North Elevation* (Plate 2)

This has a door at first floor level, which is accessed by a metal stair. All the ground floor windows are blocked and there is an arched window at the west end on the first floor. The wall is rendered and painted white and has a series of rectangular ties. This could not be fully accessed during the survey for detailed recording.

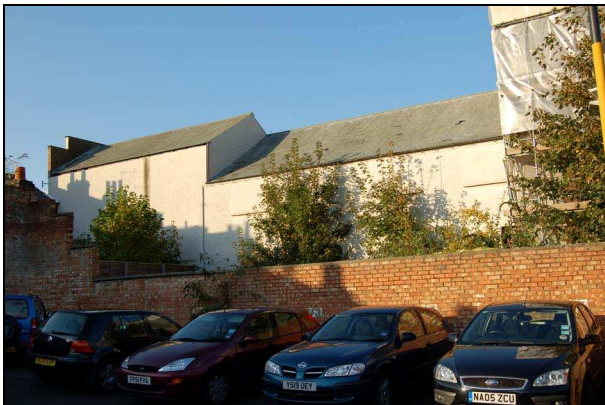
Plate 3: South elevation

4.4 *South Elevation* (Plate 3)

There are two blocked windows on the ground floor and one that has a boarded opening. All the windows on the first floor are blocked. This could not be fully accessed during the survey for detailed recording.

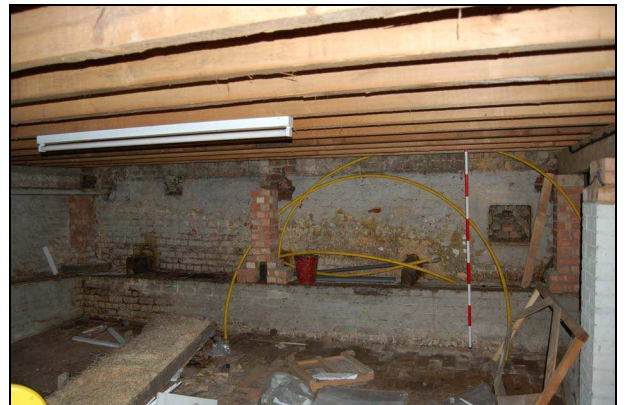
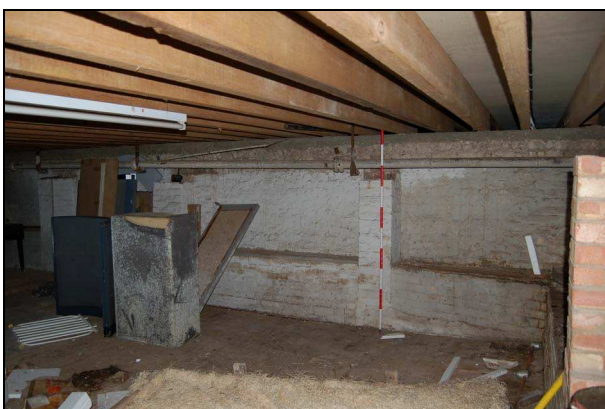
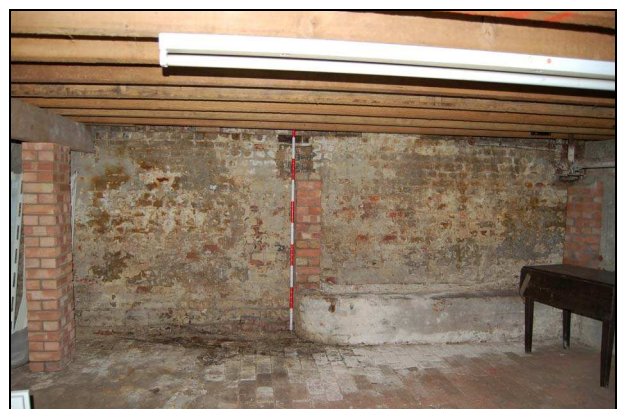
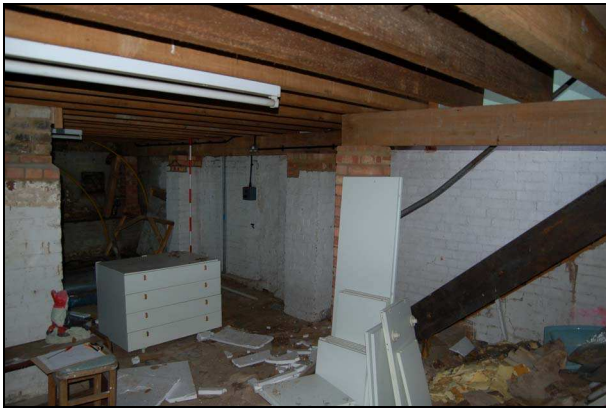
Room C1 (Plates 4-7)

Size: 9.20 × 6.17m, height 2.20m

Description: The walls are largely built in an English Bond with bricks measuring approximately 20 x 10 x 6.5cm and repaired with white and Fletton bricks. Much of the walling is painted. There are modern joists with chipboard over and modern Ketton brick pillars supporting the beam to the west of the staircase. There is also a freestanding brick pillar in the centre of the room. The bricks in the floor measure 22 x 12 x 10cm.

There are no doors or windows in the cellar, but there is a platform along the north, west and most of the south wall with a series of modern brick columns and pillars on it. There is an open timber stair in the southeast corner of the room with 12 risers.

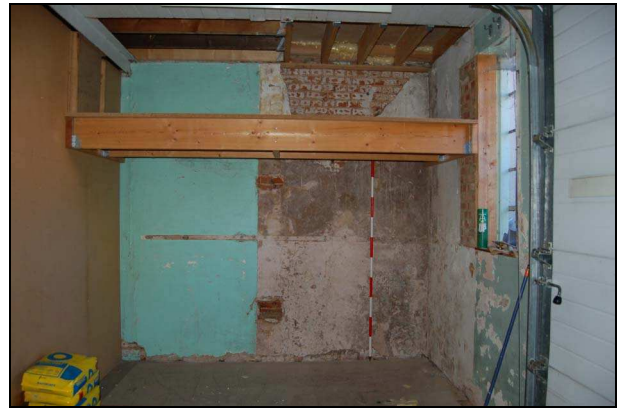
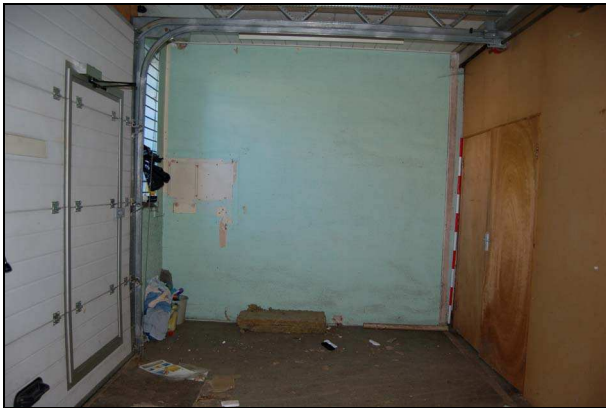
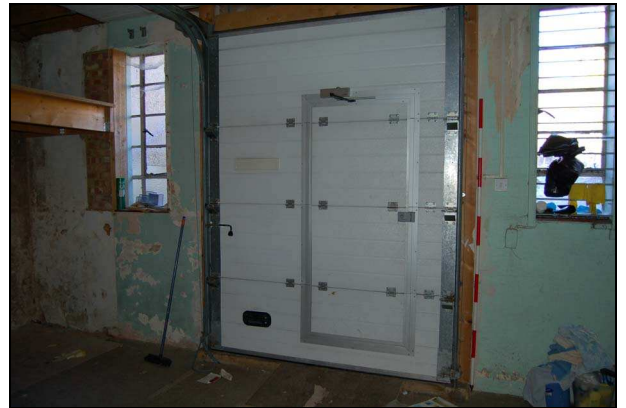
Room G1 (Plates 8-10)

Description: This has been created out of the eastern end of Room G2 and provides an entrance lobby with the main door in the east wall. There is a double door to Room G2 in the west wall and a modern gallery along the south wall. The main door is flanked by a 5-light window to the north and a 10-light window to the south. The room has a vinyl tiled floor, painted walls and the ceiling has painted timber boards orientated north-south.

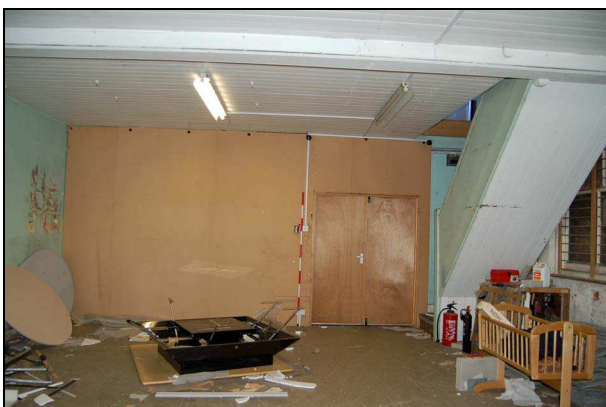
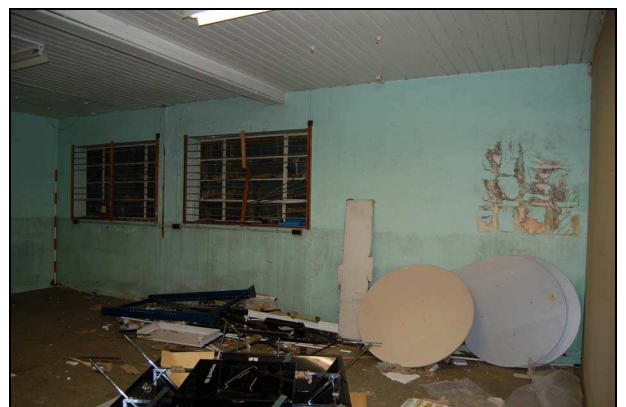
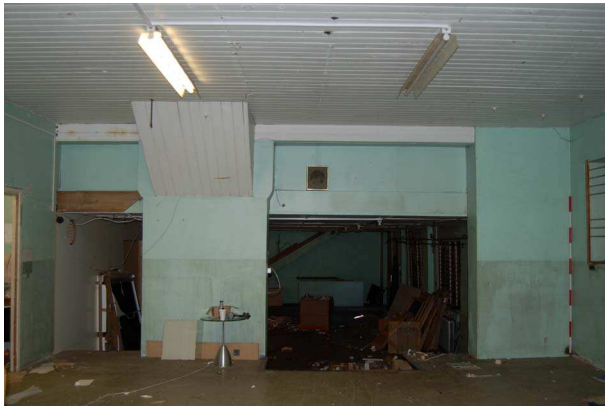
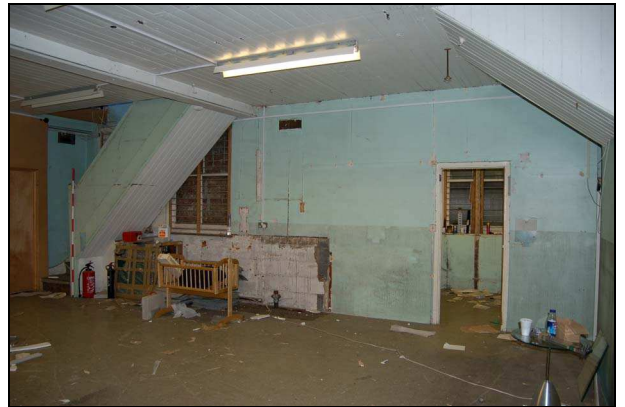
Room G2 (Plates 11-14)

Description: The walls, ceiling and floor are the same as in Room G1. There are two 12-light windows in the south wall and two 2 over 2 light sash windows in the north wall. There is a double door in the west wall to G1 and a doorway in the north wall to G4. A series of 6 steps leading down to G3 are located to the south of a full height opening in what could be considered to be the east wall.

There is a staircase with a solid banister in the northwest corner of the room leading to the first floor. There is evidence for a workbench or similar against the north wall between the stairs and the door to G4.

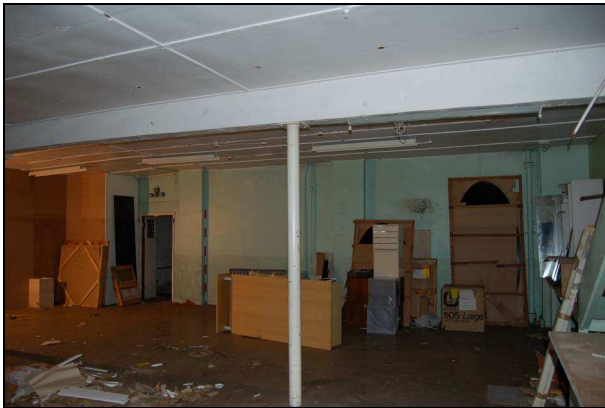
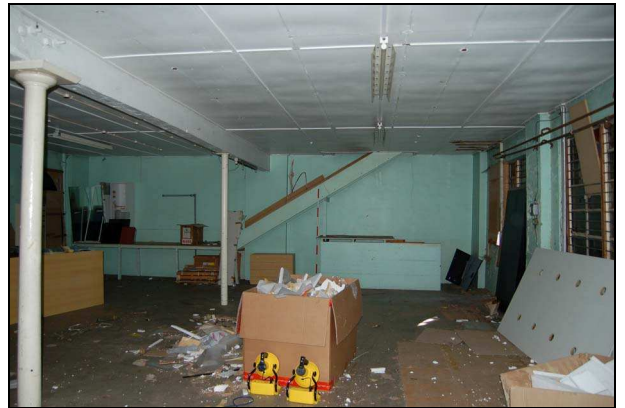
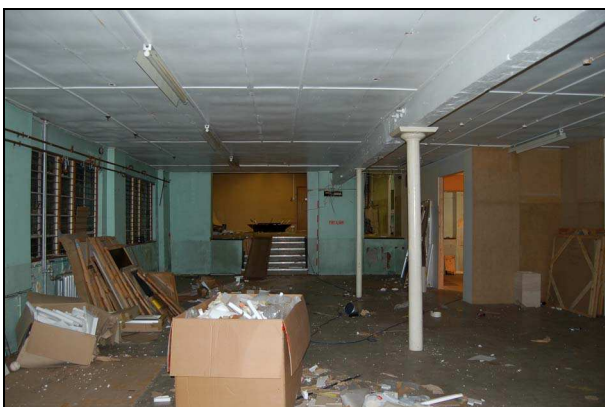
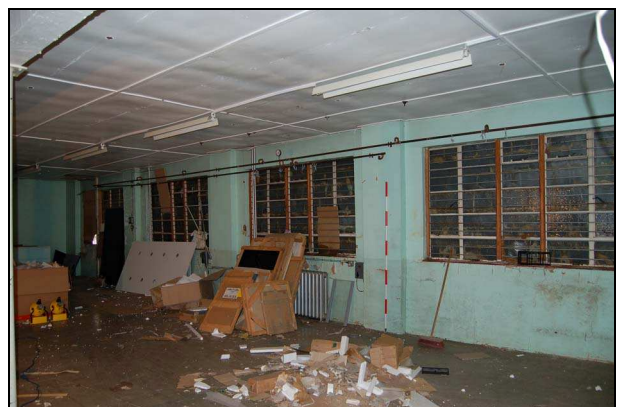
Room G3 (Plates 15-19)

Description: Although the floor and walls are the same as before, the ceiling here is plasterboard. There are four 5-light Crittal type casement windows in the south wall, four of which are blocked, but the easternmost window has been altered to have just 12-lights and a hinged panel. There are two door openings in the north wall to Room G5 and G6.

The stairs up to Room G2 and along the east wall leading to the cellar have been described above. There is a chute from the first floor above the cellar stairs and a series of pipes and a pressure gauge along the south wall.

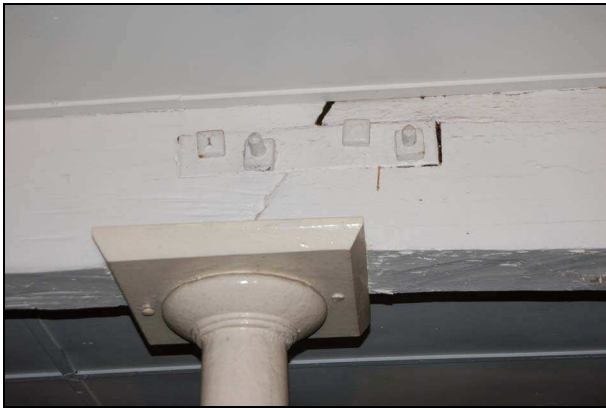
Plate 19: Room G3: column & scarf joint detail

There are three iron columns running east-west supporting a bridging beam that is chamfered with tool marks to the west of the scarf joint and machine cut to the east. The central column has a capital and a square plate, but the other two resemble agroprops.

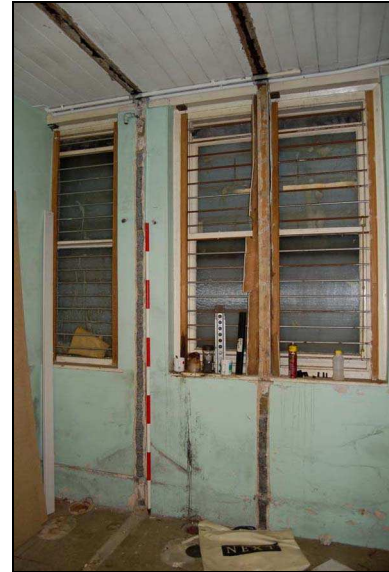
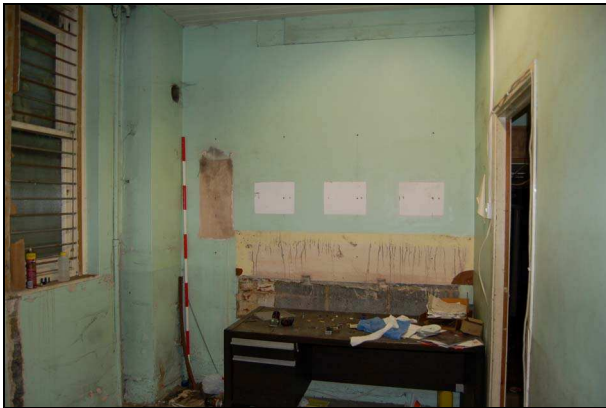
Room G4 (Plates 20-21)

Description: The walls, ceiling and floor as the same as in Room G1 and G2. There is a door in the south wall to G2 and another to a WC in the northwest corner of the

room. There is evidence for two further WC stalls along the north wall measuring approximately 1.43 x 0.78m long. There are two 2 over 2 light sash windows in the north wall and another in the west wall.

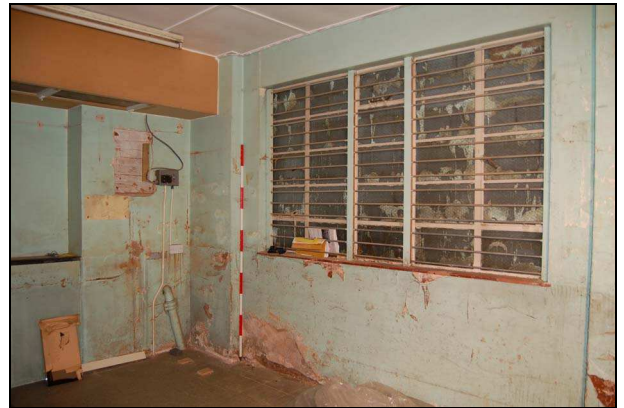
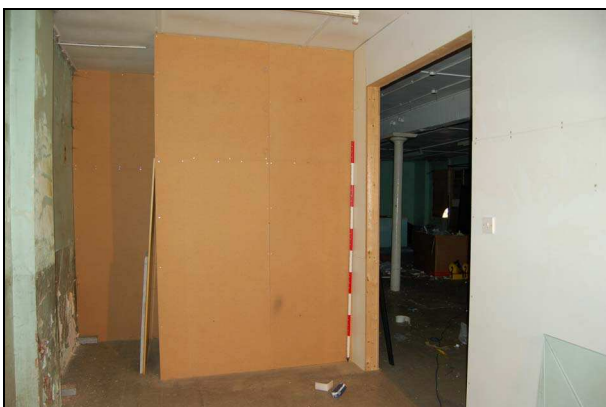
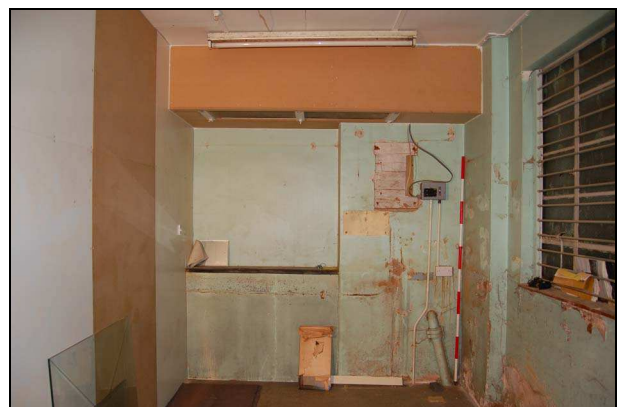
Room G5 (Plates 22-24)

Description: This room is accessed by a double door opening in the south wall and has a 5-light window in the north wall. The east and south walls are partition walls, and the east wall forms a recess at its northern end. There is an alcove in the south end of the west wall c.1m above the floor.

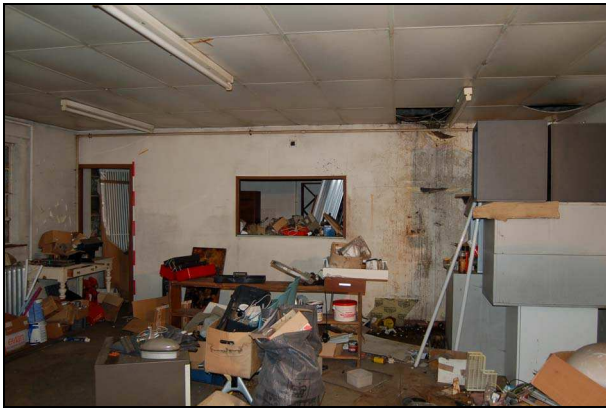
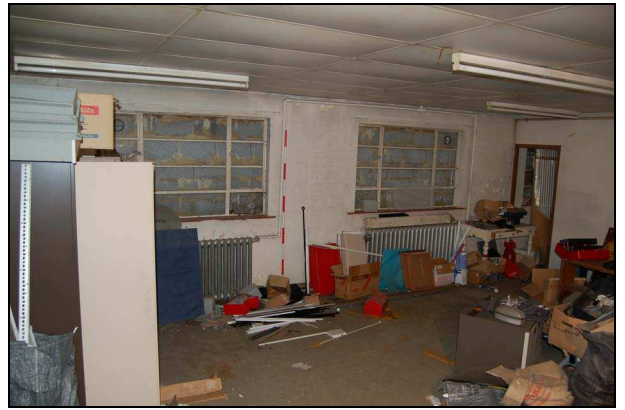
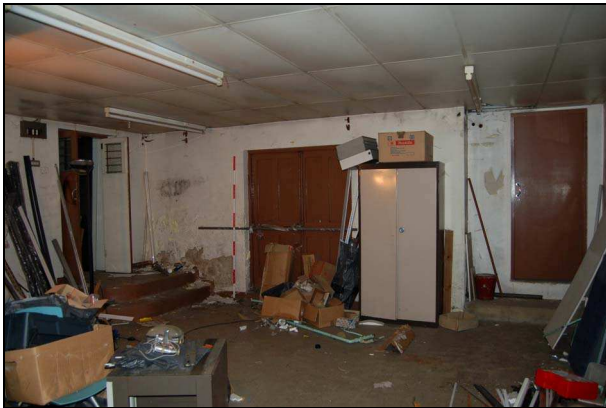
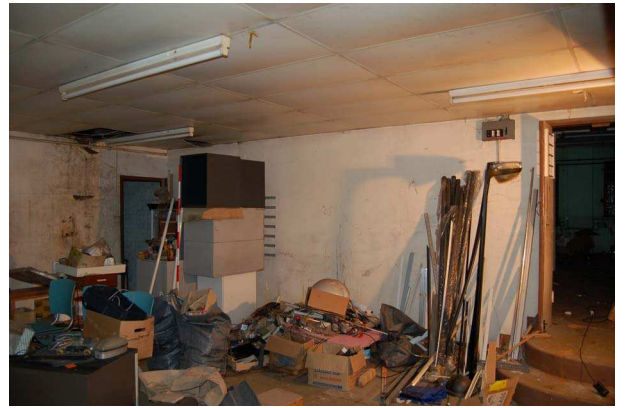
Room G6 (Plates 25-28)

Description: The door from G3 is in the southwest corner of the room and there are 2 steps down to the floor level. There is also a double door in the west wall and a single door to the north of that opening into a covered passage (G7). There are two door openings in the east wall to Room G8 and G9.

The walls and floor are as elsewhere on the ground floor and the ceiling is plasterboarded.

There are two 3-light windows in the north wall and an opening to Room G8 in the east wall.

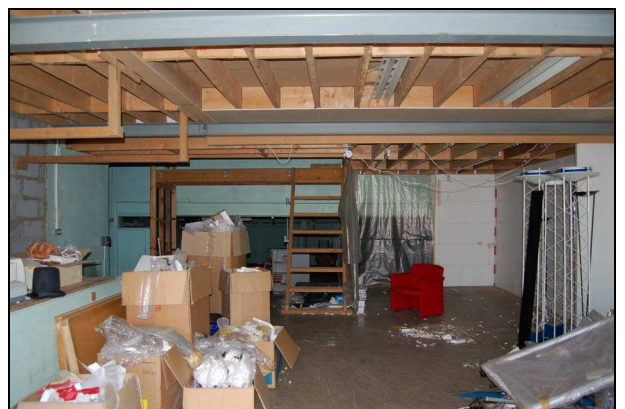
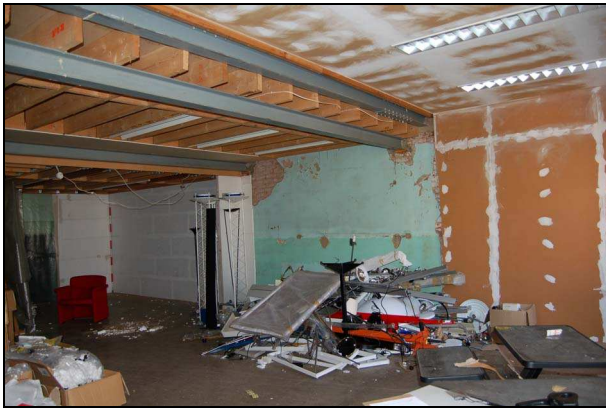
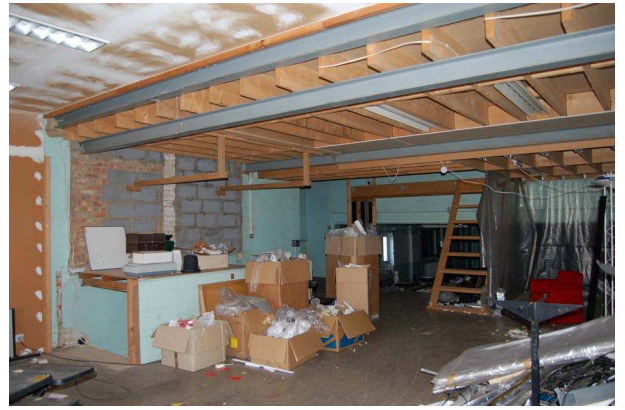
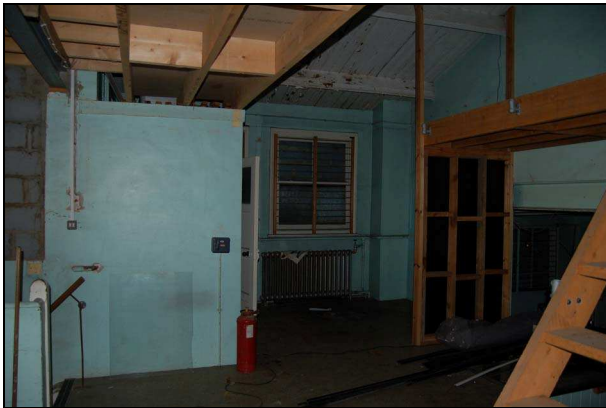
Room F1 (Plates 29-34)

Description: This is accessed by a staircase in the north of the room with 16 risers in total. The south and south walls consist of painted brick and blockwork, which is mostly plastered. The west end of both these walls and the west wall are covered with composite boards. There are two windows flanking a tall window made of glass blocks in the west wall, two 2 over 2 sash windows in the north wall and another in the west wall within the WC. This is located to the north of the main staircase and is accessed by a door with a glazed panel in the east wall.

There is a set of 6 steps leading down to Room F2 at the eastern end of the room and a timber stair of 7 risers to the south of it leading up to a modern galleried area in the roof space. The ceiling above the gallery has king posts with raking struts and sloping joggles, queen posts and cleats.

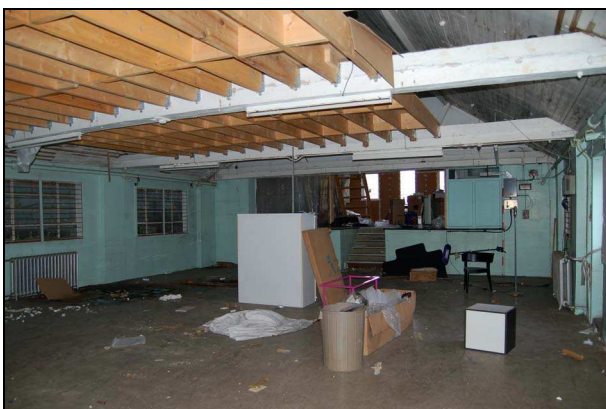
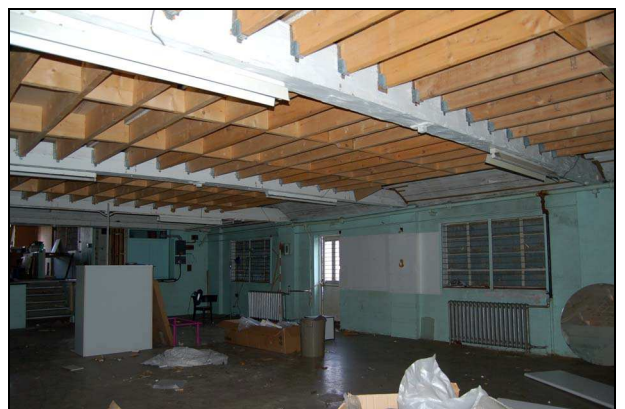
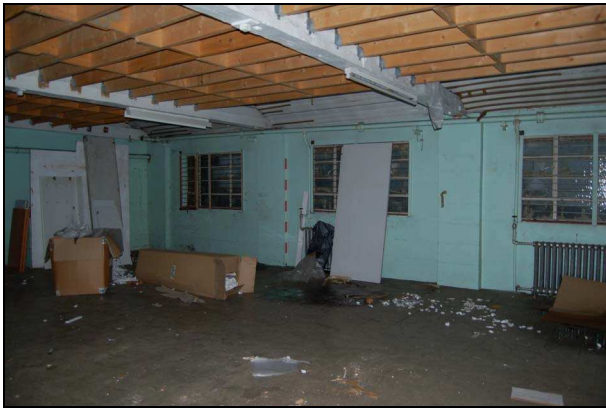
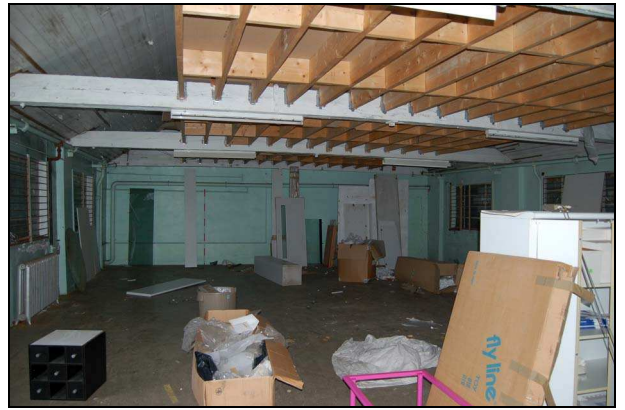
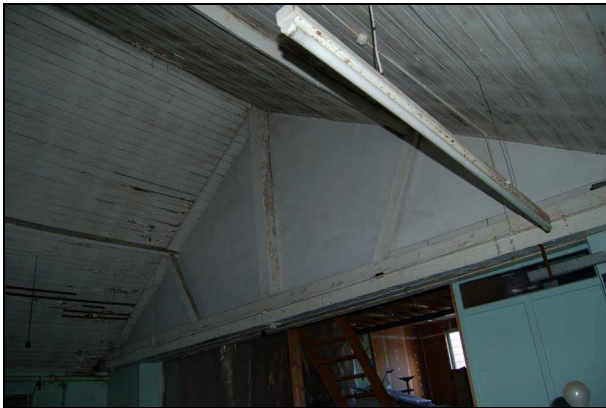
Room F2 (Plates 35-39)

Description: This room consists of 4 bays with a pilaster between each of the window/door openings and is 1.11m lower than Room F1. It has four 4-light Crittall type windows in the south wall and three in the north wall. These as well as the half glazed door in the north wall have horizontal bars on the inside. The floor has vinyl tiles, the walls are plastered and painted and the room has a suspended ceiling over much of it providing storage space. The roof trusses have a king post and raking queen posts. There are painted tongue and groove boards running east-west above the trusses.
