ARCHAEOLOGICAL EVALUATION: ROUNDWOOD PARK SCHOOL HARPENDEN HERTS

on behalf of Mace Ltd

ASC: 1017/HRP/2

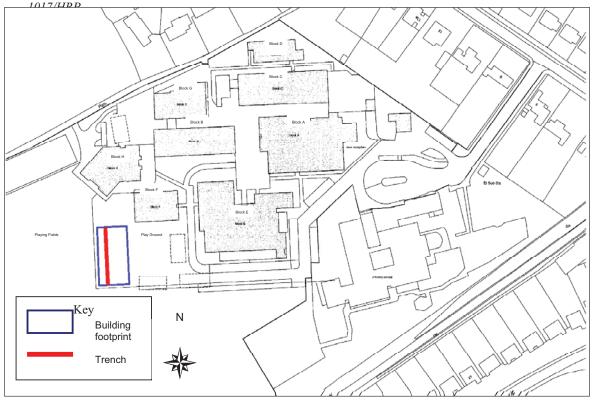
Figure 2: Site plan (Scale 1:2000)

• A single trench *c*.30m long was excavated across the footprint of the proposed building. Its location is shown on Figure 2.

- 4.2 One 30m x 1.8m trench was excavated within the footprint of the proposed building, orientated approximately north-south (Figure 2). The stratigraphy consisted of 0.45m of silty clay topsoil (101) overlying 0.30m of compacted made ground (102). This consisted of a mixture of modern hardcore, concrete, rubble, and a tarmac surface that covered the eastern 1.50m of the trench. Beneath this layer was a yellowish brown (10YR 5/8) natural clay geology (Plate 6).
