**HISTORIC BUILDING RECORDING:  
CHURCH FARM BARN  
DEEVES HALL LANE  
RIDGE  
HERTFORDSHIRE**

NGR: TL 21461 00400

December 2008

ASC: 1019/RCF/1r

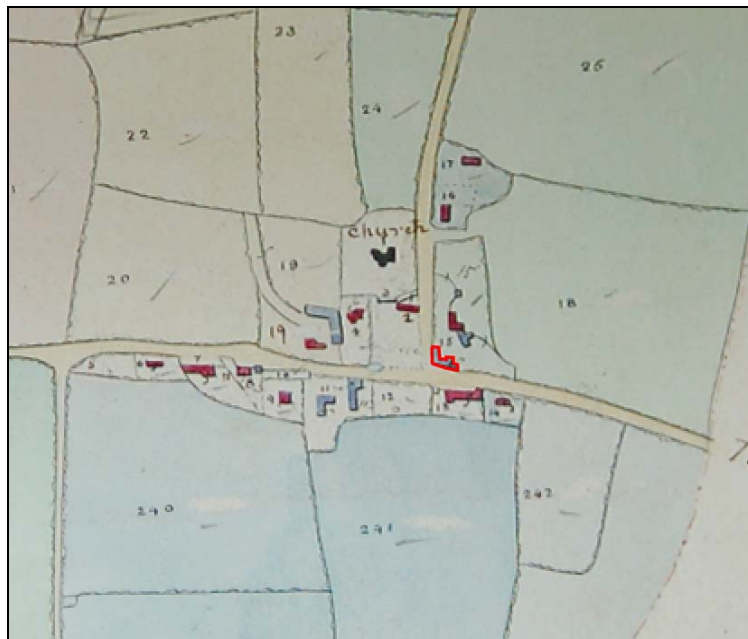
**Figure 3:** Extract from the Tithe Map of 1838 (*not to scale*)

The earliest cartographic evidence for the barn is on the 1838 Tithe Map (Fig. 4). It is, however, more clearly shown on the 1<sup>st</sup> edition Ordnance Survey Map of 1881 (Fig. 5), where it has its present layout. The small addition to the east of the north elevation is not shown on any of the Ordnance Survey maps reviewed for this project (Figs. 5-7). Indeed, the photograph accompanying the English Heritage Images of England online listing description taken in 1985 depicts a flimsy corrugated metal structure (<http://www.imagesofengland.org.uk>). This had been removed prior to the survey for this report.

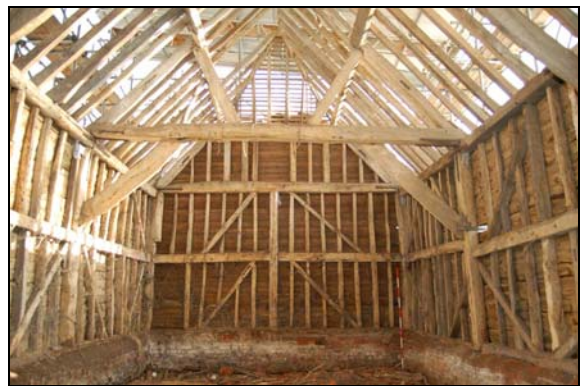
**Plate 4:** East wall

This elevation rests on a dwarf wall, which is largely built in a stretcher bond using lime mortar. The upper course has bullnose bricks, apart from the southern end, which has been rebuilt. The truss has been built using the normal assembly method where the wall plate is tenoned into the back of the vertical post and the tiebeam rests on both the post and wallplate. In this instance, both ends of the truss have an iron clamp. There appears to have been an opening in the wall above the wallplate. There are mortices in the principal rafters, which would suggest that they have been re-used.

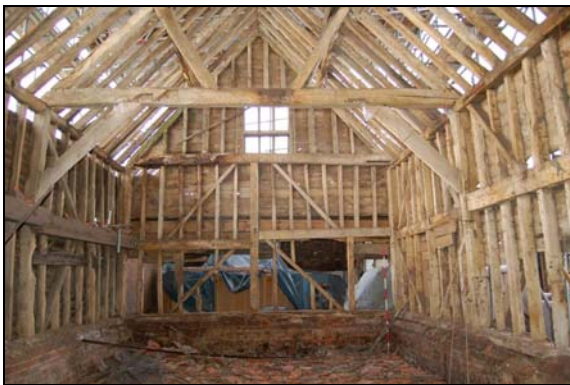
**Plate 5:** West wall

The basic format is similar to the east elevation but with a few variations. The midrail to the north of the vertical post has been replaced and a number of studs have been removed. The southern corner post has a gently sloping jowl, but that in the north is straight and appears to be a later replacement. Both the reversed assembly and normal construction methods have been used for this truss: the former on the southern end and the latter on the north.

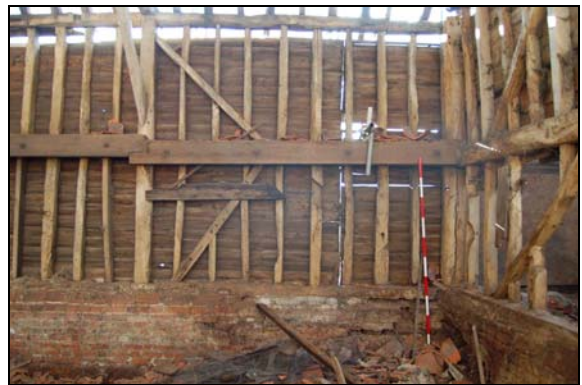
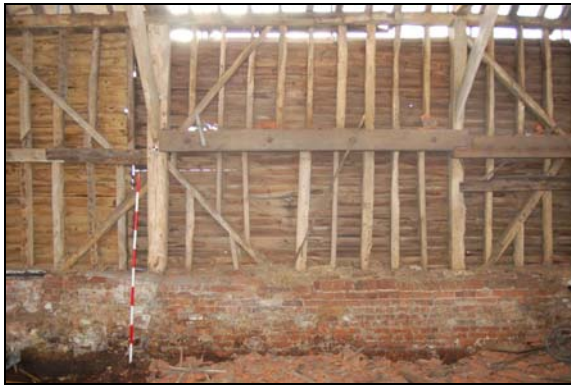
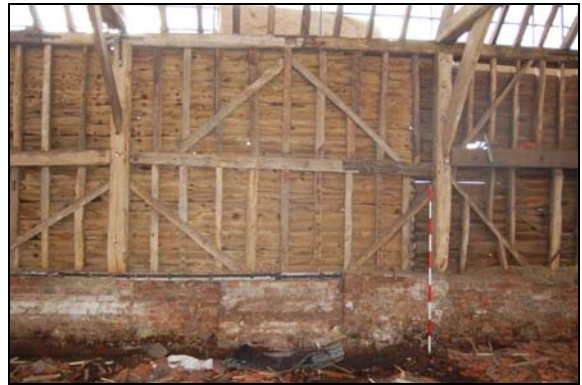
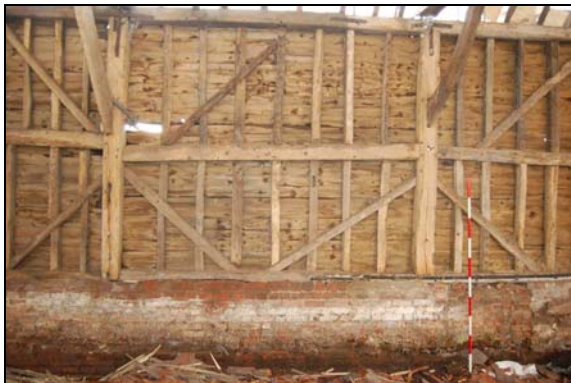
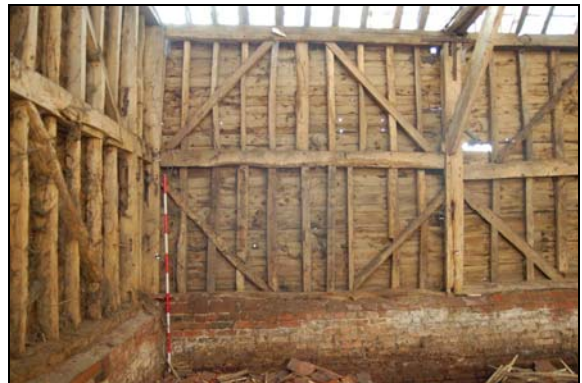
Bays 1 and 2 have a new midrail in front of the original; that in Bay 3 is in two parts with an iron tie and that in Bay 4 is re-used. The vertical post dividing Bays 1 and 2 has been replaced and the vertical posts supporting Trusses 3 and 4 have horizontal and vertical iron ties. The wall plate displays a number of different scarf joints including a bridle joint in Bay 1 and a bladed scarf on Bay 4.

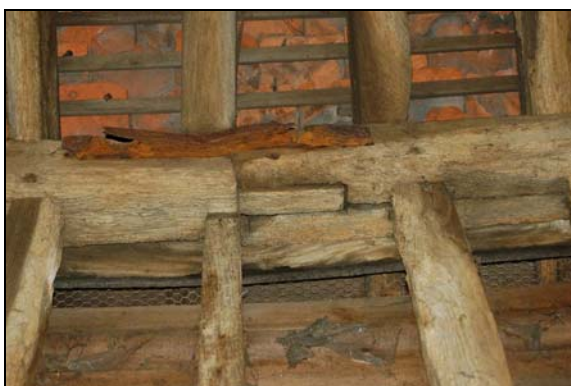
**Plate 11:** Bridled scarf joint in Bay 1

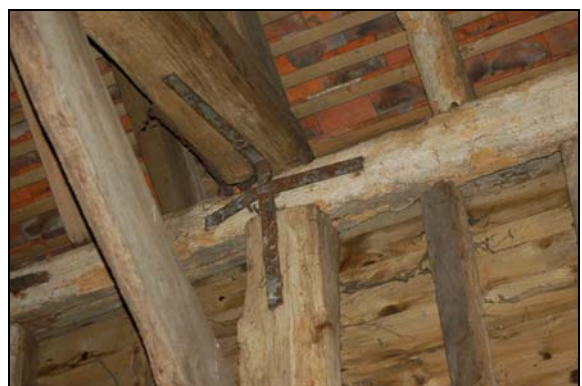
Each bay has a fishplate bridging joints in the north and south wall plates. There are also internal brackets securing the tiebeams to the vertical posts in Trusses 4 and 5 beneath the fishplates securing the scarf joints in the wallplate. Three of the corner posts have iron clamps. In effect, many of the major timbers are secured by ironwork due either to inherent weaknesses in the assembly and/or movement in the building.

**Plate 12:** Reversed assembly and iron ties on Truss 3

- 5.5 The quantity of iron repairs is indicative of the structural problems in the barn. The use of iron fishplates as opposed to timber ones suggest that at least some of these repairs are fairly modern (cf. Hillman-Crouch 2006). The use of brackets in the trusses is of interest. They are rarely used but when they are it is often in mill buildings where they dampen the vibrations to the joints (*ibid*). Whether their use in this barn suggests an informed response to a problem with vibrations or whether this was an amateurish attempt at repair work is unclear.

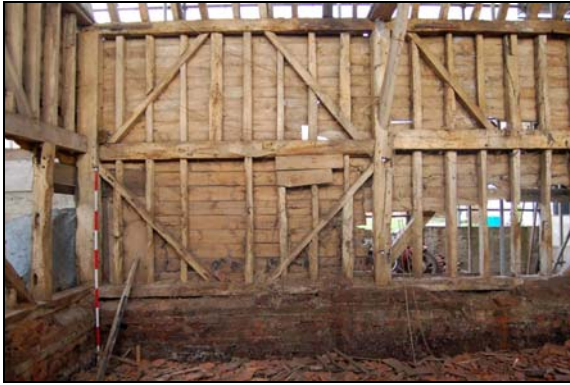
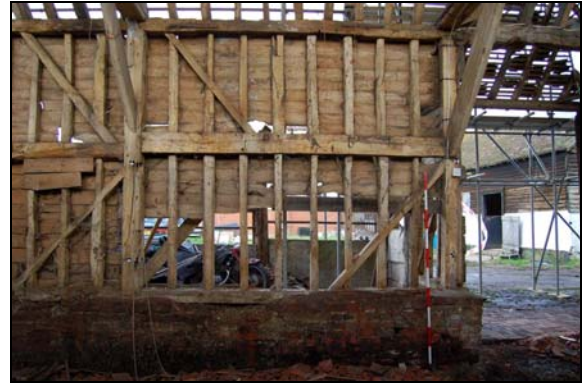
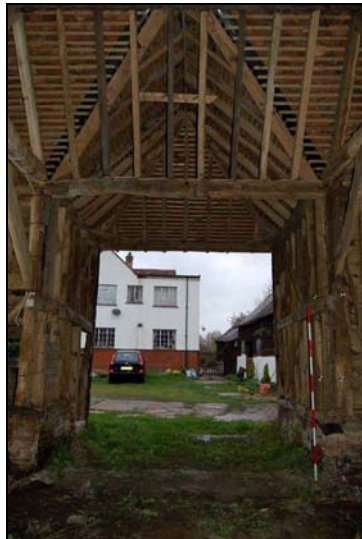
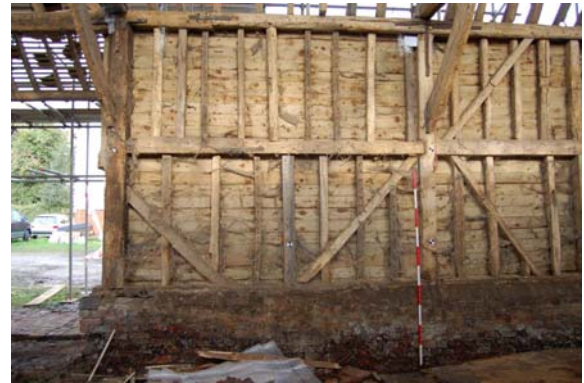
The midrail in Bays 1 and 2 are re-used timbers and that in Bay 5 is new. There are a number of timbers making up the wall plate. Most joints are simple scarf joints with iron ties, but there is also an edge halved scarf joint in Bay 2. There are three parts to

the wallplate in Bay 2, the central section of which has a complex series of mortices and stave holes (Fig. 18).

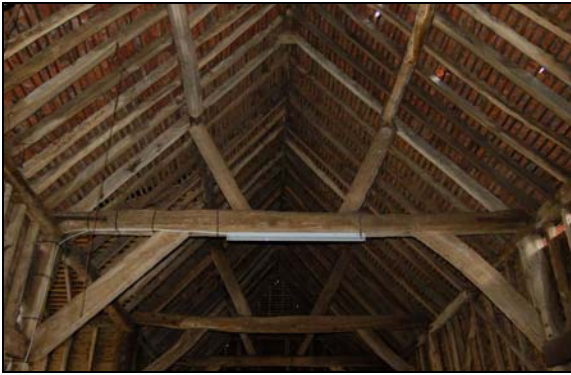
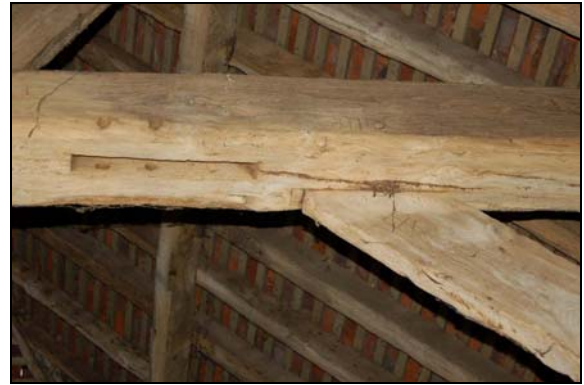
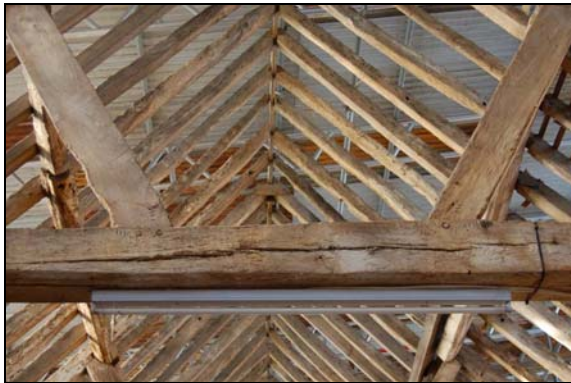
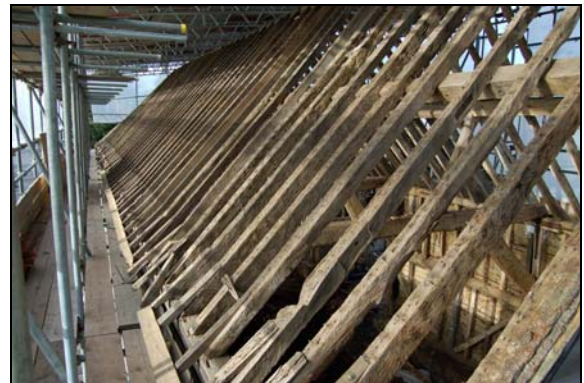
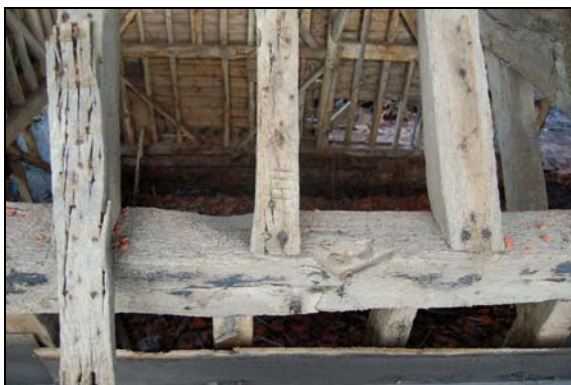
The roof has raking queen posts supporting clasped purlins and reduced principals. Many of the rafters have been replaced (Fig. 11). Truss 1 has chamfered, straight braces and a chamfered tie beam, which also has extra mortices next to the braces and rafter seatings. Truss 3 has knee braces and the tiebeam has been spliced at the northern end and an unusual joint between the southern principal rafter and the tie beam. It is similar to the trait de Jupiter scarf joint and is the only one of its kind in the barn. Truss 4 has the same extra mortices as Truss 1, a knee brace to the north and a straight brace to the south. Carpenters assembly marks were observed on Trusses 2-4. These have been labelled V – VII, which would suggest that the present barn is a reduced version of an earlier structure. The numbers III and IIII are carved onto the tiebeam and braces on Truss 2.

Many of the rafters have carpenters assembly marks at the feet, predominantly on the south side of the roof. Every rafter in Bay 4 is marked either ~~III~~ or IIII and two rafters in Bay 6 have IIIII carved into them. Although these are all scored through, the un-scored marks are not present on the opposite side of the roof.

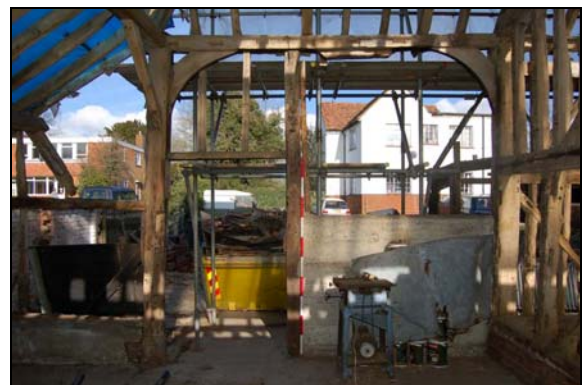
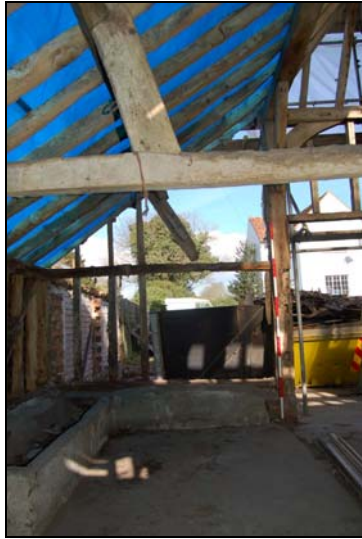
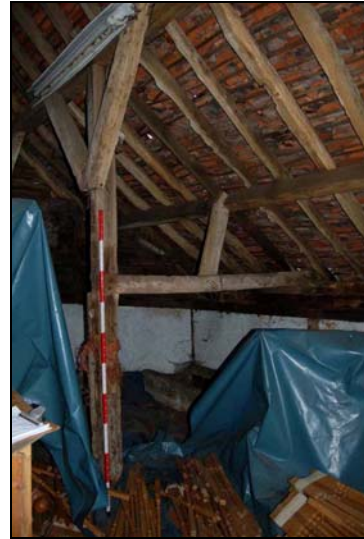
The western extension has a door in the north wall with a window to the west of it. The lower half of the walls is largely rendered/ breeze block with timber framing above. There are two troughs at the western end of the extension.

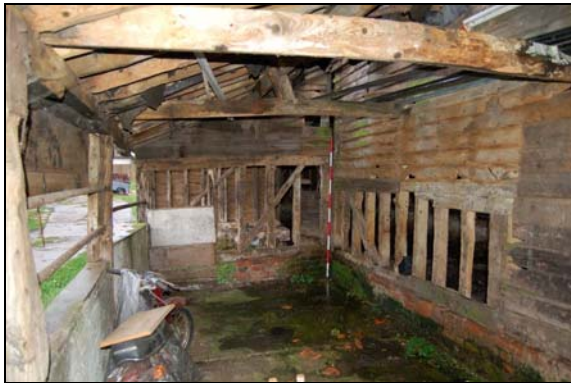
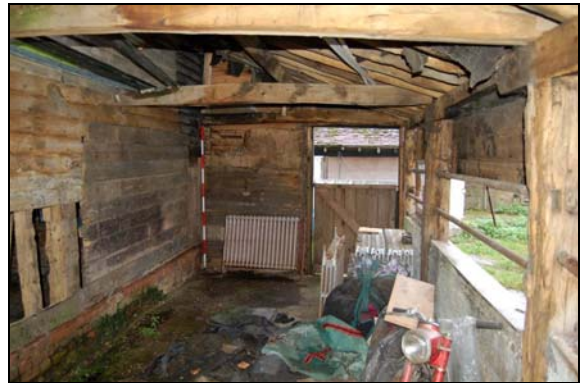
The external wall of the northern extension is made of telegraph poles and concrete. It has a stable door at the western end. The upper part of the walls has iron bars set horizontally between the poles and is partially open to the weather, although some weatherboarding survives.

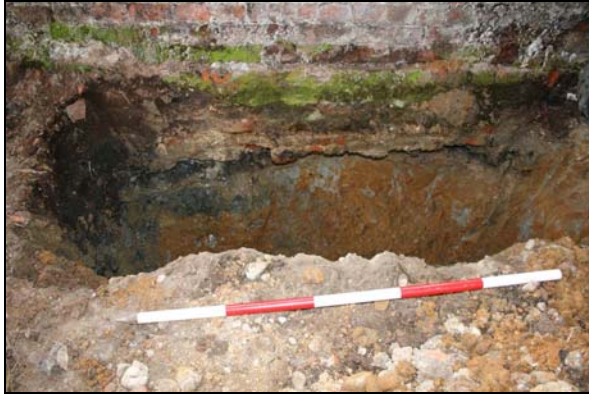
**Plate 1:** Underpinning pit 1, looking north, 1m scale

1.2.1 Initially four pits were excavated in the corners of the barn, as part of the underpinning process (Plate 1). These pits revealed that the barn's dwarf supporting wall was resting on a flint base, *c.*0.10-0.15m thick. This overlay either a *c.*0.25m thick layer of grey clay, or the natural hoggin. Pits 1 and 4 (Fig. 1) also contained a thin layer of black soil directly beneath the brick dwarf wall. After the excavation of these pits, trenches were excavated along all four sides of the barn as part of the underpinning process (Plate 2). These trenches revealed the same soil profile as noted above. The excavation of these trenches revealed a difference in the depths of the footings throughout the barn. In the porch area the footings were 4 courses deep on either side. The western side of the barn varied between 3 and 4 courses from south to north. However, the footings beneath the eastern wall were 8 courses deep.

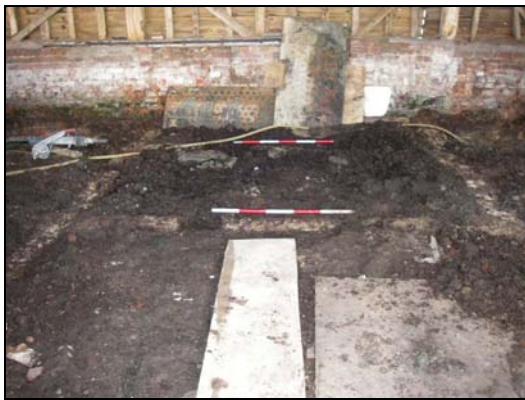
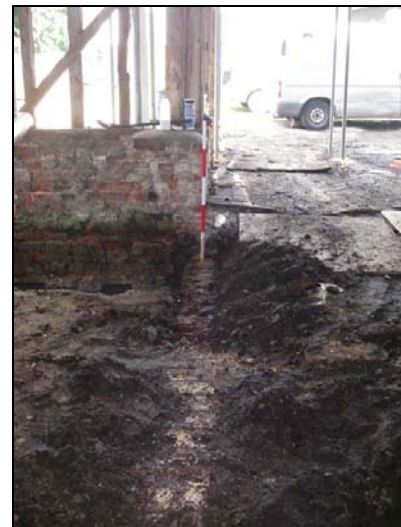
1.2.2 During the groundworks, three courses of brick footings were observed *c.*0.15m below the level of the barn floor (Fig. 1, Plates 3&4). These footings continued the line of the porch wall on both sides, and were butt-jointed to both the north and south walls of the barn. Two cross-walls were also uncovered. The footings were constructed of frogged red bricks, measuring 23.5x12x6.5cm, and were mortar bonded. The frogging suggests a mid 19<sup>th</sup> century date for the footings.

The three courses of brick footings observed during the watching brief are likely to date to the mid 19<sup>th</sup> century, suggesting they are a later addition to the barn. This theory is further supported by the fact that the footings are butt-jointed to the original supporting wall of the barn.

**Plate 3:** Brick footings, looking south, 2x 1m scale

**Plate 4:** Brick footings, looking north, 1m scale

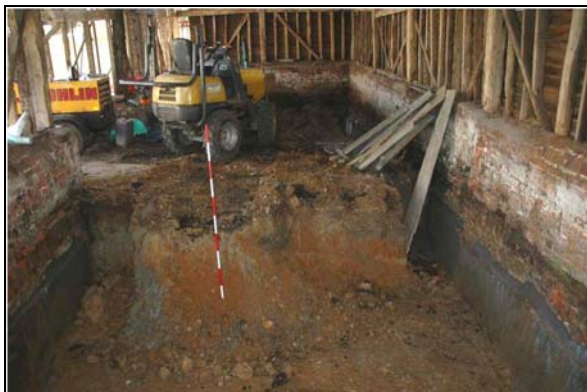
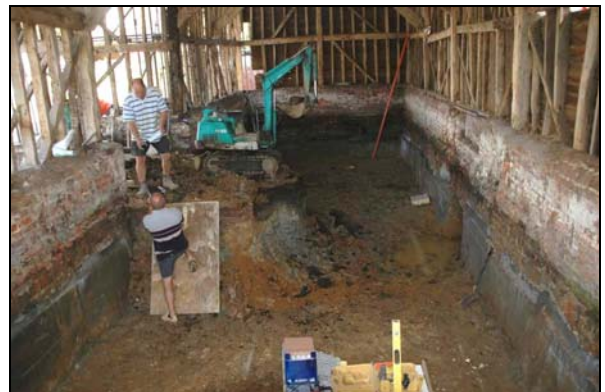
1.2.3 After all the walls had been underpinned, the internal floor level was reduced by *c.*1-2m (Plates 5&6). The ground consisted of *c.*0.2-0.6m of mixed material or clinker, containing some peg tile fragments as well as lumps of concrete and glass bottles. No other archaeological finds or features were observed within the general barn floor reduction.

**Plate 5:** General ground reduction, looking east, 2m scale
