**HISTORIC BUILDING RECORDING & WATCHING BRIEF:  
ROSE & CROWN COTTAGE  
STATION ROAD  
LONG MARSTON  
TRING  
HERTFORDSHIRE**

NGR: SP 8956 1572

September 2008

ASC: 1024/LMS/2

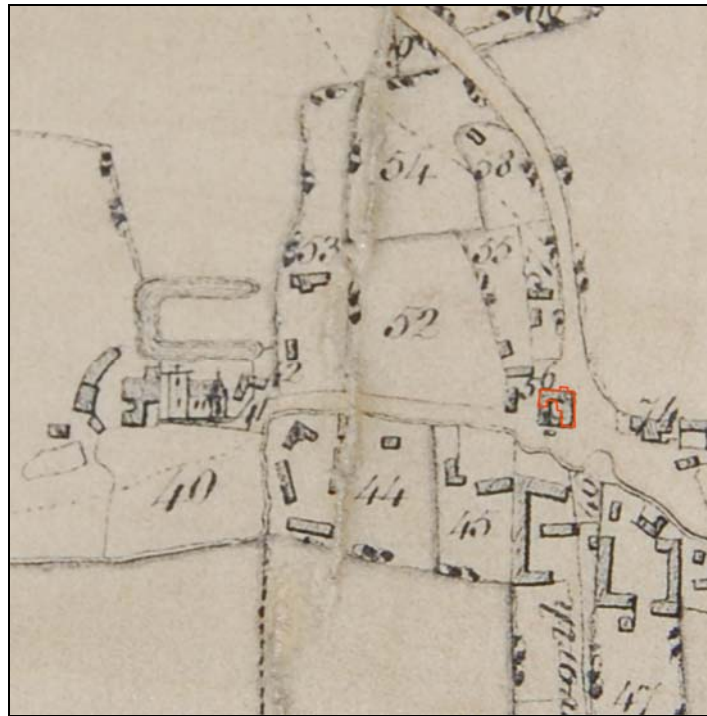
**Figure 3:** 1799 Tithe map (not to scale)

The earliest detailed cartographic evidence for the cottage is the Enclosure Map of 1799, (Fig. 3), which shows the barn making up part of a courtyard to the rear of the public house. This courtyard remained unchanged until the later 20<sup>th</sup> century when the southern end of the west wing and the south range were demolished (Figs 4-6).

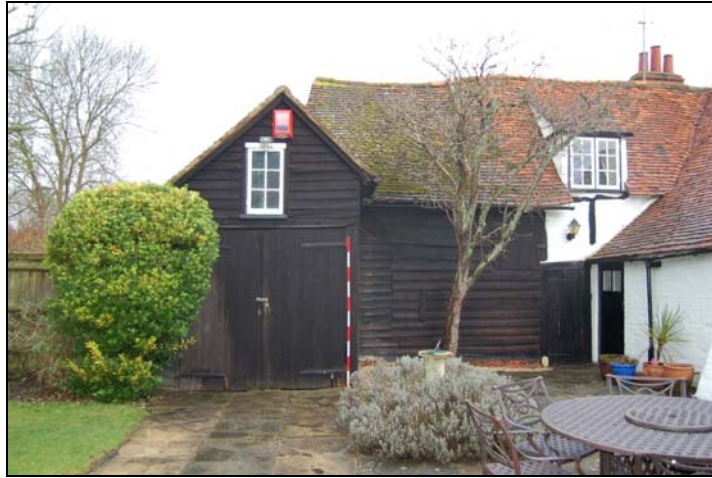
There is a set of ledged and braced double doors in the western end of the south elevation with a 6-light casement window above. There is also a small timber shutter at the east end of the same elevation that is obscured internally by the new ceiling and a single ledged and braced door to the east of the shutter. The strap hinges on the double doors rest on pintles and have spearhead shaped ends which could be indicative of a 17<sup>th</sup> century date.

**Plate 1:** South elevation

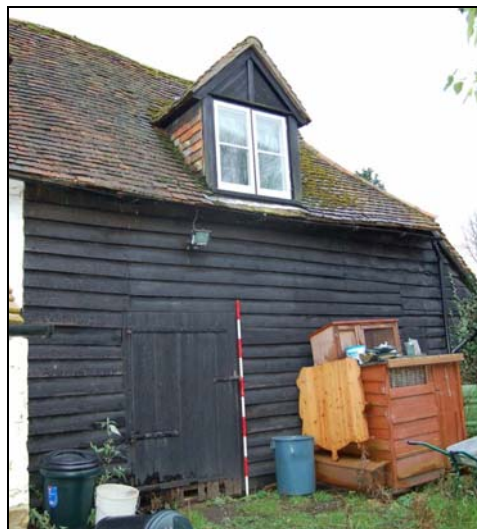
There is a shutter at the western end of the north elevation and a single ledged and braced door at the eastern end. The shutter also has spearhead ends to strap hinges on pintles, but the strap hinges on the door to the west have straight ends and are likely to be of a more recent date.

**Plate 3:** North elevation

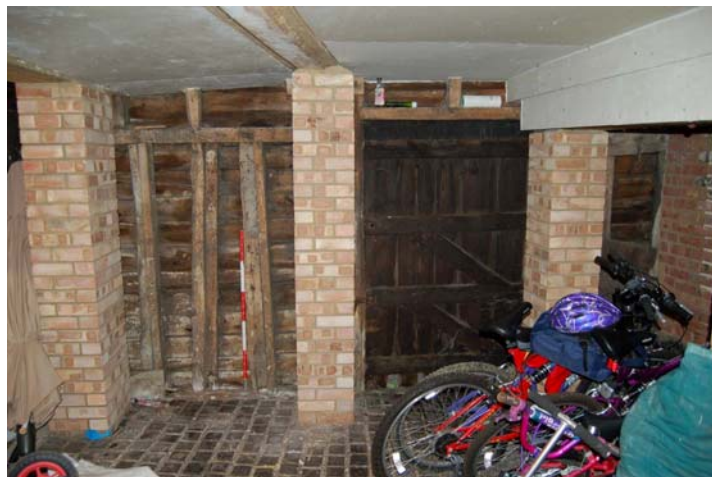
The former stable has been altered in recent years to allow a bathroom to be installed next to the master bedroom at first floor level. The floor for this is supported by a series of brick pillars measuring between 33 x 33cm and 33 x 43cm. They are all of modern Fletton brick and lie within the footprint of the original barn. The timber walls have therefore been left undisturbed by the floor insertion, but both the north and south walls have some additional modern struts. The initials WP survive in one of the posts in the north wall, which contains a number of waney edged timbers.

**Plate 6:** North wall of former stable

- 6.4 The north and south walls of the eastern end of the barn contain a number of waney edged timbers as well as some additional modern studs. However, as the upper part of the walls and the roof trusses could not be inspected due to the inserted floor, it is not possible to confirm whether the waney edged timbers are actually the remnants of early post-medieval timberwork.

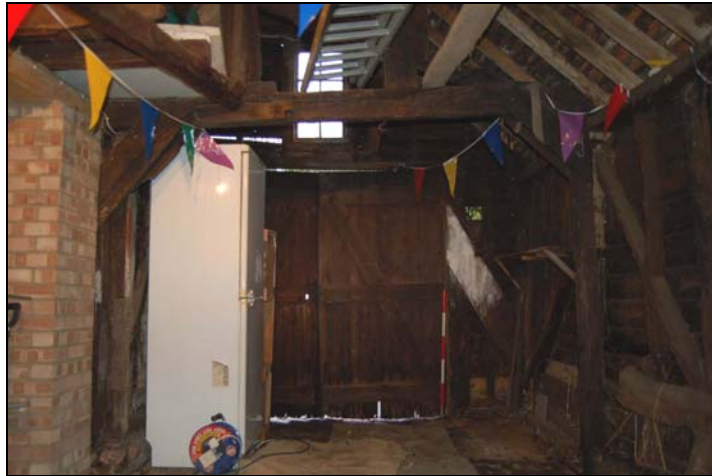
The barn comprises two elements; the former stables in the eastern end and the foreshortened western end, which was formerly part of the south range of the rear courtyard of the public house. The eastern part of the barn has retained the stable setts in the floor, but the western end has a concrete floor. There is primary bracing in the north and west walls and in the return wall to the south. The south and west walls rest on a brick dwarf wall. The east wall is brick built and consists of red bricks in a stretcher bond set in a lime mortar with modern Ketton repair work at the northern end.

**Plate 7:** South wall of western end of barn

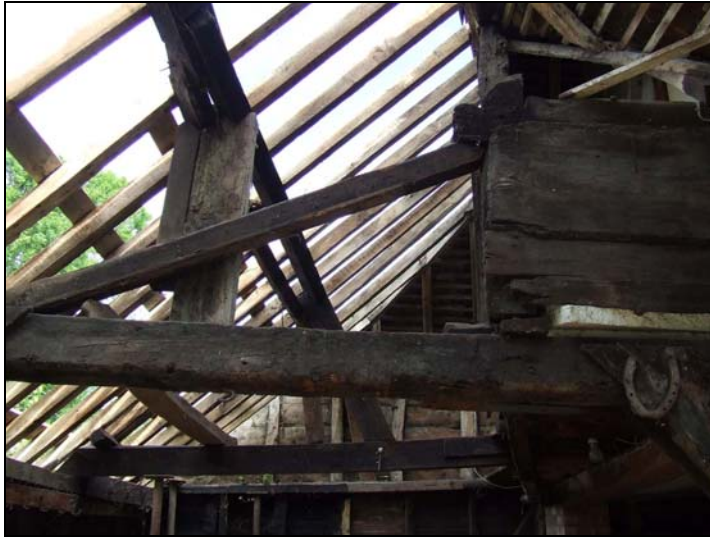
There are two trusses in the western end of the barn, numbered from south to north. The tiebeam in Truss 1 is clearly re-used as the south face is chamfered with pegs and peg holes within the chamfer. The initials FH are carved into the north face of this truss. The western queen post supporting the purlin has been modified to also support the timber that has been added to the purlin. The post on the eastern end of the truss is supporting a truss running diagonally between the two parts of the barn. The braces, which are thin and straight, are attached to the outside of the tiebeam and are structurally useless.

**Plate 10:** Truss 1 looking north

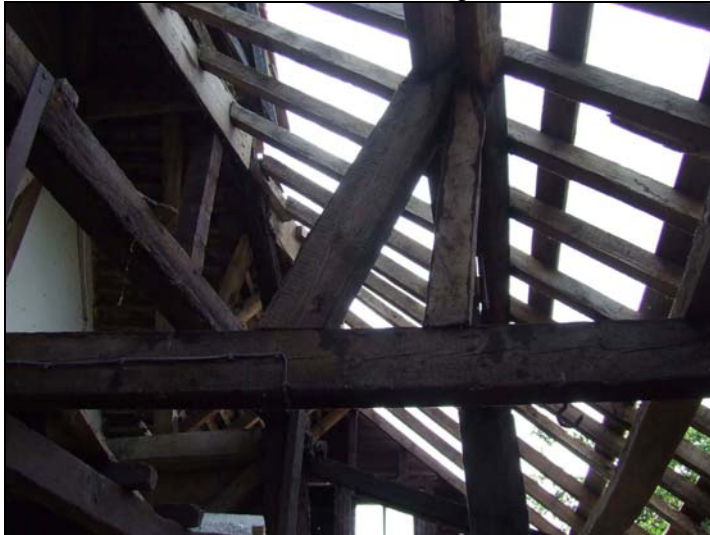
**Plate 11:** Truss 1 looking south

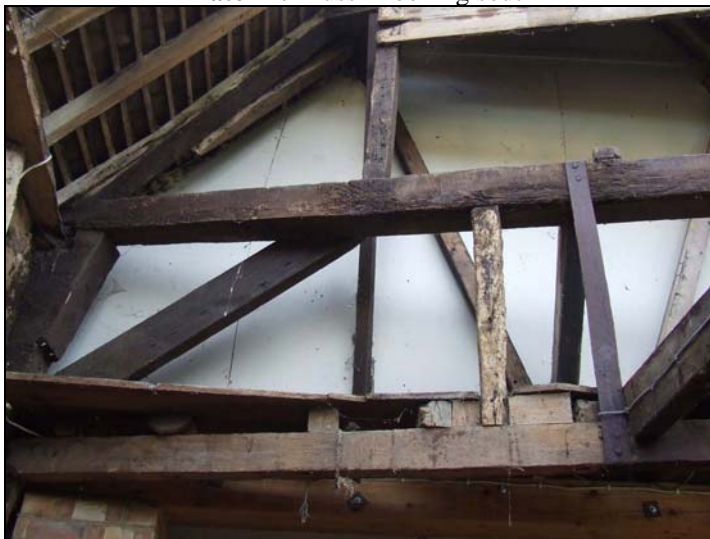
The rafters are modern but the tiles are largely original clay peg tiles.

**Plate 12:** Northern end of roof truss at barn junction

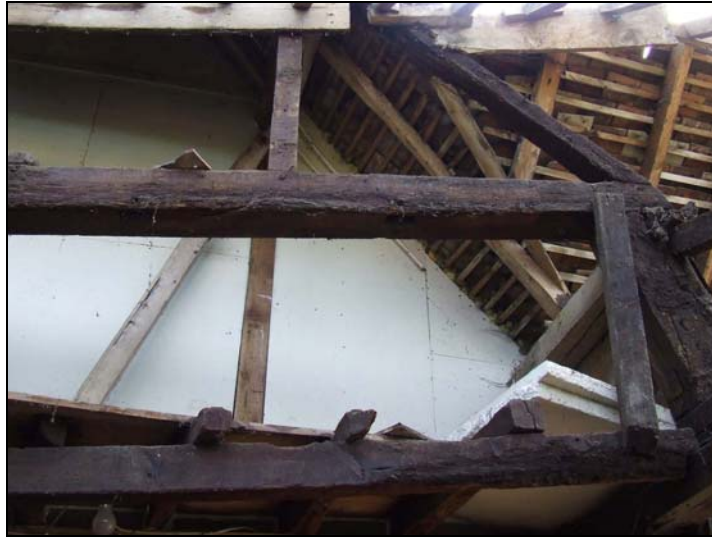
**Plate 13:** Roof truss junction looking southeast

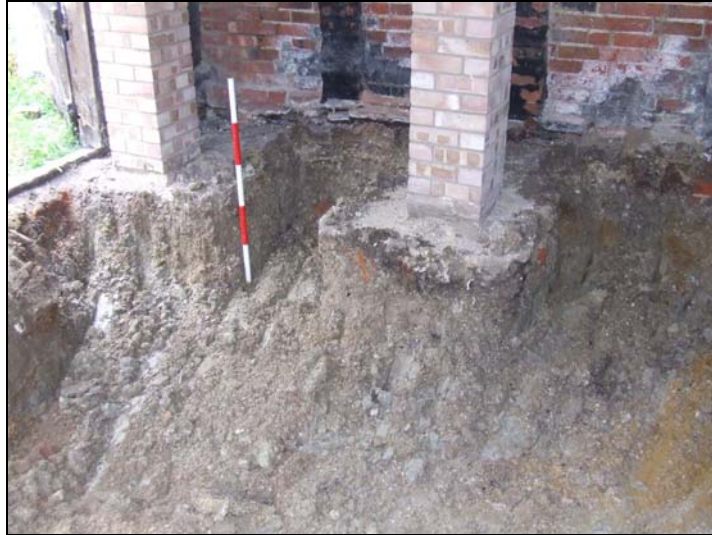
- 5.1 A watching brief was carried out during the reduction of the floor level within the barn. The floor level was reduced by c.0.45m across the entire barn. The soil that was removed comprised a mid yellow/cream sandy loam with frequent inclusions of modern pot and glass. Below this was a mid orange grey sandy clay. No archaeological features or finds were observed during the watching brief.

**Plate 14:** Northeast corner of the barn during ground reduction

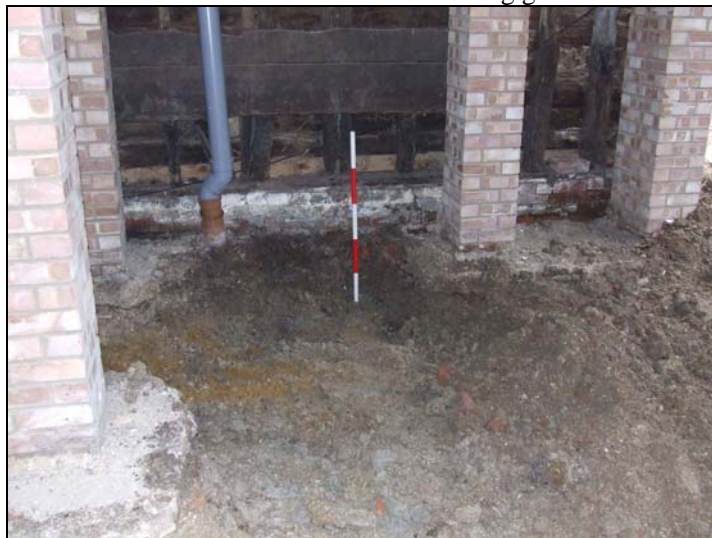
**Plate 15:** Ground reduction looking north

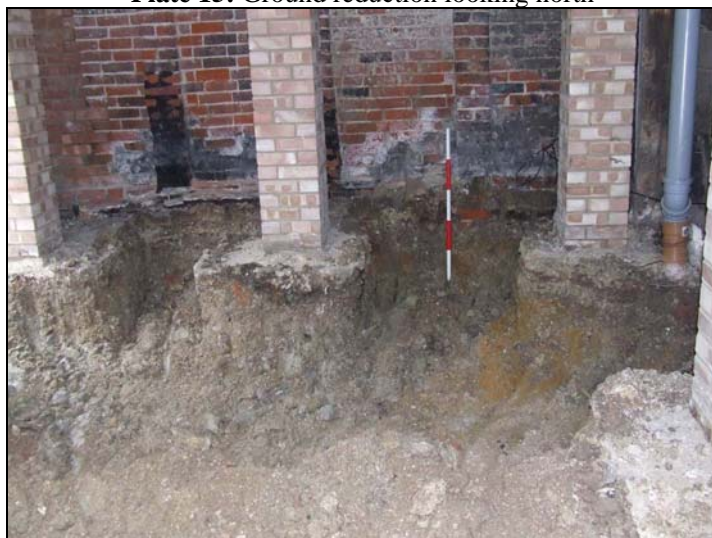
**Plate 16:** Ground reduction looking east
