**HISTORIC BUILDING RECORDING & WATCHING BRIEF:
BAPTIST CHURCH
89 HIGH STREET
TRING
HERTFORDSHIRE**

on behalf of High Street Baptist Church

March 2008

ASC: 1028/TBC/2

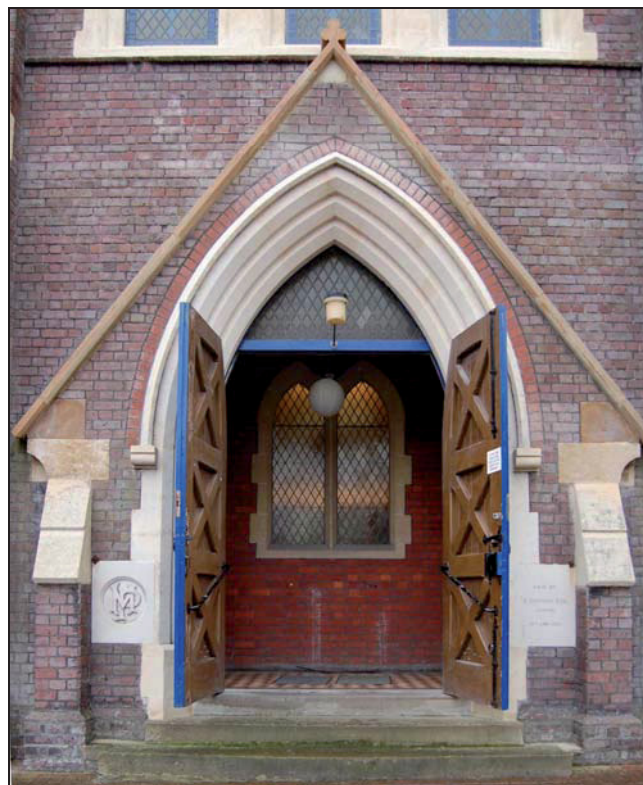
Plate 1: Main entrance

- 4.2 The areas affected by the present works are the steps leading up to the church, the entrance lobby and the reception area (Fig. 3). The three doors to the front of the building are to be replaced by timber doors with glass panels, part of the wall between the lobby and the reception area is to be replaced by a glass screen and the reception area is to be re-organised to include a new section of the screen between it and the main body of the church. This involves the loss of the three main doors to the front of the building, the window immediately behind the double doors to the street, the doors opening from the entrance lobby to the corridors on either side, and the modern glass doors from the reception into the church. The tiled floor in the lobby will also be replaced by a sisal carpet.

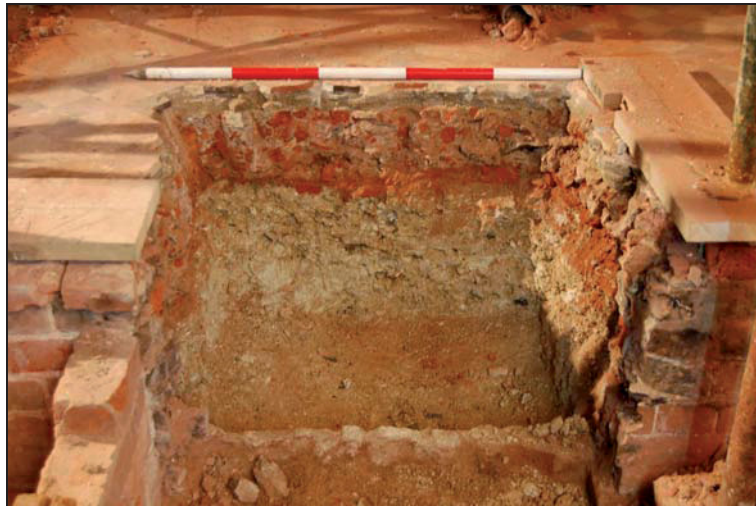
Plate 6: South facing trench section

5.1.1 Two trenches were inspected during the course of the current restoration programme. The internal trench ran east – west along the line of the wall between the reception area and the lobby (Fig. 4). It was approximately 0.53m deep and up to 1.50m wide. The stratigraphy consisted of 0.02m of glazed floor tile over 0.045m of concrete. This lay over a 0.22m deep layer of hardcore that had been deposited over the chalk natural. A few fragments of post-medieval pot and brick/tile were recovered.

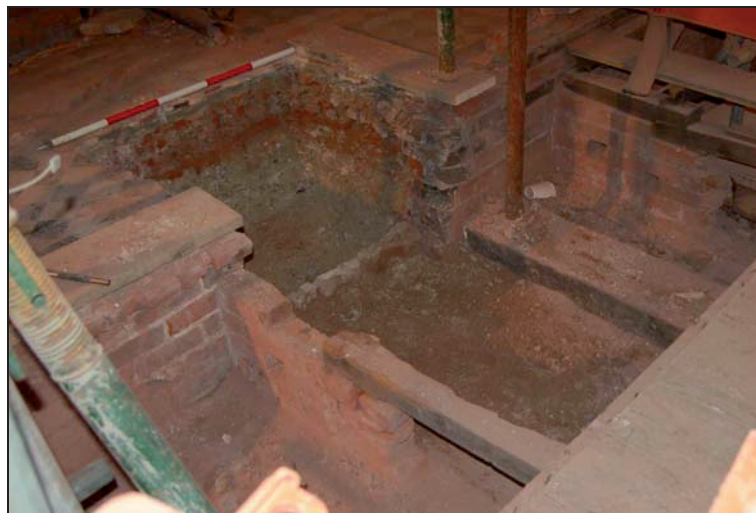
Plate 7: Walls within the internal trench

5.1.2 The trench abutted the east – west wall that was part of the original church fabric and a series of north – south aligned walls, between 0.31 and 1.50m apart, ran from the this towards the southern end of the church. These appear to have been a later insertion for the new floor.

- 6.1 The Baptist church was constructed at the very end of the 19th century on, what may have been the periphery of the medieval town. The groundworks that were inspected during the project did not reveal any features that may be associated with earlier use of the site. On the contrary, the internal trench revealed structural evidence for the floor that was inserted into the main body of the church in the late 20th century.
