**WATCHING BRIEF:
ST MARY'S CHURCH
ASPENDEN
HERTFORDSHIRE**

NGR: SP 3536 2839

on behalf of Aspenden Parochial Church Council

May 2008

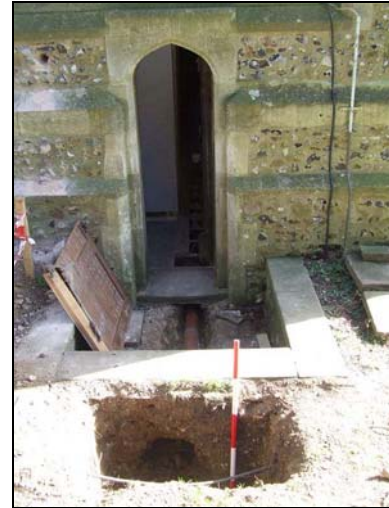
Situated 1.5m west of the church tower this was hand dug at the point where the drainage pipe would turn 90° and continue south. An electric cable ran through the test pit running north-south as well as a clay drainage pipe. No archaeological remains were observed and the natural geology was not reached.

Plate 2: Test pit and drainage run into tower, facing East

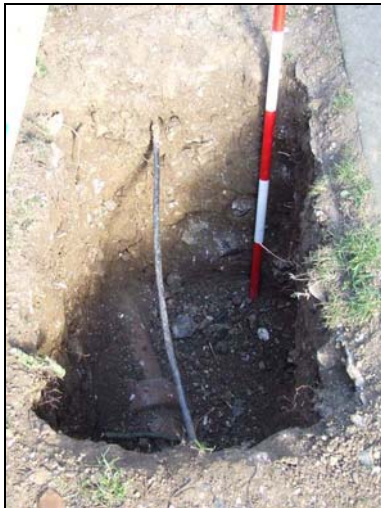
- 900mm x 600mm and 600mm deep

- 100mm of silty clay topsoil with occasional flint nodules
- 500mm of re-deposited, mid brown-beige, silty clay

Plate 3: Test pit, facing North

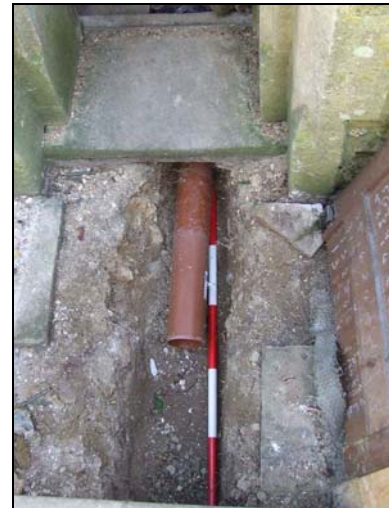
Plate 4: Drainage run under church tower doorway, facing East

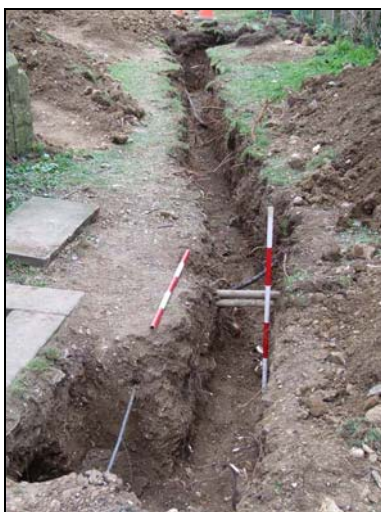
The trench ran between the test pit and the cess pit, and was machine excavated. Services within the trench included a large electric cable that crossed the trench twice, and a scaffold pipe containing electrics at the northern end. No archaeological remains were observed and the natural geology was not reached.

- 10.2 metres long x 400mm wide x 800mm deep.

- 300mm of silty clay topsoil with occasional flint nodules
- 500mm of re-deposited mid brown-beige, firm, silty clay with frequent chalk and flint nodules

Plate 5: Test pit and trench, facing South

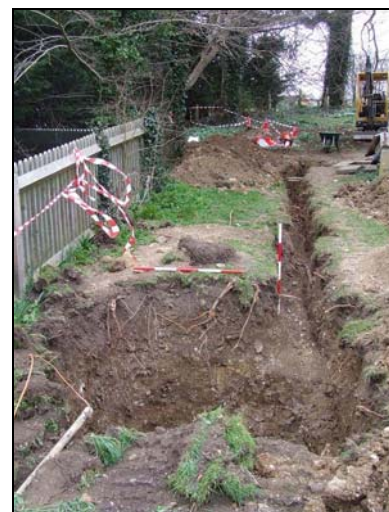
Plate 6: Cess pit and trench, facing North

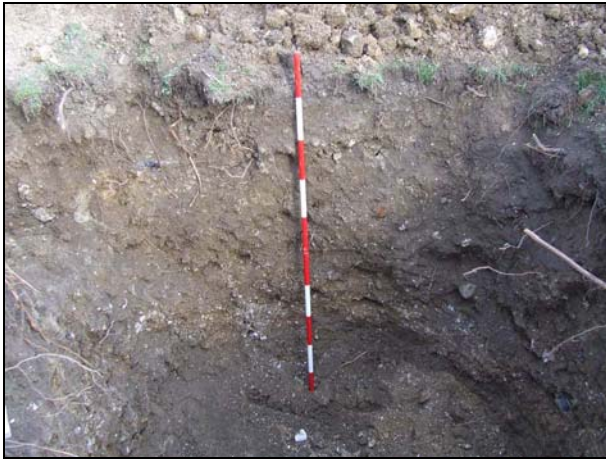
The cess pit was located at the southern end of the trench. The pit was machine excavated to a depth of 2m and then hand dug to a depth of 2.20m. It was roughly 2.2m in diameter and sub circular in plan.

Plate 7: Cess pit, facing East

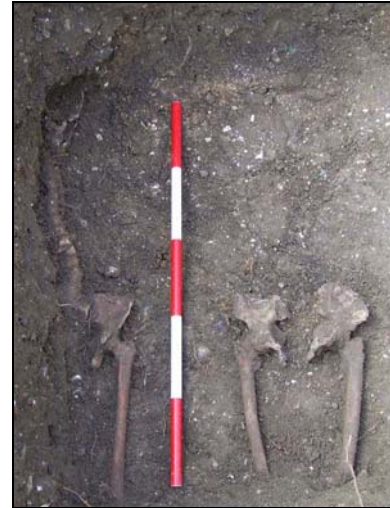
Both skeletons were discovered within the same grave cut [0004], indicating that they were buried at much the same time. The burials were accompanied by coffin nails, a coffin bracket and handle (Plate 11).

Plate 8: Skeleton 0006 and 0007, vertical shot

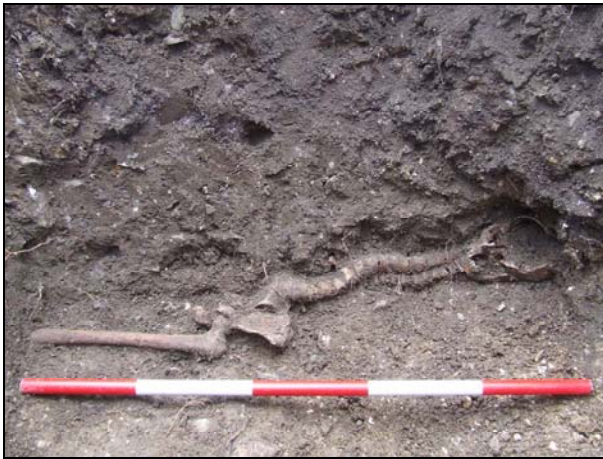
Skeleton 0006 was a female aged between 16-20 years. Markings on the spinal cord indicated the individual suffered from biological stress in early childhood but no other pathological signs of ill health were present on the surviving skeleton.

Plate 9: Skeleton 0006, facing South

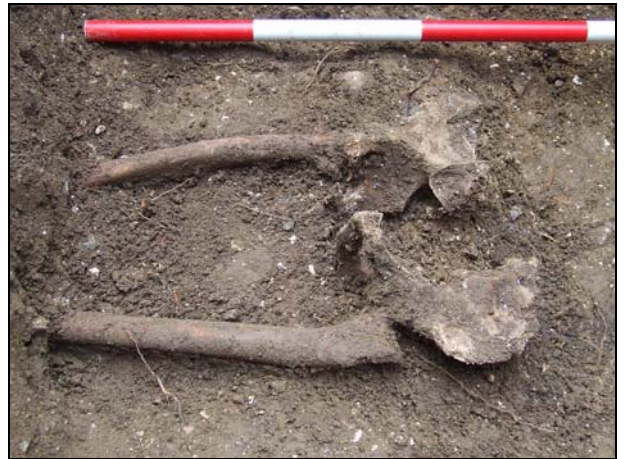
Skeleton 0007 was a male aged between 36-51 years. Due to the lack of dental remains further age indicators could not be used, although it is likely the individual falls into the older age range. This conclusion is supported by the severe osteoarthritis discovered on both hip joints, the condition being most severe on the right.

Plate 10: Skeleton 0007, facing South

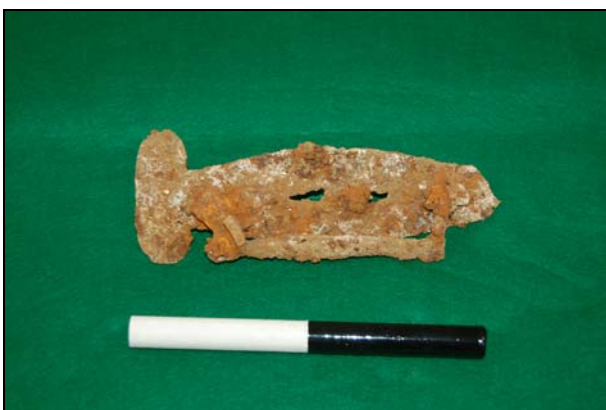
Plate 11: Coffin Handle from (0005)

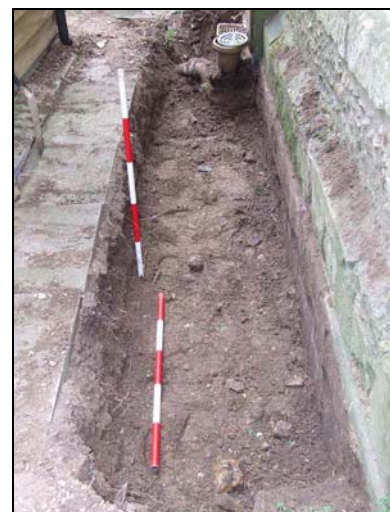
The French drain was machine excavated along the north side of the church tower.

- 5.2m long x 800mm wide x 500mm deep

- 500mm of re-deposited topsoil

The trench revealed the concrete that had apparently been applied to the stone wall in the 1960s to counter the damp problem.

Plate 12: French drain, facing East
