**WATCHING BRIEF:
BELMONT VIEW
HAILEY DRIVE
HODDESDON
HERTFORDSHIRE**

NGR: TL 37110 10676

on behalf of Hertfordshire County Council

ASC: 1086/HBV/2

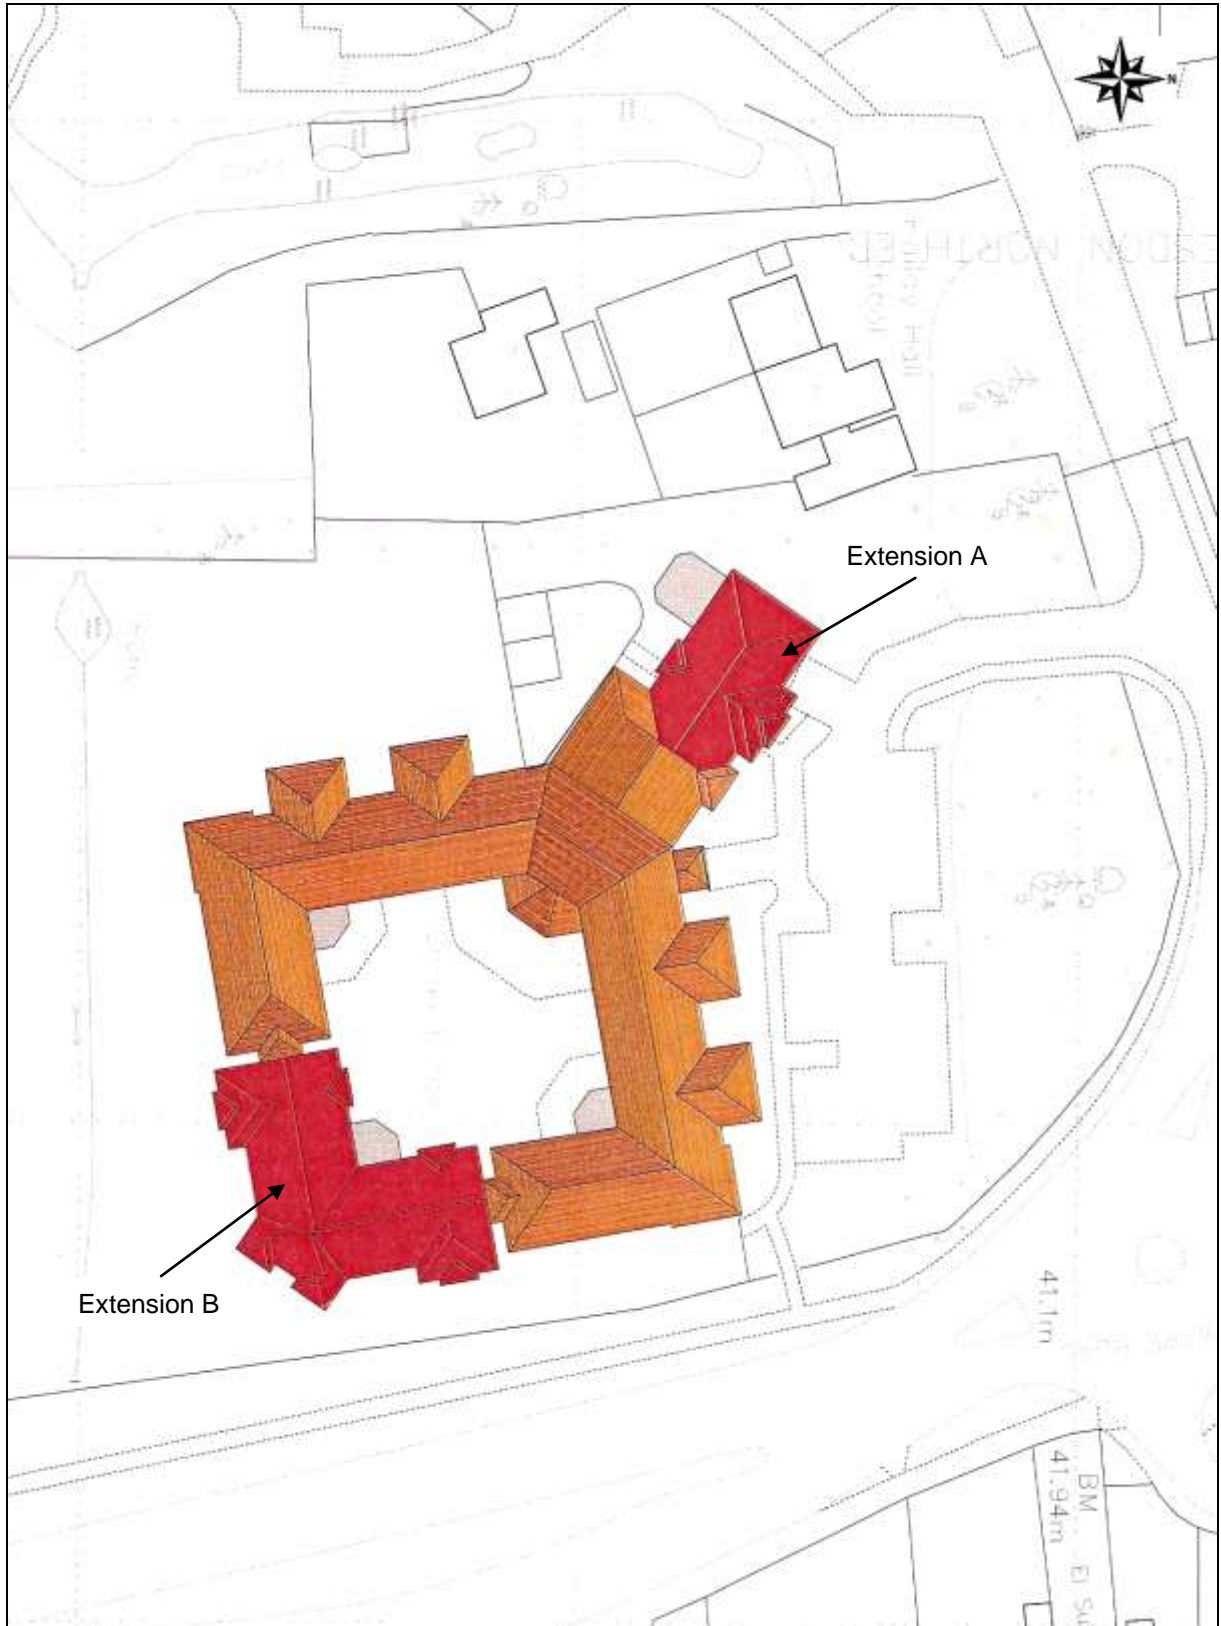
The proposed development comprises extensions to the northwest and southeast of the existing building (Fig. 3, Extensions A and B).

Figure 3: Proposed developments, shown in red (*not to scale*)

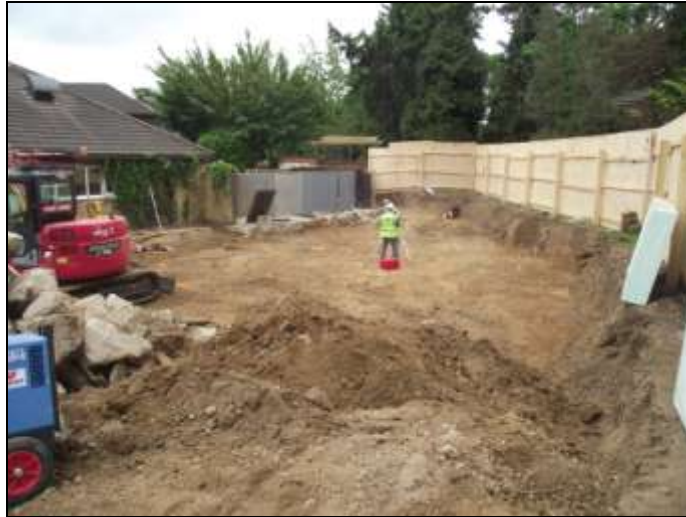
The area of the smaller extension, to the north-west of the existing care home, was reduced in level by up to 1.3m in depth. The stratigraphy encountered comprised:

0.00 – 0.30m	Topsoil & turf	
0.30 – 0.80m	Redeposited soil	Mid brown/orange, very silty friable clay
0.80 – 1.05m	Subsoil	Clean orange/brown, very fine silty friable clay
1.05m+	Natural	Orange clay with pea gravel

Plate 1: Extension A: general shot of reduced area

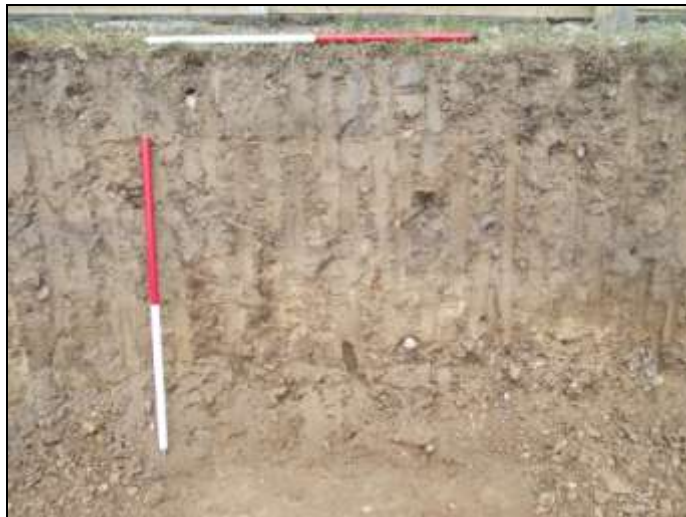
Plate 2: Extension A: detail of stratigraphy

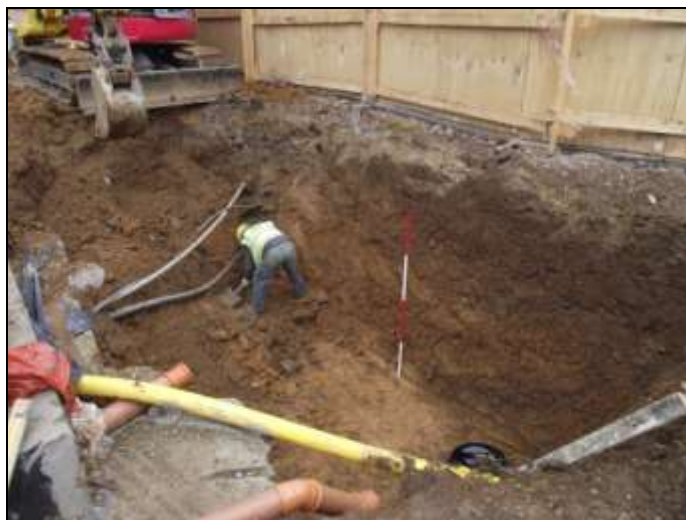
With the exception of a small area in the west corner, the whole of Extension A was reduced to natural, so the excavation of footing trenches in this area was not monitored. Excavation of a large soakaway pit on the north-east side of the extension revealed similar stratigraphy to that described above.

Plate 3: Extension A: soakaway

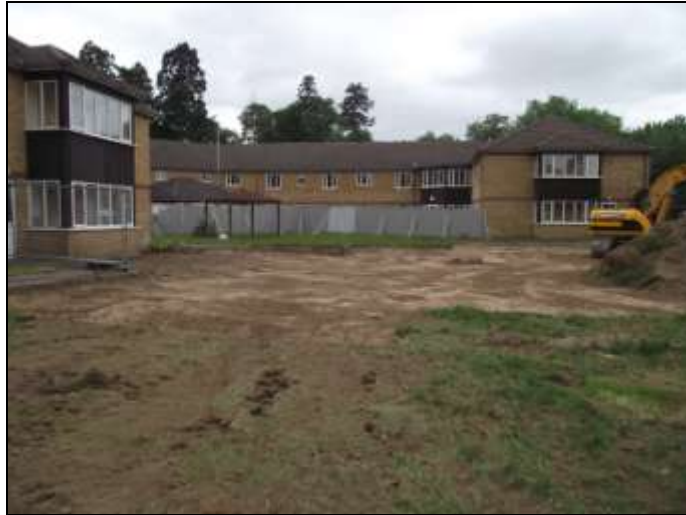
The area of the larger extension, at the south-east corner of the existing building, was mechanically stripped of topsoil, following which footing trenches were excavated to a depth of c. 1m below the stripped level. The stratigraphy encountered comprised:

Plate 4: Extension B: general view during topsoil stripping

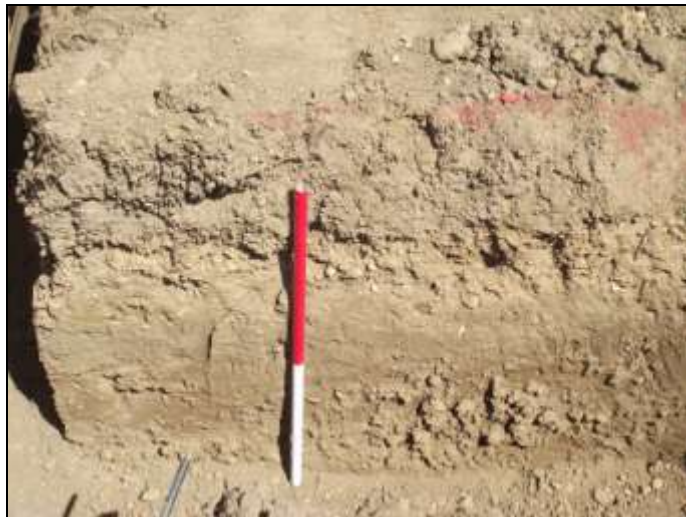
0.00 – 0.60m	Redeposited soil	Mid brown/orange, very silty friable clay
0.60 – 1.00m	Subsoil	very gravelly, mid brown/red sandy silt
1.0m+	Natural	Orange clay with pea gravel

Plate 5: Extension B: detail of stratigraphy

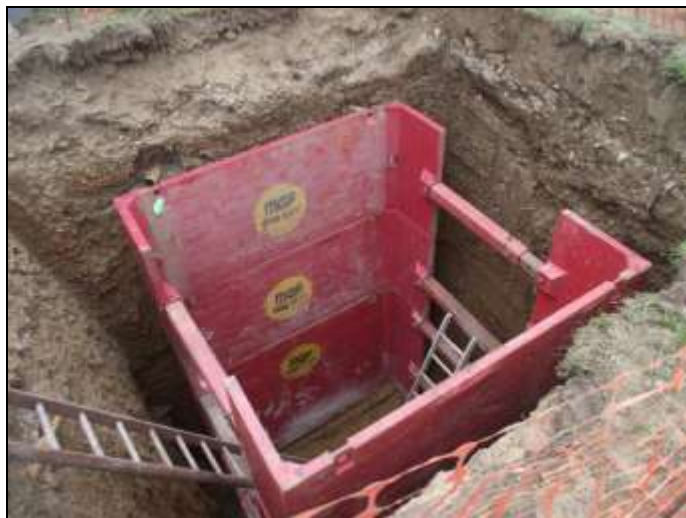
The actual depth of the natural varied across the site: not all footing trenches reached it (Fig. 5). Two soakaways were excavated in association with this extension, to the north-west and south-east respectively. Both revealed similar stratigraphy to that described above.

Plate 6: Extension B: northern soakaway
