**WATCHING BRIEF:
THE HOMESTEAD
EYTHROPE PARK
WADDESDON**

NGR: SP 7703 1415

September 2008

ASC: 1089/ETH/2

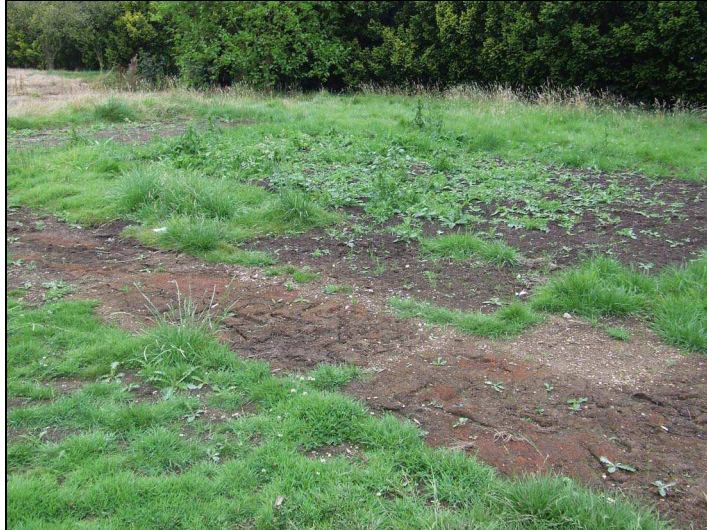
Plate 1: Planting area to north of The Homestead

- 4.3 The remains of garden paths and planting areas were observed to the north of the Homestead (Fig. 7, Plates 1 & 2). These were examined by a historic gardens expert and interpreted as typical of a late Victorian or Edwardian formal garden. The footpaths were likely to be formed of hoggins, and the central area of the axial footpath would have held either a statue or fountain; several small shrubs were removed during the ground reduction in this area, but any decorative feature that may have stood here had already been removed. These footpaths are shown on the second edition 6" to 1 mile Ordnance Survey map of 1900, and were still present in 1950 (Figs. 4 & 5); but only the axial path remained prior to this development.

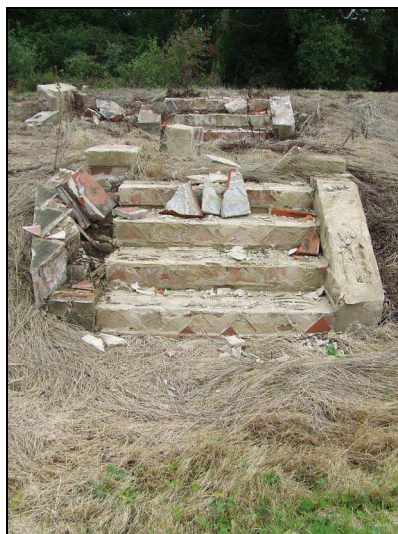
Plate 3: Detail of steps to terrace

- 4.4 The southeastern edge of the pond had been raised to form a terrace and walkway, accessed via steps to the south of The Homestead (Plate 3). Small fragments of bricks and other rubble were observed within the topsoil during the reduction of this embankment, but no retaining wall was present. The embankment was formed of mid brownish orange clay with occasional small chalk fragments, below topsoil 0.30m thick (Plate 4).

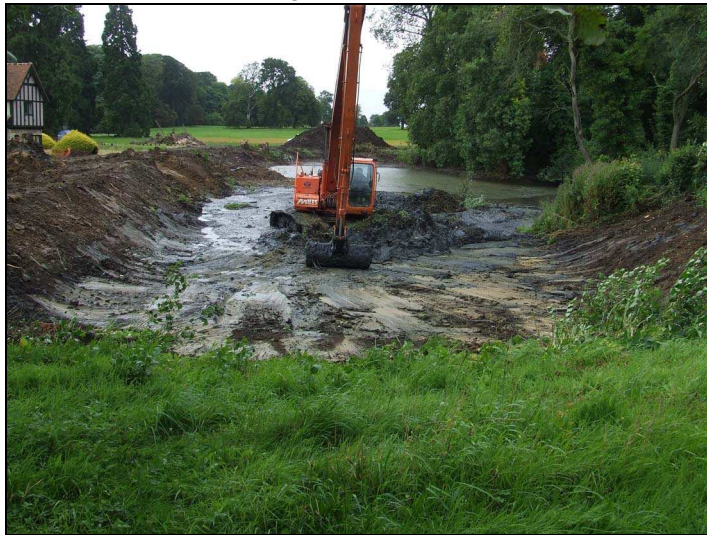
Plate 5: Cleaning northern end of pond

- 4.5 The banks of the pond were covered with vegetation, which concealed concrete steps set into the northern bank. The base of the pond was formed of light yellow clay below a deposit of dark blue-black silt comprising decayed plant matter (Plate 5).

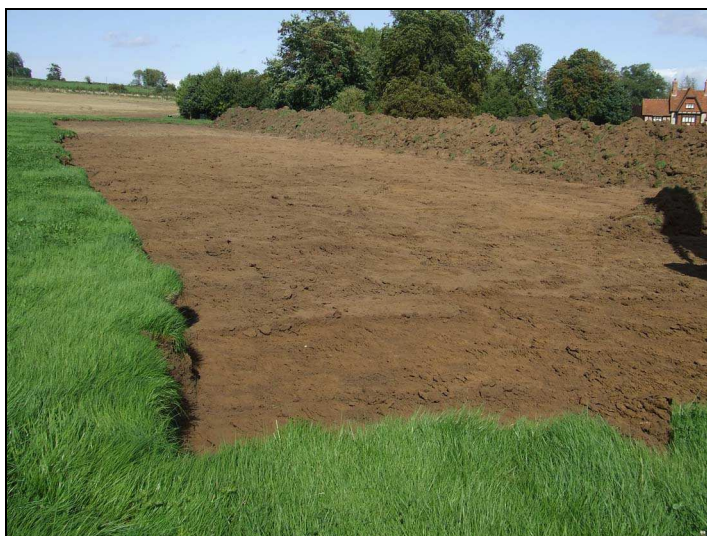
Plate 6: Stripped area of paddock

- 4.6 An area of paddock to the south of The Homestead, and immediately southeast of a large arable field, was stripped of topsoil so that the clay removed from the pond could be stored (Plate 6). No archaeological features were observed in this area, but a few small, abraded fragments of tile were noted within the subsoil. A second area to the north of the pond was also stripped of topsoil (Fig. 7), but no archaeological finds or features were observed in this area.

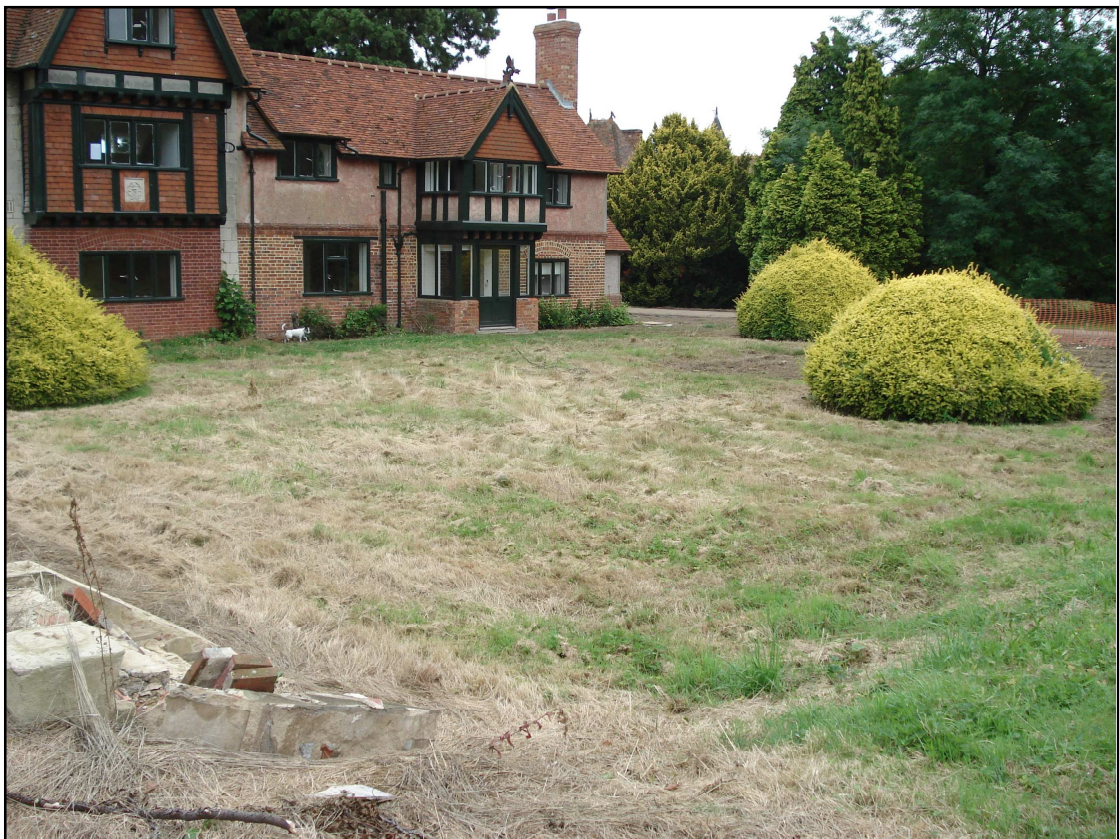
This had the remains of a shallow sunken garden 27.70m on the SE-NW axis by 19m on the SW-NE axis. This was laid to rough grass with three outgrown golden yew topiary cones (Fig 1).

Fig. 1: View from NW corner across sunken garden to The Homestead.

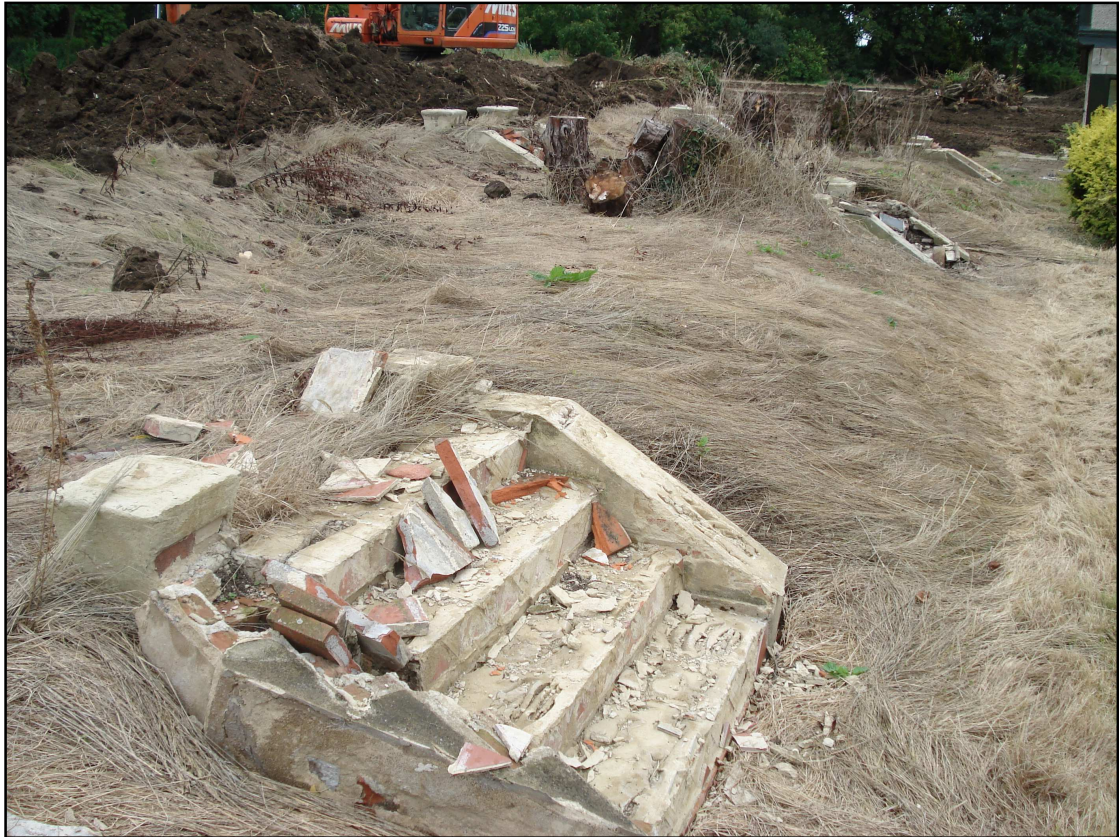
Northwest from this garden were two terraces of approx. 2.80m width running along the whole of the NW side and reached from the garden by three flights of steps at equal intervals (of 7.70m). These steps were 1.10m wide and in flights of four from the garden to first terrace and three from first to second terrace (Fig 2). Information from the digger driver confirmed that these terraces had run long the NW side of the house and the formal garden.

Fig. 2: View from SW end of terrace.

The tops of the steps were flanked with small pedestals 12cm square covered in some cases with four terracotta tiles. Fragments of tiles were found on some of the treads and risers of the steps.

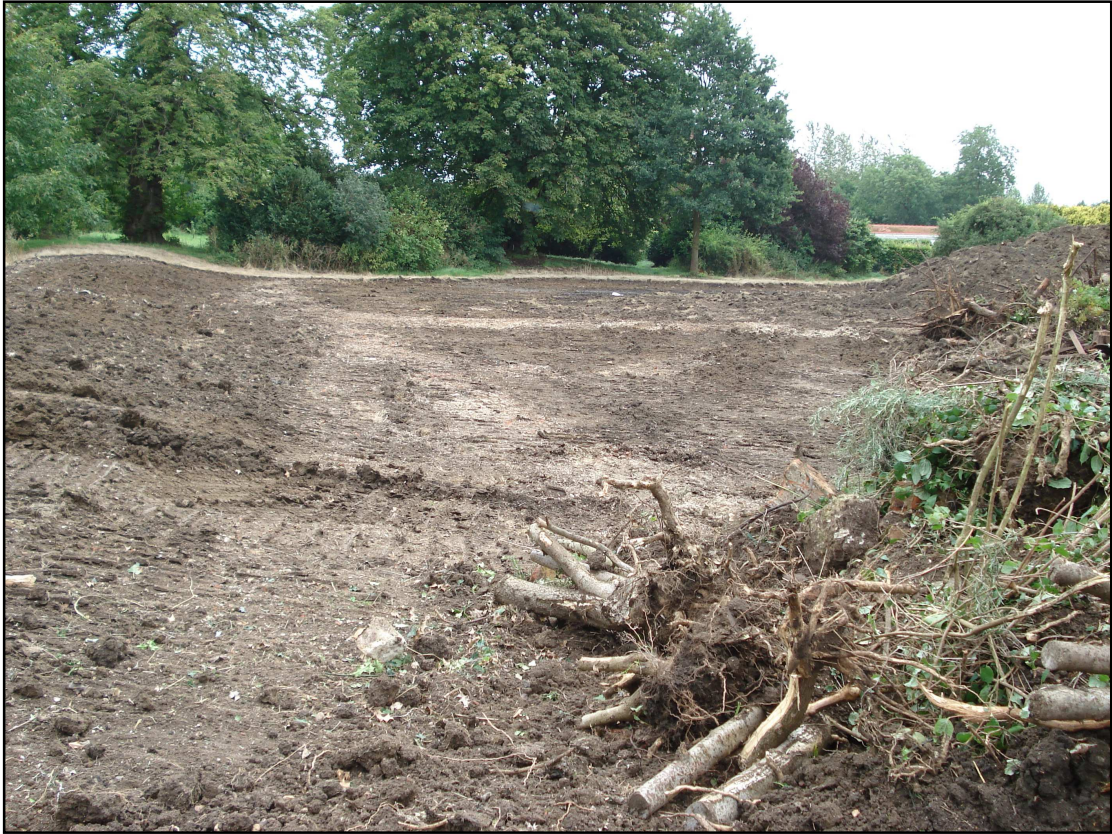
At the time of the visit the topsoil had been removed but the paths were visible a lighter coloured material running along the central NW-SE axis, along the NE side and along the NW side (Fig 4). It was not possible to determine the material these were formed from but hoggin is a possibility. The annular pattern of the path in centre of the footpath was visible and may have enclosed a pond, fountain or statue.

Fig. 4: View of paths in formal garden from W corner of garden.
