**DESK-BASED ASSESSMENT:  
HARROLD TENNIS CLUB  
HARROLD  
BEDFORDSHIRE**

NGR: SP 9502 5690

ASC: 1095/HTC/1

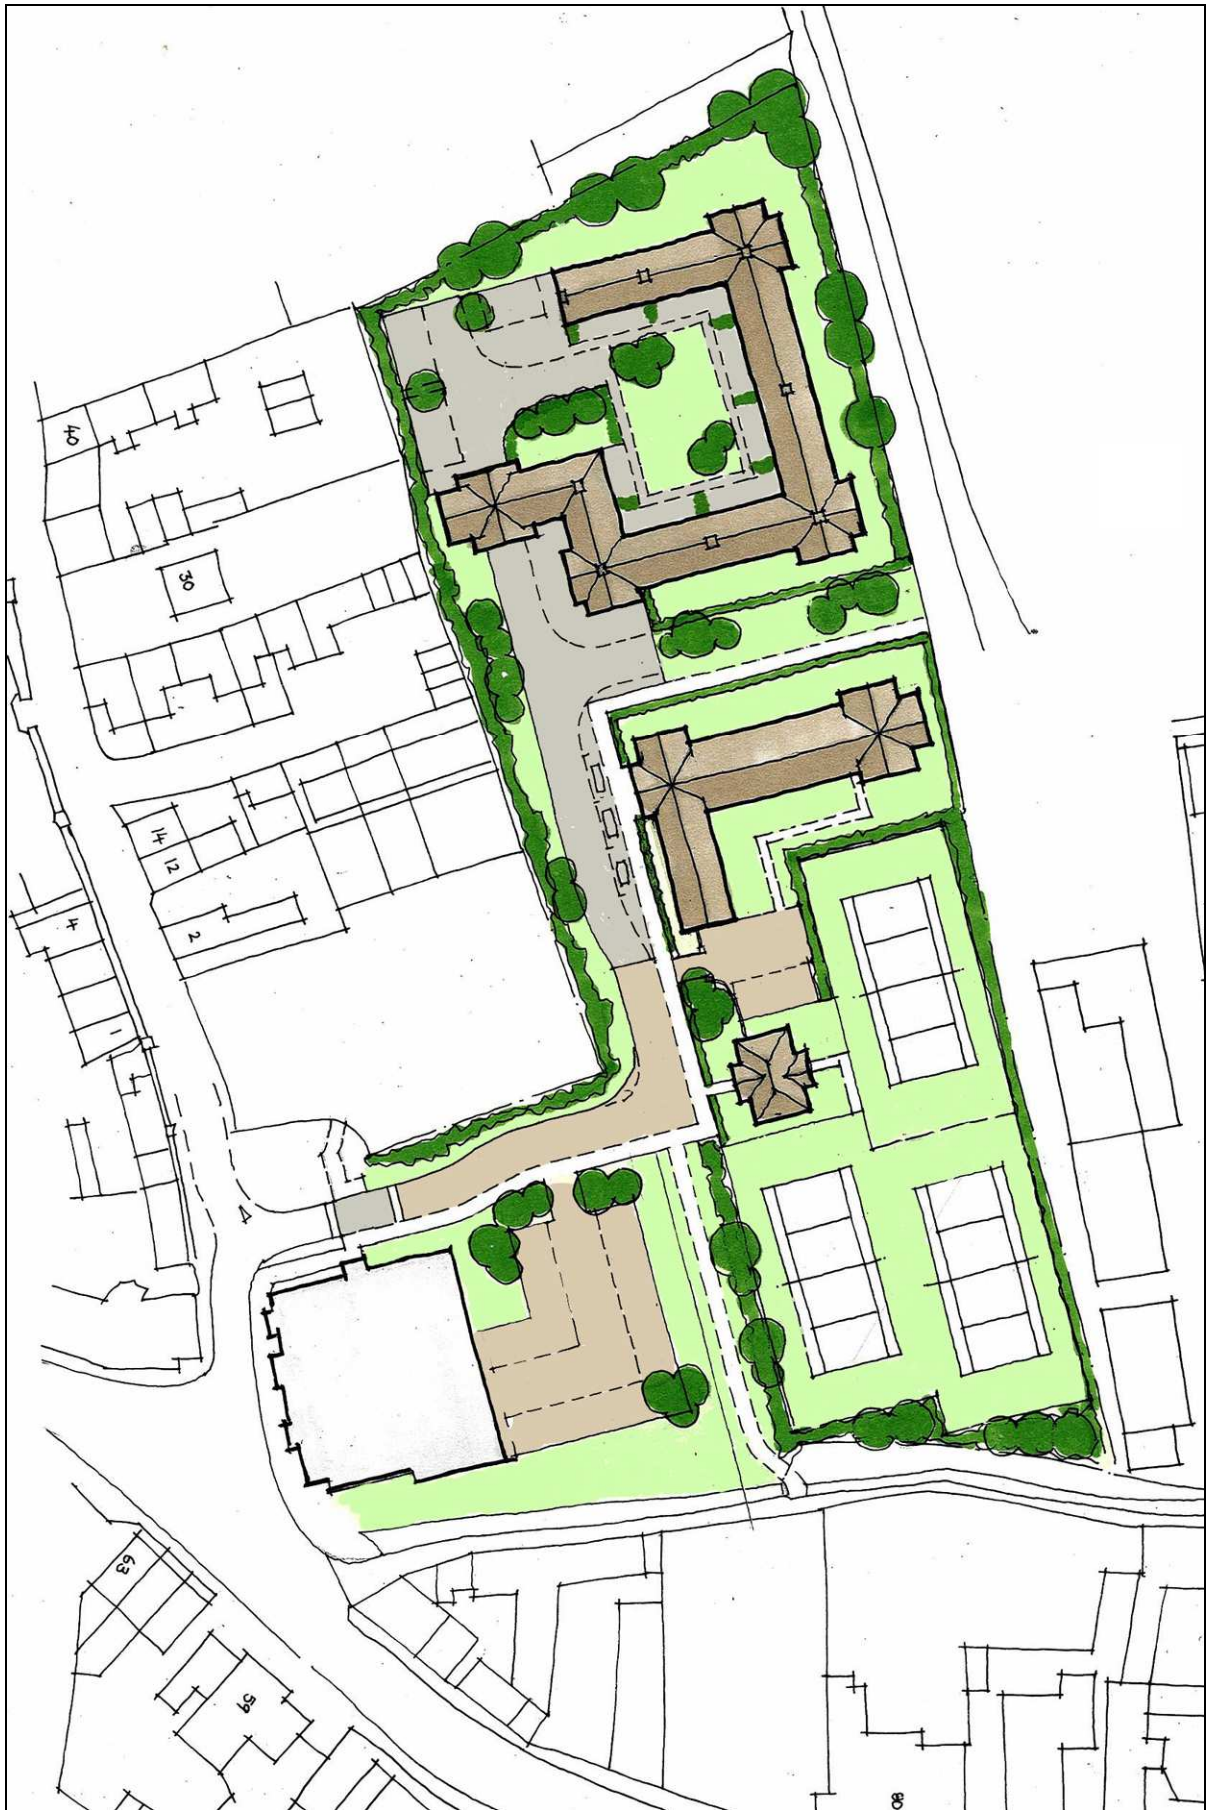
**Figure 2:** Site location and proposed development (*not to scale*)

The proposed development comprises the erection of a clubhouse, three new tennis courts, a new access road, car parking and associated works (Fig. 2).

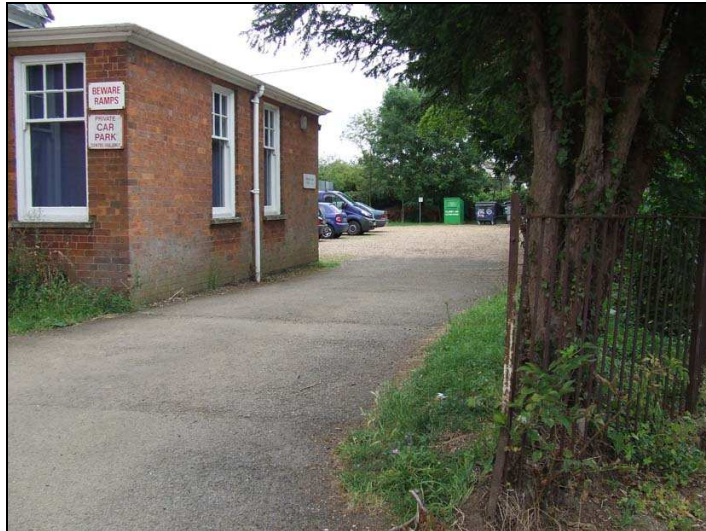
The site is essentially split into two separate areas, both of which have separate access points (Plates 1 & 7), and are partially separated by a brick wall. The western area comprises the current village hall, tennis courts and play area (Plate 3). This area is accessed from Brook Lane, which runs along the western edge of this part of the site. The eastern area is approximately twice as long as the western area, and currently comprises two fields (Plate 5). The southernmost field is currently being used as pasture for horses, while the northern part is more overgrown (Plate 8).

**Plate 1:** Access to the existing tennis courts, looking east

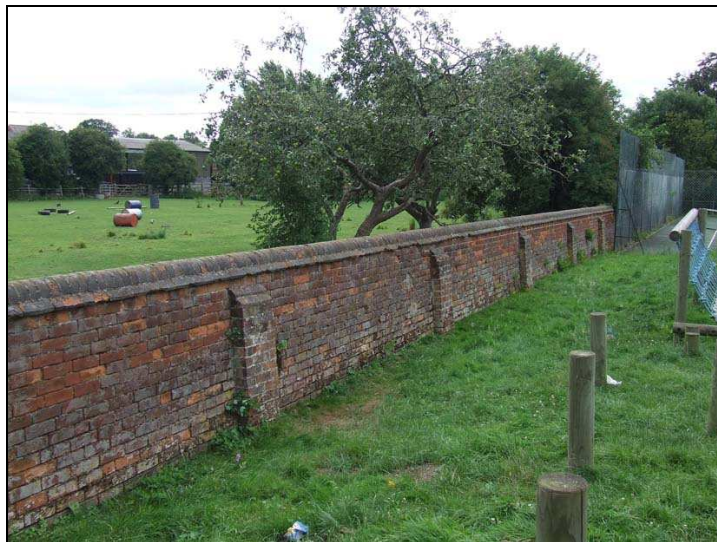
**Plate 2:** Central boundary wall, looking southeast

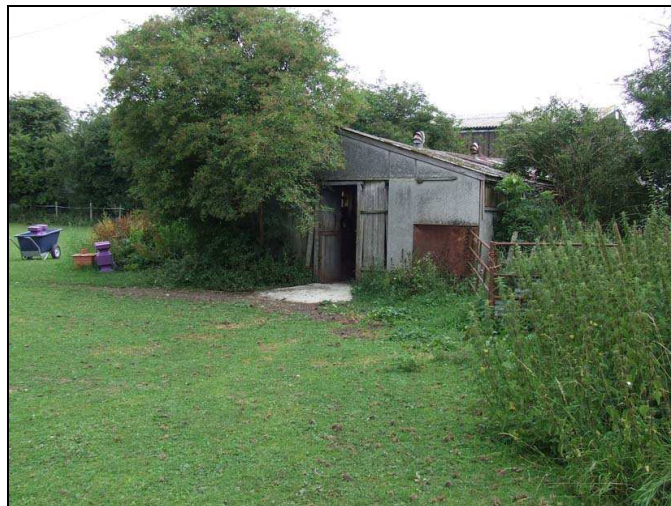
The village hall (front cover) is located in the southwestern corner of the site, and is to be incorporated into the proposed development. There is a concrete building with a corrugated iron roof located close to the southeastern corner of the site (Plate 5).

**Plate 5:** Building in the southeastern corner of the site, looking east

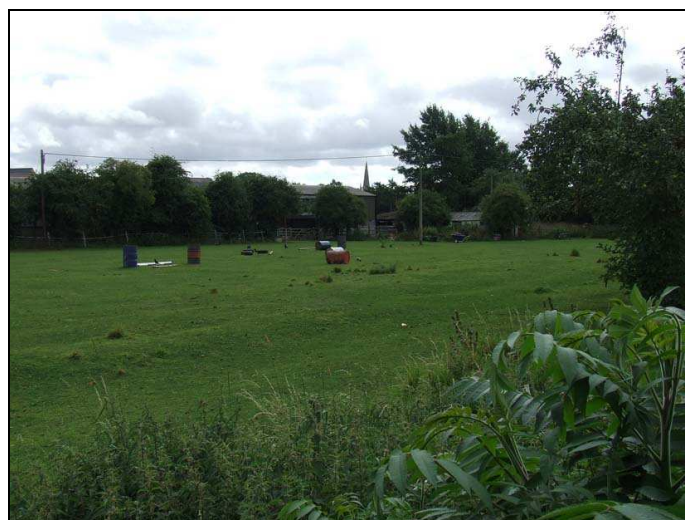
There are likely to be underground services in the western part of the site, particularly located close to the village hall, and the buildings in the southwestern corner of the site. There are overhead telephone cables running across the southeastern corner of the site, with a telegraph pole situated within the southern part of the eastern area of the development site (Plate 6).

**Plate 6:** Potential ridge and furrow, looking southeast

The proximity of the site to areas of dense archaeological remains suggests that they may extend within the site. The walkover survey revealed some earthworks within the southeastern third of the site, including potential ridge and furrow close to the existing play area (Plate 6). This may extend further into the northeastern third of the site, but the overgrown nature of that area made it difficult to tell during the walkover survey. The presence of these earthworks indicates that this side of the site may not have been subjected to any significant development, and therefore has a relatively high potential for the survival of archaeological remains, potentially relating to the core of Saxon settlement identified in the HEUS. Comparatively, the western part of the site has been subjected to too much development to have a high potential of the survival of archaeology, although there is limited potential for buried remains beneath the existing tennis courts.

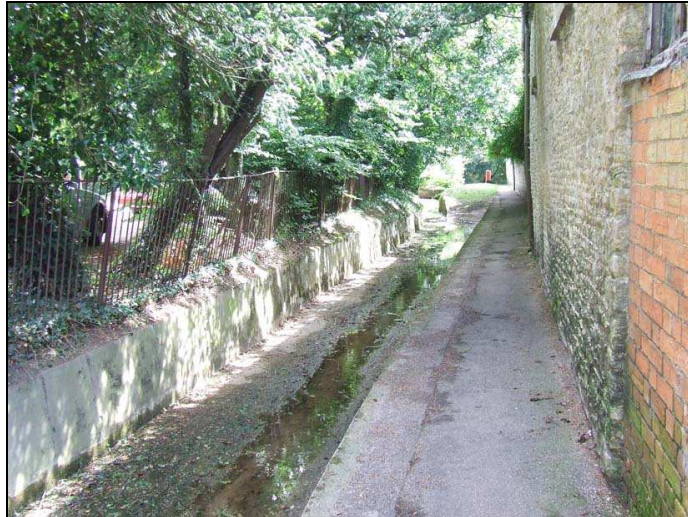
**Plate 7:** Current access to the eastern part of the site, looking east

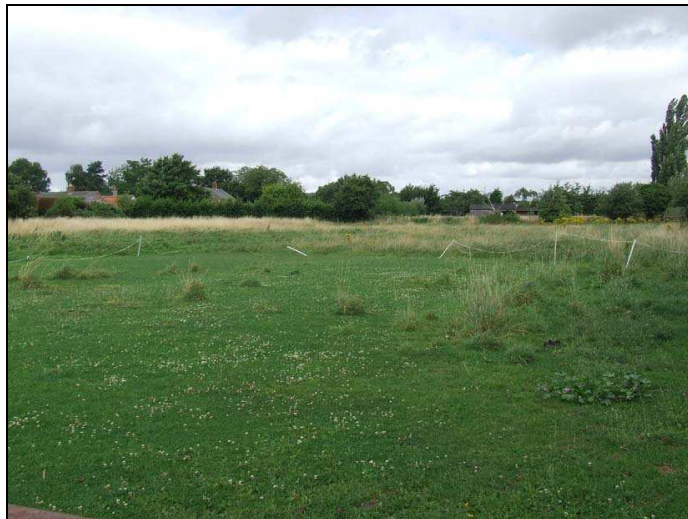
**Plate 8:** The northern part of the site, looking north
