**HISTORIC BUILDING RECORDING:
BARN AT ELM COTTAGE
ST ALBANS ROAD
REDBOURN
HERTFORDSHIRE**

NGR: TL 1117 1156

For Richard Lloyd, on behalf of Mr Reekhaye

NOVEMBER 2008

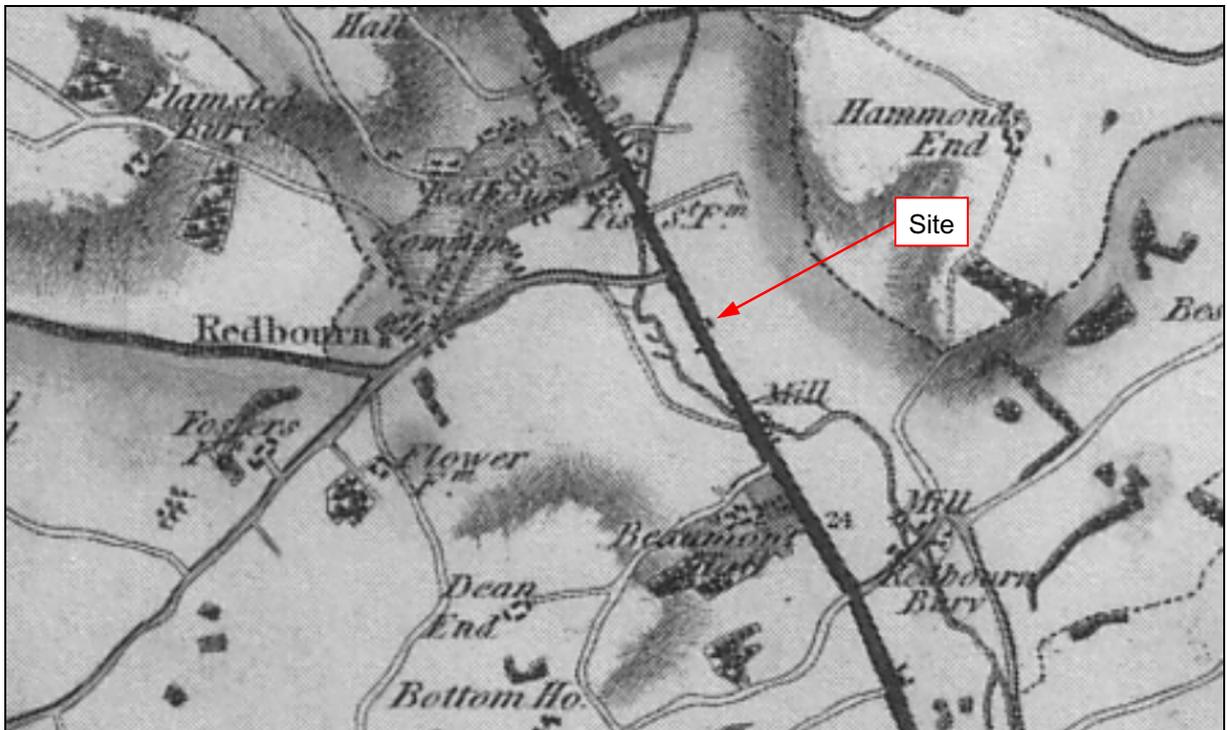
Figure 4: Extract from Bryant's map of Hertfordshire, 1821 (not to scale)

The earliest surviving maps are mostly of too small a scale to show the site in any detail. Dury and Andrews’ county map of 1766 (Fig. 3) does show the area in some detail, but provides no indication that the site was inhabited at that time. Bryant’s map of Hertfordshire, dated 1821 (Fig. 4), shows a single building on the site, presumably *The Elms*, which was constructed c.1800. By the middle of the 19th century, the first large-scale map of the area, the Redbourn Tithe Map of 1841 (Fig. 5) shows *The Elms* in its own enclosure, with a small outbuilding to the rear, and an adjoining enclosure to the immediate north-west, containing a larger outbuilding or barn at right angles to the adjoining road. A similar picture is provided by the 2nd Edition Ordnance Survey sheet of 1898 (Fig. 6), and it is apparent by comparing this map with subsequent editions (Figs 7, 8) that this outbuilding was located to the immediate south-west of the later structure which forms the subject of this survey.

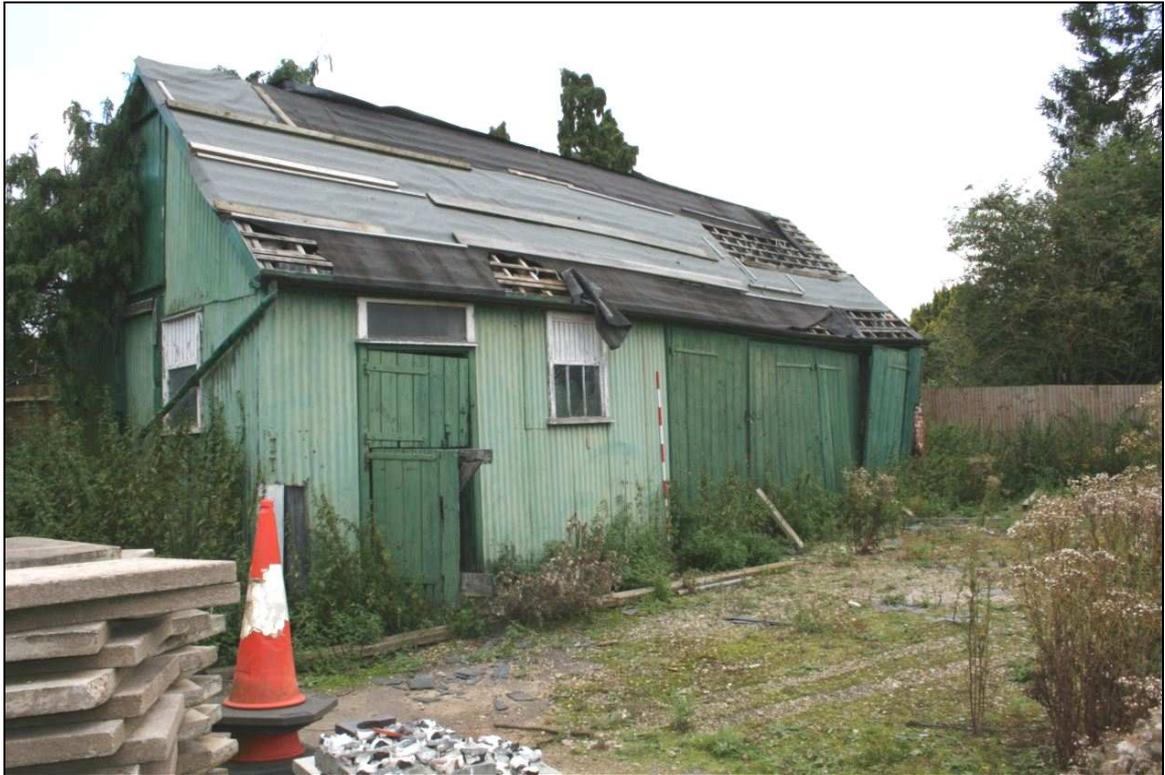
Plate 1: West elevation, from north-west

4.2 *West Elevation* (Plate 1)

This forms the front of the building, facing St Albans Road (Watling Street). The area in front of the building is overgrown, and it is difficult to determine if there were any external features (e.g. paths, drainage) related to the building. The south half of this elevation is occupied with two pairs of ledged and braced doors, of slightly different widths, giving access to Room 3. In the north half of the elevation is a ledged and braced stable door with a transom above, giving access to Room 1, and a timber-framed, three-light window with a ventilator panel above.

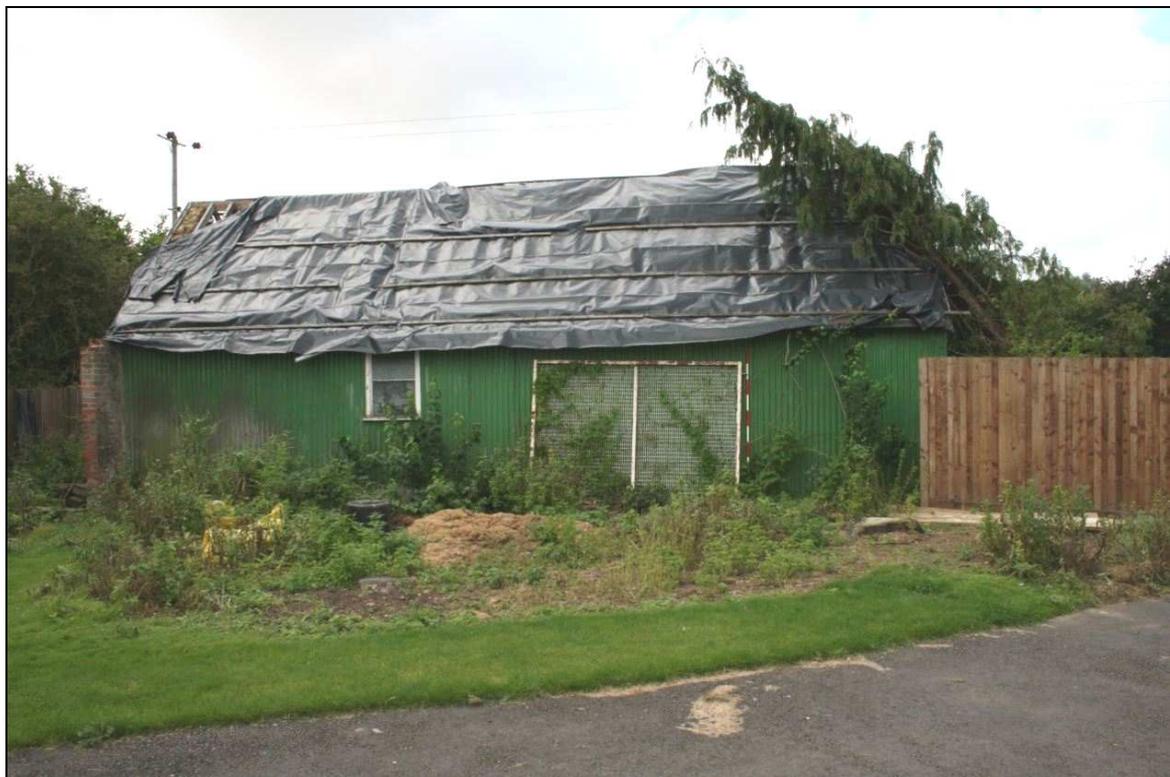
Plate 2: East elevation, from east

4.3 *East Elevation* (Plate 2)

This elevation forms the rear of the building. It is pierced by a single timber-framed window, of similar dimensions to that in the west elevation, but having two lights and no ventilators. At the south end of this elevation, the brick south wall extends *c.*760mm east of the east wall.

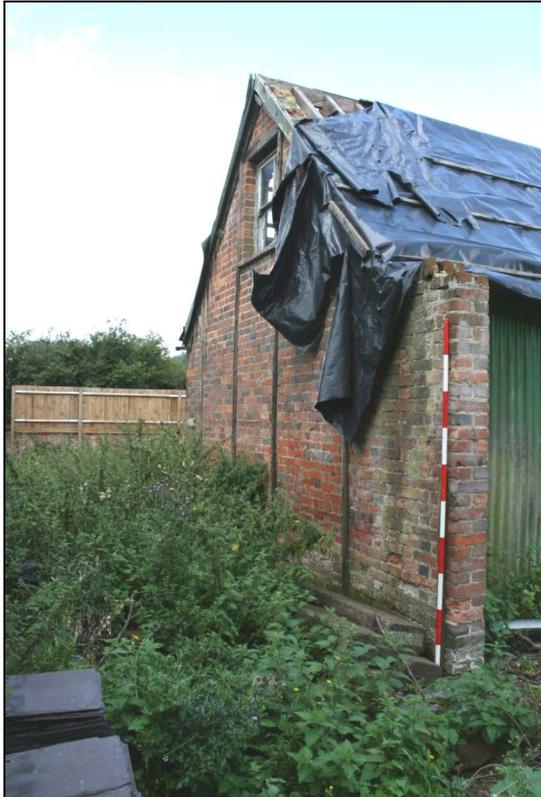
Plate 3: South elevation, from south-east

4.4 *South Elevation* (Plate 3)

This elevation is constructed of brick, laid in Flemish bond with cement mortar. The wall is *c.*225mm thick, constructed of reddish bricks, *c.*225 × 105 × 60mm. As noted above it extends eastwards, beyond the south-east corner of the building. A number of timber battens are nailed to its outer face, suggesting that it may have originally been clad. There is a single timber-framed, 2/2 sash window set high in this elevation, lighting the attic.

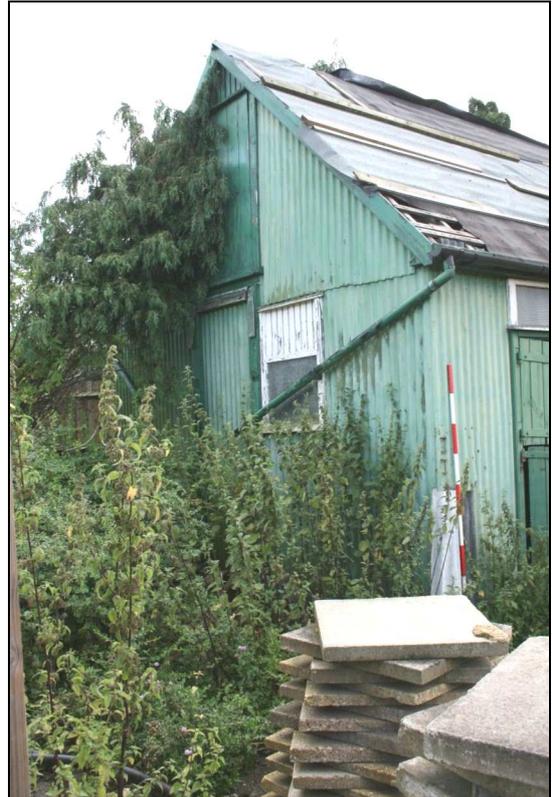
Plate 4: North elevation, from north-west

4.5 *North Elevation* (Plate 4)

This elevation was largely overgrown at the time of the survey. It contains two features: a single-light window at ground-floor level, similar to that already described in the west elevation, and a ledged and braced door at attic level.

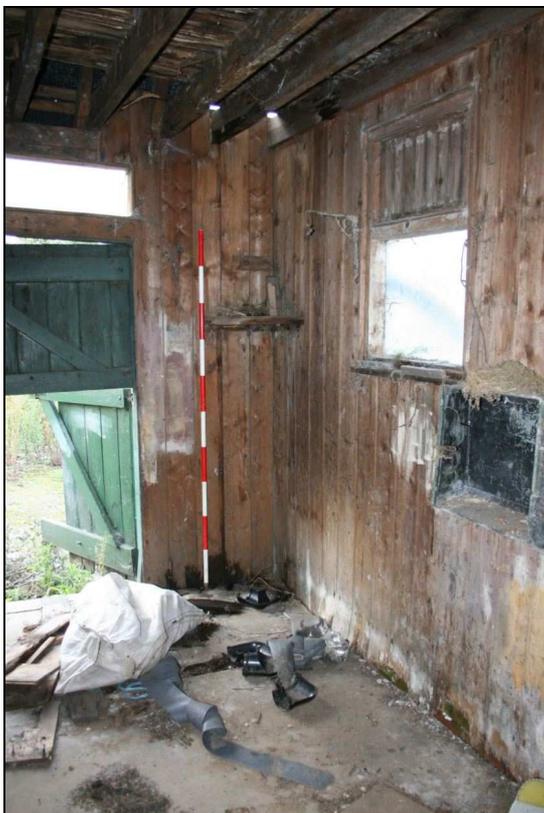
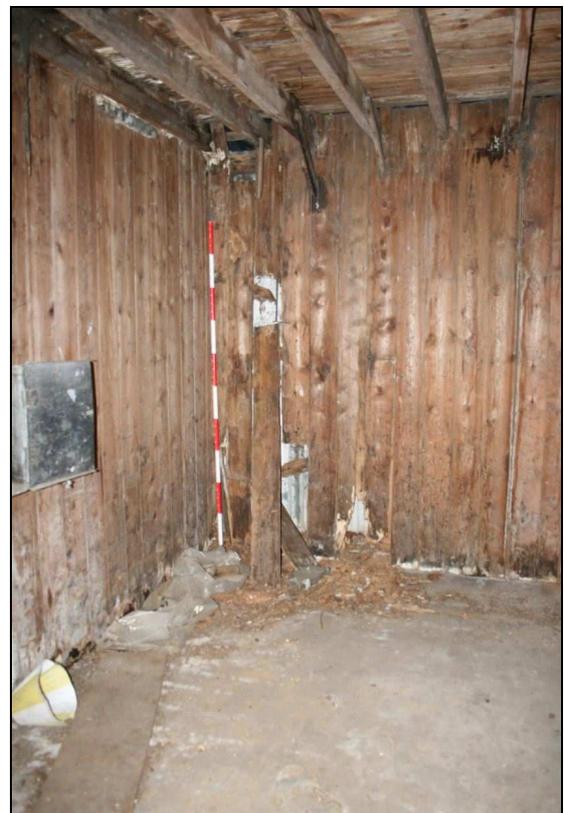
4.6 *Room 1* (Plates 5, 6)

Size: 4.35 × 2.12m, height 2.65m

Location: North end of building

Description: The interior walls are all clad with vertical planking, and the floor is concrete. A drainage gully follows a north-south alignment across the west end of the room, extending into Room 2. In the north-west corner is a small quadrant-shaped wooden shelf, and on the north wall is mounted a sheet metal box with a hinged lid.

Above, east-west aligned joists carry the planked attic floor. There is an external stable door to the west, and a door to Room 2 to the south. In the north wall is a fixed single light window with a ventilator panel above.

Plate 5: Room 1, view north-west

Plate 6: Room 1, view north-east

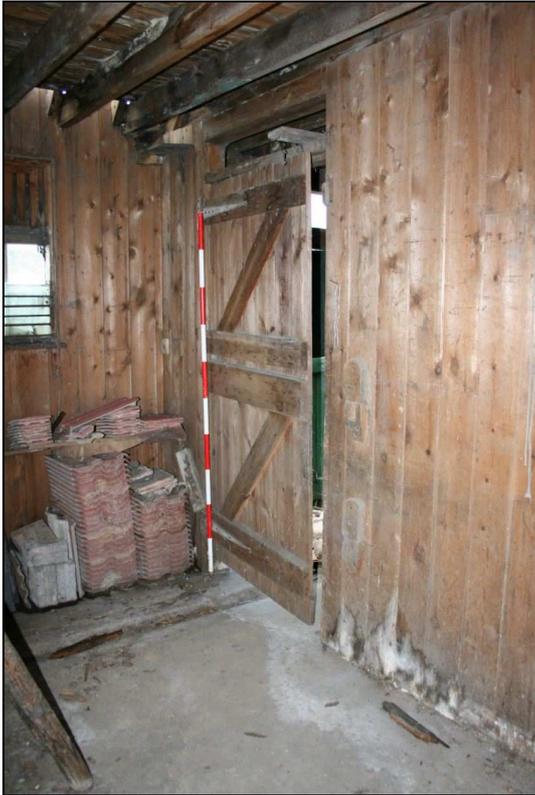
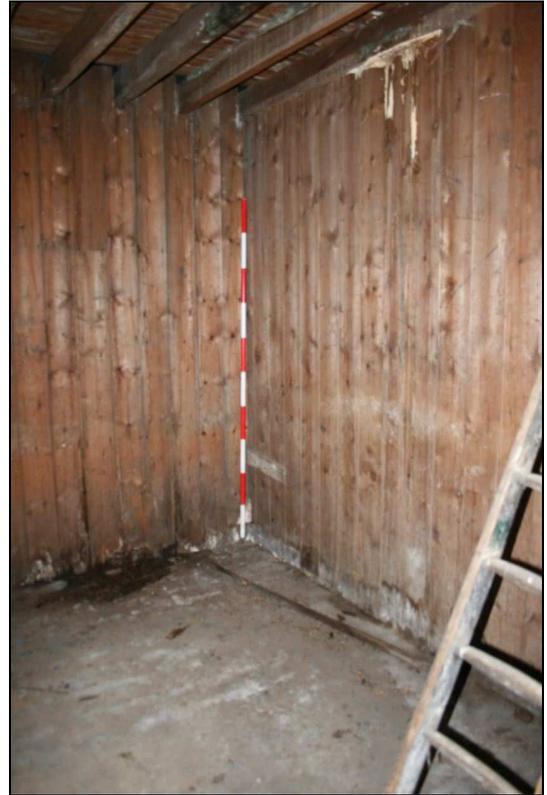
4.7 **Room 2** (Plates 7, 8)

Size: 4.35 × 2.41m, height 2.65m

Location: Between Rooms 1 & 3

Description: The interior walls are all clad with vertical planking, and the floor is concrete. A drainage gully follows a north-south alignment across the west end of the room, extending into Room 1. The door to Room 1, to the north, is ledged and braced. Above, east-west aligned joists carry the planked attic floor. In the south edge of the ceiling is an access hatch to the attic. To the west is a fixed three-light window with a ventilator panel above.

Plate 7: Room 2, view north-west

Plate 8: Room 2, view north-east

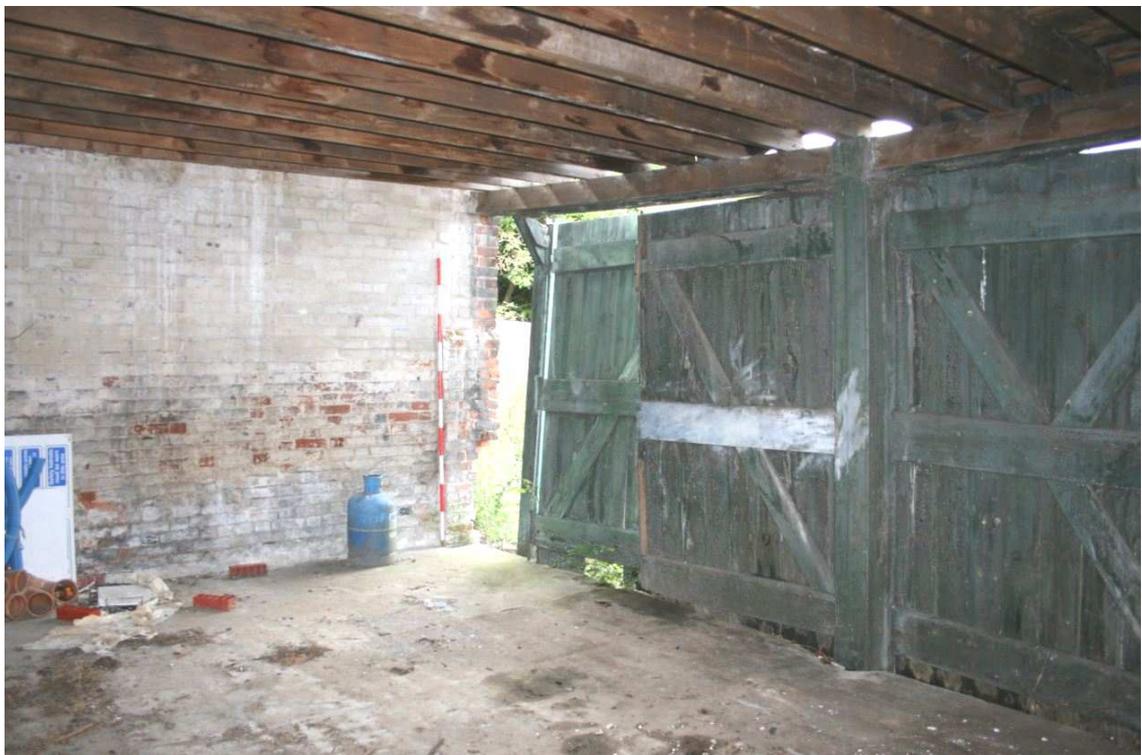
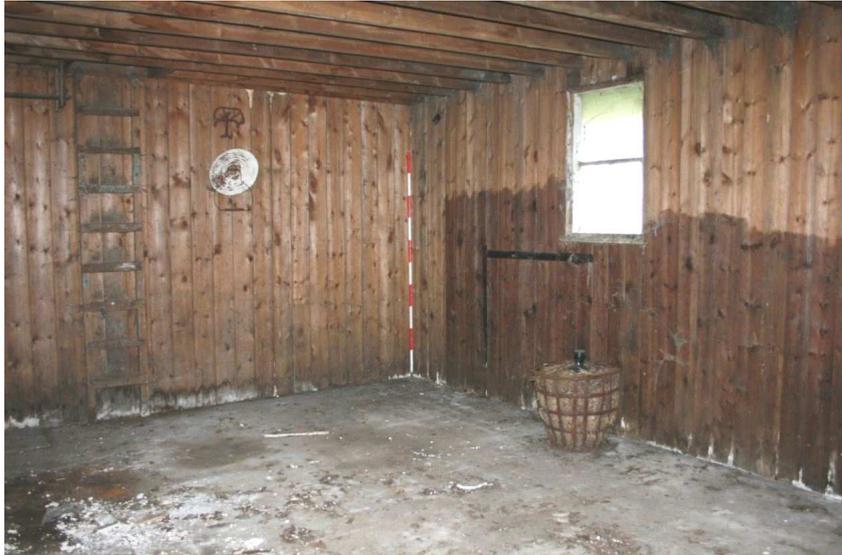
4.8 **Room 3** (Plates 9, 10)

Size: 6.38 × 4.42m, height 2.65m

Location: South half of building

Description: The north and east walls are clad with vertical planking, while the south wall is lime-washed brick. The floor is concrete. The west side of the room consists of the two pairs of doors described above, between which a substantial post provides support for the wall-plate above, and the adjacent doors. Above, east-west aligned joists carry the planked attic floor. In the north edge of the ceiling is an access hatch to the attic, reached by a vertical ladder fixed to the wall beneath. To the east is a fixed two-light window.

Plate 9: Room 3, view south-west

Plate 10: Room 3, view north-east

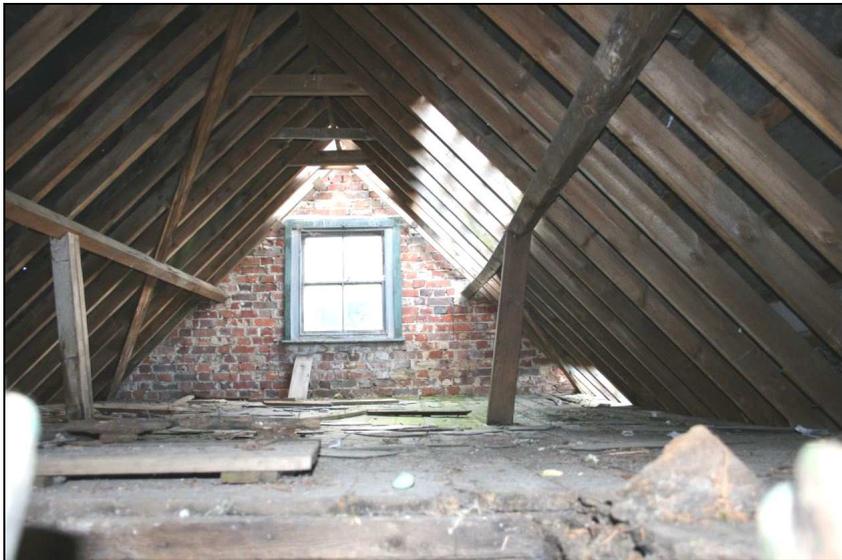
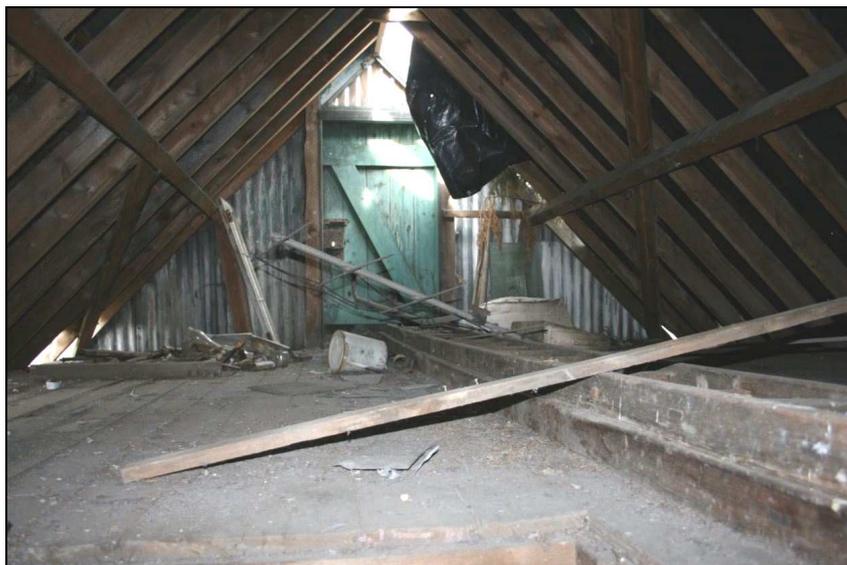
4.9 **Attic** (Plates 11, 12)

Dimensions: 11.2 × 4.4m overall, height to ridge 2.20m

Description: The attic runs the full length of the building, and is accessed by hatches from Rooms 2 and 3, and by a door in the north gable end. In the south gable end is a timber-framed 2/2 sash window. The floor is planked over closely spaced joists, and the roof structure comprises rafters and a single purlin on each side, supported on the gables and intermediate vertical struts, with short collars between alternate rafters.

Plate 11: Attic, view south

Plate 12: Attic, view north

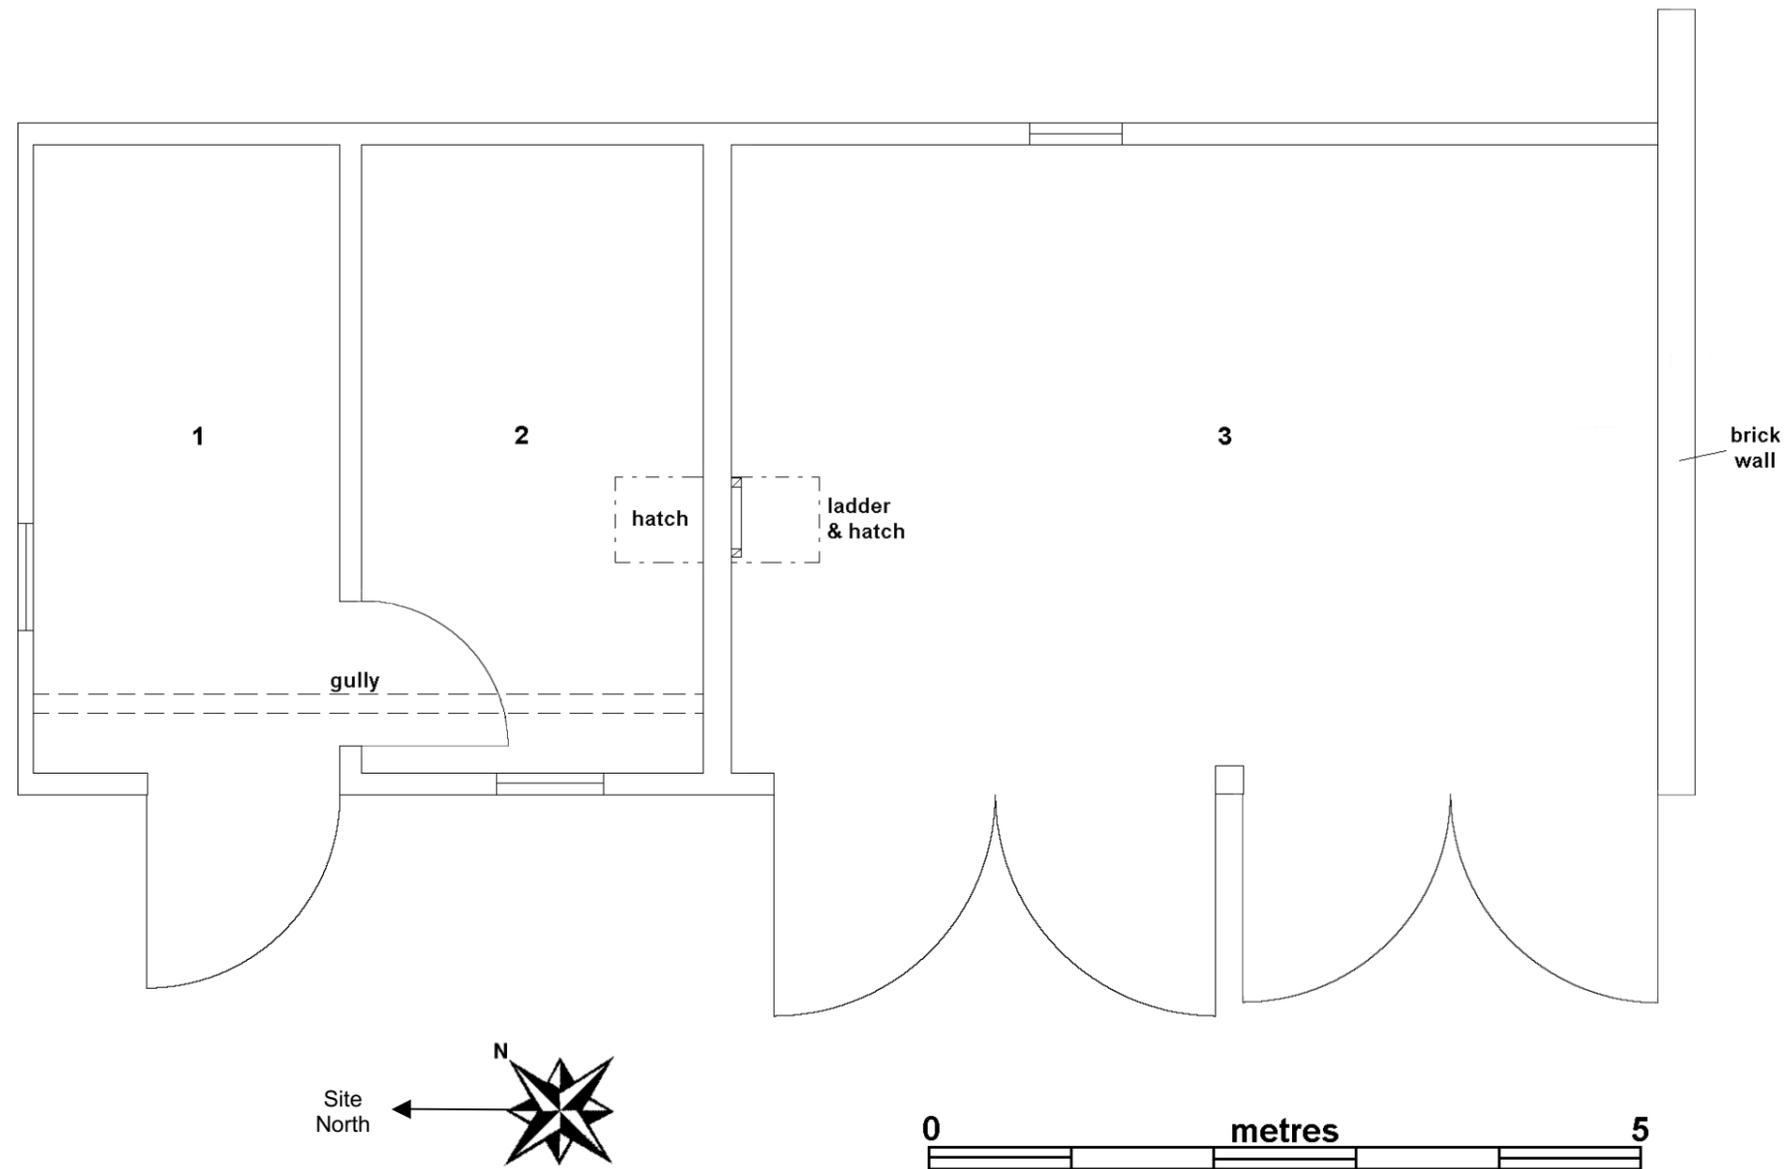
Figure 9: Floor plan (scale 1:50)

4.1 *General* (Fig. 9)

The barn at Elm Cottage is a single storey timber-framed structure, clad externally with corrugated iron sheeting, painted green. In contrast, the south wall is constructed of brick. The roof was originally slate clad: this had been removed prior to the survey. The overall dimensions of the building are *c.*11.75 × 4.7m, with a ridge height of *c.*4.9m. The building is constructed on a NNE-SSW axis: in order to facilitate description, this is taken to be north-south.
